SUBJECT: Lee Gulch Flume

DATE: December 6, 2024

Routine Inspection Flume Structure Inspection and Inventory Report

LEAD-BASED PAINT INSPECTION REPORT

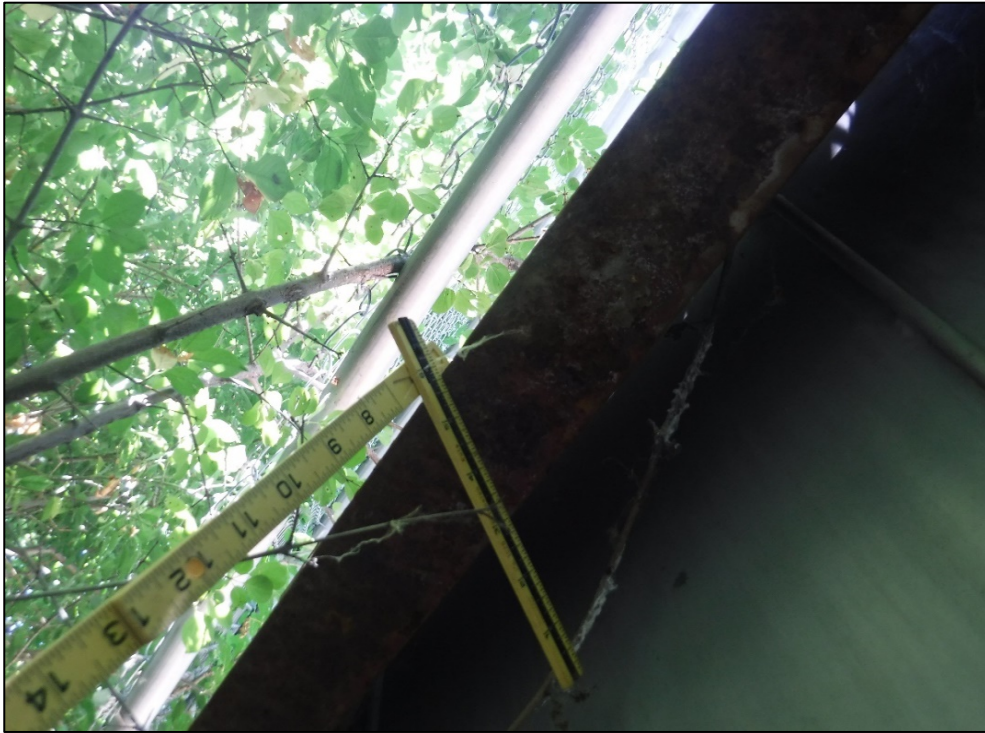
107/1	Steel Open Girder	(LF)	112	0%	0	100%	112	0%	0	0%	0
(2) C-channel beams with frequent web splice plates welded to east beam and bolted to west beam; transverse bracing at 3 feet spacing; painted gray. Beams have R1 corrosion throughout (112LF CS2).											
120/1	Steel Truss	(LF)	96	0%	0	100%	96	0%	0	0%	0
Span 3 is a welded truss; painted gray. Truss chords, diagonals, and verticals have R1 corrosion throughout (96LF CS2).											
207/1	Steel Tower	(LF)	37	68%	25	32%	12	0%	0	0%	0
Steel trestles at all piers; painted gray. Trestles at Piers 2 and 3 are coated black from groundline and above up to 22 inches high. Trestle diagonals, horizontals, and verticals have R1 corrosion starting at groundline up to 3 feet high (12LF CS2).											
215/1	R/Conc Abutment	(LF)	14	64%	9	0%	0	36%	5	0%	0
Active water leakage along both abutments. Abutment 1 both ends at bearing has 6 inch x 8 inch x 6 inch deep spall with exposed rebar and anchors (2LF CS3). Abutment 6 has S3 scaling for 3 feet (3LF CS3).

Beam has R1 corrosion, typical.

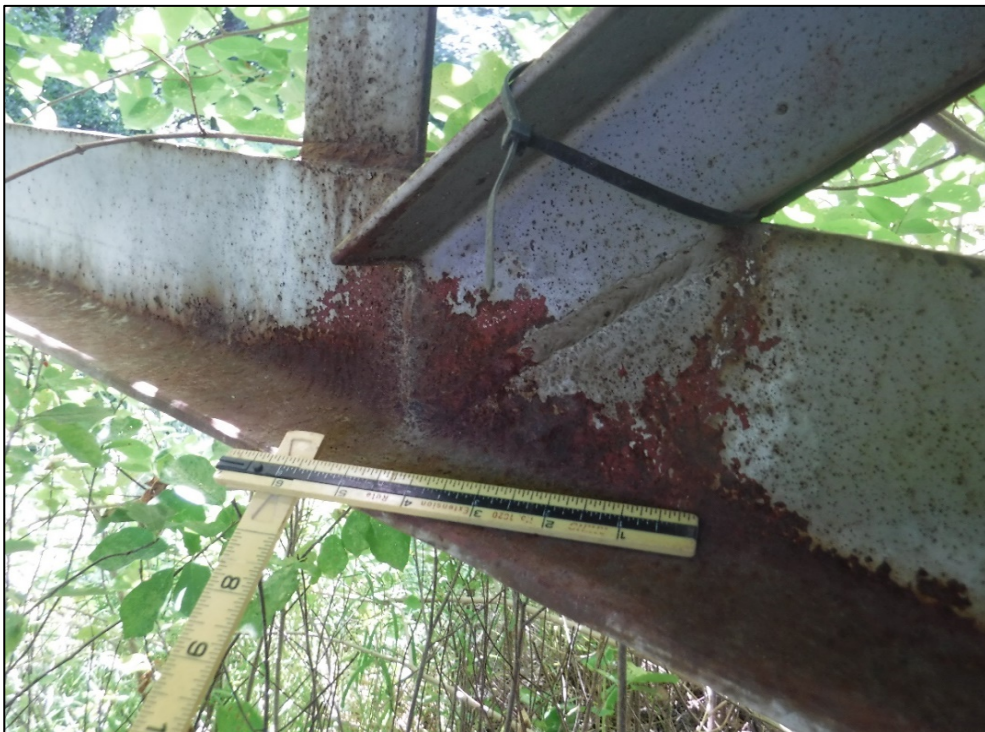
Truss 3A lower chord has R1 corrosion, typical.

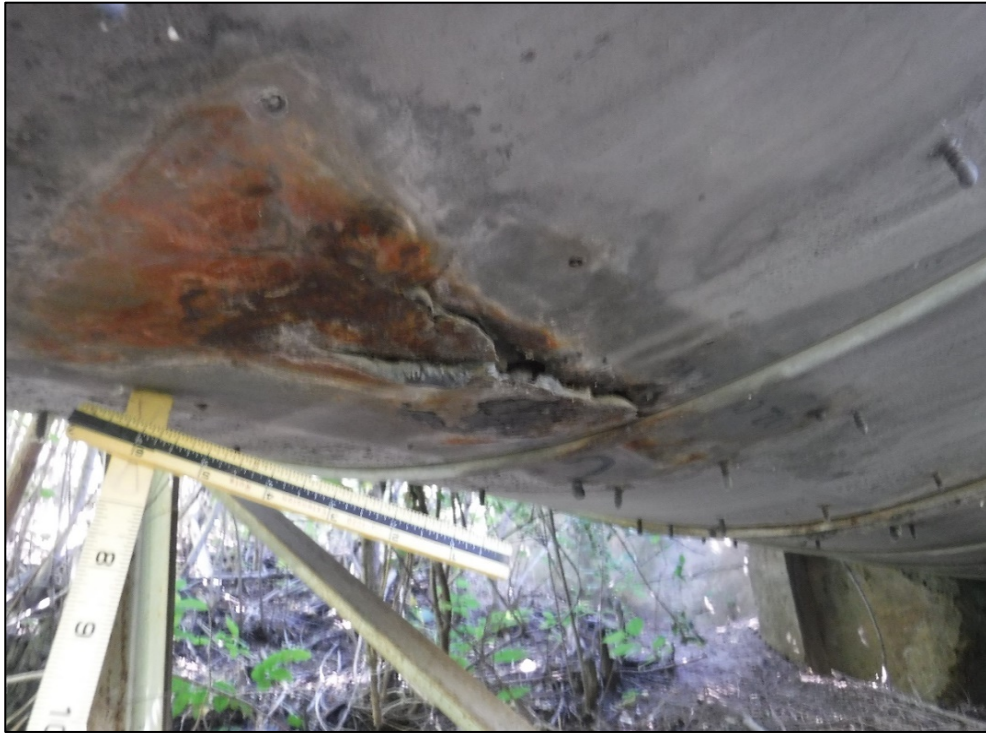
Elm/Env	Description	Unit	Total Qty	% in 1	CS 1	% in 2	CS 2	% in 3	CS 3	% in 4	CS 4
60/1	Other Deck	(SF)	715	94%	670	2%	12	3%	25	1%	8
Deck is a steel open half cylinder flume with painted liner with (2) bolt bands at each joint and (1) intermediate bolt band at 3 feet spacing; painted gray. Span 3 north side near mid-point has a diversion with active leakage. Top: Mostly covered with water, no major deficiencies noted. Spans 1 and 2 mostly inaccessible due to fencing. Bottom: Paint is peeling off throughout, primarily along joints. Span 1 at Abutment 1 has area of active leakage with corrosion holes (2SF CS4). Span 2 near Pier 2 has 8 inch long tear/damage (1SF CS4). Span 3 along joint band north half has active leakage with corrosion holes on east side of diversion (3SF CS4). Span 3 east side of diversion has area of corrosion holes through metal liner for 12 feet (12SF CS2). Spans 4 and 5 have full length corrosion holes through metal liner with rust staining up to 1 foot wide (24SF CS3). Span 5 at Abutment 6 has active leakage with corrosion holes (2SF CS4). Span 5 near Abutment 6 has 8 inch area of liner damage (1SF CS3).

Span 2 near Pier 2 has area of tear and damage.

Maintenance Recommendations	Quantity	Date Recommended	Maintenance Category
Deck-Seal	8 SF	07/30/2024	High
Patch holes in steel deck to prevent water leakage.			
Channel-Remove Debris	1 EA	07/30/2024	High
Clear vegetation under and around the structure.

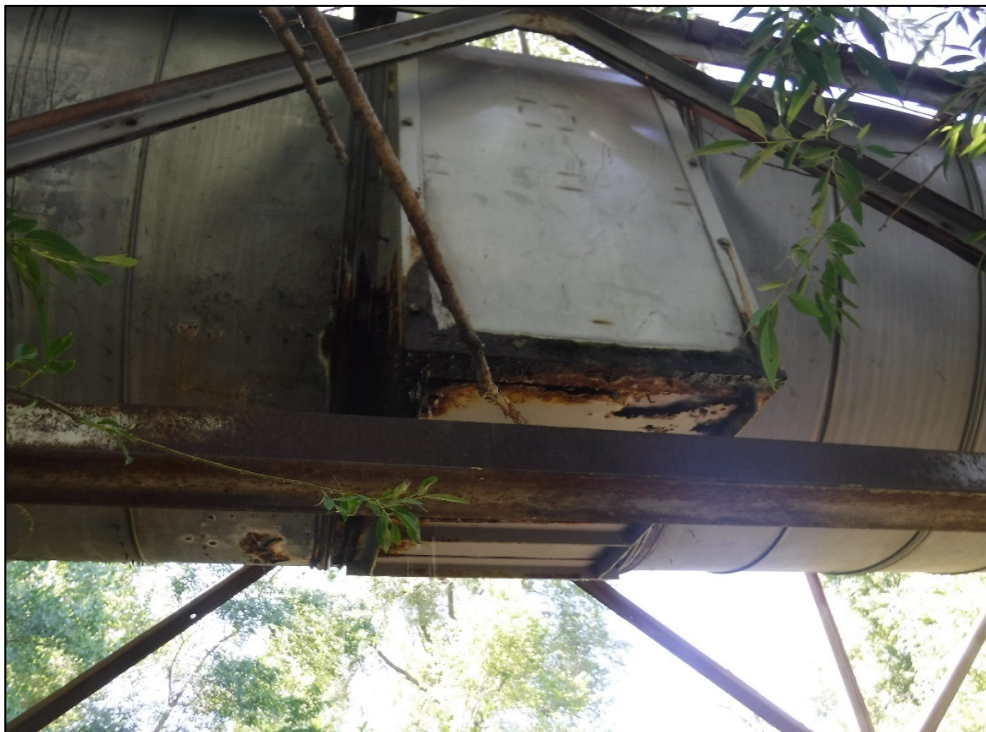
Span 3 active leakage at diversion with R4 corrosion holes.

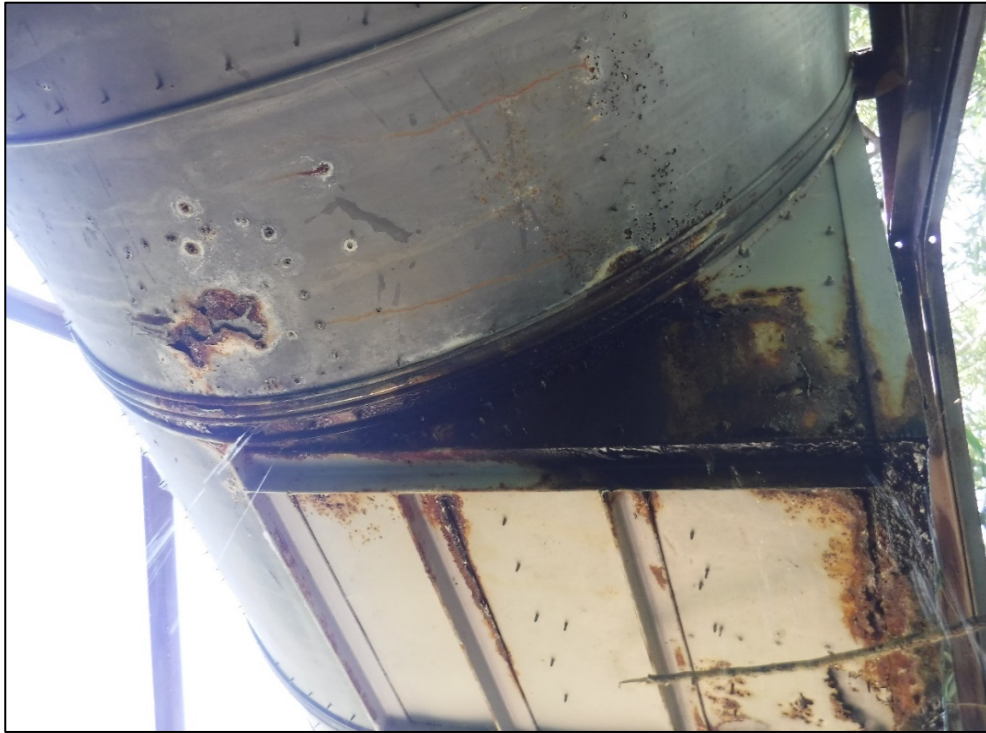
Span 3 at joint has R4 corrosion holes with active leakage.

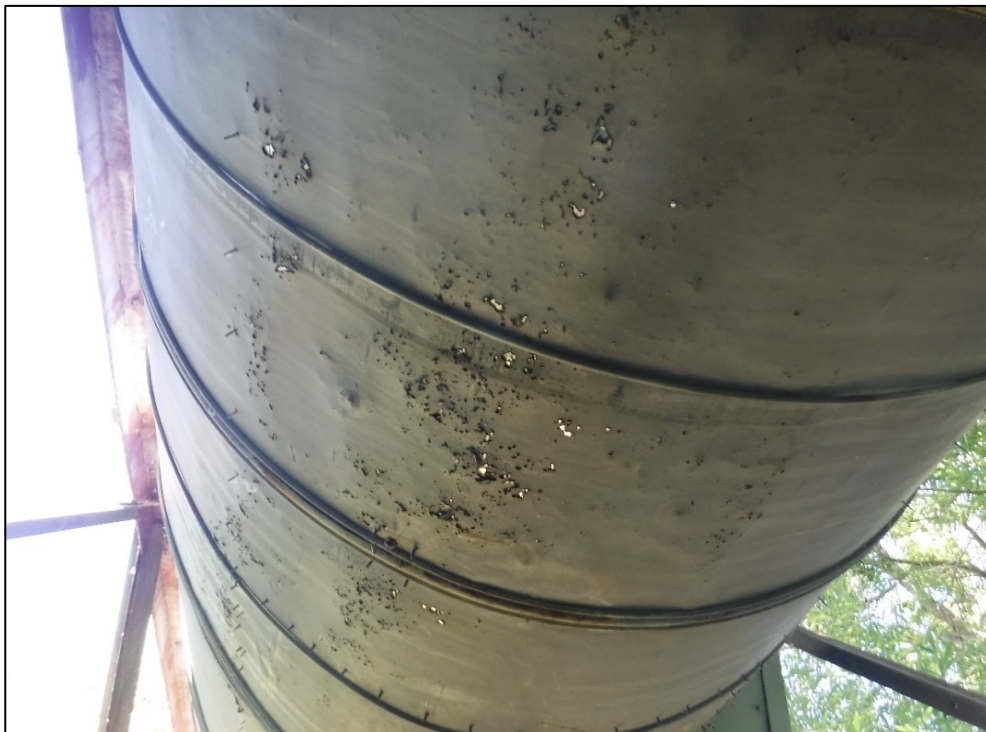
Span 3 deck underside has area of perforations through liner.

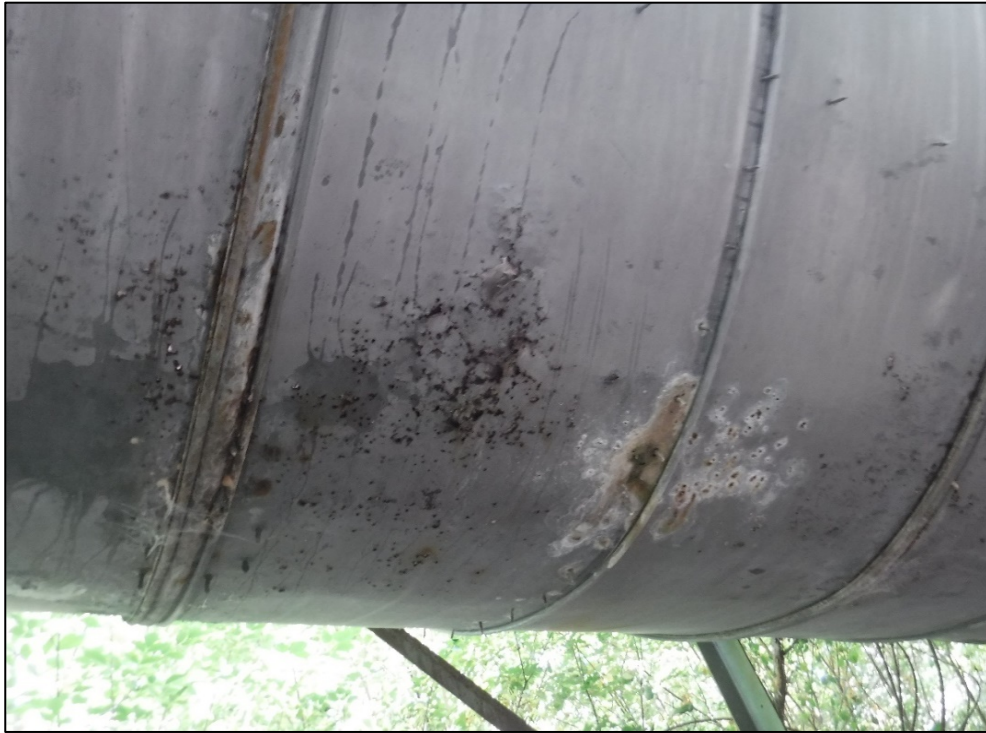
Span 4 underside has area of perforation through liner with rust stains.

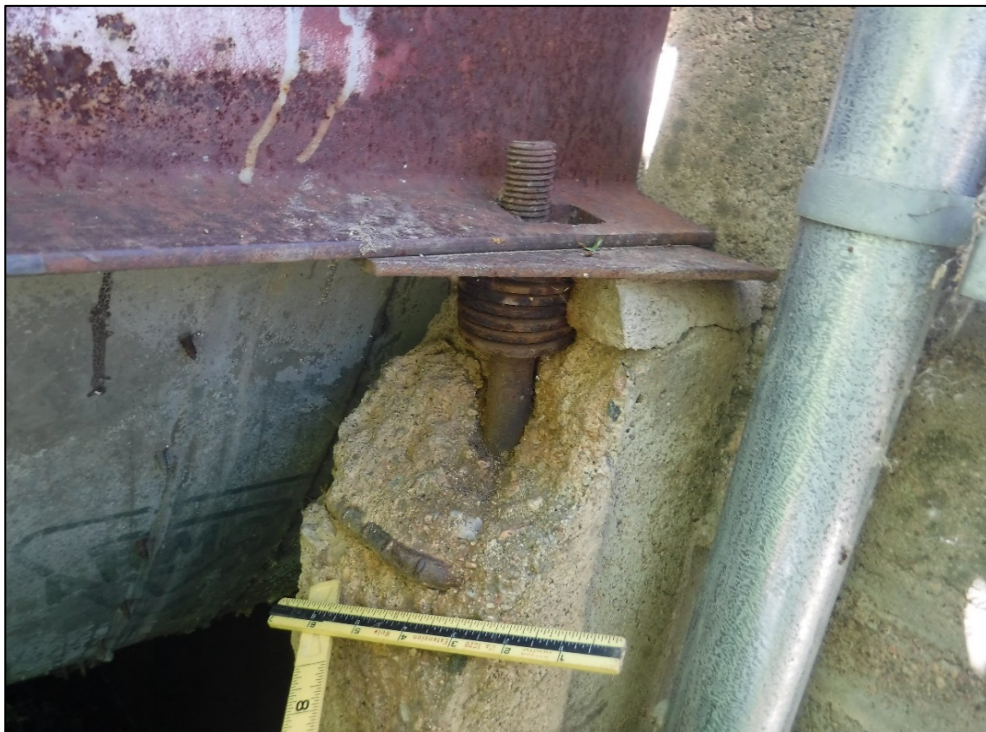
A1 north end spall with exposed rebar and anchor and missing nut at bearing.

Install Anchor Bolt	High	7/30/2024	INSTALL ANCHOR BOLT	EA	\$ -	\$ 250.00	2.00	\$ 500.00	Abutment 1 install anchor bolts

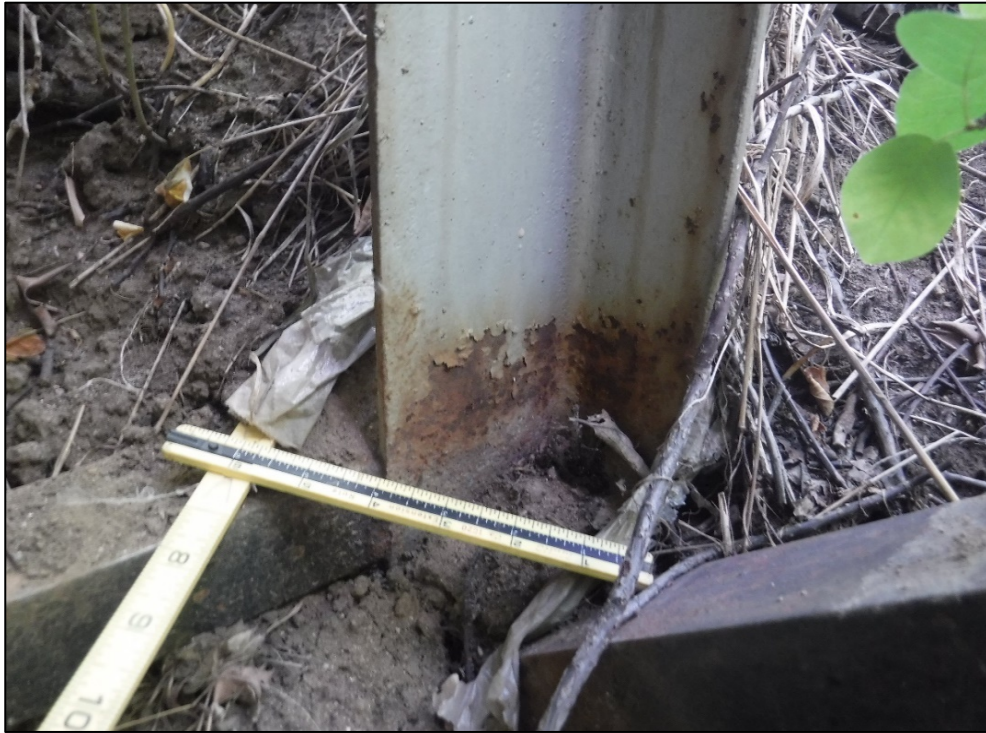
Trestle vertical at groundline has R1 corrosion, typical.

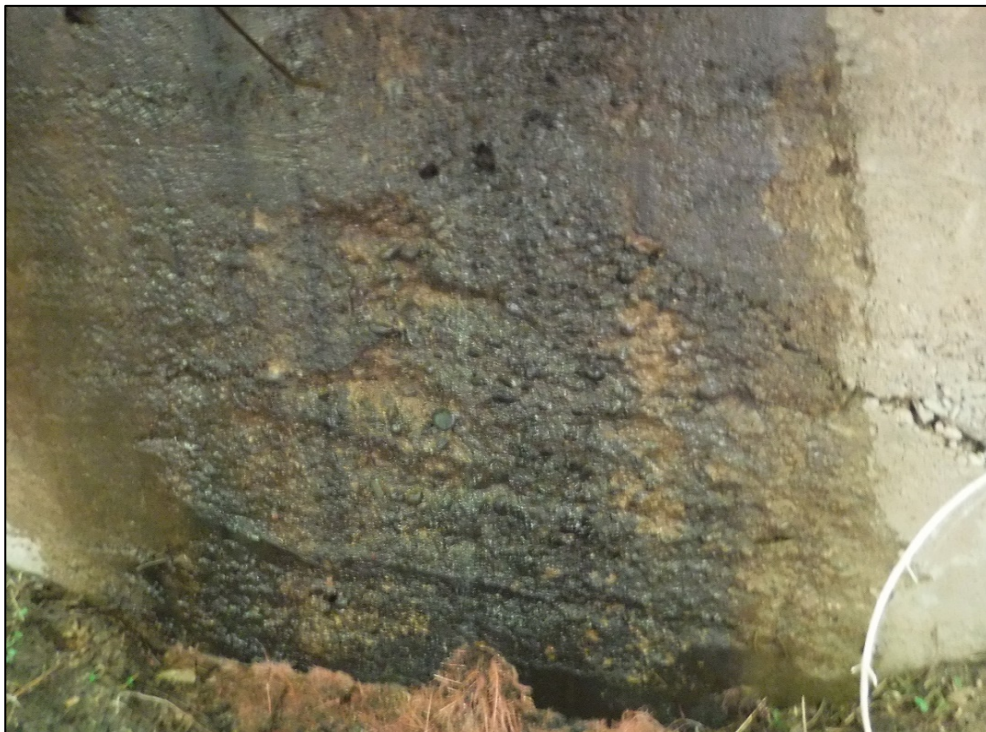
Abutment 6 has S3 scaling.

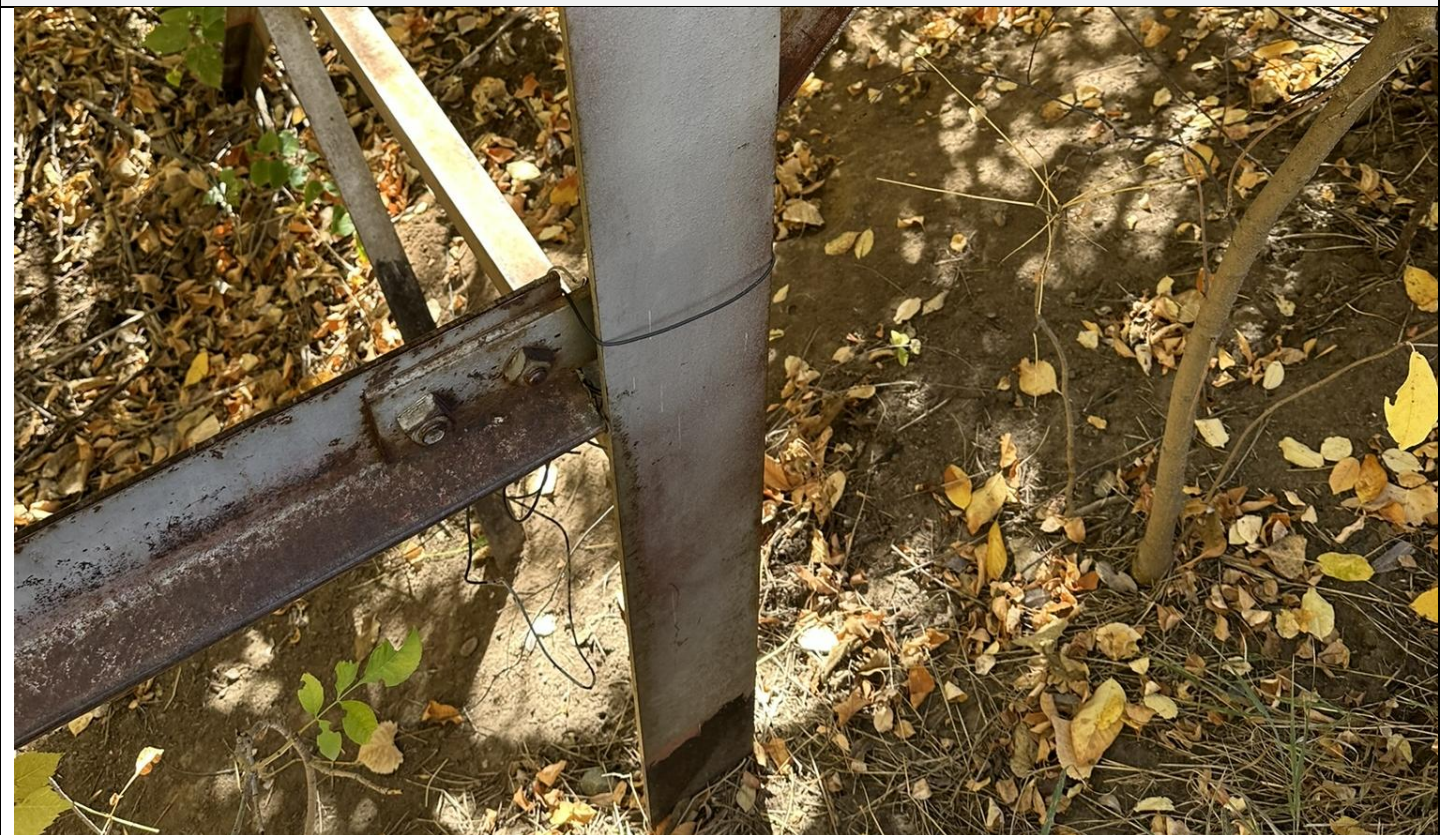
The vertical supports are identified as Towers in this report; the towers on this flume had two types of paint, silver and black. The black paint is only present on the West end of the tower, near and under the ground.

Negative

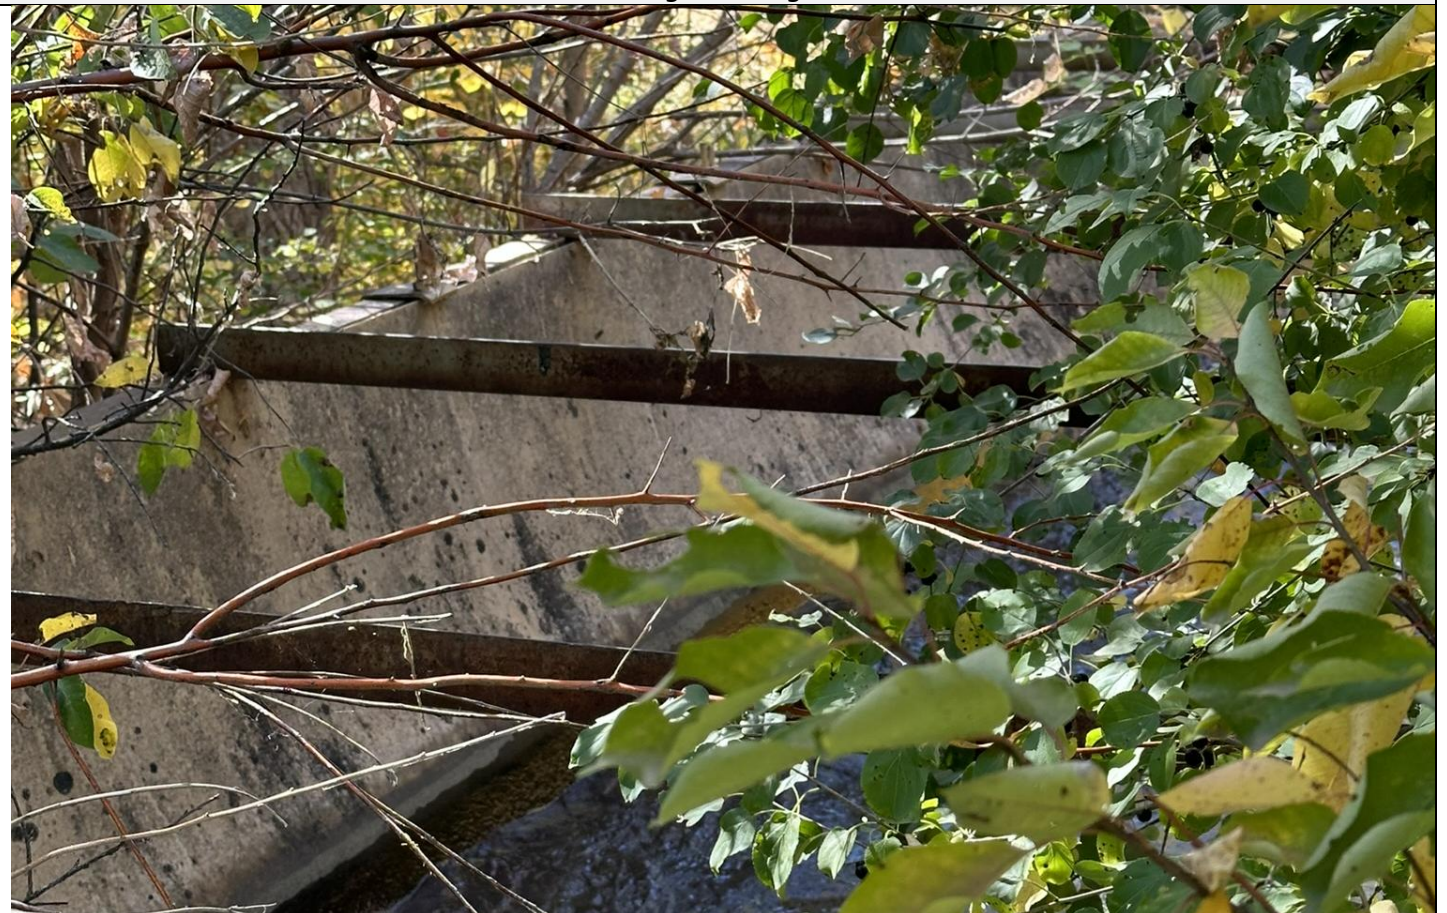
These components are identified as spanning trusses in this report. Only one could be safely accessed due to overgrowth. Negative

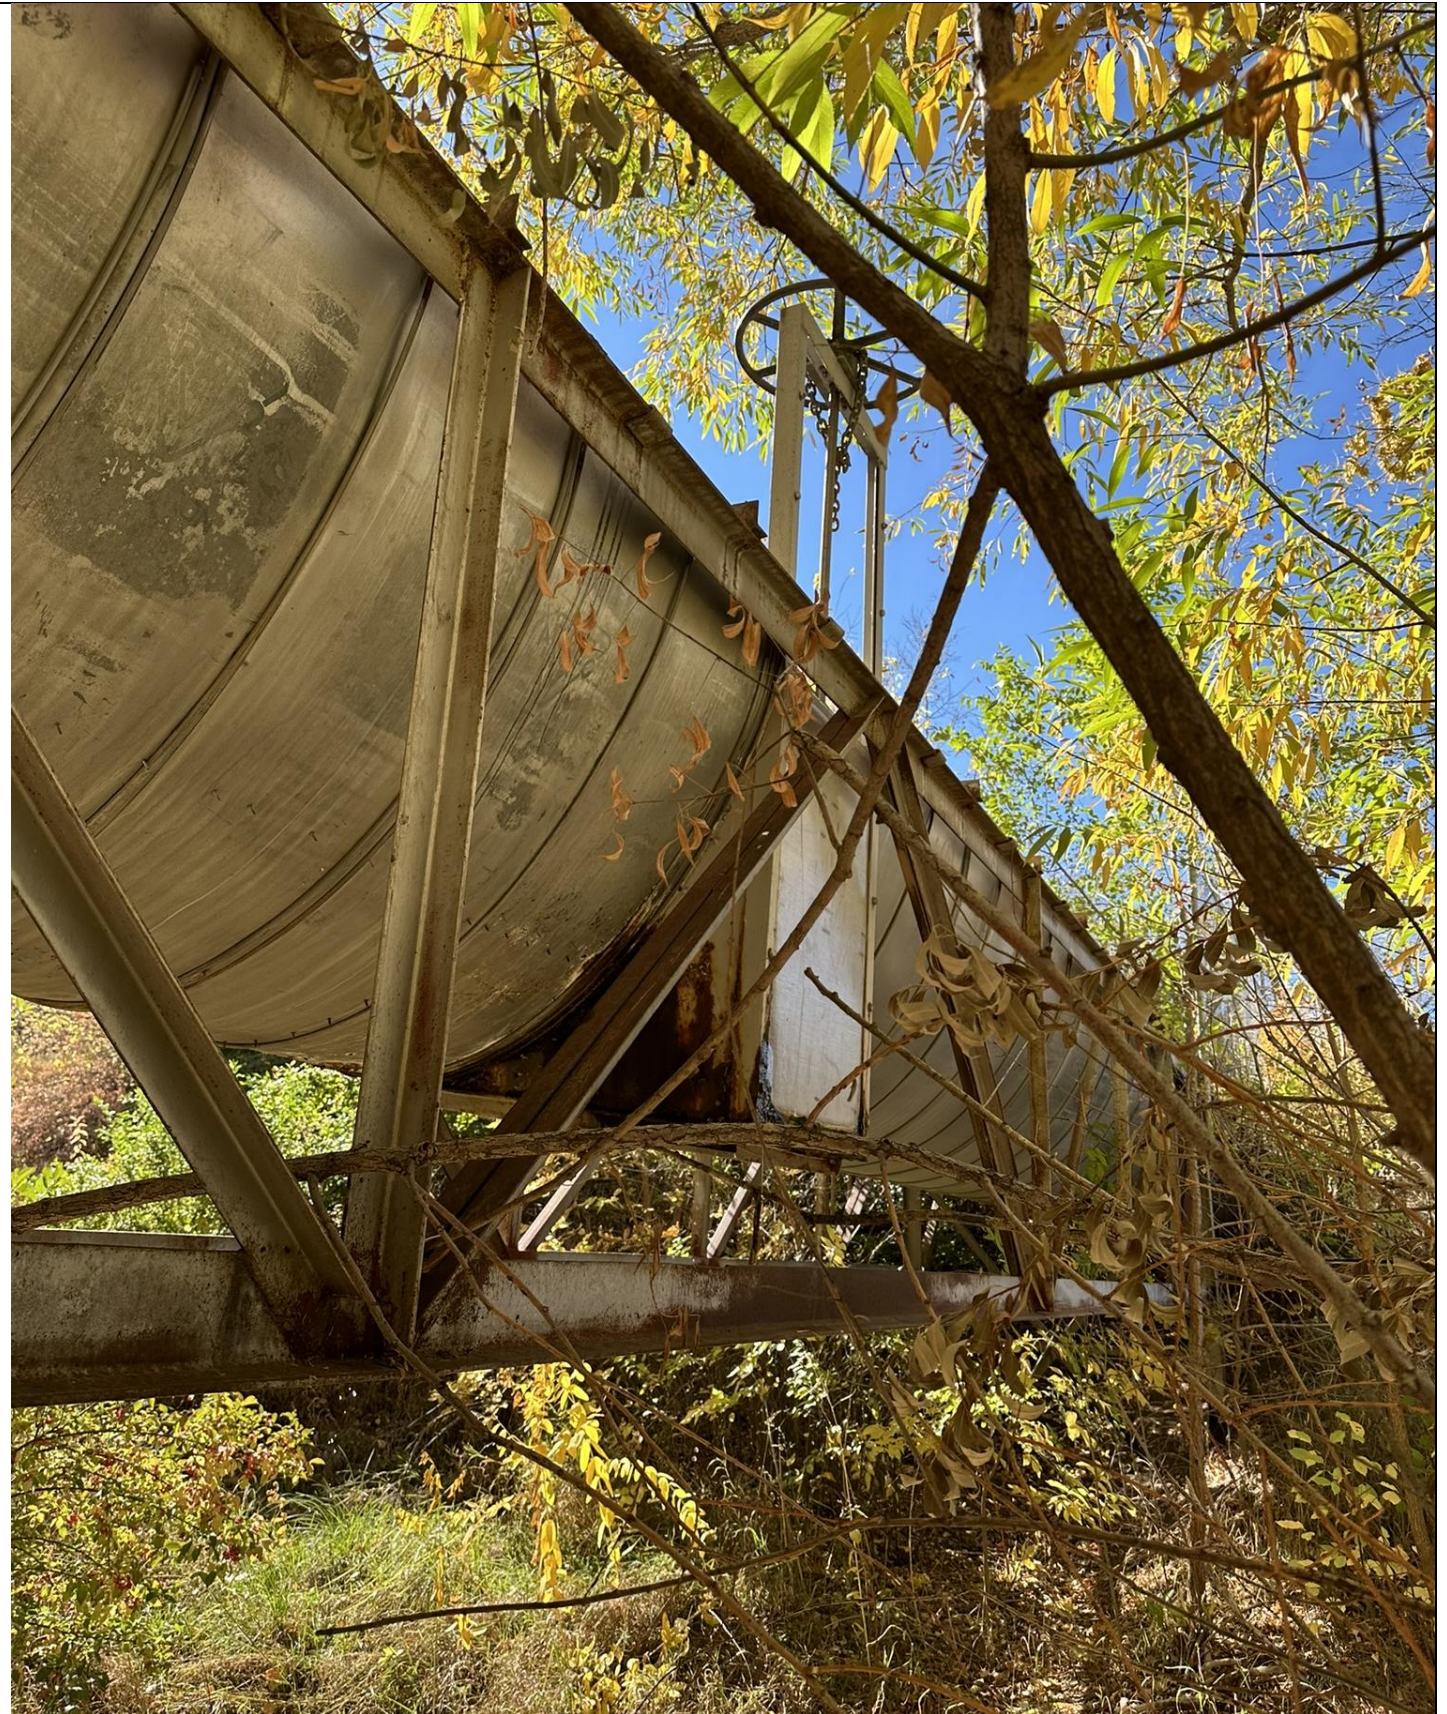
The sluice gate and associated mechanism could not be safely accessed at the time of this inspection and is assumed to have LBP components. Assumed LBP

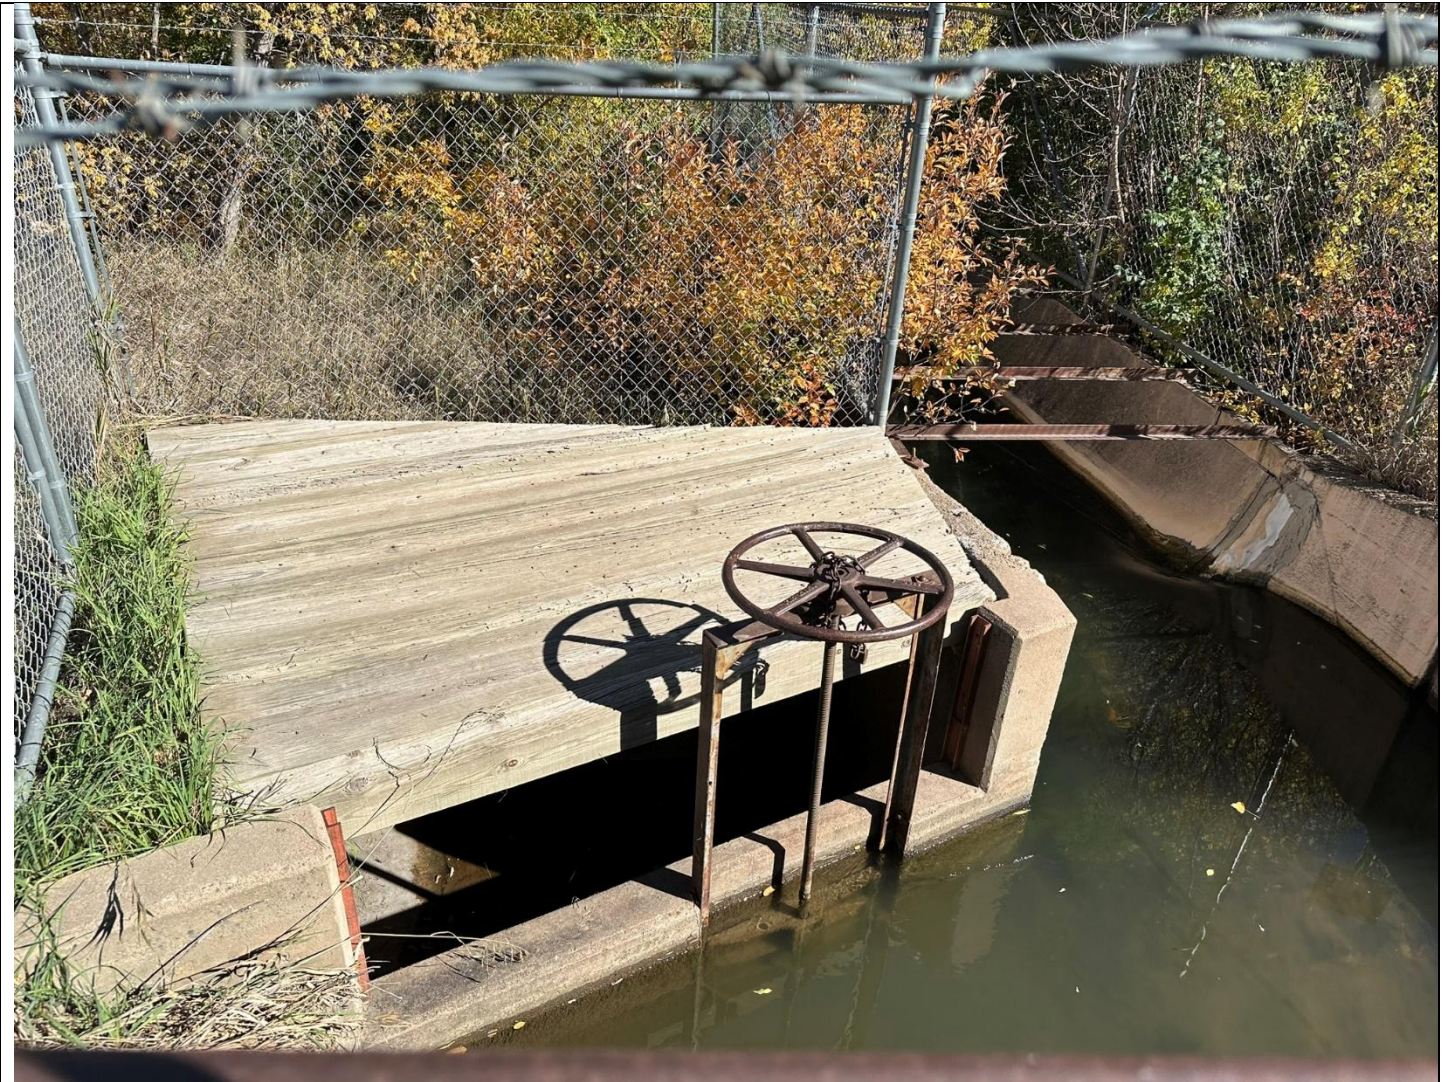
All components visible in this photo were not accessible due to a locked gate, and must be assumed to have LBP until tested. Assumed LBP
