Executive Summary

TO: Brent Soderlin, PE, CFM, Director of Public Works and Utilities, Littleton, Colorado (City)
FROM: Tim Phelan, PE
SUBJECT: Lee Gulch Flume
DATE: December 6, 2024
CC:

Routine Inspection Flume Structure Inspection and Inventory Report

LEAD-BASED PAINT INSPECTION REPORT

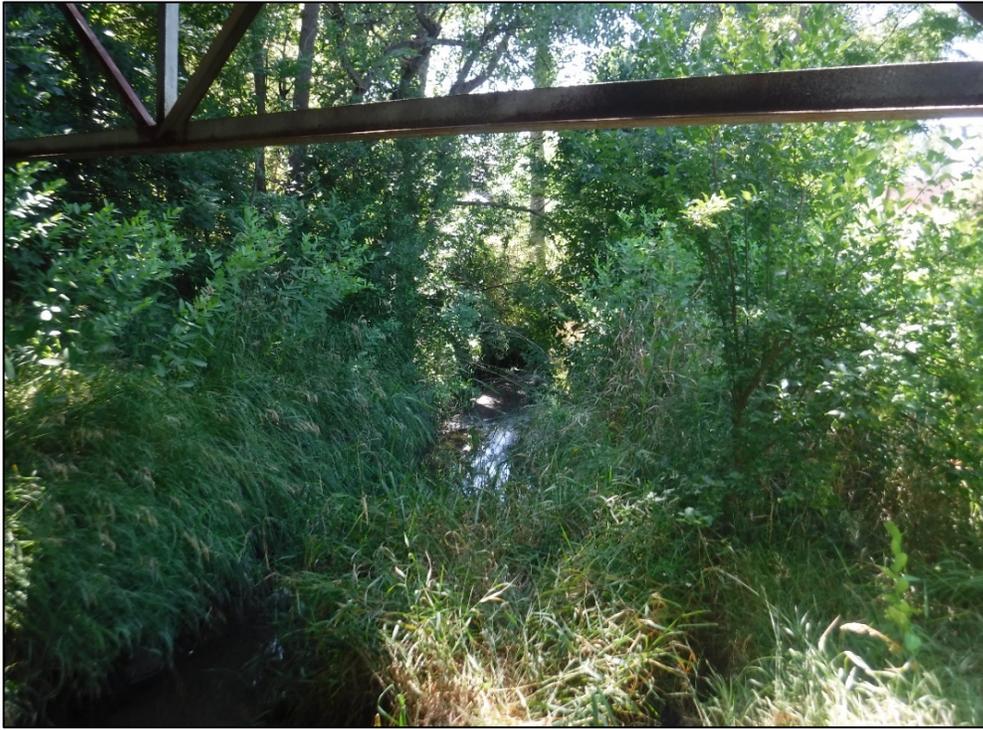
Channel looking south upstream.

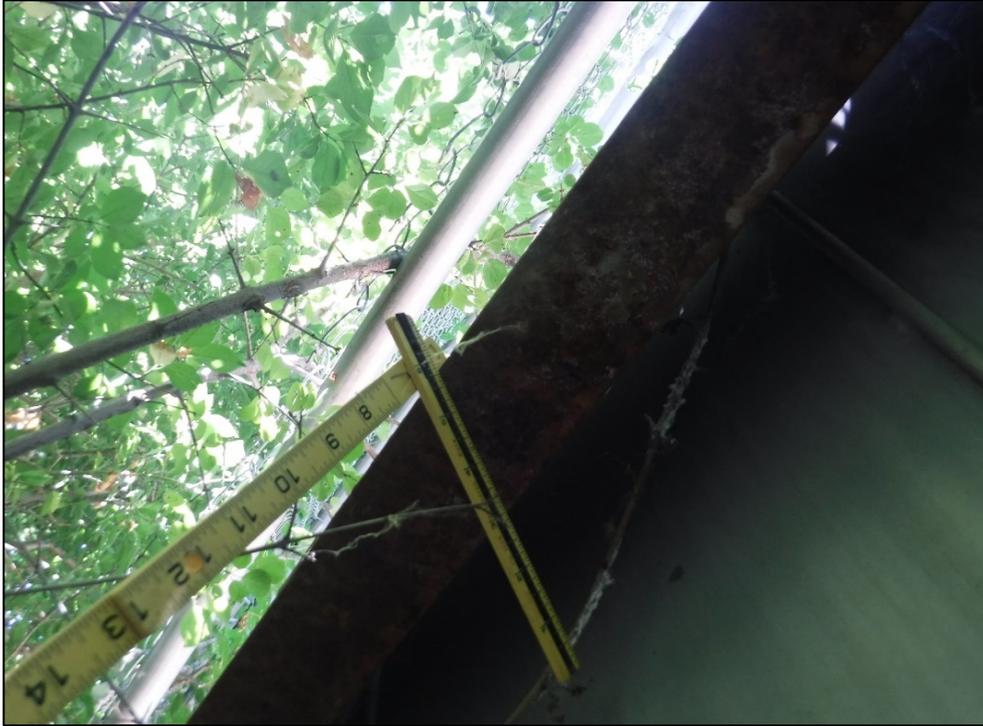
107/1	Steel Open Girder	(LF)	112	0%	0	100%	112	0%	0	0%	0
(2) C-channel beams with frequent web splice plates welded to east beam and bolted to west beam; transverse bracing at 3 feet spacing; painted gray. Beams have R1 corrosion throughout (112LF CS2).											
120/1	Steel Truss	(LF)	96	0%	0	100%	96	0%	0	0%	0
Span 3 is a welded truss; painted gray. Truss chords, diagonals, and verticals have R1 corrosion throughout (96LF CS2).											
207/1	Steel Tower	(LF)	37	68%	25	32%	12	0%	0	0%	0
Steel trestles at all piers; painted gray. Trestles at Piers 2 and 3 are coated black from groundline and above up to 22 inches high. Trestle diagonals, horizontals, and verticals have R1 corrosion starting at groundline up to 3 feet high (12LF CS2).											
215/1	R/Conc Abutment	(LF)	14	64%	9	0%	0	36%	5	0%	0
Active water leakage along both abutments. Abutment 1 both ends at bearing has 6 inch x 8 inch x 6 inch deep spall with exposed rebar and anchors (2LF CS3). Abutment 6 has S3 scaling for 3 feet (3LF CS3).

Beam has R1 corrosion, typical.

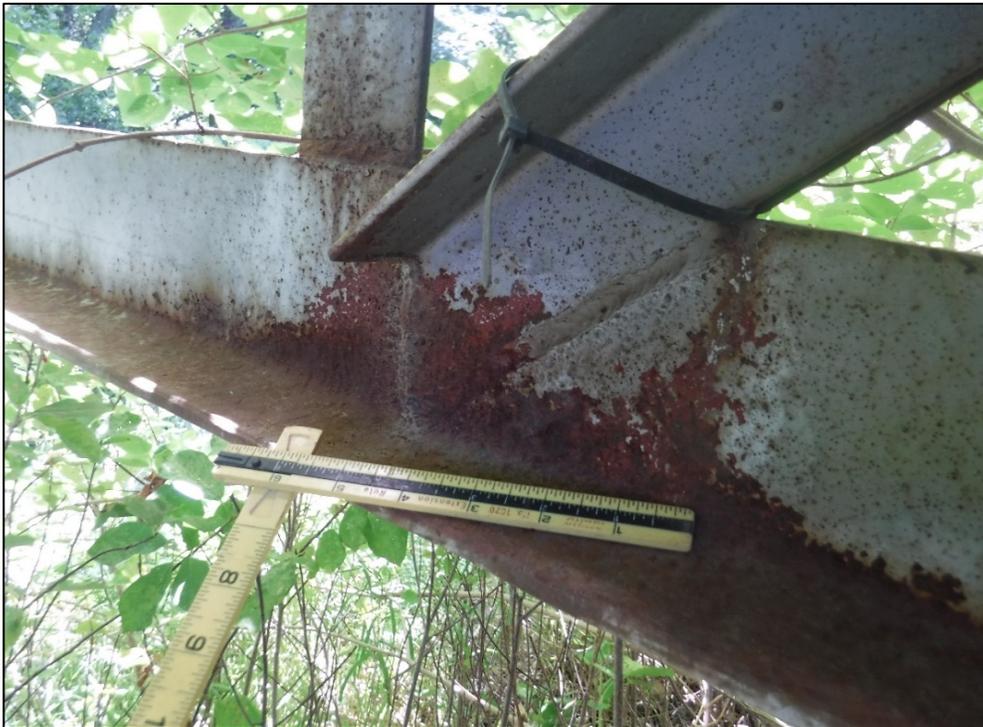
Truss 3A lower chord has R1 corrosion, typical.

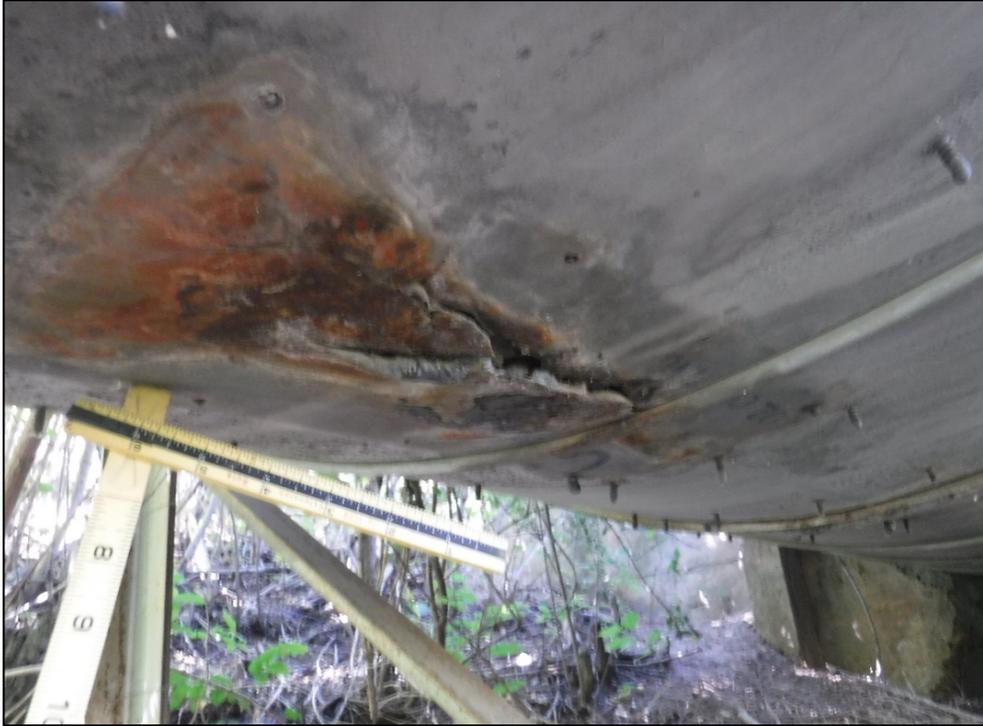
Span 2 near Pier 2 has area of tear and damage.

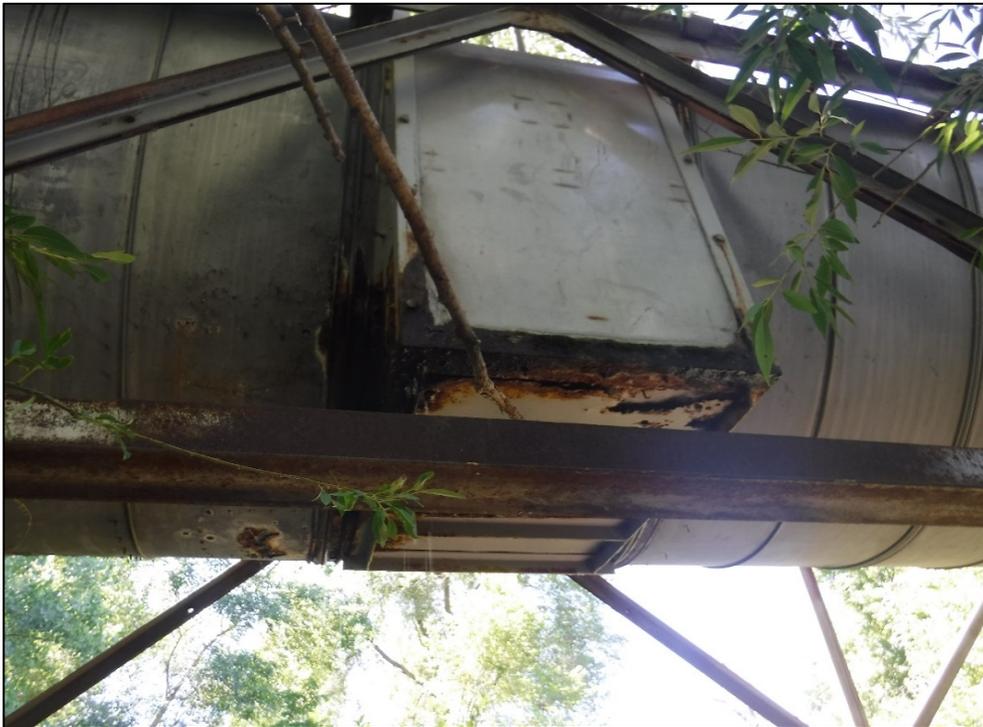
Elm/Env	Description	Unit	Total Qty	% in 1	CS 1	% in 2	CS 2	% in 3	CS 3	% in 4	CS 4
60/1	Other Deck	(SF)	715	94%	670	2%	12	3%	25	1%	8
Deck is a steel open half cylinder flume with painted liner with (2) bolt bands at each joint and (1) intermediate bolt band at 3 feet spacing; painted gray. Span 3 north side near mid-point has a diversion with active leakage. Top: Mostly covered with water, no major deficiencies noted. Spans 1 and 2 mostly inaccessible due to fencing. Bottom: Paint is peeling off throughout, primarily along joints. Span 1 at Abutment 1 has area of active leakage with corrosion holes (2SF CS4). Span 2 near Pier 2 has 8 inch long tear/damage (1SF CS4). Span 3 along joint band north half has active leakage with corrosion holes on east side of diversion (3SF CS4). Span 3 east side of diversion has area of corrosion holes through metal liner for 12 feet (12SF CS2). Spans 4 and 5 have full length corrosion holes through metal liner with rust staining up to 1 foot wide (24SF CS3). Span 5 at Abutment 6 has active leakage with corrosion holes (2SF CS4). Span 5 near Abutment 6 has 8 inch area of liner damage (1SF CS3).

Span 3 active leakage at diversion with R4 corrosion holes.

Maintenance Recommendations	Quantity	Date Recommended	Maintenance Category
Deck-Seal	8 SF	07/30/2024	High
Patch holes in steel deck to prevent water leakage.			
Channel-Remove Debris	1 EA	07/30/2024	High
Clear vegetation under and around the structure.

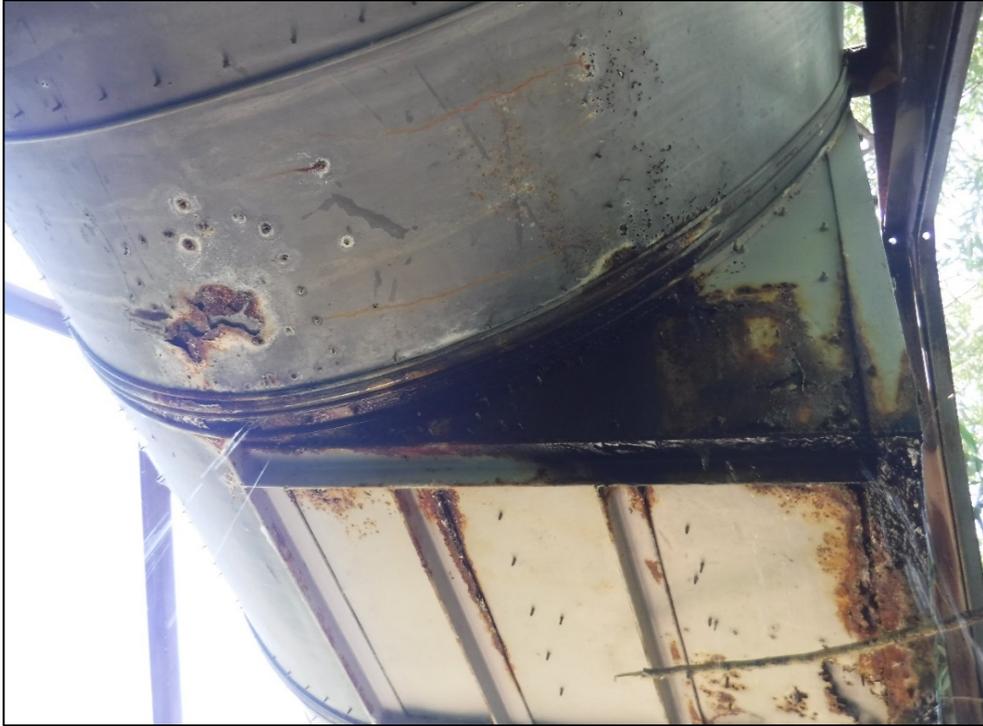
Span 3 at joint has R4 corrosion holes with active leakage.

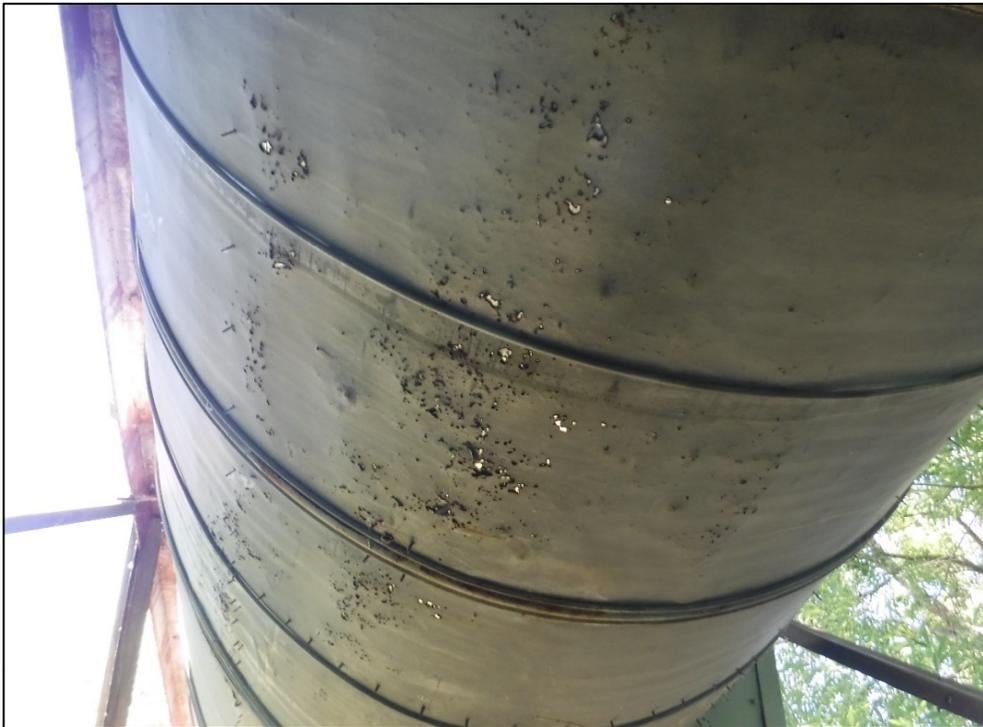
Span 3 deck underside has area of perforations through liner.

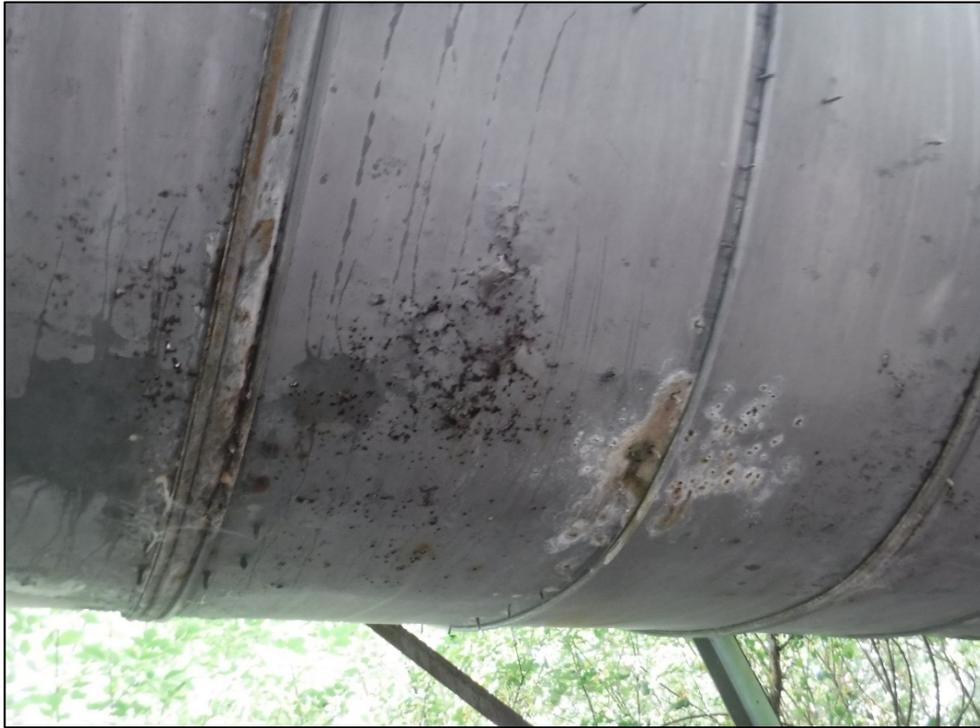
Span 4 underside has area of perforation through liner with rust stains.

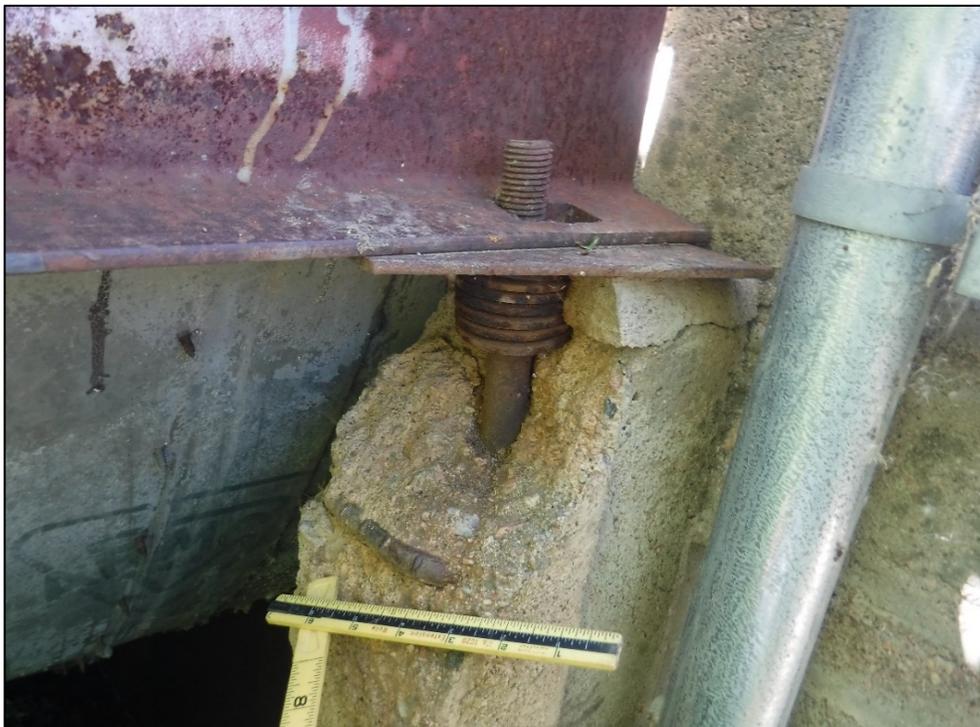
A1 north end spall with exposed rebar and anchor and missing nut at bearing.

Install Anchor Bolt	High	7/30/2024	INSTALL ANCHOR BOLT	EA	-	\$ 250.00	2.00	\$ 500.00	Abutment 1 install anchor bolts

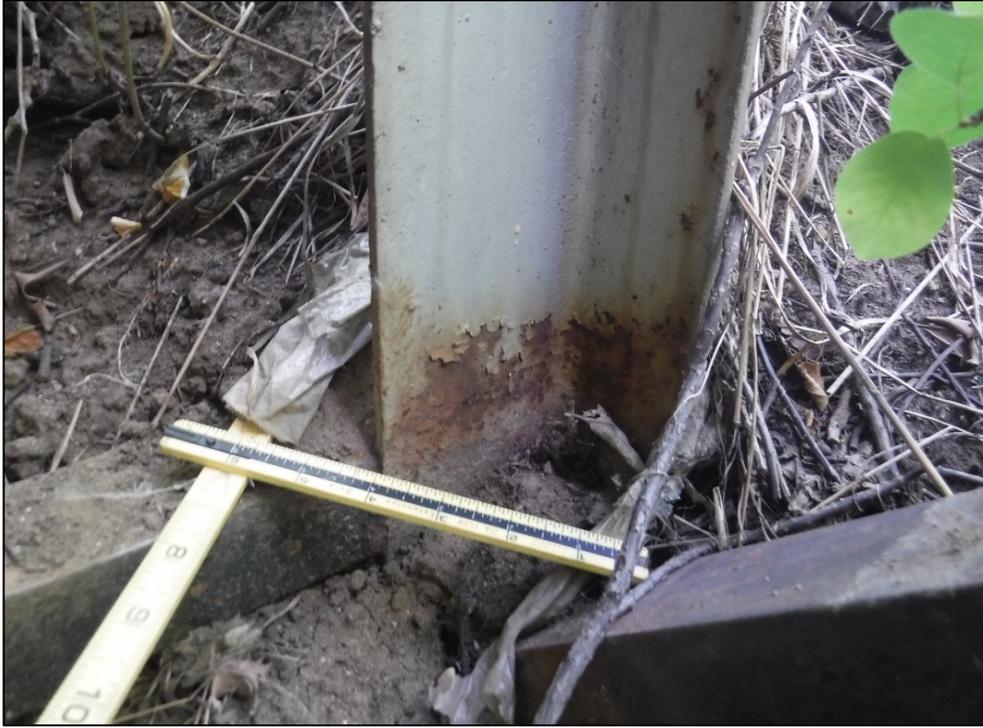
Trestle vertical at groundline has R1 corrosion, typical.

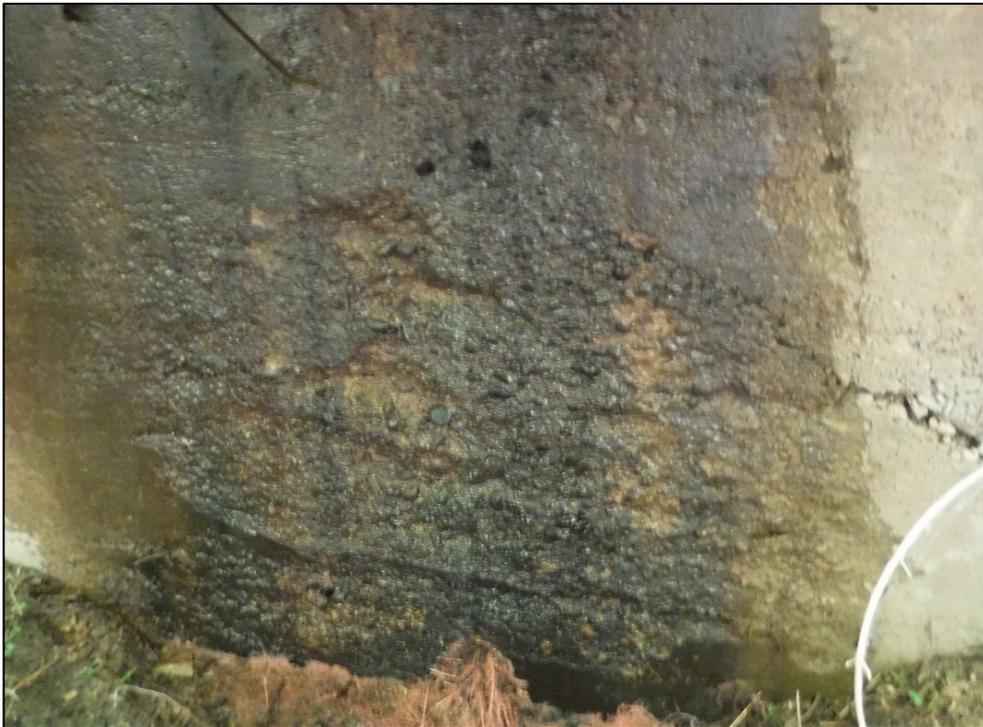
Abutment 6 has S3 scaling.

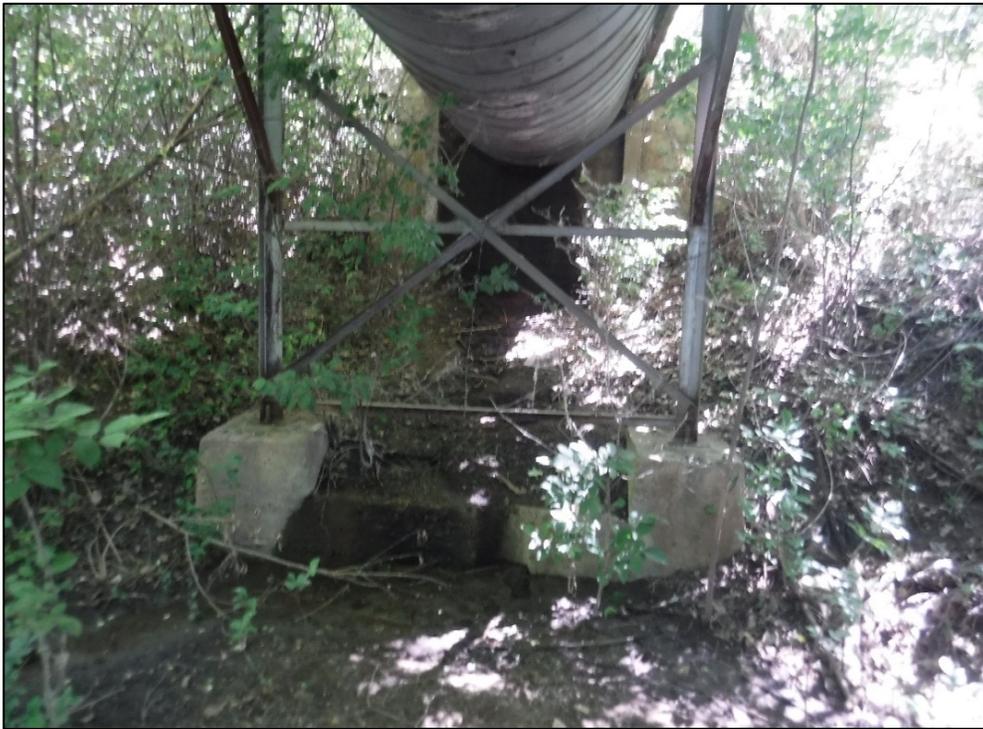
220/1	R/Conc Pile Cap/Footing	(LF)	28	100%	28	0%	0	0%	0	0%	0
All pier footings are covered in silt and not visible except Pier 5 footing. Pier 5 footing exposed up to 22 inch for full length with no undermining.											
311/1	Movable Bearing	(EA)	4	50%	2	0%	0	0%	0	50%	2
Moveable bearings at both abutments. Abutment 1 both bearings have missing anchor nuts and loss of bearing area up to 50% (2EA CS4).											
313/1	Fixed Bearing	(EA)	8	100%	8	0%	0	0%	0	0%	0
Fixed bearings at piers. No significant defects noted.											
326/1	Wingwall	(EA)	4	100%	4	0%	0	0%	0	0%	0
Concrete wingwalls monolithic with abutments. Wingwalls have S1-S2 scaling.											
501/1	Channel/Bank	(EA)	1	100%	1	0%	0	0%	0	0%	0
Channel flows south to north under Span 3. Erosion channel under Span 2 up to 18 inches deep at Pier 2 and 22 inches deep at Pier 3 exposing a black coating. Large grouted boulders and concrete wall with 24 inch outlet. Northwest side of channel has concrete weir. Northeast side of structure and across channel has flumes merge into inlet at outlet end. Heavy vegetation growth under and around structure.

Pier 5 general.

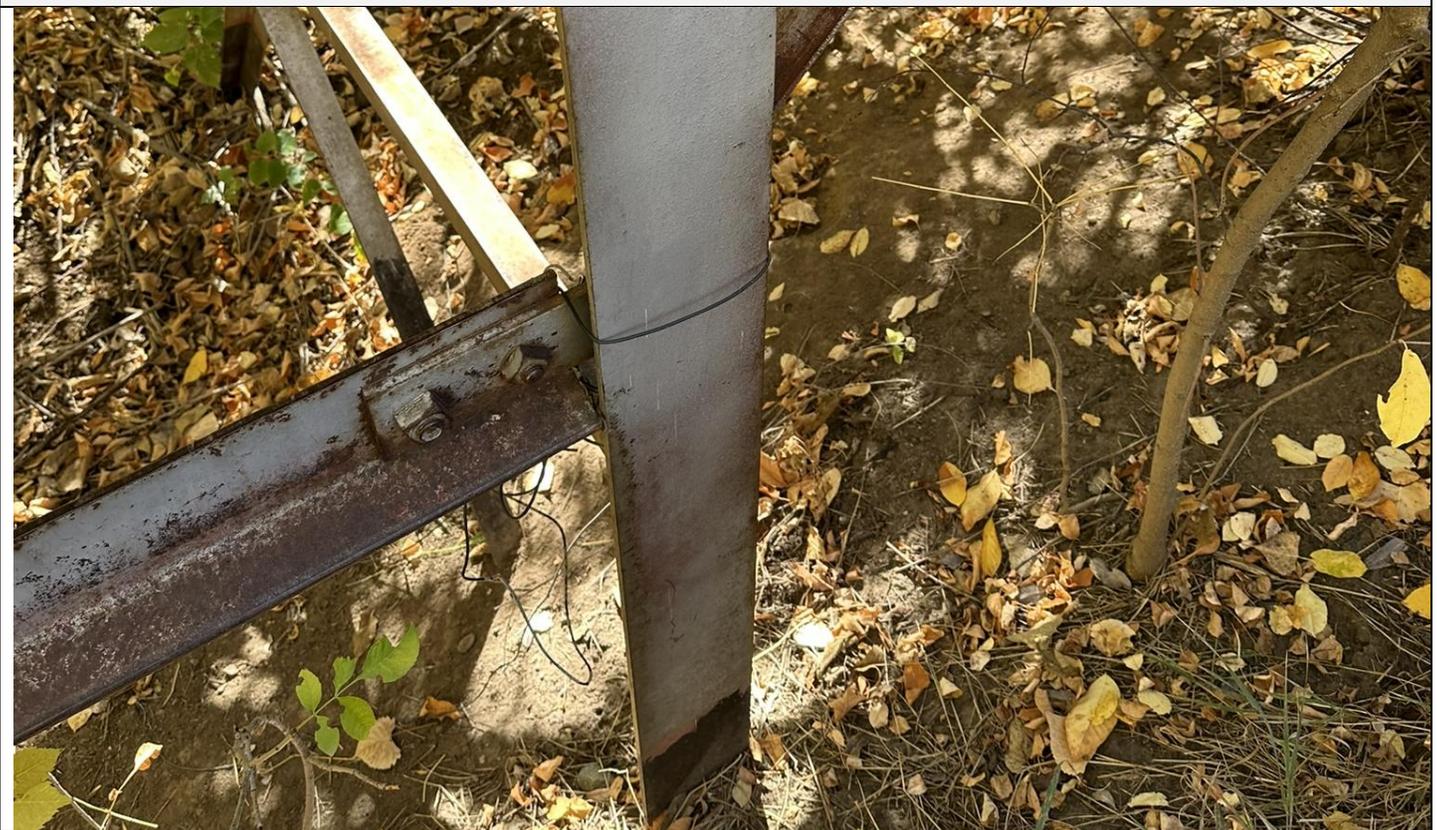
The vertical supports are identified as Towers in this report; the towers on this flume had two types of paint, silver and black. The black paint is only present on the West end of the tower, near and under the ground.

Negative

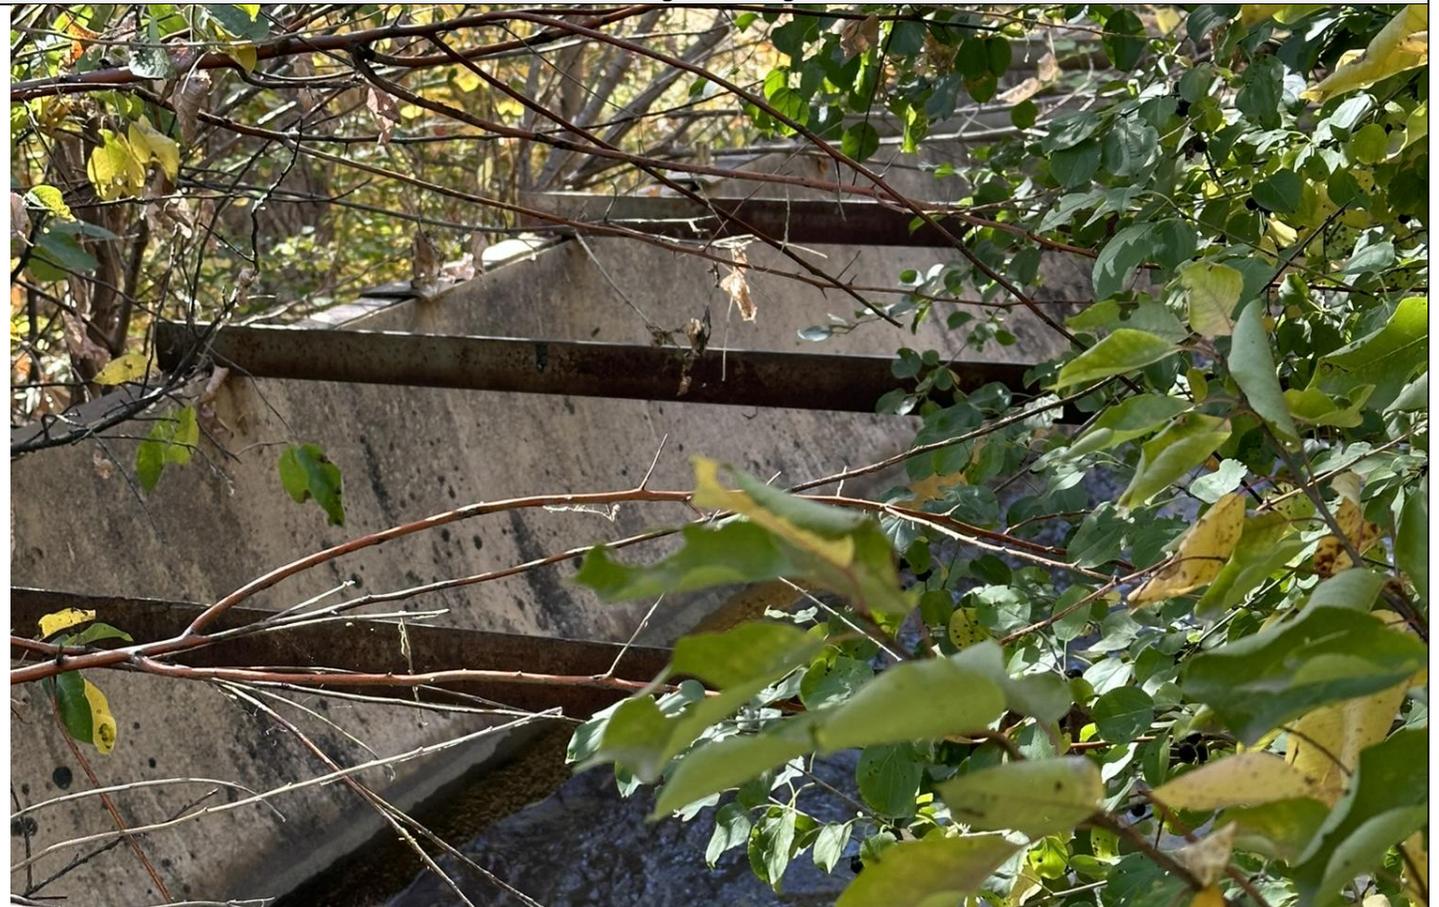
These components are identified as spanning trusses in this report. Only one could be safely accessed due to overgrowth. Negative

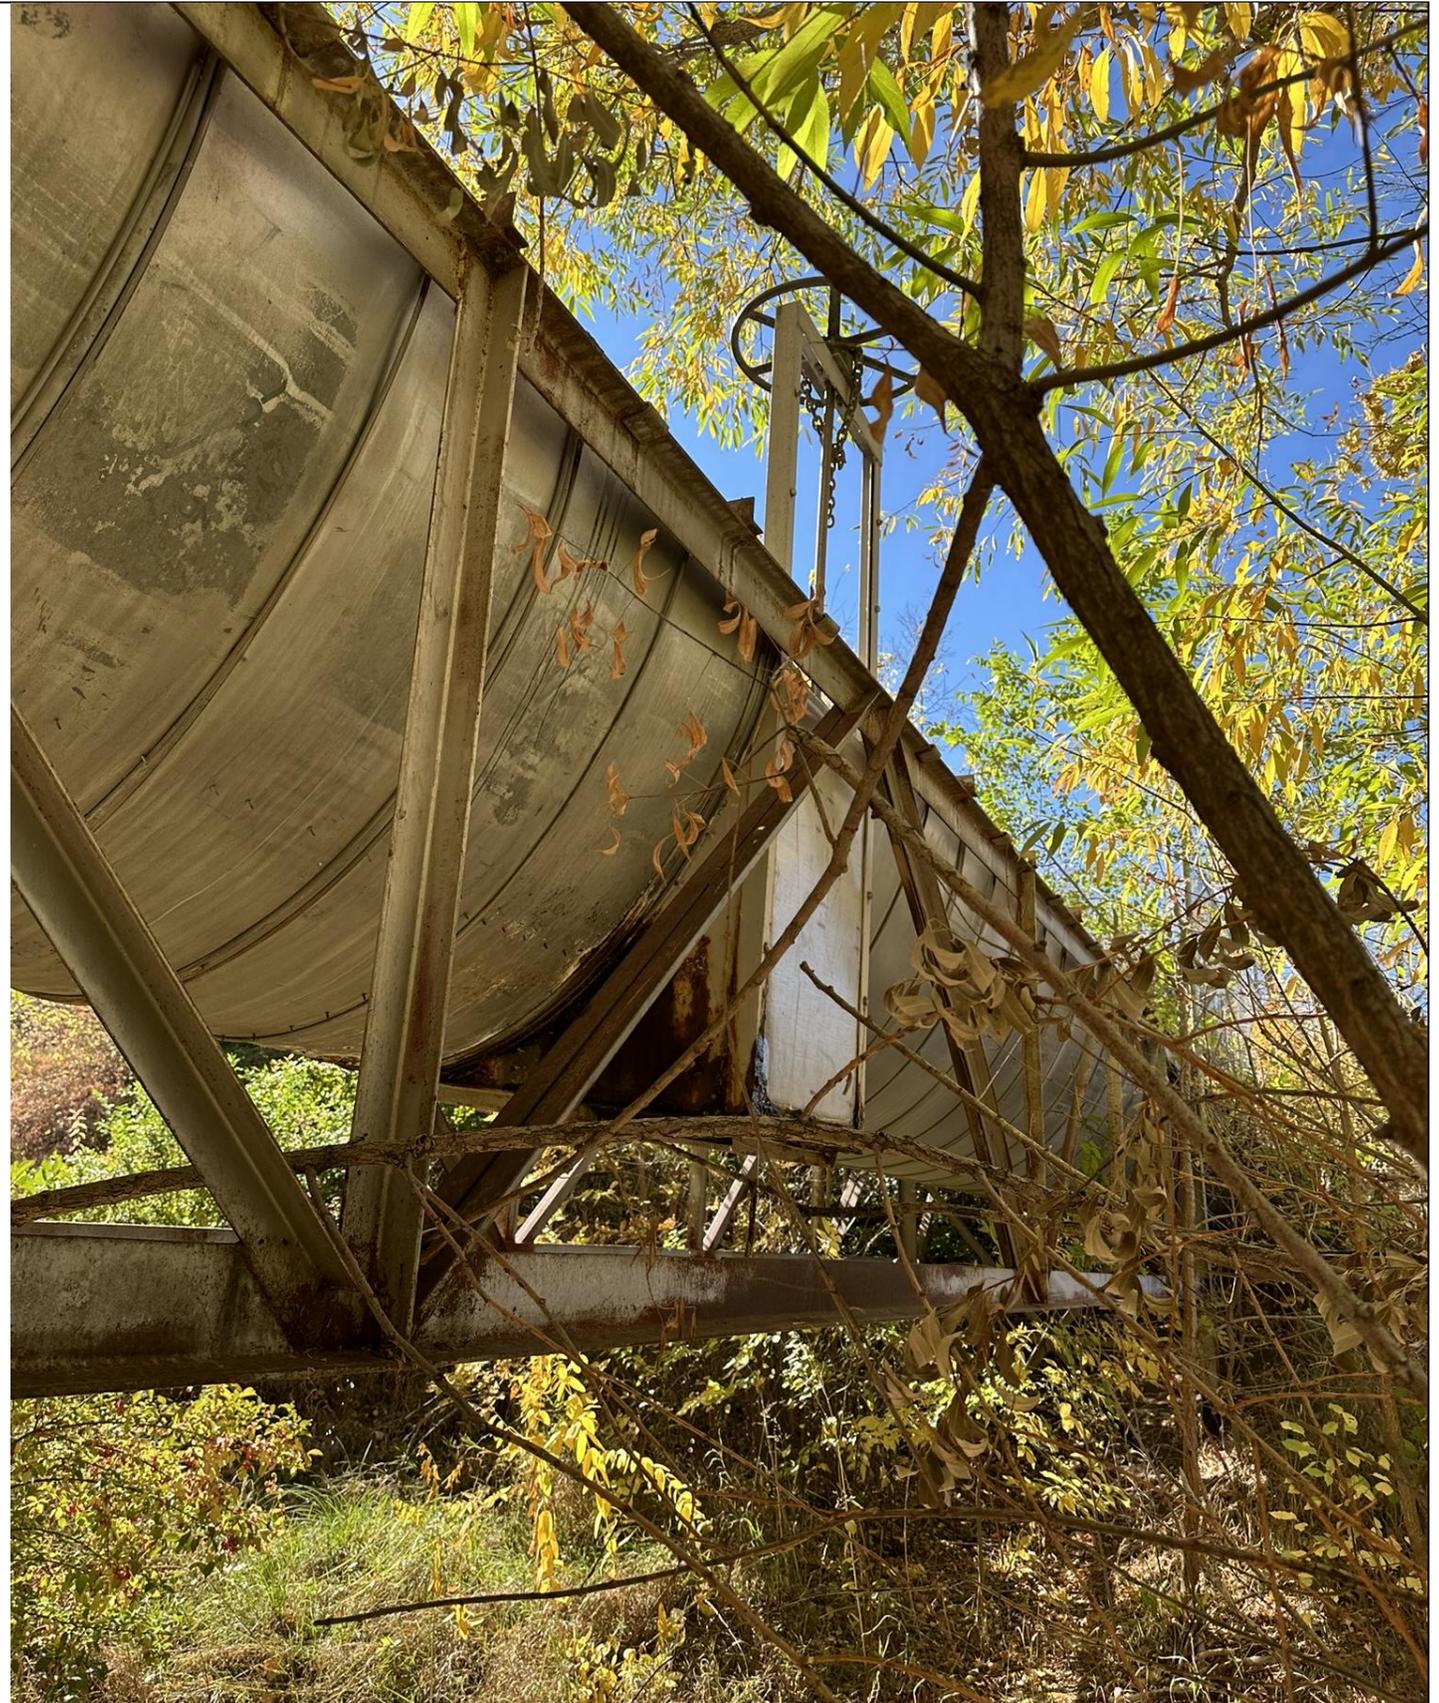
The sluice gate and associated mechanism could not be safely accessed at the time of this inspection and is assumed to have LBP components. Assumed LBP

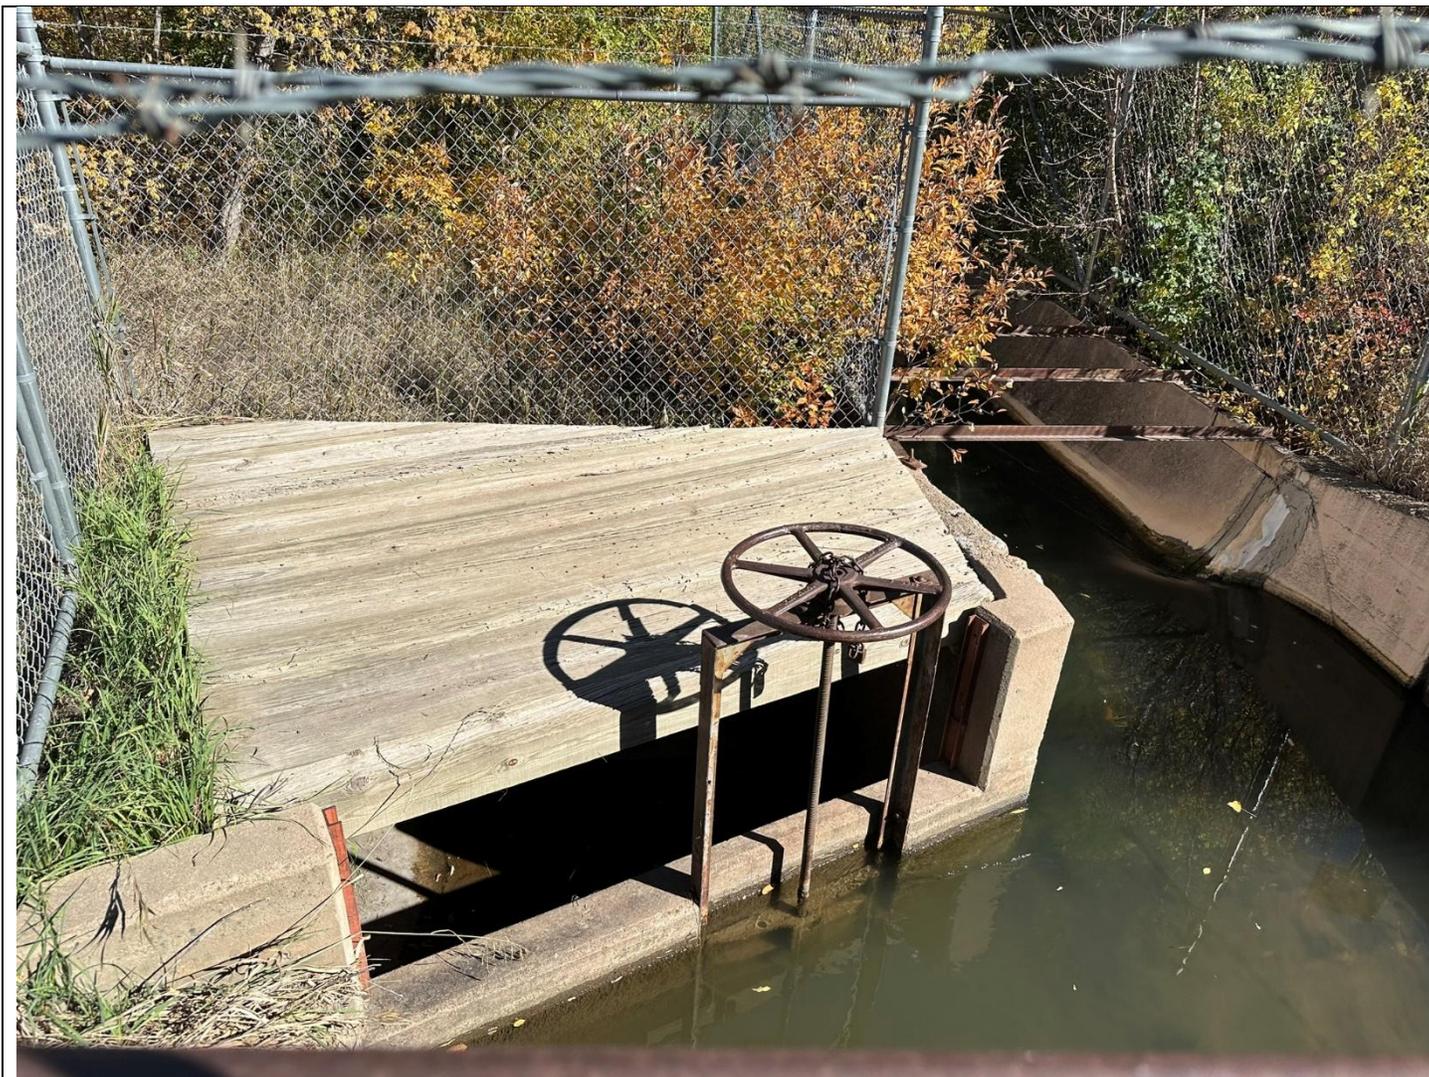
All components visible in this photo were not accessible due to a locked gate, and must be assumed to have LBP until tested. Assumed LBP
