**APPLICATION FOR COLORADO STATE INCOME TAX CREDIT  
FOR THE PRESERVATION OF HISTORIC STRUCTURES  
(RESIDENTIAL PROPERTY – 2014 CREDIT)**

Name of Property: The Nyman House

Address: 5475 S Mohawk Road

DESCRIPTION OF REHABILITATION

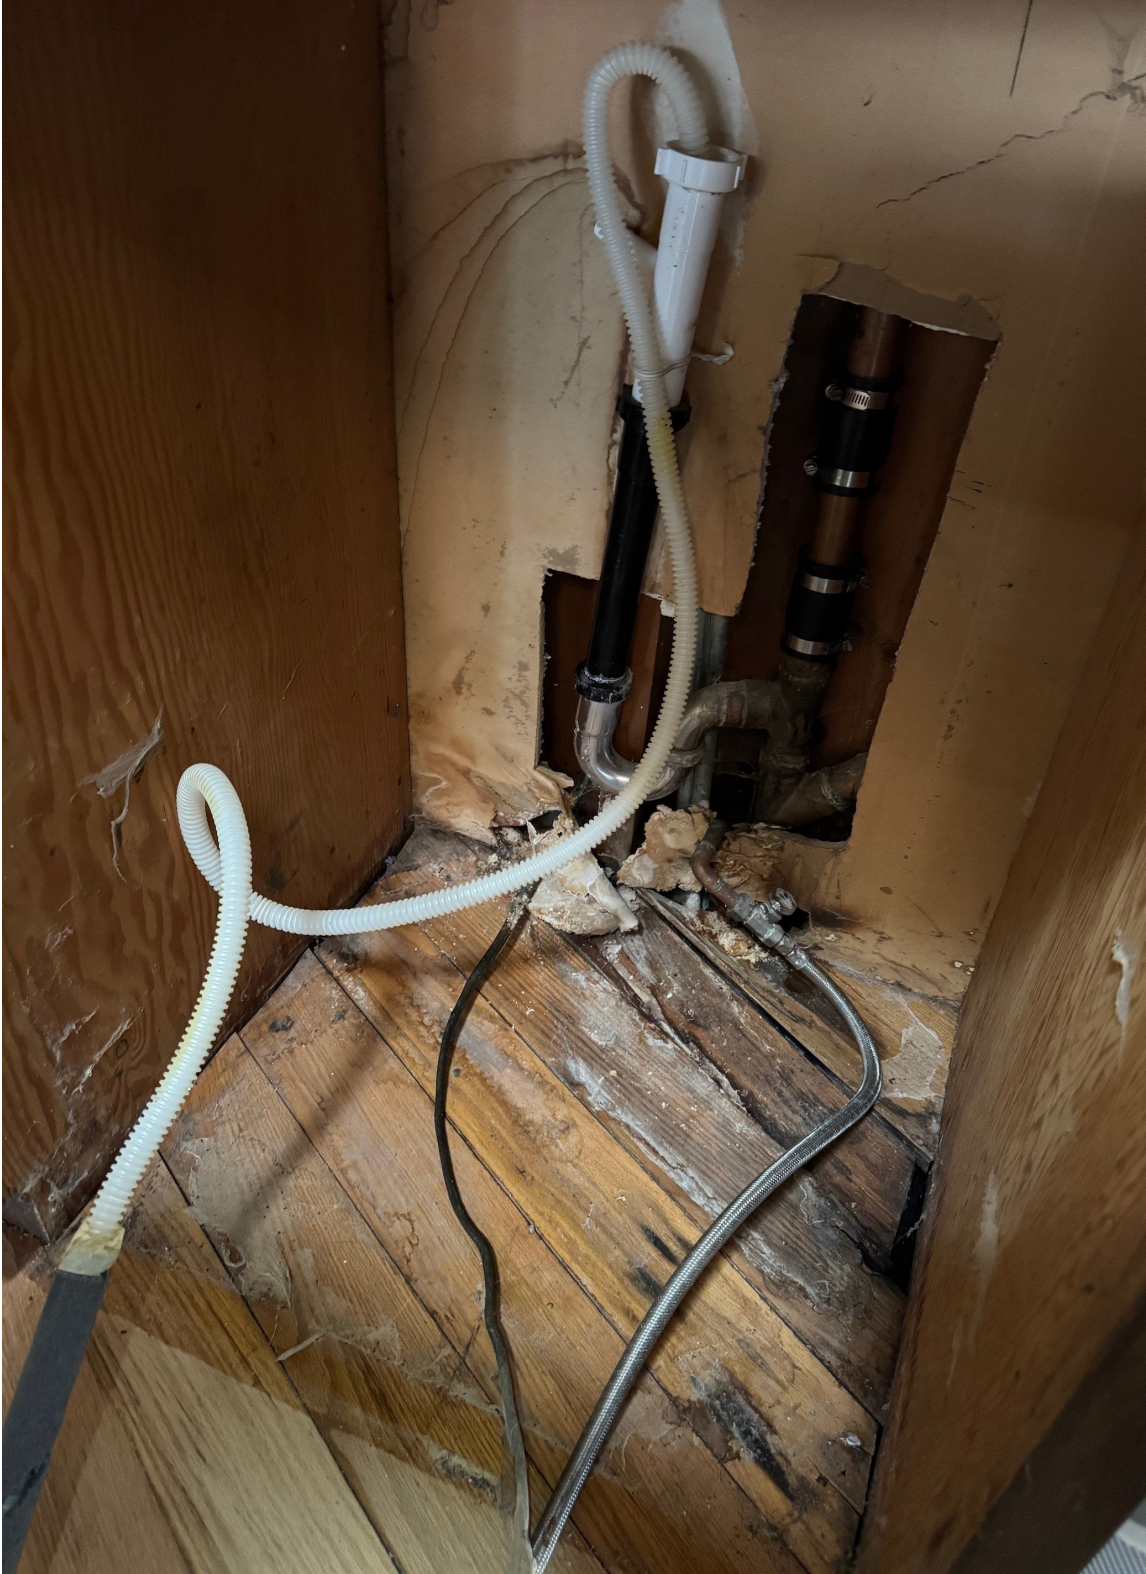
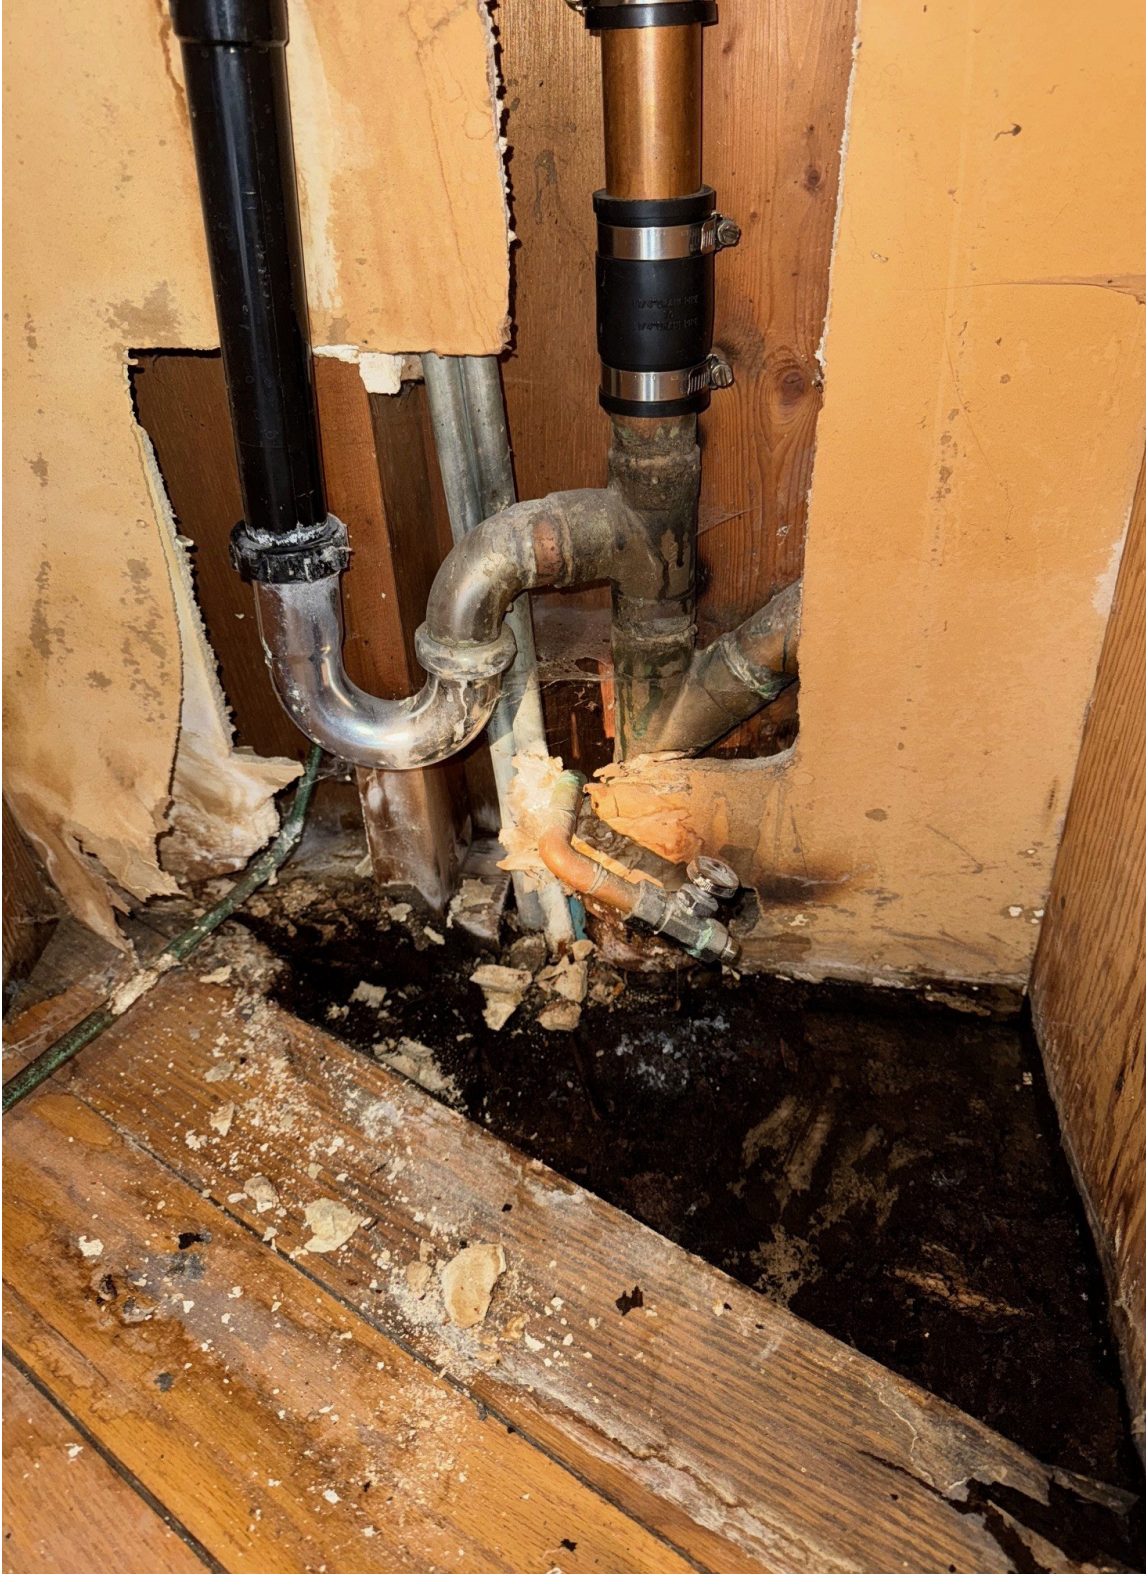
## #1 - Sewer Line Back-up

| 1. | Architectural Feature: <small>Sewer Line Backup</small><br><br>Describe feature and its condition: | Describe work/impact on feature: |
|---|---|---|
| | <p>In March of 2025, we discovered that a partially blocked sewer line caused a slight leak every time the dishwasher ran since before we purchased the home. This leak had caused rot and mold in the wood floor and subfloor, and damage to the kitchen cabinets.</p> | <p>Sewer line scoping, tracing, and water jetting were required. Ultimately a section of the sewer line under the dining room had to be replaced. Mold and water remediation was required which resulted the removal and loss of kitchen base cabinets and the wall paneling between the kitchen and dining room. The water had rotted out the toe kick area of the cabinets and warped the wall paneling. Mold had spread throughout the base cabinets.</p> |

WATER DAMAGE FROM SEWER BLOCKAGE  
AT DISHWASHER

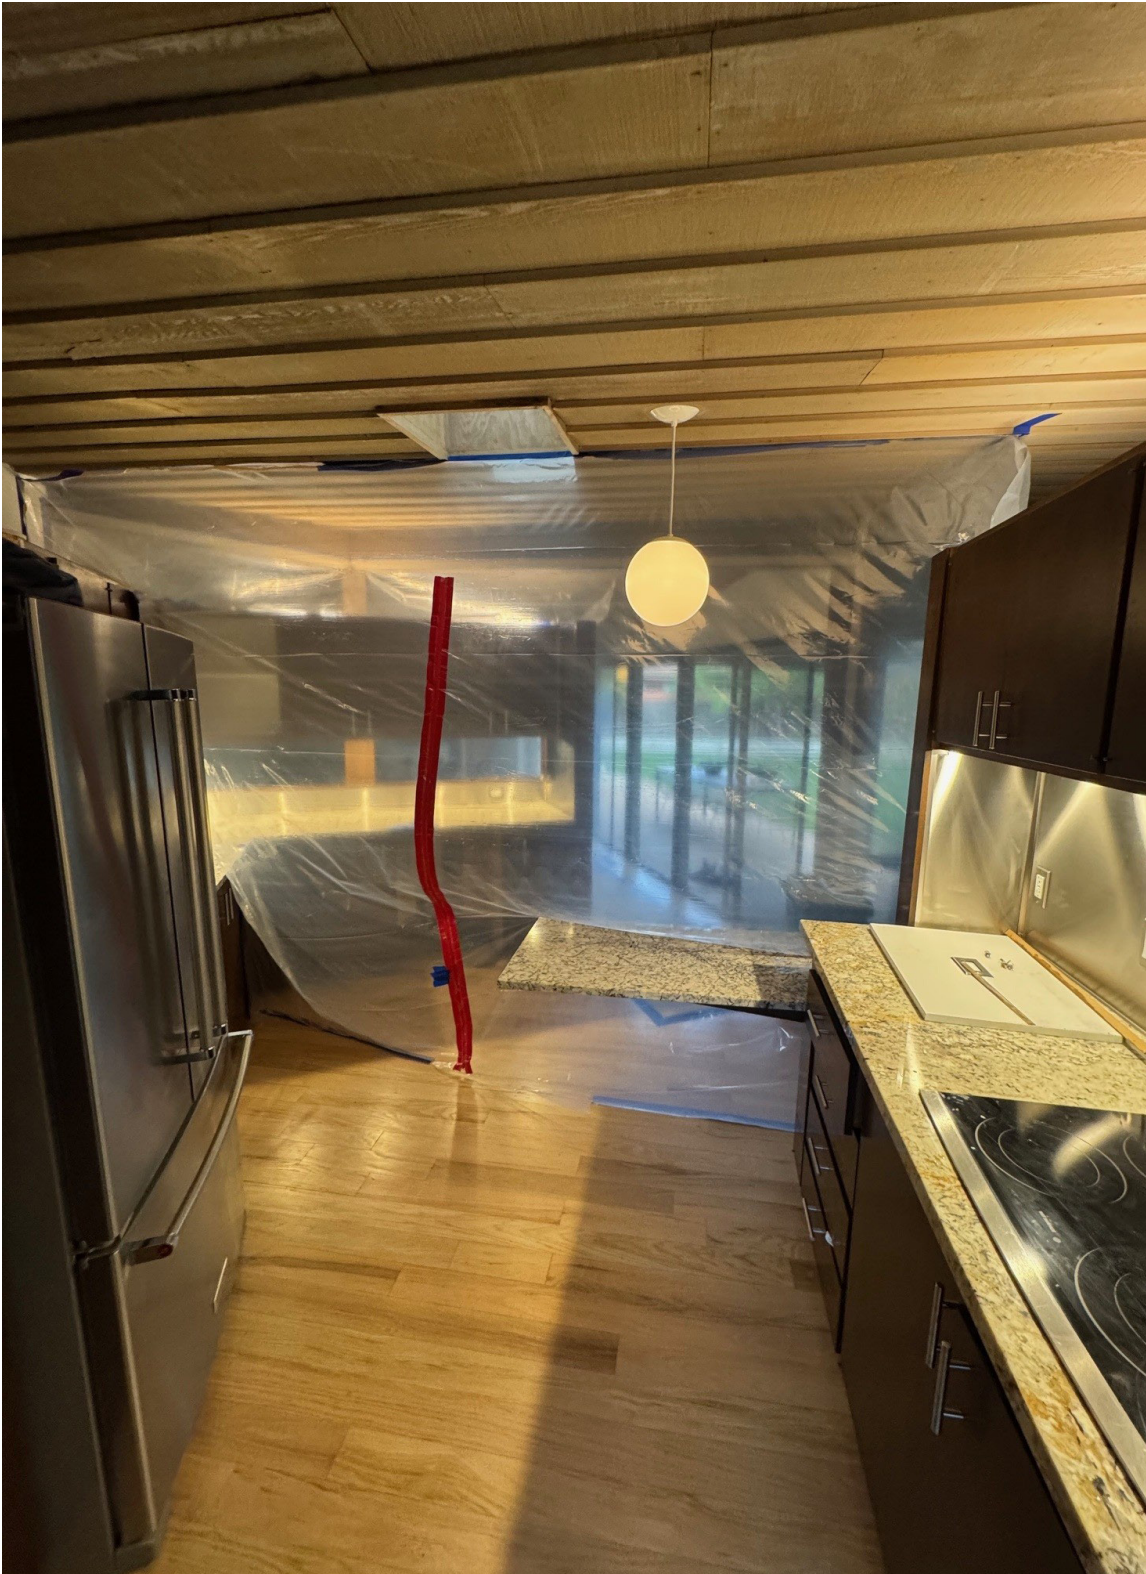
## #1 - Sewer Line Back-up

DURING MOLD AND WATER REMEDIATION

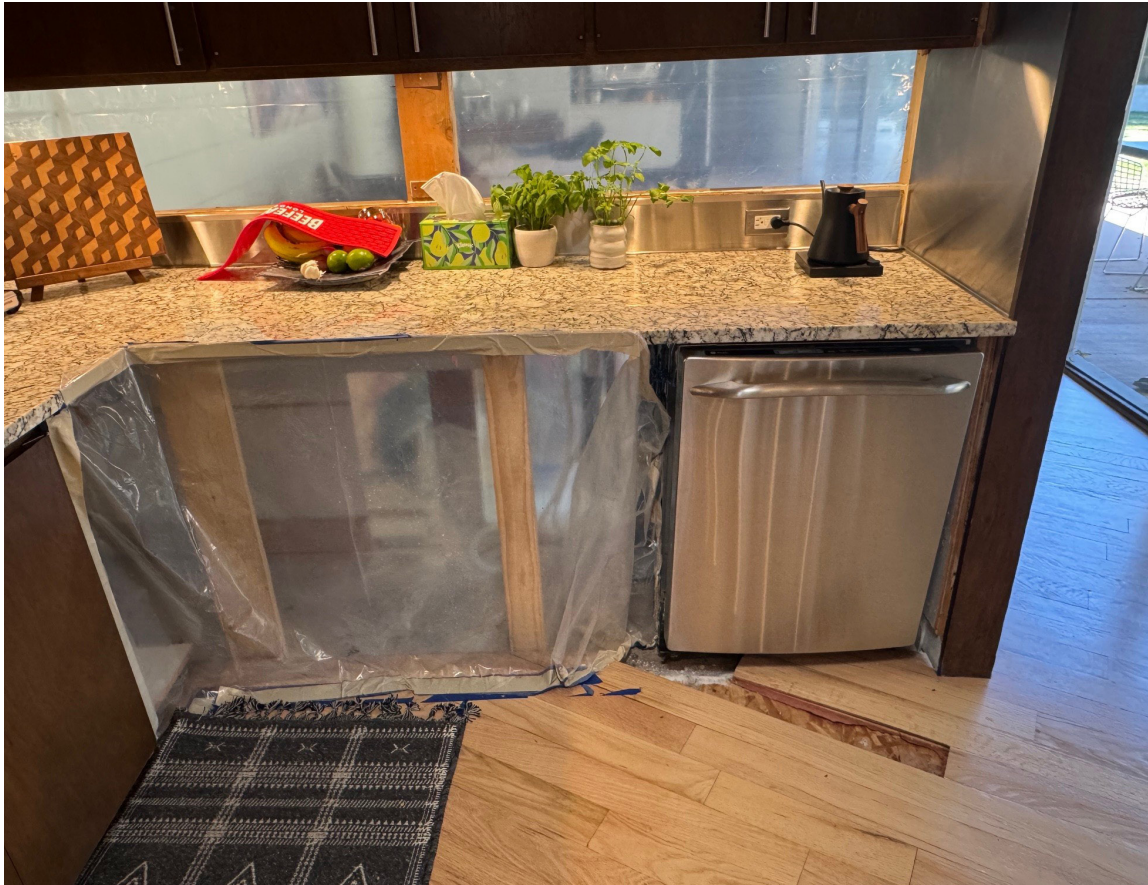
## #1 - Sewer Line Back-up

AFTER REMEDIATION, BASE CABINETS  
DAMAGED BY WATER AND MOLD BEYOND  
REPAIR AND HAVE BEEN REMOVED

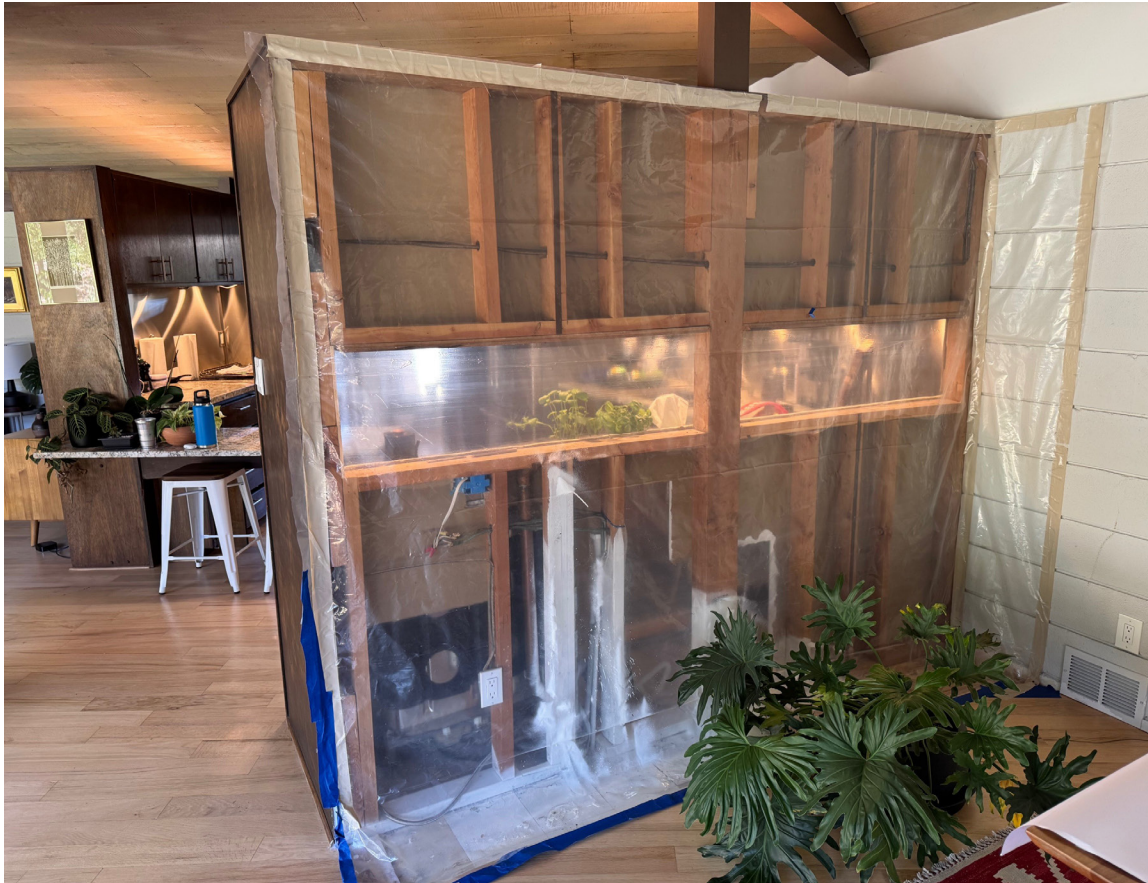
## #1 - Sewer Line Back-up

WOOD PANELING AND WOOD FLOORING  
ON DINING ROOM SIDE DAMAGED BEYOND  
REPAIR BY MOLD AND WATER AND HAVE  
BEEN REMOVED

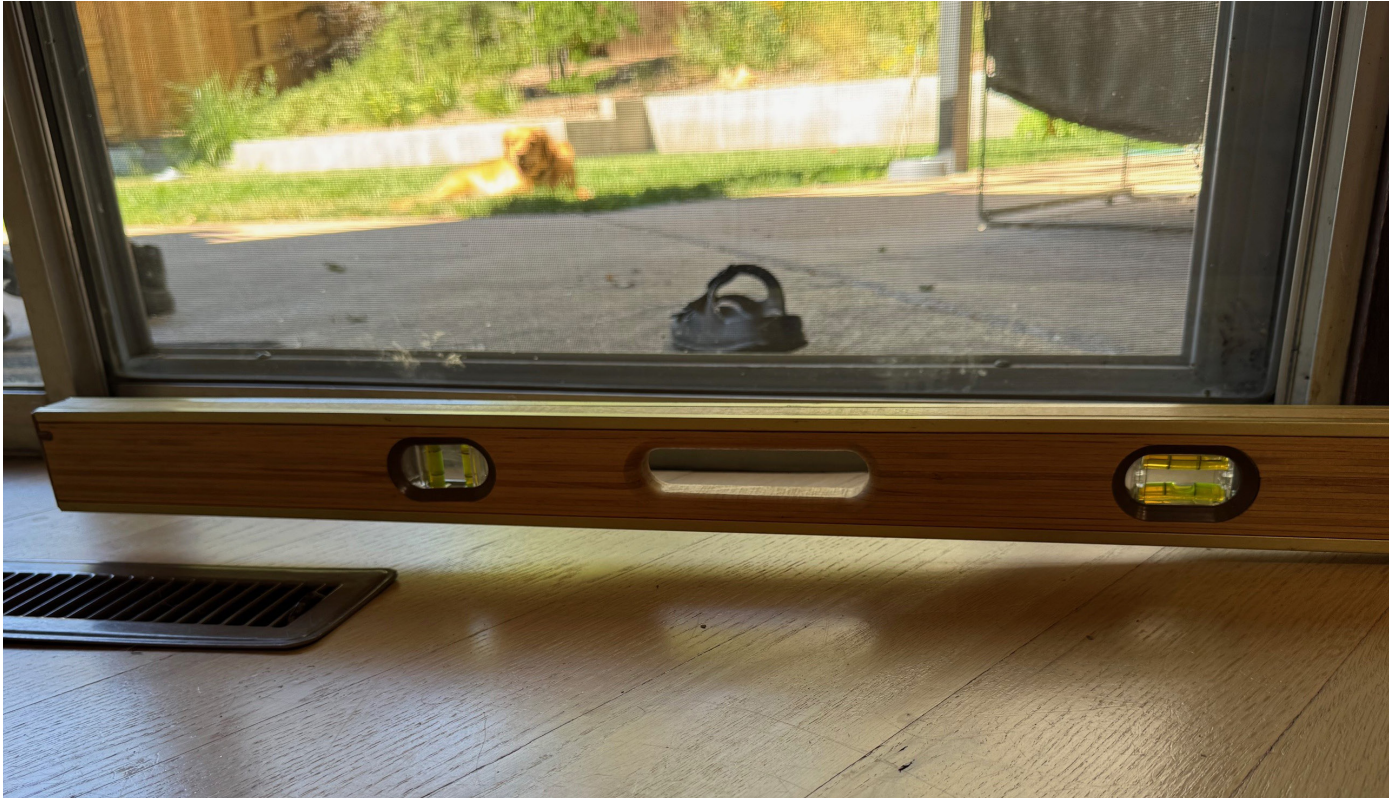
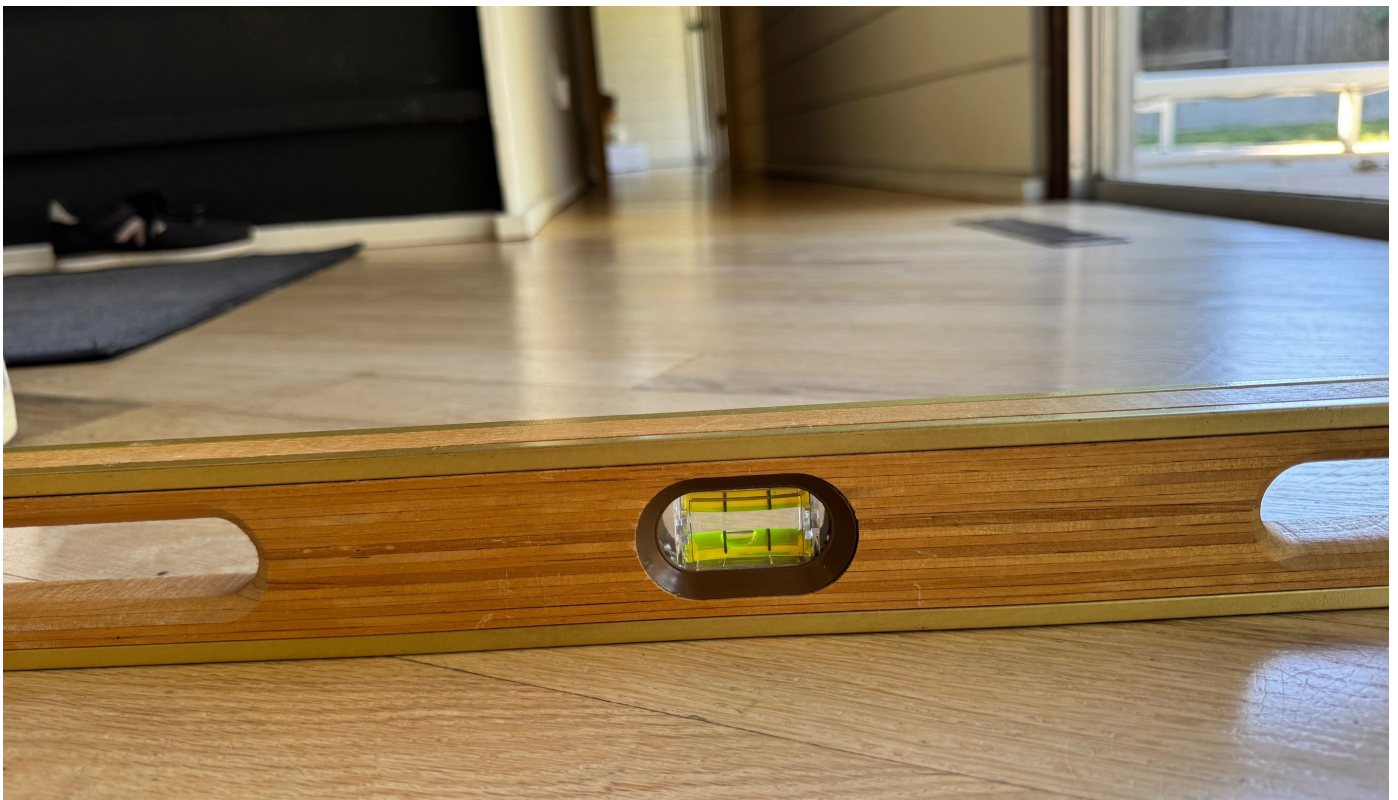
## #2 SLAB SETTLEMENT

| 1. | Architectural Feature: <small>Sewer Line Backup</small><br><br>Describe feature and its condition: | Describe work/impact on feature: |
|---|---|---|
| | <p>The house is slab on grade. When the small area of wood flooring was removed from the kitchen for mold remediation, it revealed major cracks in the concrete slab. When a hardwood floor installer came to look at patching the wood floor in the kitchen he put a laser on the floor and revealed that the slab had settled up to 2 inches in many areas, with a high point at the center of the home, and the low points along the exterior walls. The settlement was so extreme that it was not possible to install new wood flooring over top of it to patch the kitchen floor because the floor variation exceeded the allowable limits for wood flooring installation.</p> | <p>The wood floor and plywood subfloor had to be removed from the living room, kitchen, dining room, and guest bedroom, which were continuous areas of flooring. This fully revealed extent of damage to the slab from settlement. The settlement extended under the kitchen cabinets, and in order to level the slab to the point that new flooring could be installed, the remaining kitchen cabinets had to be removed. Because they were site built and structurally connected, it was not possible to remove them without damaging them. The slab had to be ground down at the high point, and up to an 1-1/2" of leveling concrete with fiber mesh reinforcement had to be poured. New 4" wide white oak flooring to match the previous floors will be installed over the leveled slab.</p> |

FLOOR SLAB SETTLEMENT HAS RESULTED  
IN VERY UNEVEN FLOORS

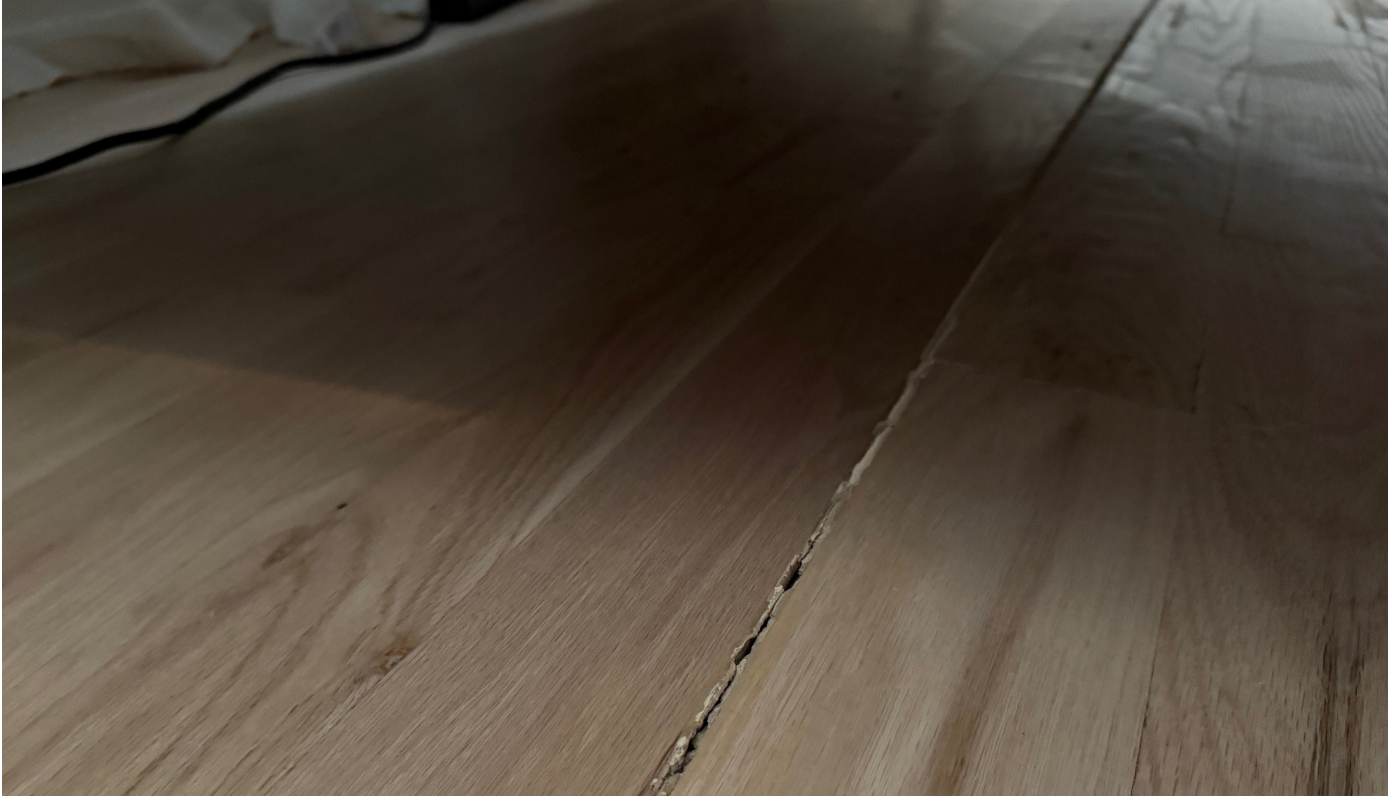
## #2 SLAB SETTLEMENT

FLOOR SLAB SETTLEMENT HAS  
RESULTED CRACKING AND BUCKLING OF  
WOOD FLOORS

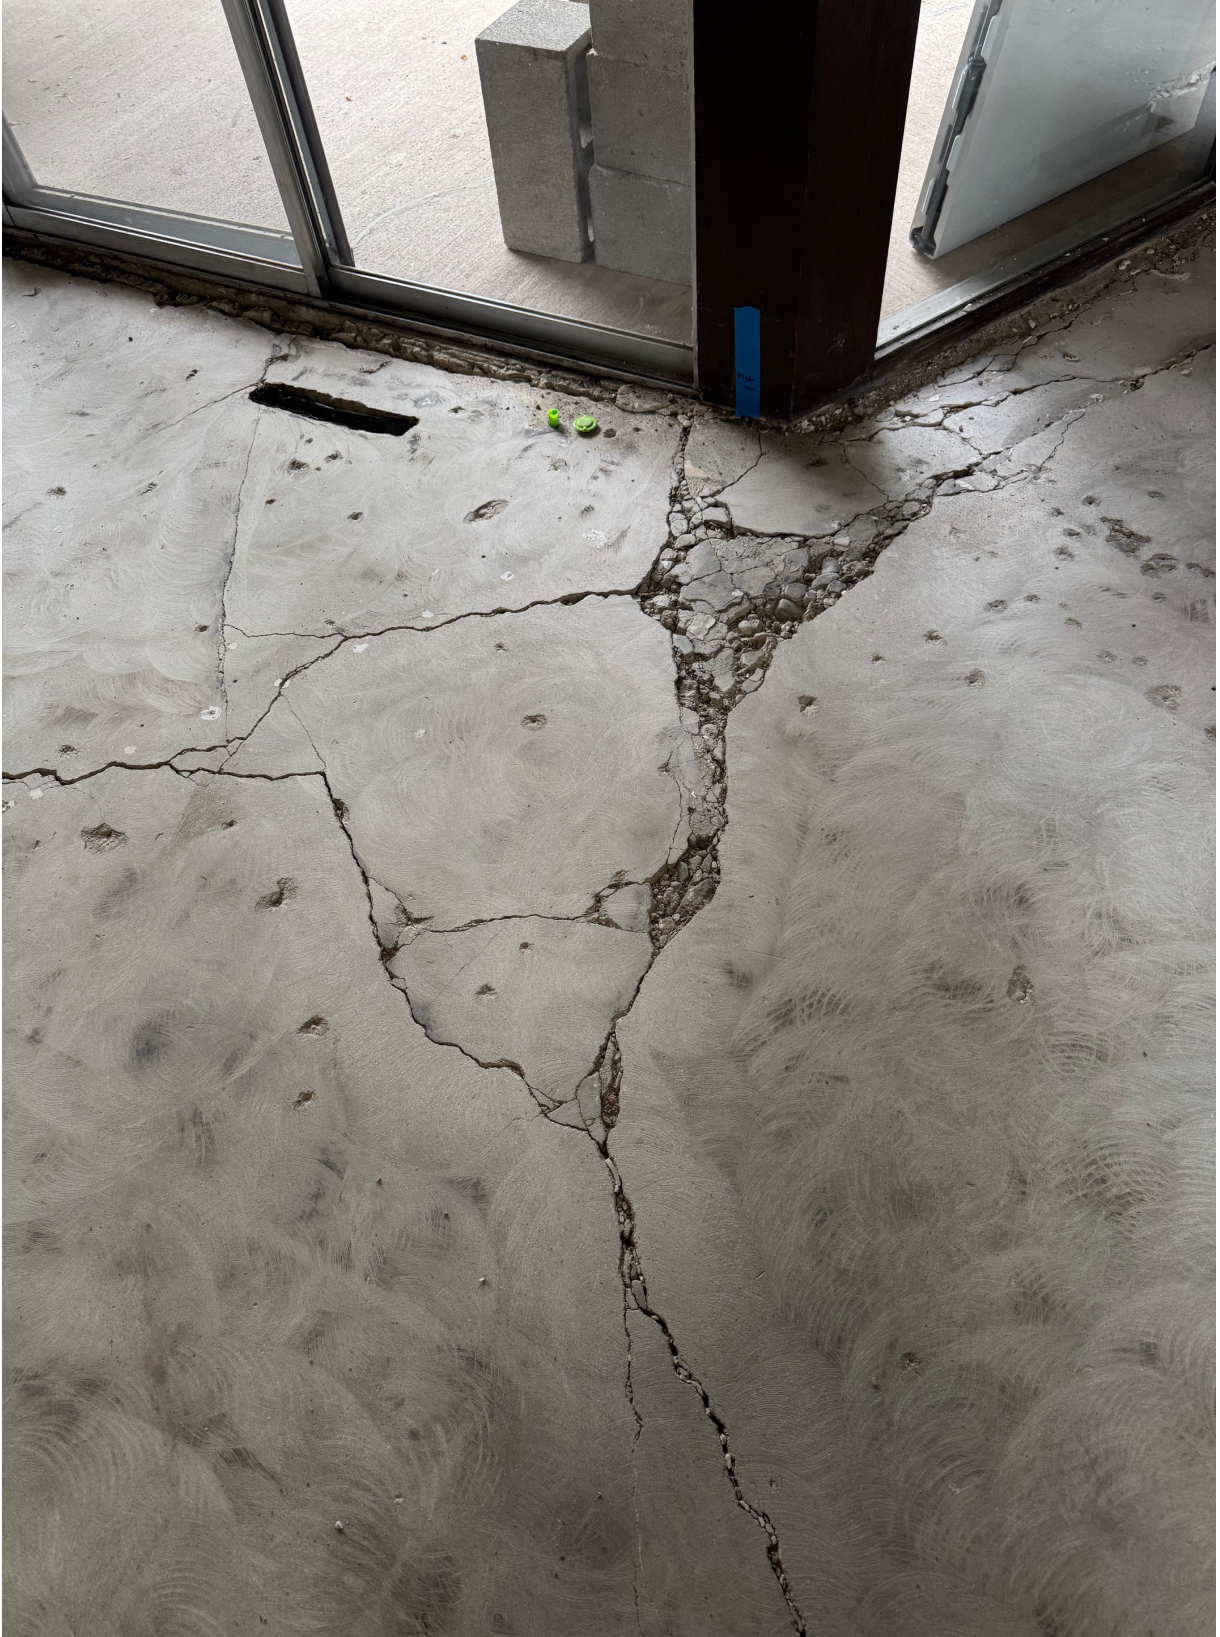
## #2 SLAB SETTLEMENT

FLOOR SLAB SETTLEMENT HAS  
SEVERELY DAMAGED CONCRETE SLAB

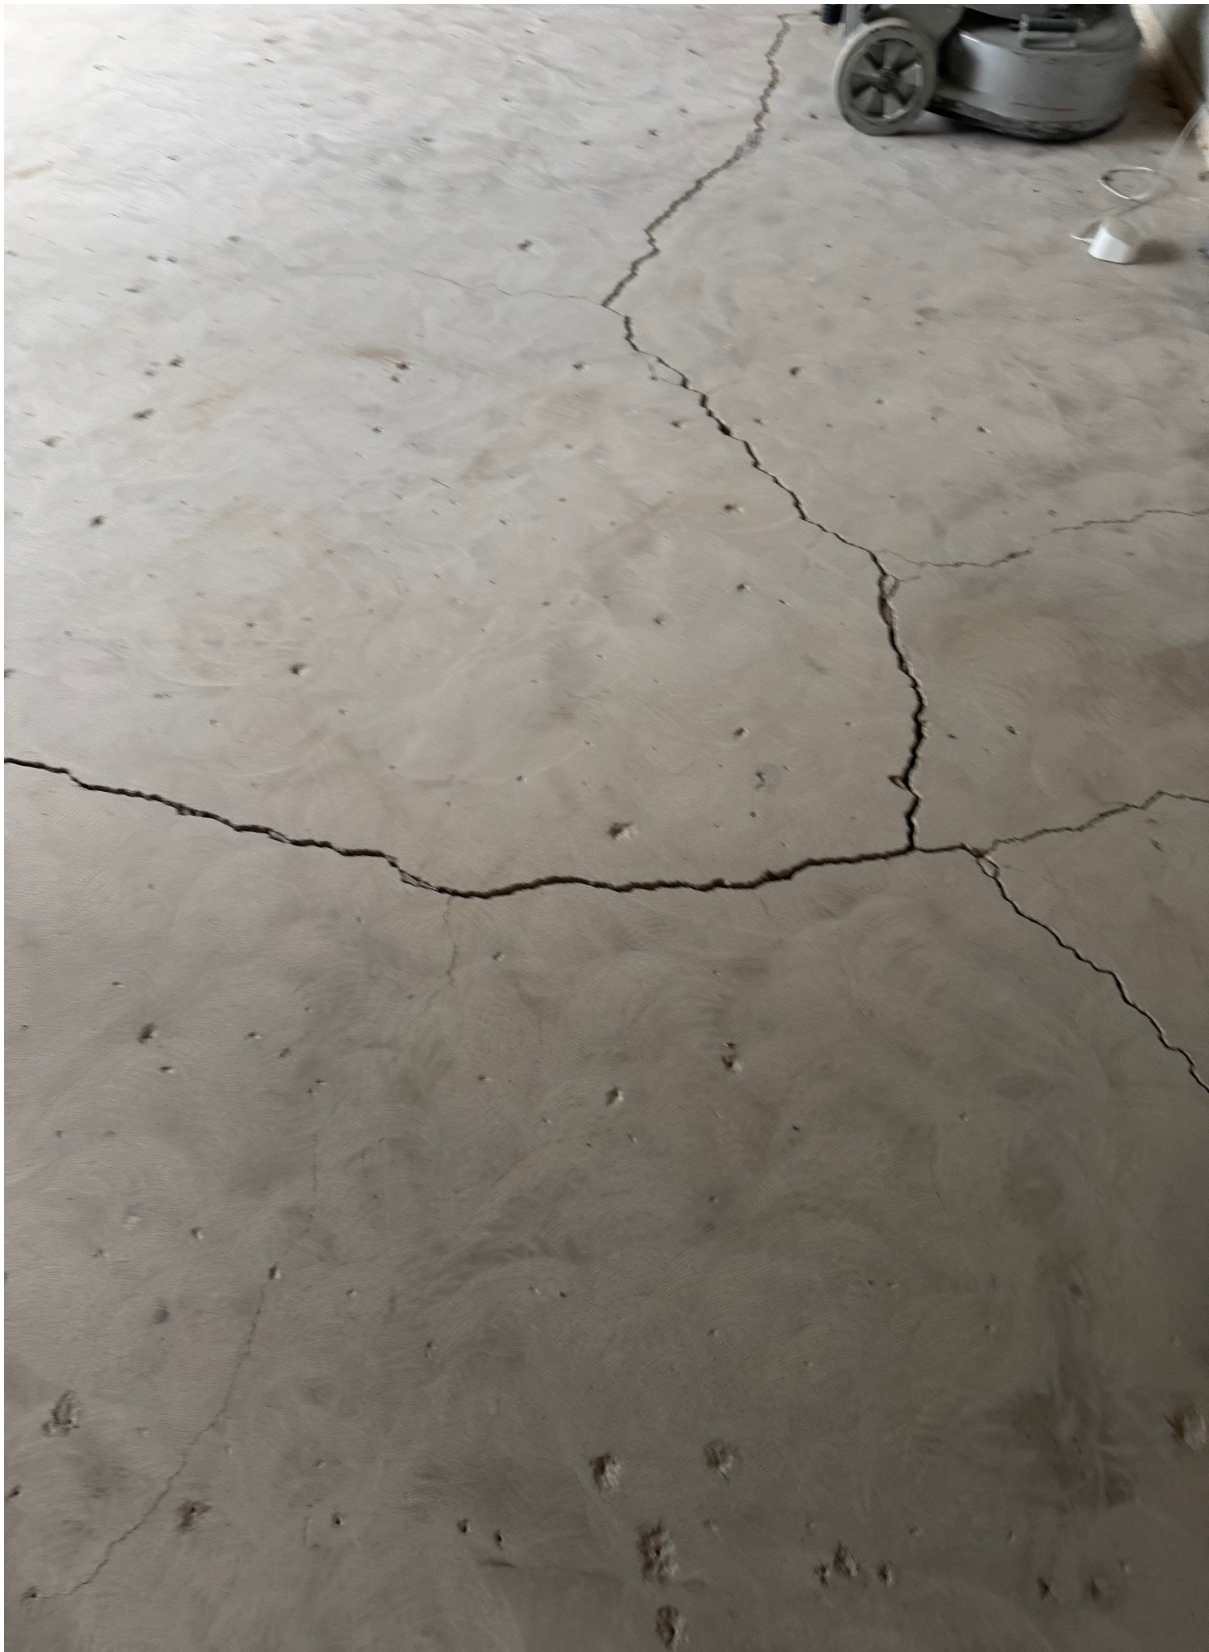
## #2 SLAB SETTLEMENT

FLOOR SLAB SETTLEMENT HAS  
SEVERELY DAMAGED CONCRETE SLAB

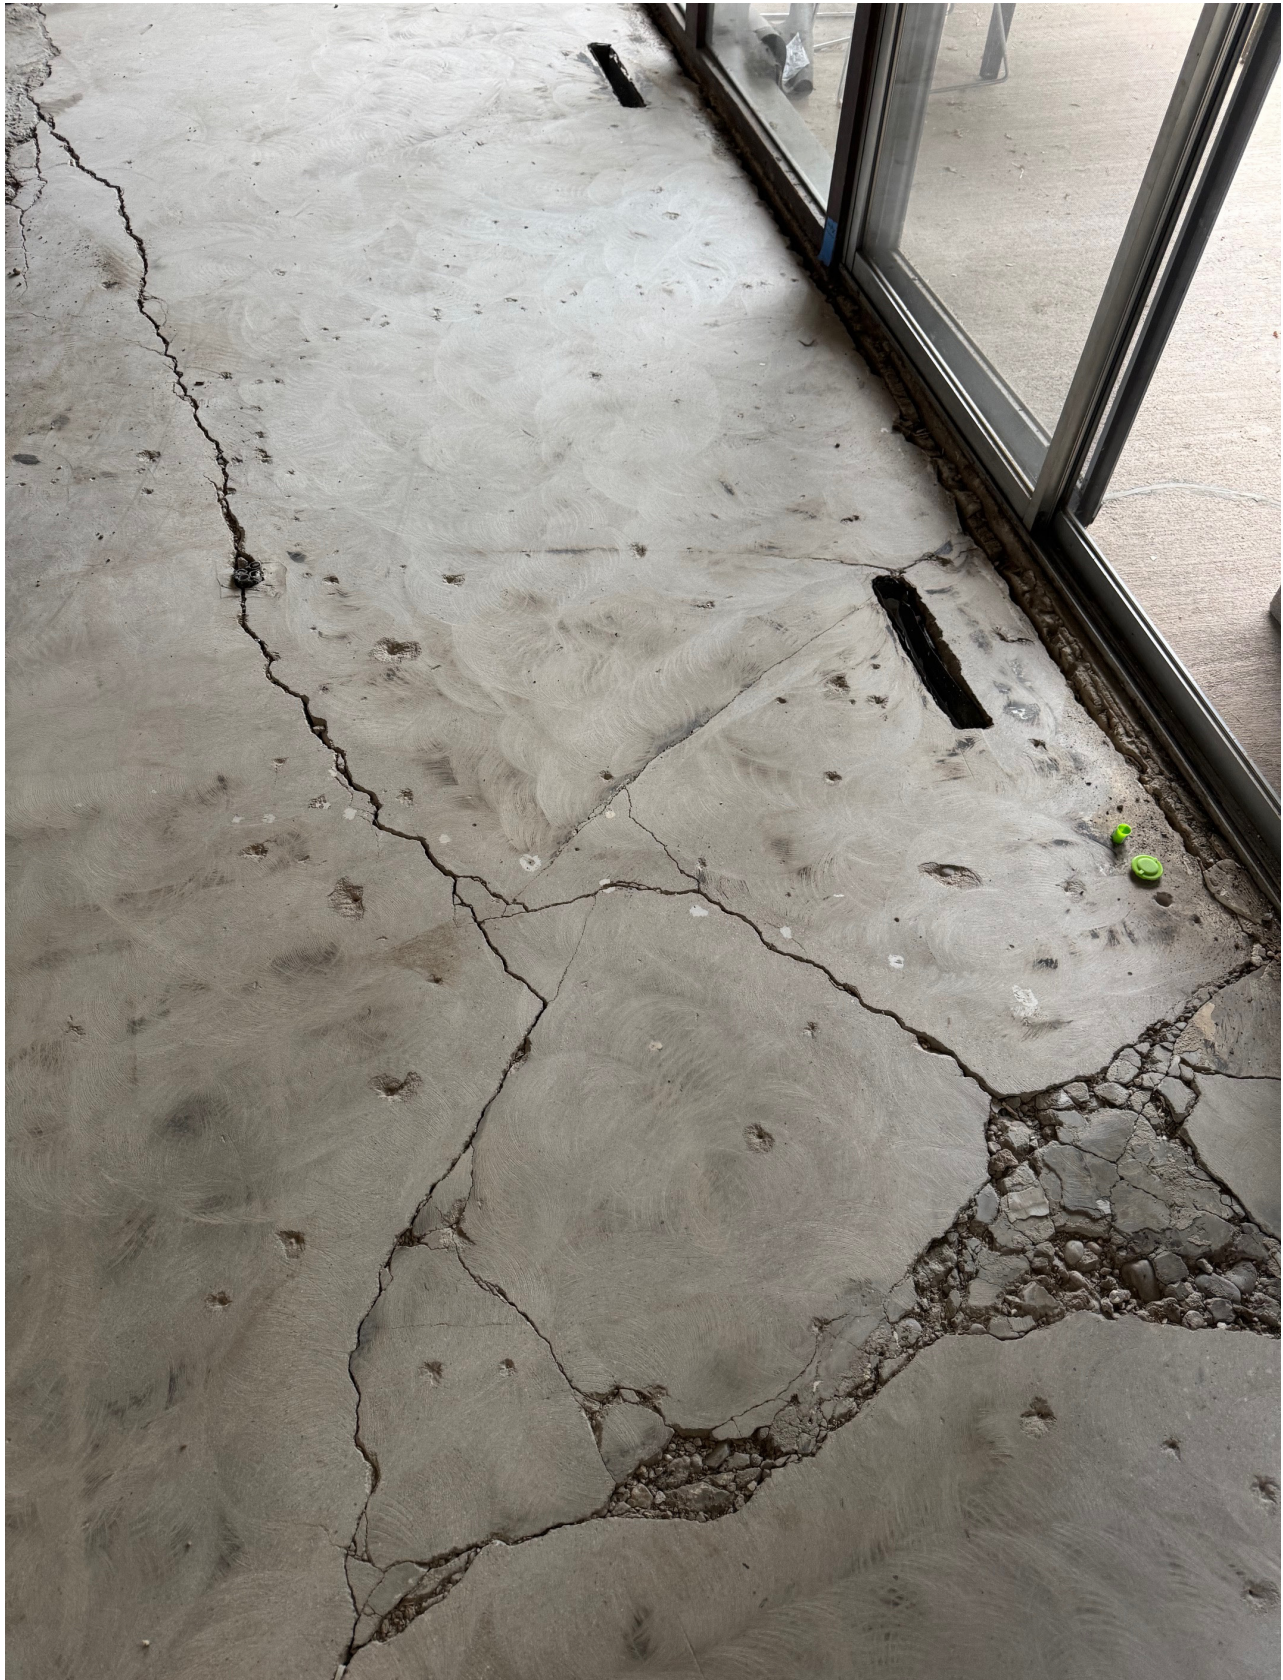
## #2 SLAB SETTLEMENT

FLOOR SLAB SETTLEMENT HAS  
SEVERELY DAMAGED CONCRETE SLAB

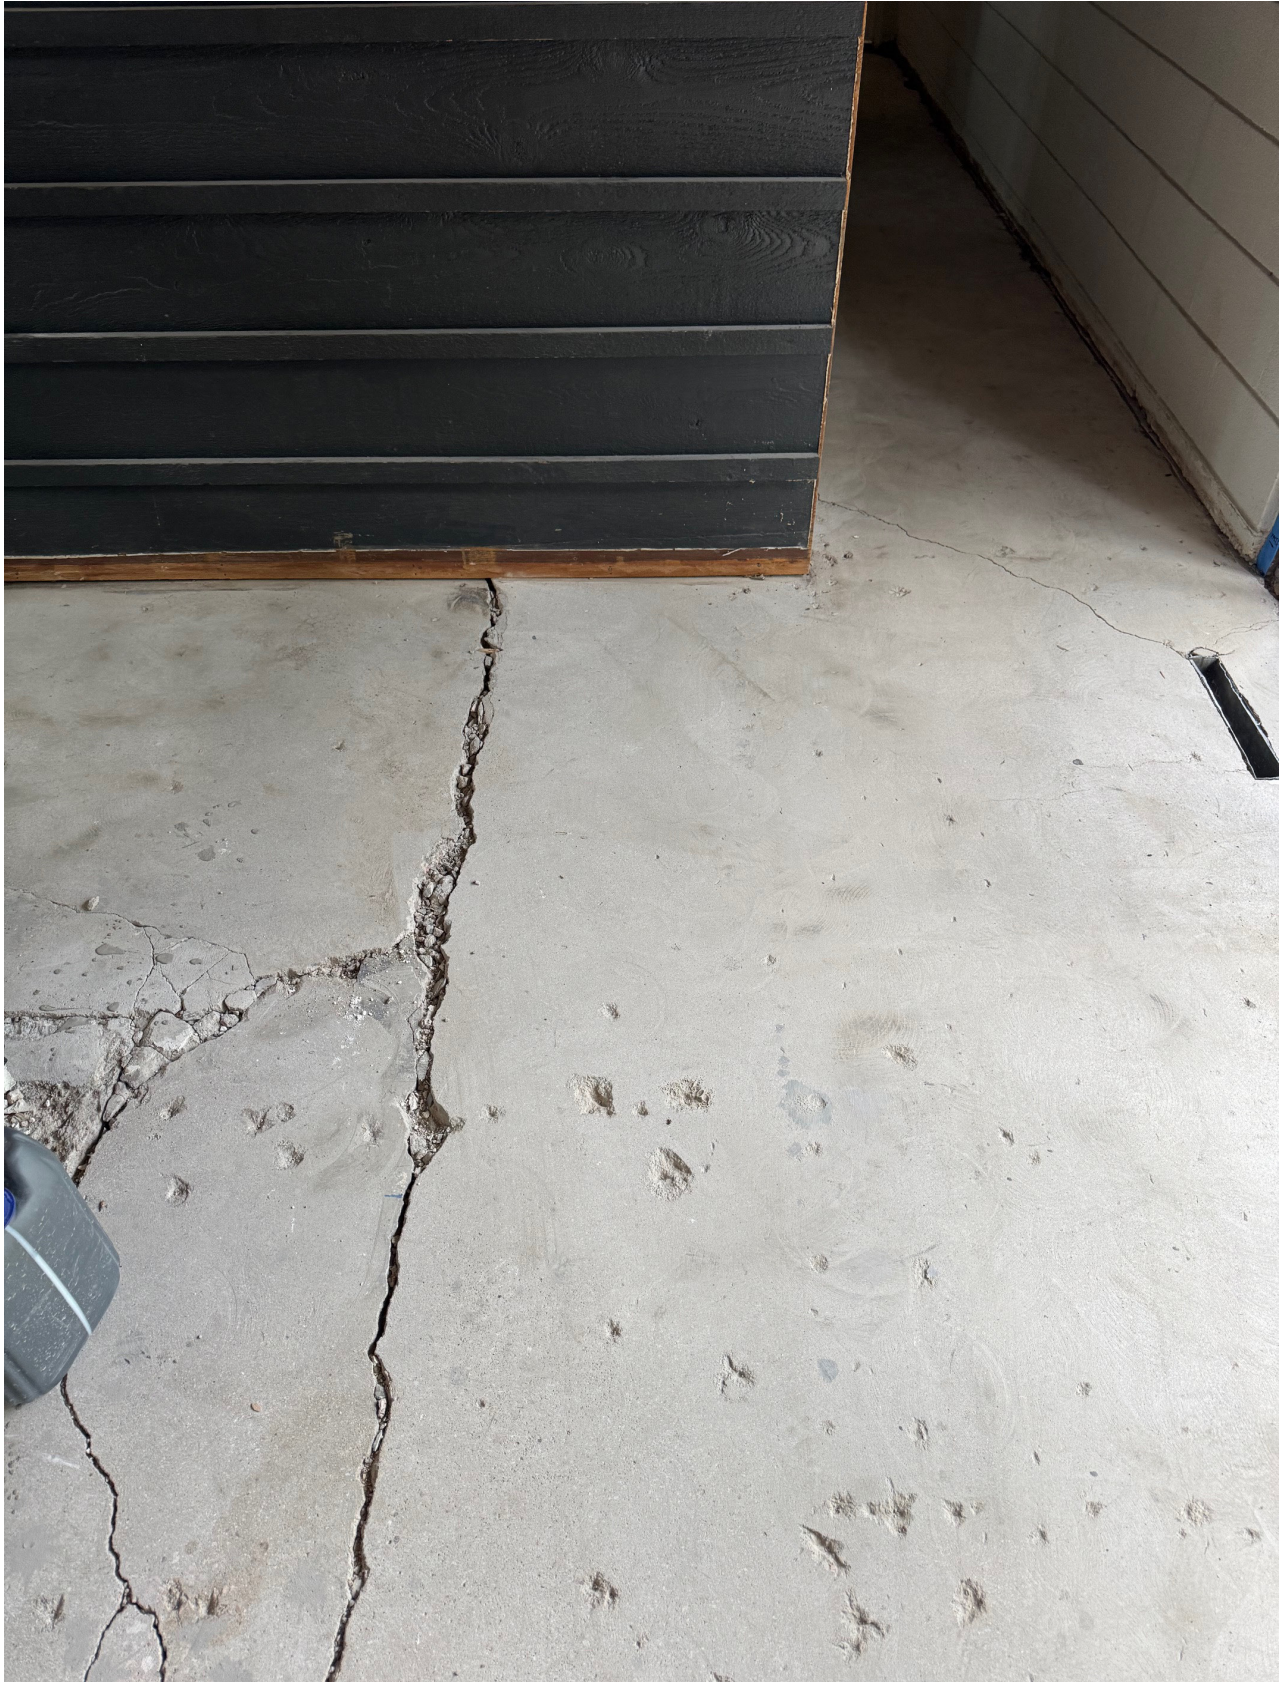
## #2 SLAB SETTLEMENT

FLOOR SLAB SETTLEMENT HAS  
SEVERELY DAMAGED CONCRETE SLAB

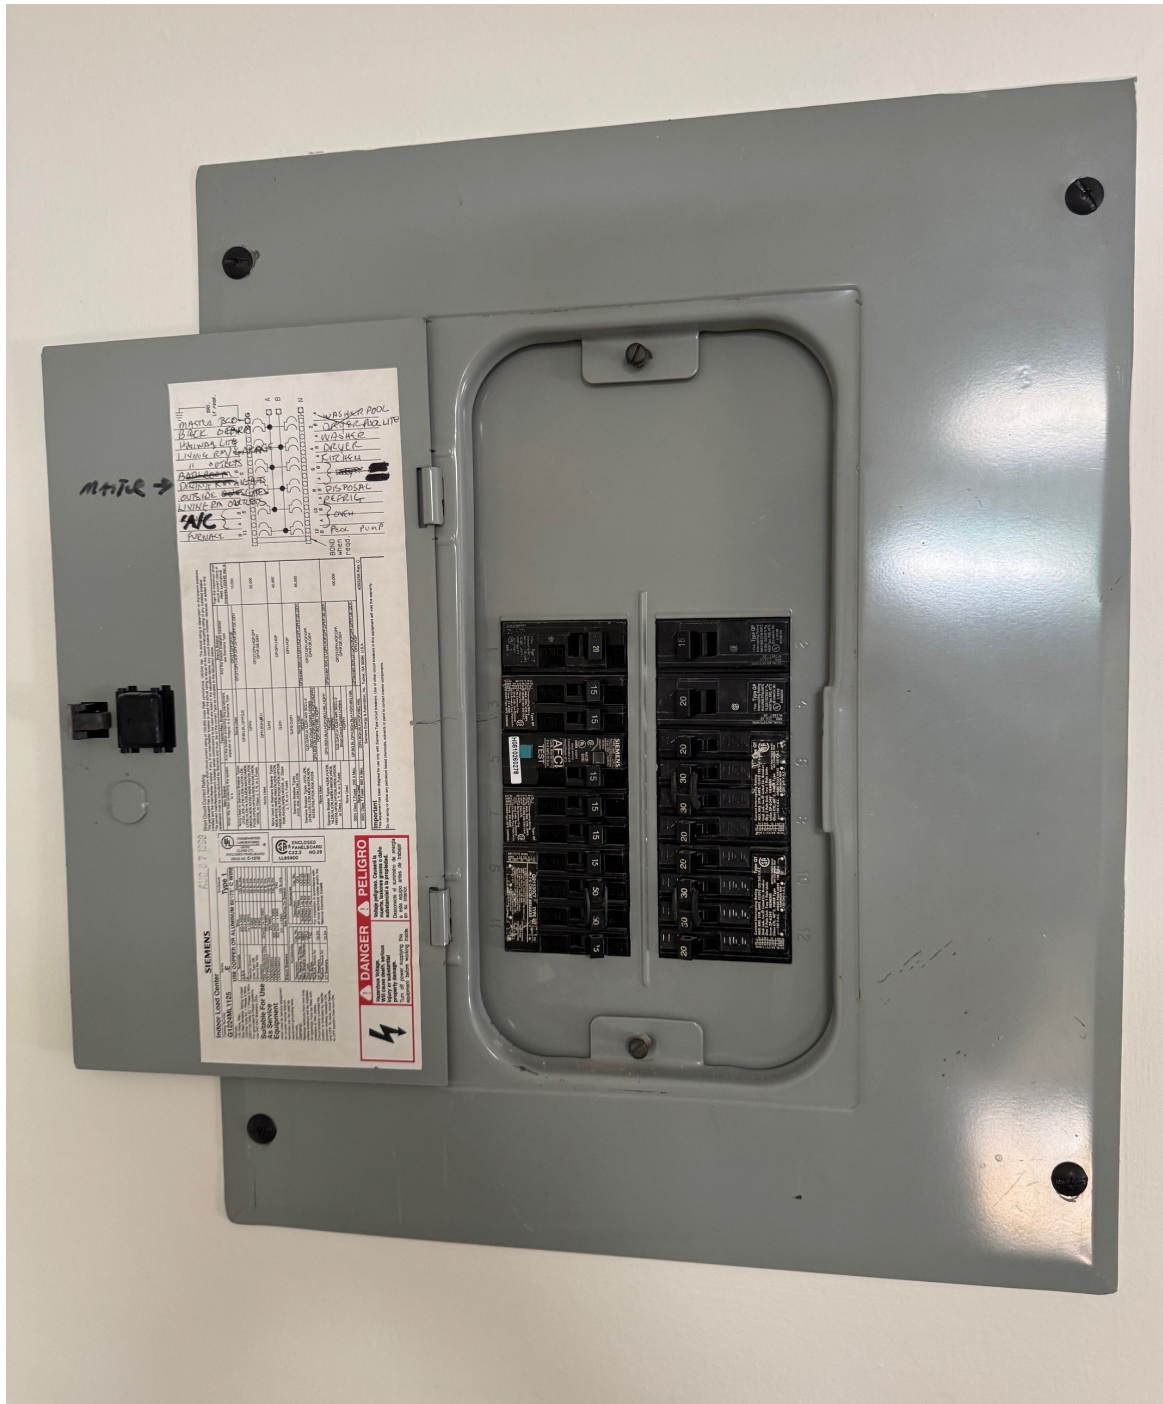
## #4 ELECTRICAL PANEL

| 4 | <p>Architectural Feature: Electrical Panel</p> <p>Describe feature and its condition:</p> <p>The electrical panel of the home was undersized, and changes by previous owners has resulted in unsafe circuiting that consistently tripped breakers</p> | <p>Describe work/impact on feature:</p> <p>A new, larger panel with additional circuits was installed to allow for safe operation and adequate amperage for circuits.</p> |

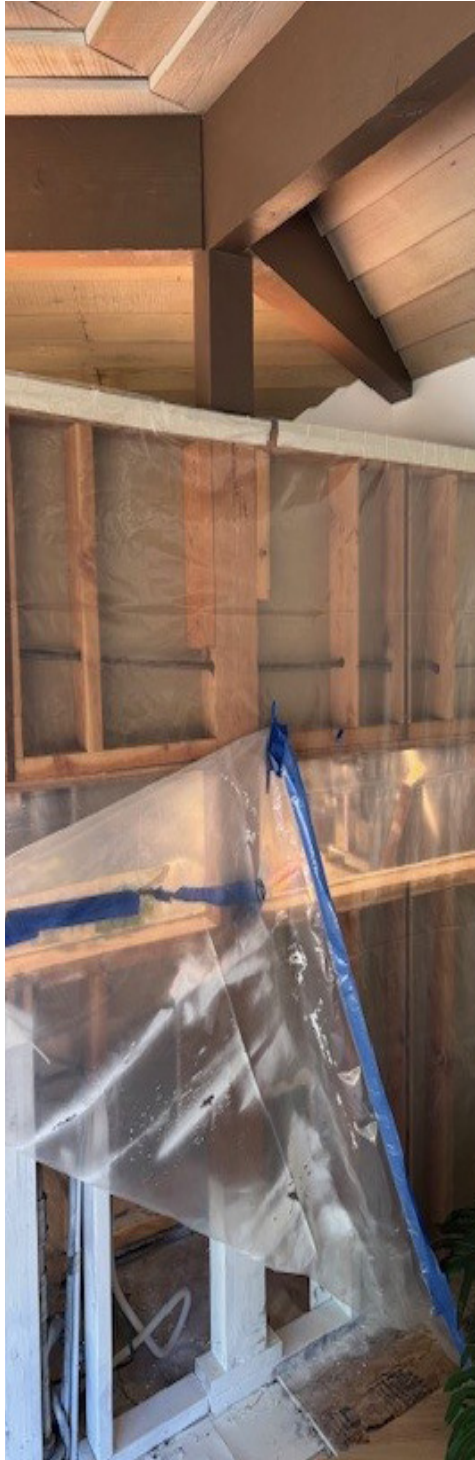
## #5 RIDGE BEAM POST

| 5 | <p>Architectural Feature: Ridge Beam Post</p> <p>Describe feature and its condition:</p> <p>At the center of the house, the three ridge beams of the three wings of the house intersect and are supported by a post. The original post was effected by the floor settlement issues and no longer had a good connection to the foundation footing. The structural engineer recommended replacing this post</p> | <p>Describe work/impact on feature:</p> <p>A new post was installed and the base plate for it was recessed to conceal the mounting plate below the wood flooring.</p> |

THE STRUCTURAL ENGINEER  
RECOMMENDS REPLACING THE  
STRUCTURAL POST BECAUSE OF FLOOR  
SETTLEMENT.
