**APPLICATION FOR COLORADO STATE INCOME TAX CREDIT  
FOR THE PRESERVATION OF HISTORIC STRUCTURES  
(RESIDENTIAL PROPERTY – 2014 CREDIT)**

Name of Property: The Nyman House

Address: 5475 S Mohawk Road

DESCRIPTION OF REHABILITATION

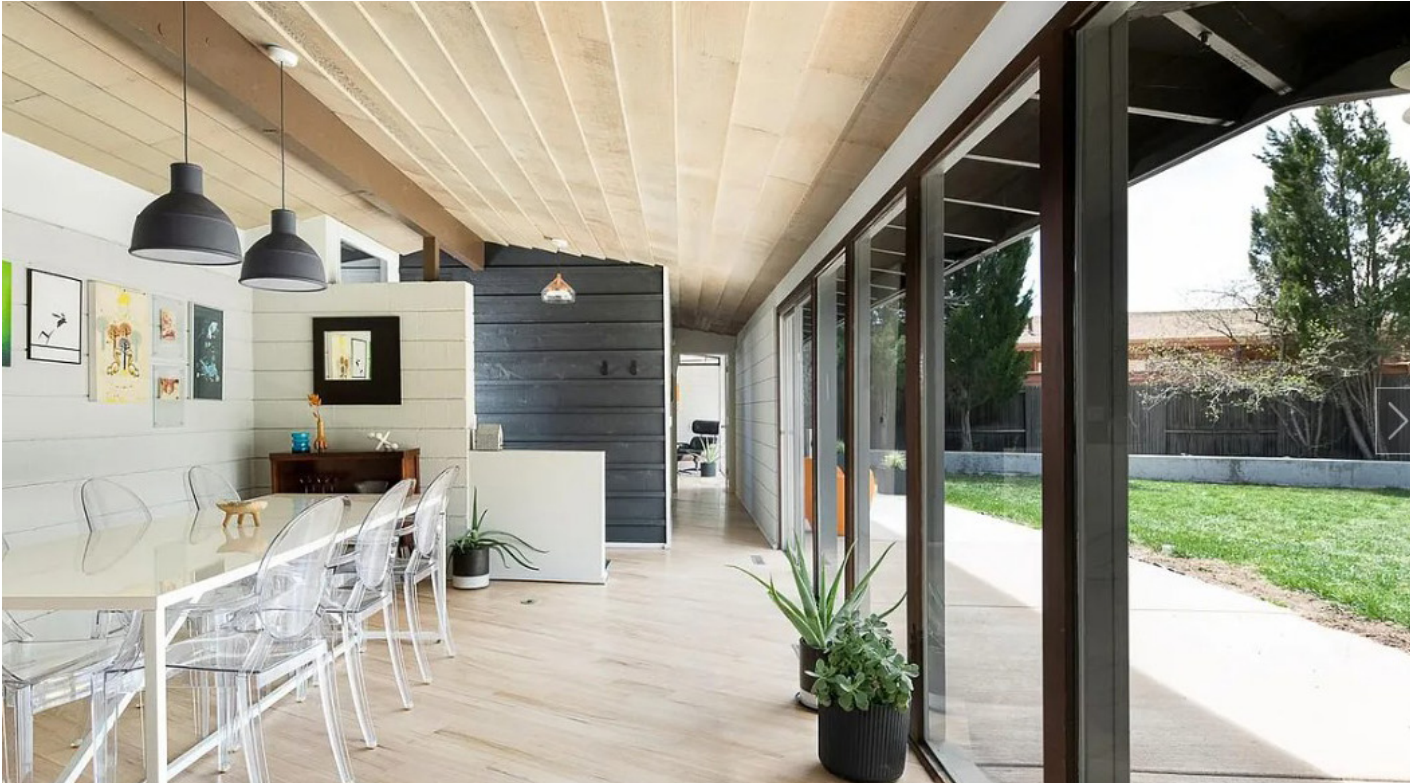
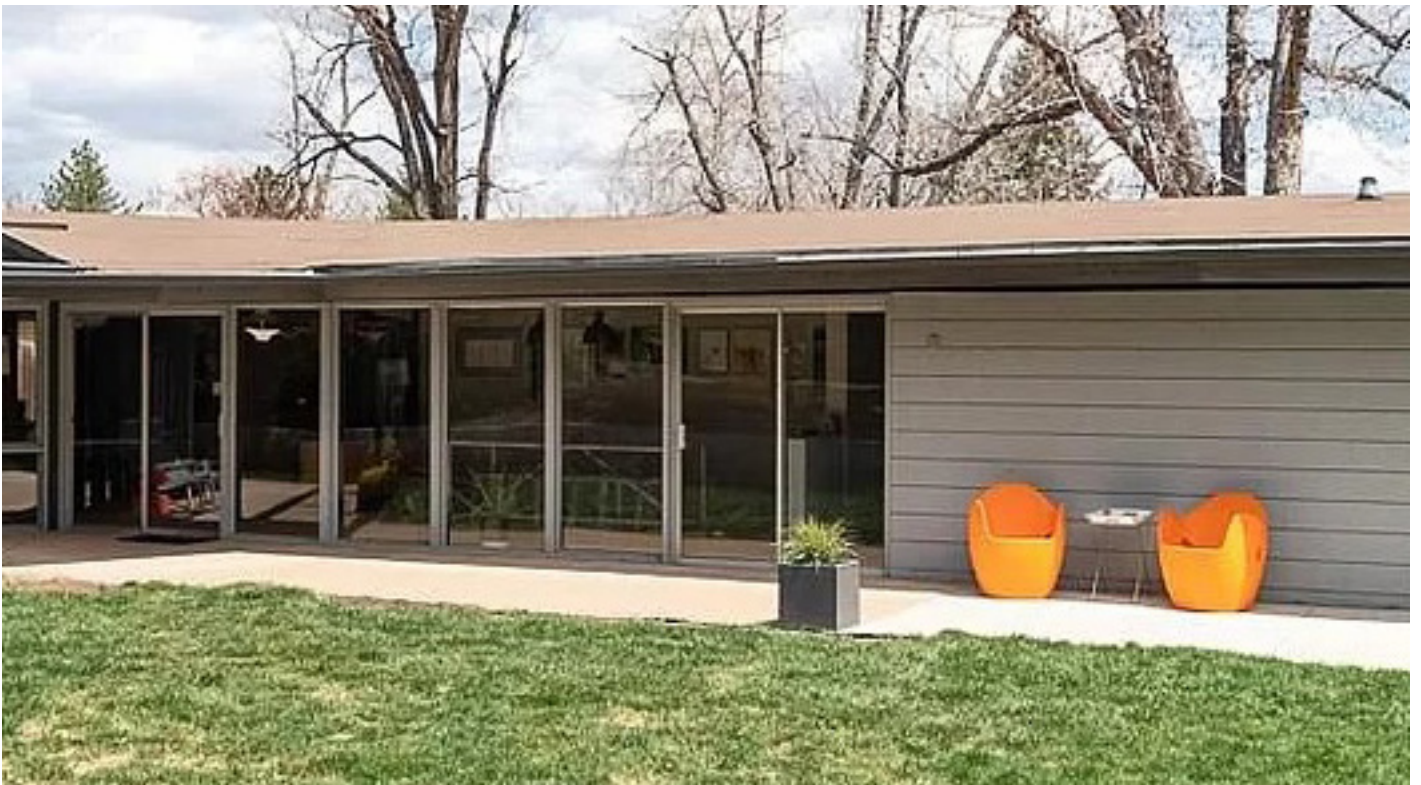
## EXISTING DINING ROOM WINDOWS

| 6 | <p>Architectural Feature: Dining Room Window Wall</p> <p>Describe feature and its condition:</p> <p>The dining room features a wall of floor to ceiling windows along its western edge. Two original aluminum sliding glass doors bracket 4 fixed windows. All of the sliding doors and fixed window feature single pane glass. The wood frames of the windows are deteriorated and rotten. The weather stripping and seals of the sliding glass doors are missing or damaged, leading to considerable air and insect infiltration. The non-thermally broken aluminum frames of the sliding door ice up on the interior side during the winter. The interior floor slab has experienced differential settling along the length of this window wall, varying by as much as 2" from end to end. The settlement of the slab and the structural posts that bear on it have lead the beam at the head of the windows to sag 1-1/2" at its center point.</p> | <p>Describe work/impact on feature:</p> <p>In order to fix the floor slab settlement issues, the two existing sliding doors, and the fixed windows had to be removed. The Nyman house was designed for direct connection of the interior and exterior spaces. Every room features a connection to outside. If the original architect had today's window and door technology, he would undoubtedly have used this to increase this connection even more. The decision was made to take advantage of today's door technology and replace the sliders and fixed windows with two bifolding Nanawall doors. This will allow the entire wall of the dining room to be opened to the exterior. The panels of the new doors match size, spacing, and rhythm of the previous sliding door and fixed window panels. A new steel beam, matching the size of the existing wood beam was installed to carry the roof load over the opening and fix the sagging issue of the previous beam.</p> |

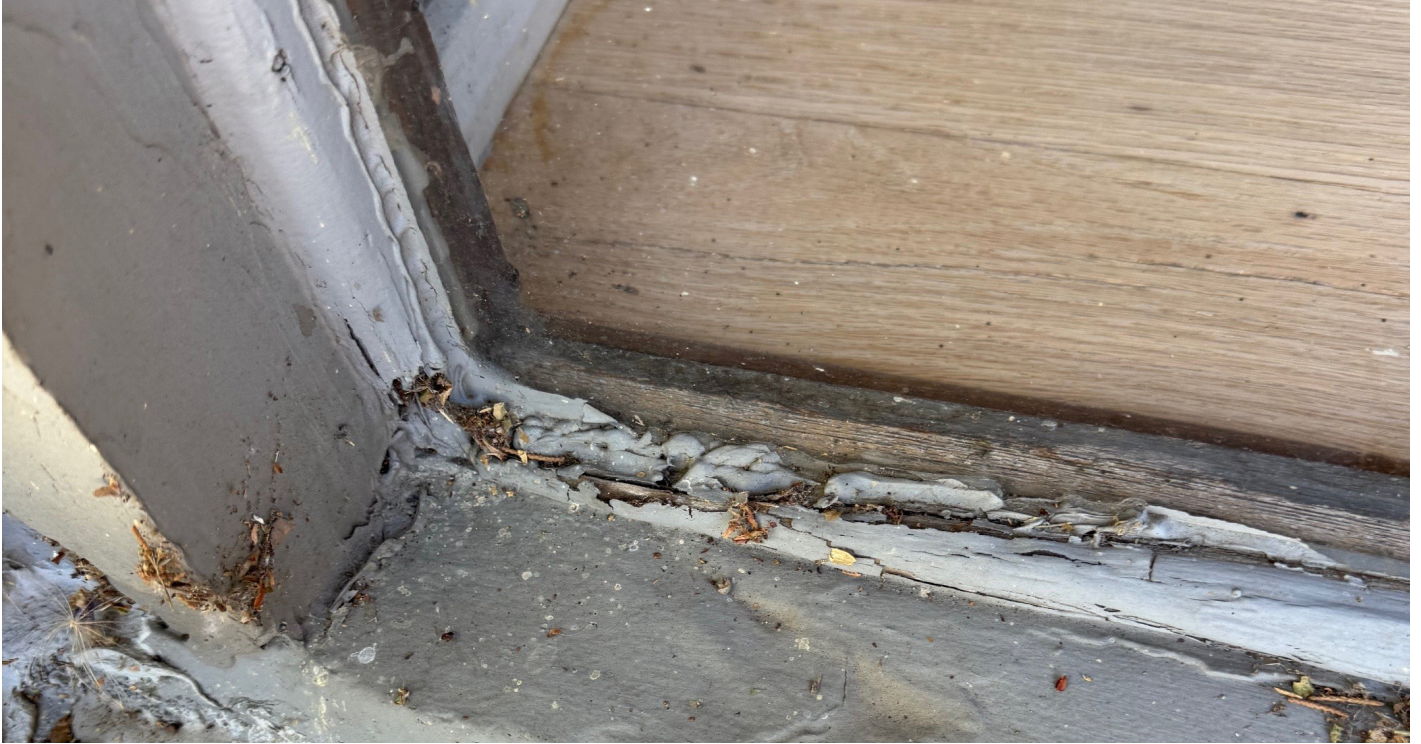
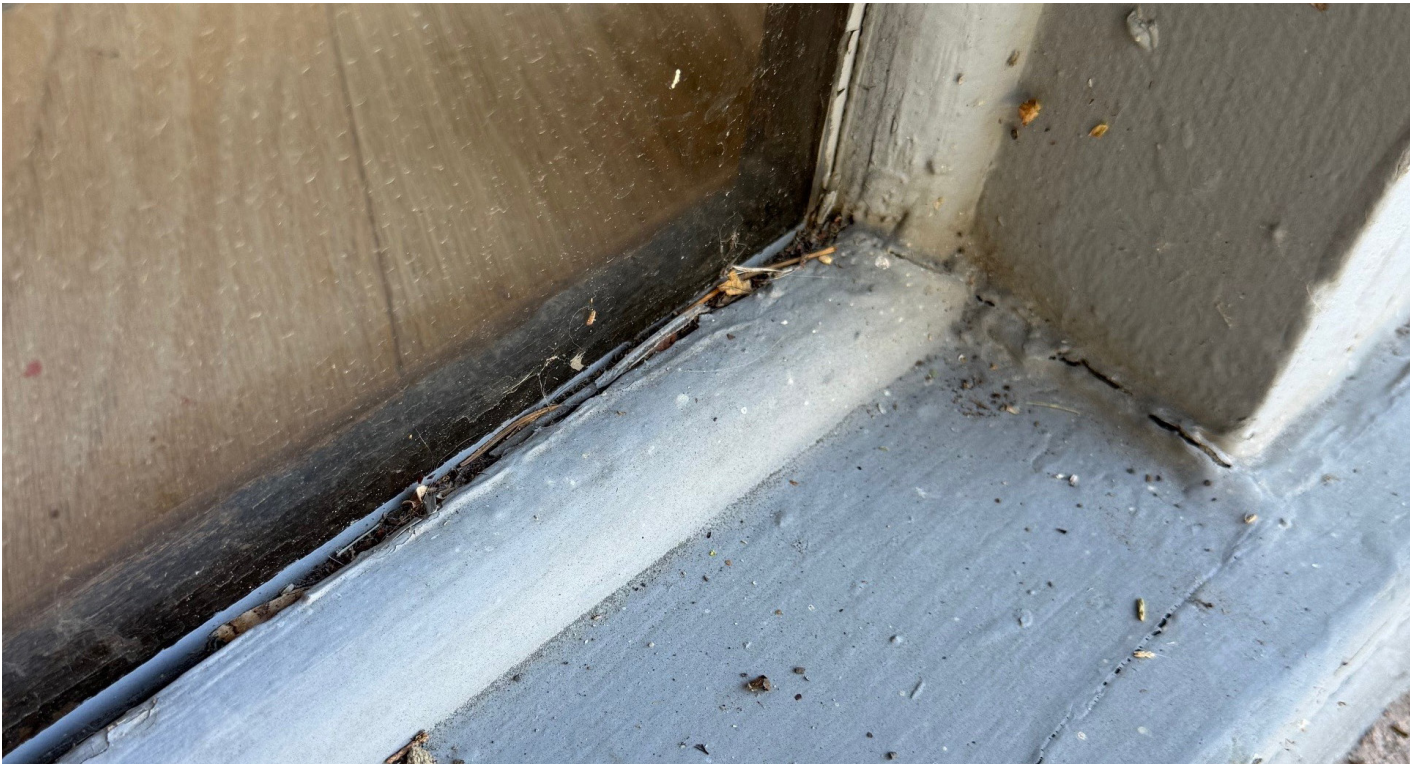
#6 DINING ROOM WINDOW WALL

PHOTOS OF ROT DAMAGE TO EXISTING  
FIXED WINDOW FRAMES

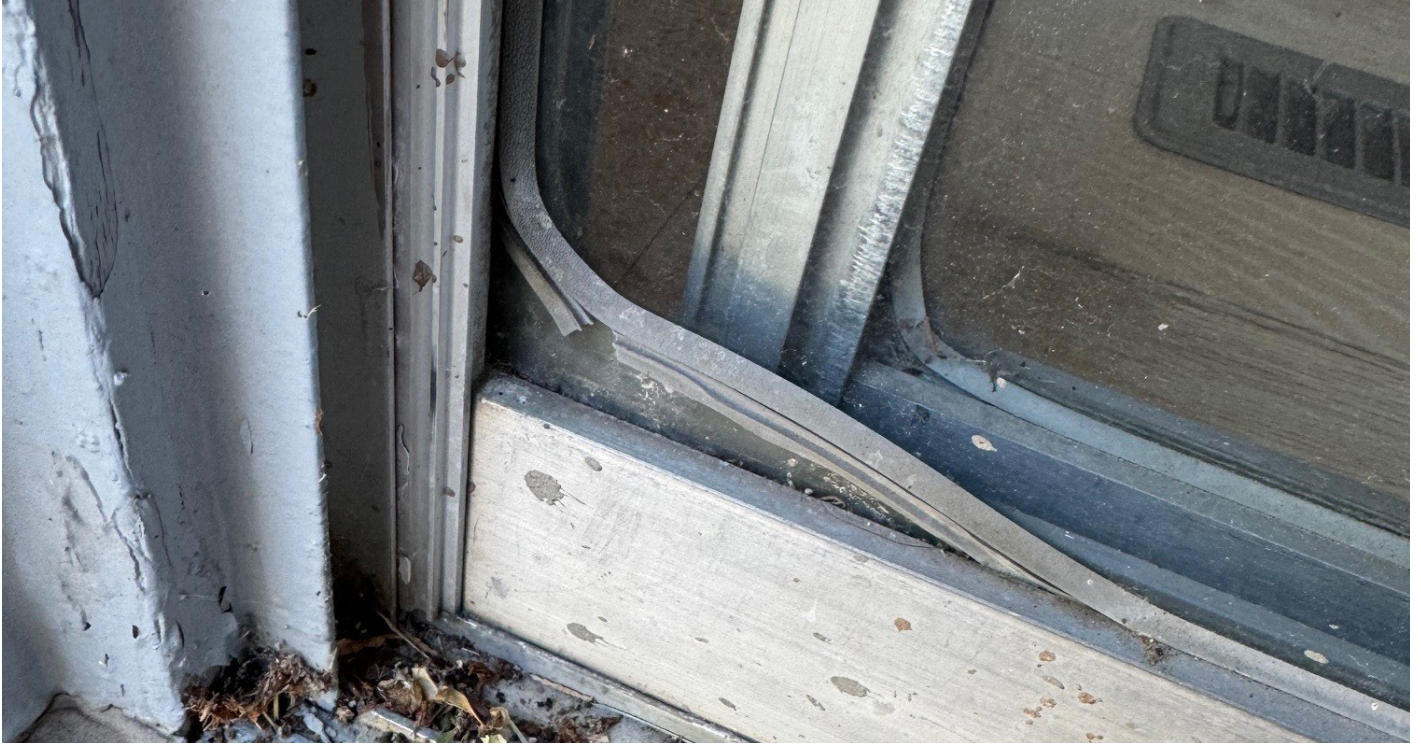
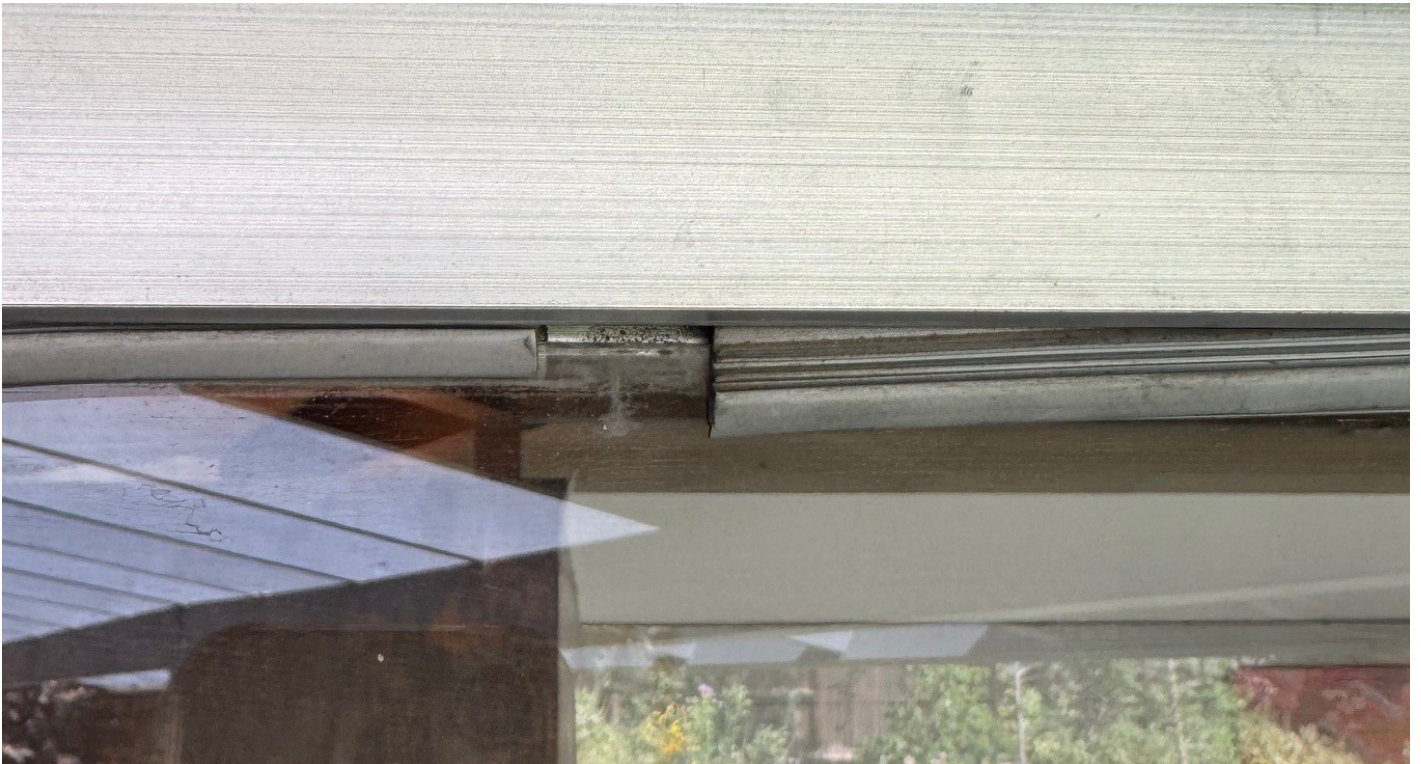
#6 DINING ROOM WINDOW WALL

PHOTOS OF DAMAGE TO EXISTING GLAZING  
STOPS AND WEATHER STRIPPING ON  
SLIDING DOORS.

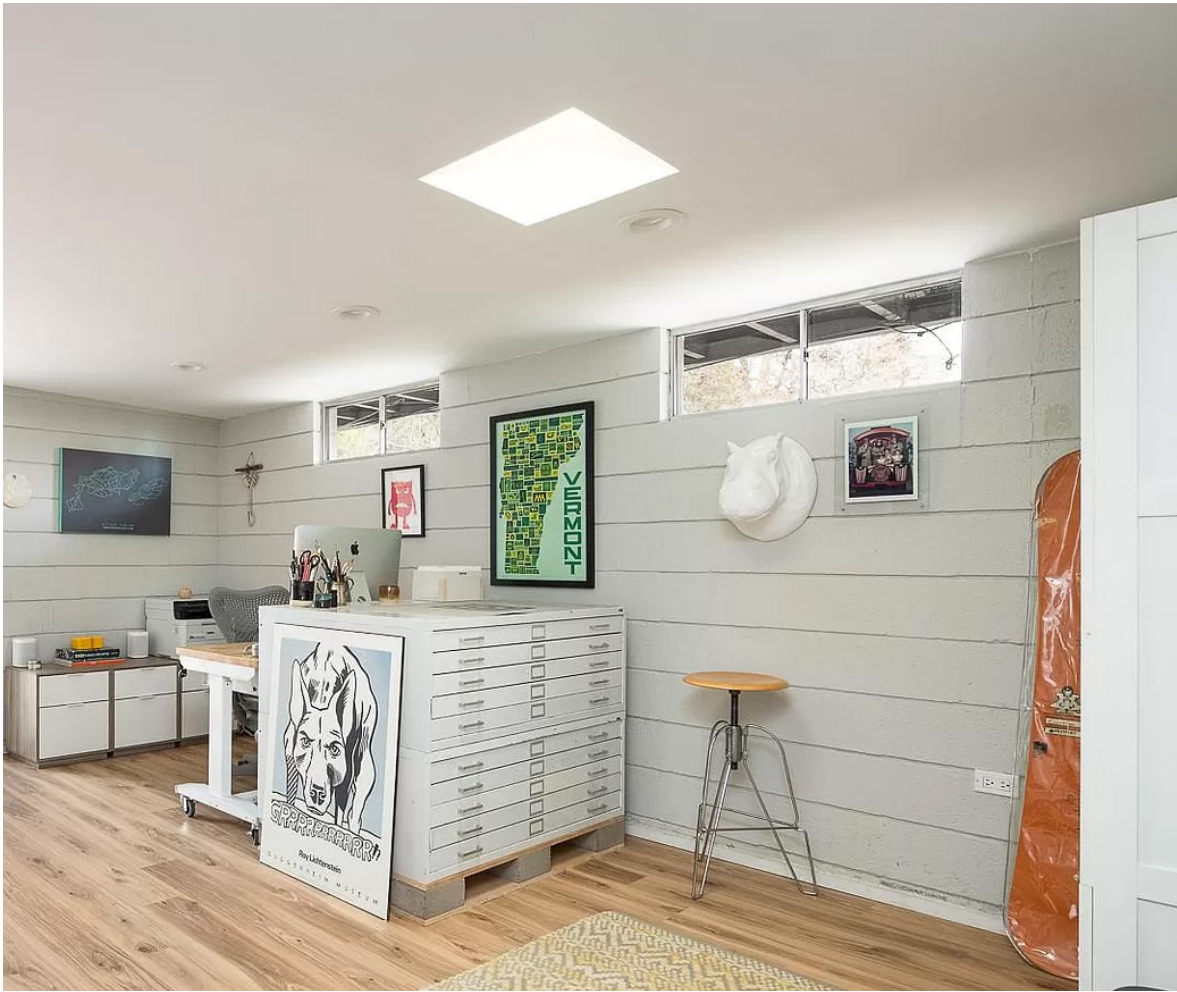
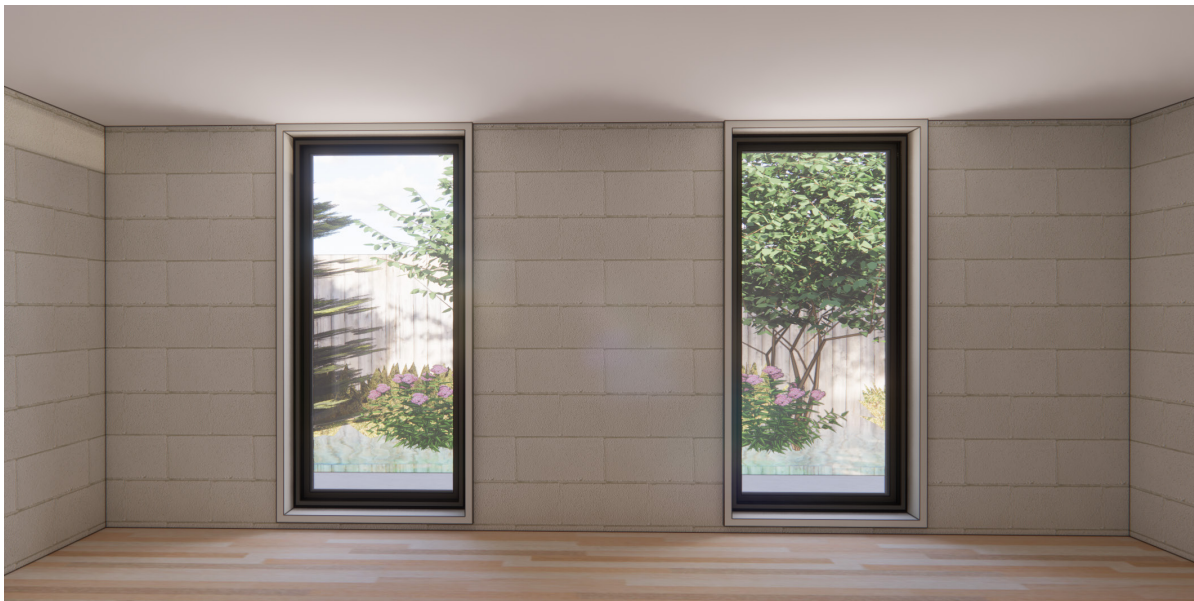
## #8 ADDITION WINDOWS

| <div data-bbox="134 730 212 1266">8</div> | <p>Architectural Feature: Addition Windows</p> <p>Describe feature and its condition:</p> <p>At some point in the past, an addition was made on the north side of the house (now used as a gym). Two windows on the north side of this addition are small sliding windows meant for basements. They are single pane, and the non-thermally broken aluminum frames ice up in the winter. The size and proportions of these windows do not match any windows in the original part of the home.</p> <p>Photo no. 30      Drawing no. A7.2</p> | <p>Describe work/impact on feature:</p> <p>The window openings are enlarged to floor to ceiling units to match all other window openings to the backyard, and new windows are installed. Shadow box frames to match the existing window frames are installed.</p> |

IN THE ADDITION, TWO SMALL WINDOWS  
WILL BE REPLACED WITH LARGER UNITS  
WITH SIZES AND FRAME DETAILS THAT  
MATCH EXISTING
