**SUBJECT:** Lee Gulch Flume

**DATE:** December 6, 2024

# Appendix A: Structure Inspection Report

## Routine Inspection Flume Structure Inspection and Inventory Report

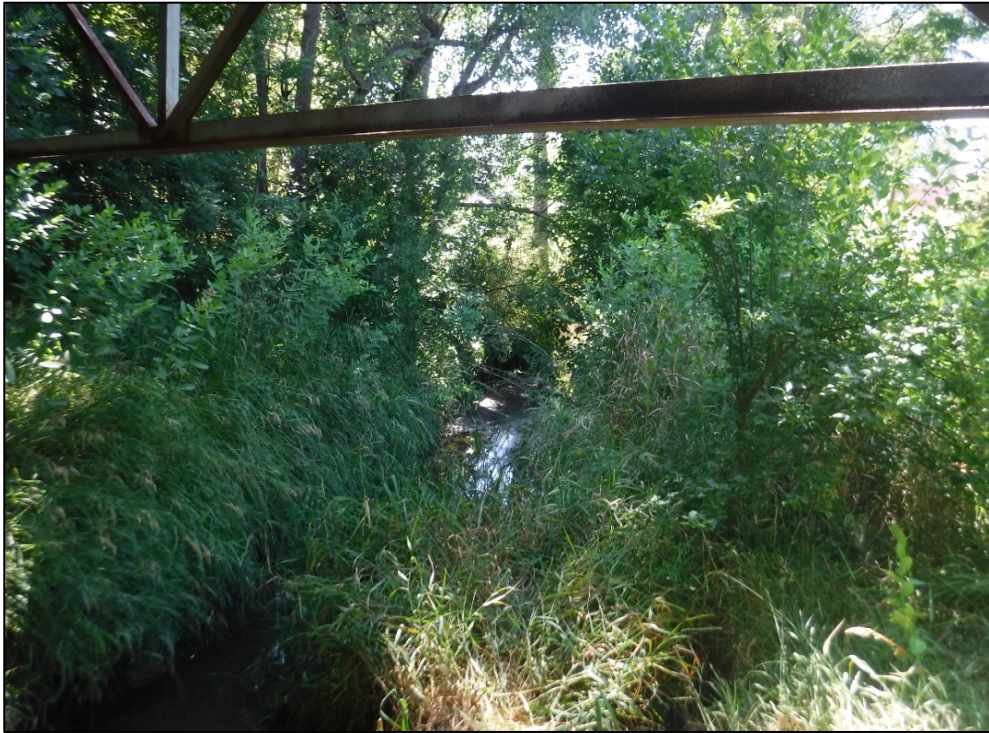
| Elm/Env | Description | Unit | Total Qty | % in 1 | CS 1 | % in 2 | CS 2 | % in 3 | CS 3 | % in 4 | CS 4 |
|---|---|---|---|---|---|---|---|---|---|---|---|
| Channel flows south to north under Span 3.<br>Erosion channel under Span 2 up to 18 inches deep at Pier 2 and 22 inches deep at Pier 3 exposing a black coating.<br>Large grouted boulders and concrete wall with 24 inch outlet.<br>Northwest side of channel has concrete weir.<br>Northeast side of structure and across channel has flumes merge into inlet at outlet end.<br>Heavy vegetation growth under and around structure. | | | | | | | | | | | |

Channel looking south upstream.

| Maintenance Recommendations | Quantity | Date Recommended | Maintenance Category |
|---|---|---|---|
| Clear vegetation under and around the structure. | | | |

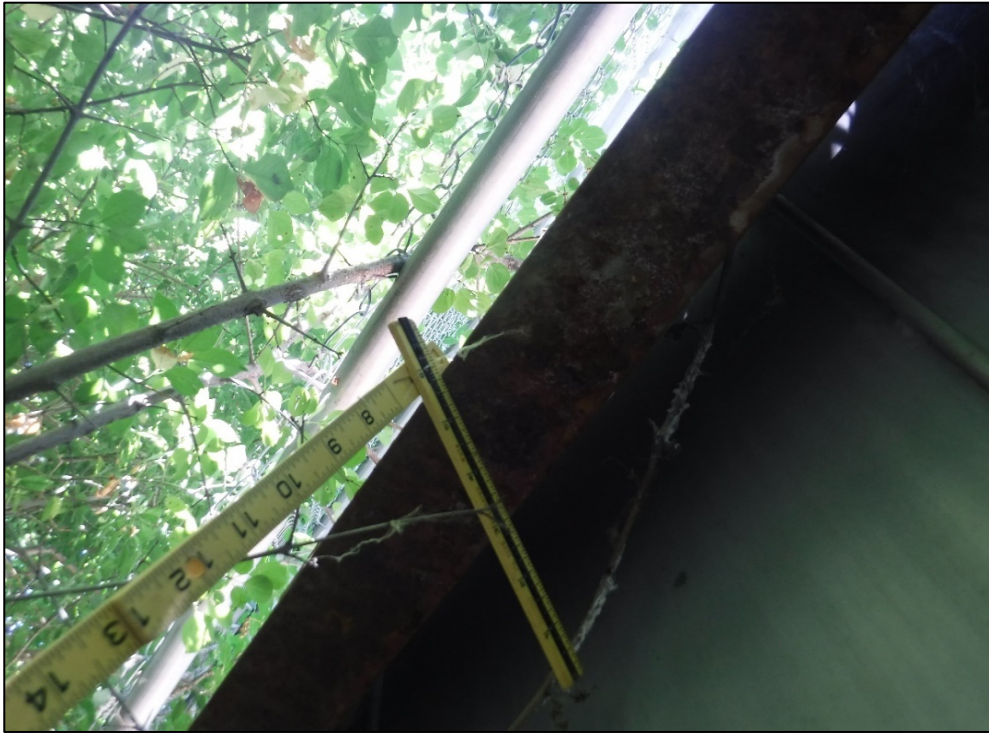
| Elm/Env | Description | Unit | Total Qty | % in 1 | CS 1 | % in 2 | CS 2 | % in 3 | CS 3 | % in 4 | CS 4 |
|---|---|---|---|---|---|---|---|---|---|---|---|
| (2) C-channel beams with frequent web splice plates welded to east beam and bolted to west beam; transverse bracing at 3 feet spacing; painted gray.<br>Beams have R1 corrosion throughout (112LF CS2). | | | | | | | | | | | |

Beam has R1 corrosion, typical.

| Repair Recommendations | Maintenance Category | Date Recommende | Description | Unit | Cost/Unit | | Quantity | Total | Notes | Quantity Basis |
|---|---|---|---|---|---|---|---|---|---|---|
| Clean and paint corrosion on channel supports | Low | 7/30/2024 | PAINT EXISTING STRUCTURE | SF | \$ - | \$ 25.00 | 184.9 | \$ 4,623.10 | Paint 2 channels outside face = ~20" x 103.7 ft length | Report |

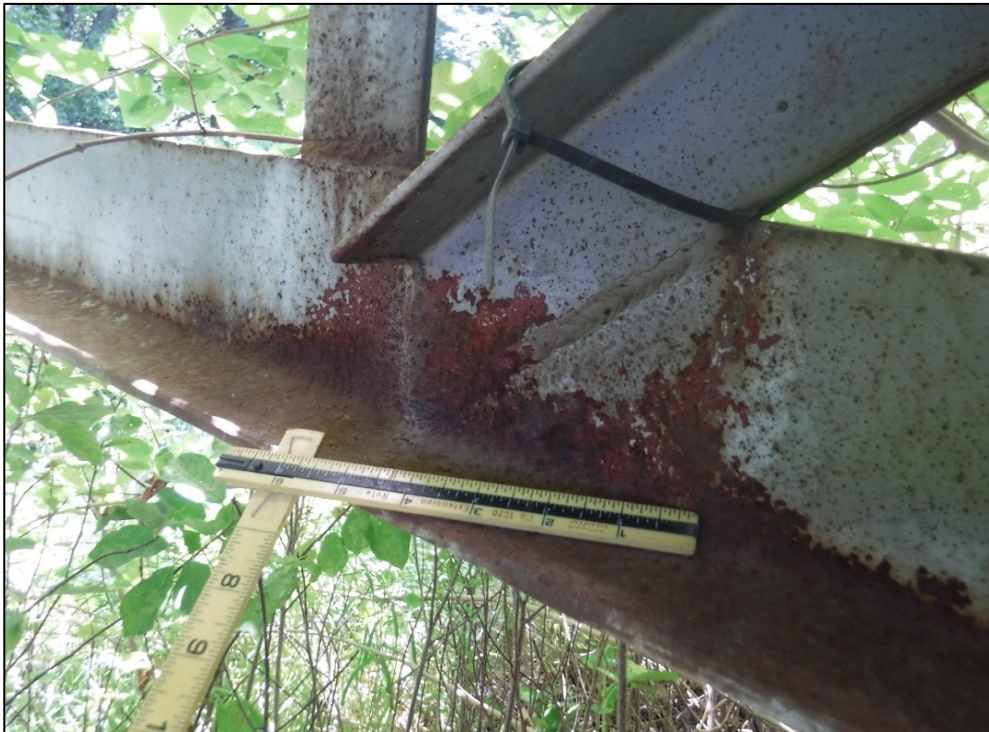
| Elm/Env | Description | Unit | Total Qty | % in 1 | CS 1 | % in 2 | CS 2 | % in 3 | CS 3 | % in 4 | CS 4 |
|---|---|---|---|---|---|---|---|---|---|---|---|
| Span 3 is a welded truss; painted gray.<br>Truss chords, diagonals, and verticals have R1 corrosion throughout (96LF CS2). | | | | | | | | | | | |

Truss 3A lower chord has R1 corrosion, typical.

| Repair Recommendations | Maintenance Category | Date Recommende | Description | Unit | Cost/Unit | | Quantity | Total | Notes | Quantity Basis |
|---|---|---|---|---|---|---|---|---|---|---|
| Clean and paint corrosion on truss members | Low | 7/30/2024 | PAINT EXISTING STRUCTURE | SF | \$ - | \$ 25.00 | 892.3 | \$ 22,307.75 | Paint 2 sides of 12 diagonals 8' LG and 6 verticals 5.25' LG of Truss Chords | Report |

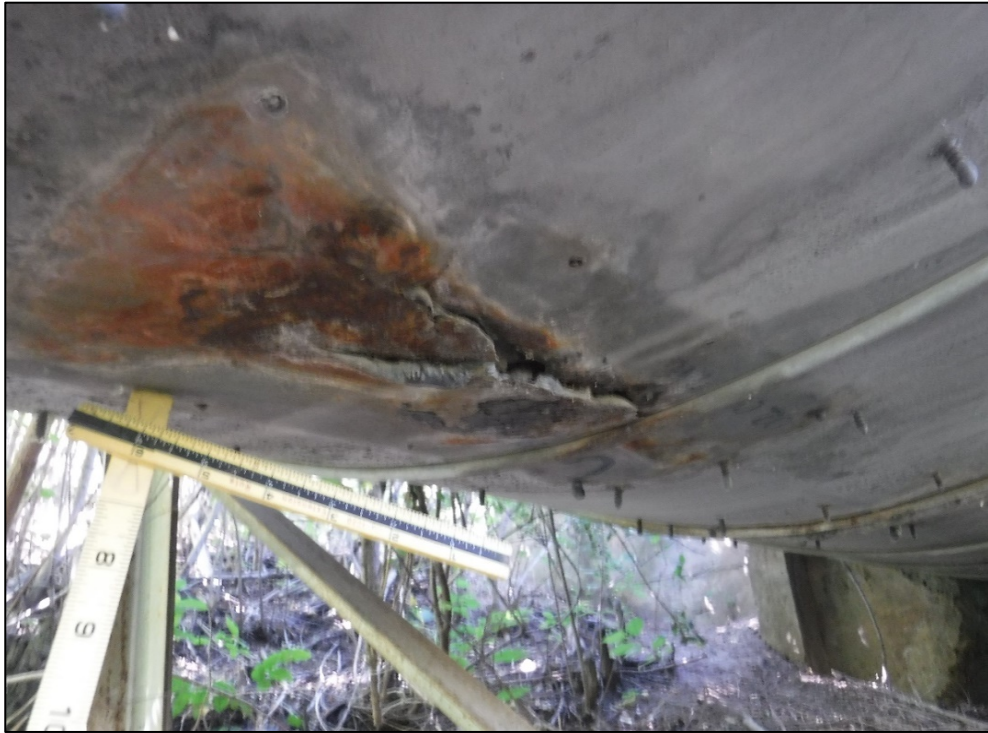
Span 2 near Pier 2 has area of tear and damage.

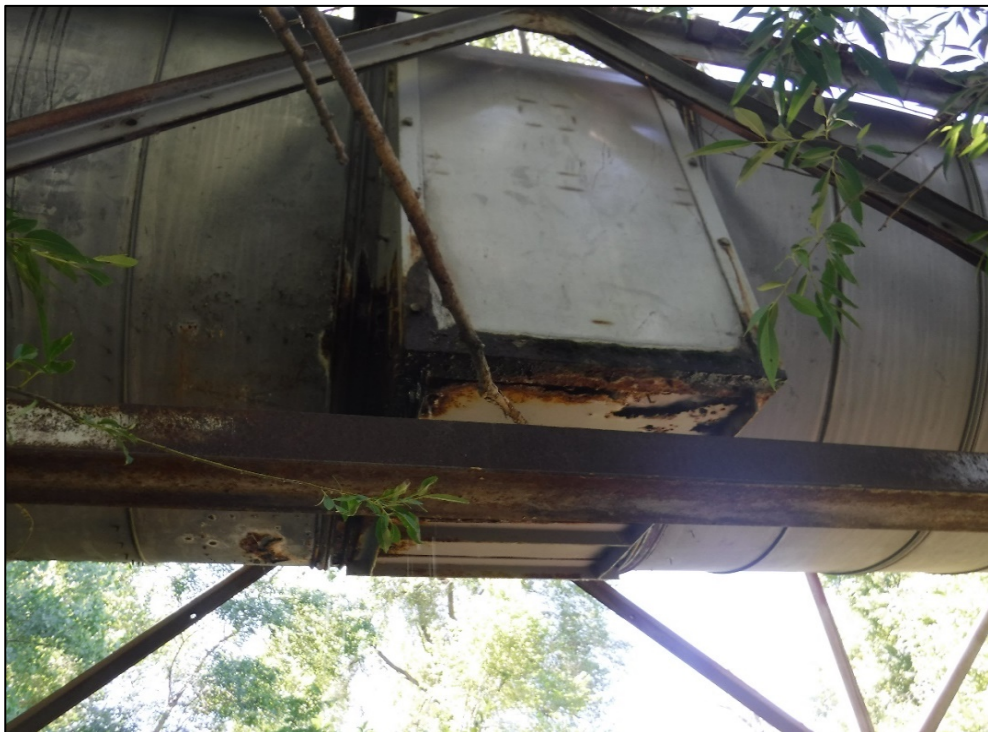
Span 3 active leakage at diversion with R4 corrosion holes.

| Maintenance Recommendations | Quantity | Date Recommended | Maintenance Category |
|---|---|---|---|
| Patch holes in steel deck to prevent water leakage. | | | |

| Repair Recommendations | Maintenance Category | Date Recommende | Description | Unit | Cost/Unit | | Quantity | Total | Notes | Quantity Basis |
|---|---|---|---|---|---|---|---|---|---|---|
| Patch holes on deck underside | High | 7/30/2024 | 78 INCH EQUIVALENT CORRUGATED STEEL PIPE ARCH | LF | \$ 400.00 | \$ 1,100.00 | 51.0 | \$ 76,500.00 | Spans with 3' sections of rusted through areas noted in report at 17 locations for replacement using similar pricing for corrugated steel pipe arch | Report |

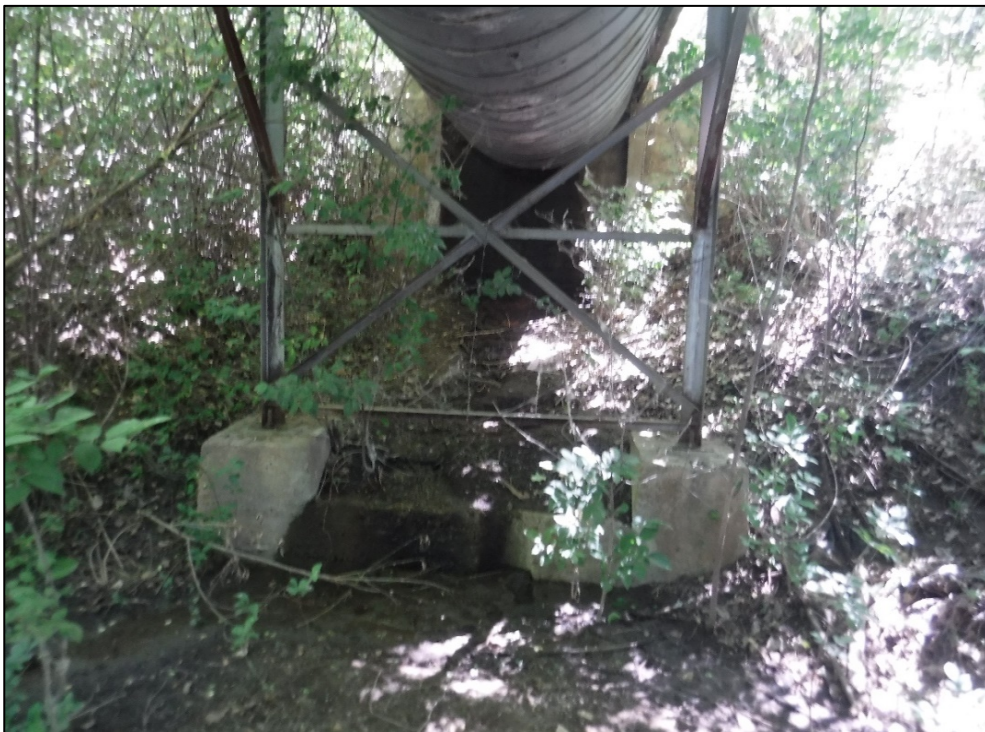
| Elm/Env | Description | Unit | Total Qty | % in 1 | CS 1 | % in 2 | CS 2 | % in 3 | CS 3 | % in 4 | CS 4 |
|---|---|---|---|---|---|---|---|---|---|---|---|
| All pier footings are covered in silt and not visible except Pier 5 footing.<br>Pier 5 footing exposed up to 22 inch for full length with no undermining. | | | | | | | | | | | |

Pier 5 general.
