**TO:** Brent Soderlin, PE, CFM, Director of Public Works and Utilities, Littleton, Colorado (City)  
**FROM:** Tim Phelan, PE  
**SUBJECT:** Slaughterhouse Gulch Flume  
**DATE:** December 6, 2024  
**CC:**

# Appendix A: Structure Inspection Report

## Routine Inspection Flume Structure Inspection and Inventory Report

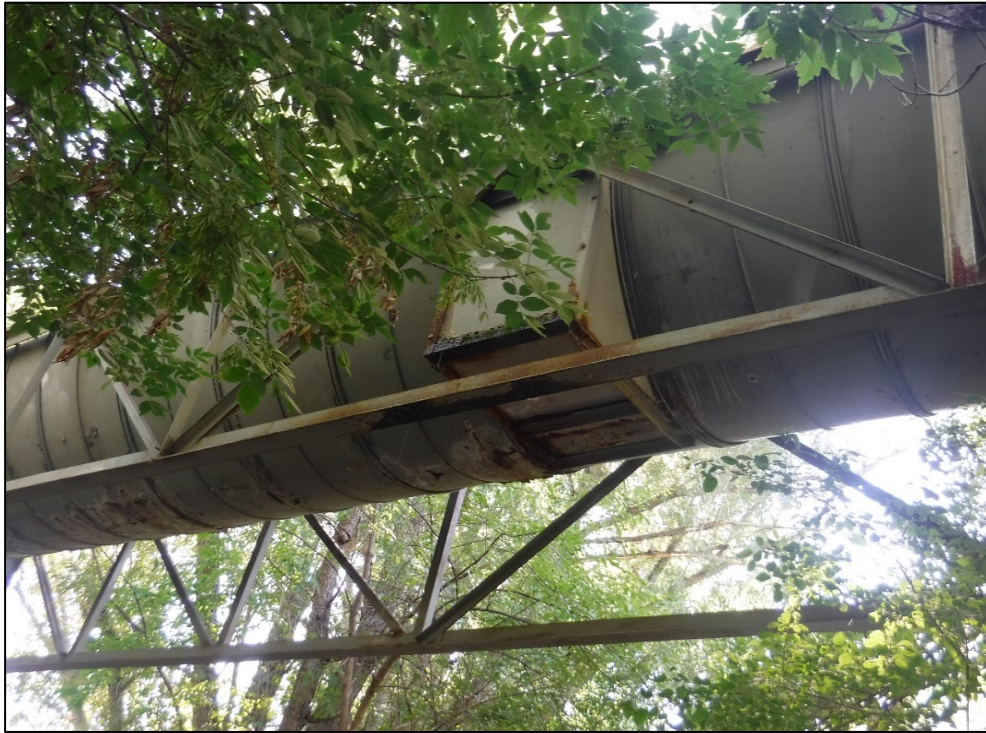
| Elm/Env | Description | Unit | Total Qty | % in 1 | CS 1 | % in 2 | CS 2 | % in 3 | CS 3 | % in 4 | CS 4 |
|---|---|---|---|---|---|---|---|---|---|---|---|
| <p>Span 6 is a welded truss; painted gray.</p> <p>Both trusses lower chords have isolated R1 corrosion throughout (96LF CS2).</p> <p>Active water leakage through diversion and water splashing Truss 6A lower chord.</p> <p>Truss 6A lower chord at mid-point has a 4 foot upward bend (4LF CS2 overlap).</p> | | | | | | | | | | | |

Truss 6A lower chord bent upwards at mid-point looking east.

Truss 6A lower chord bent upwards at mid-point looking west.

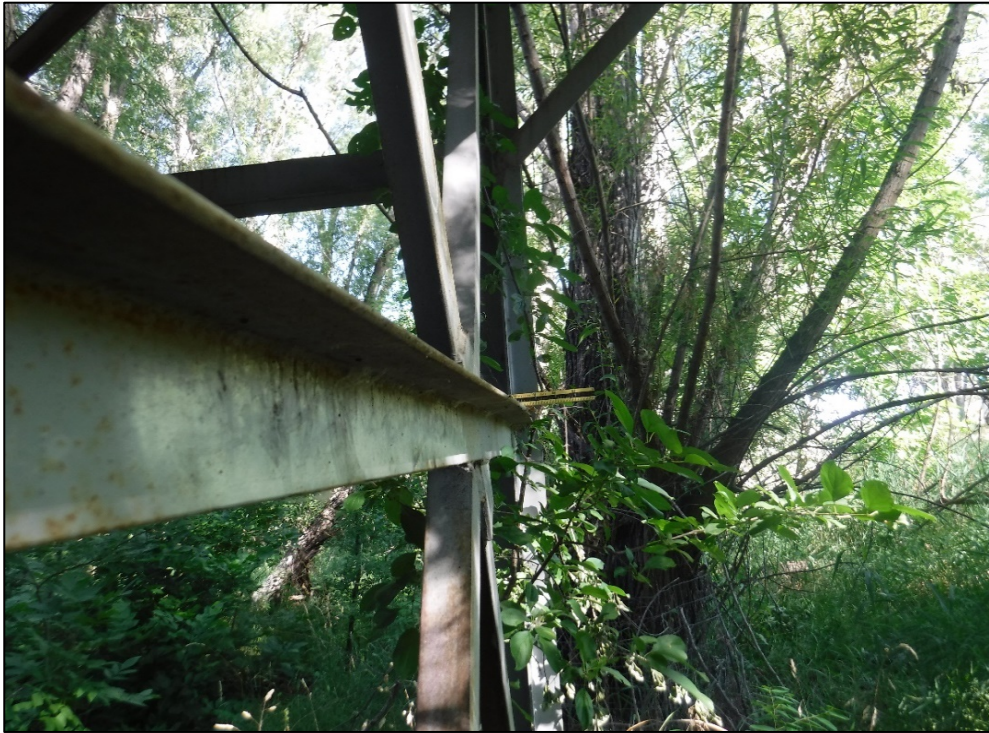
Pier 7 trestle middle horizontal member bent north.

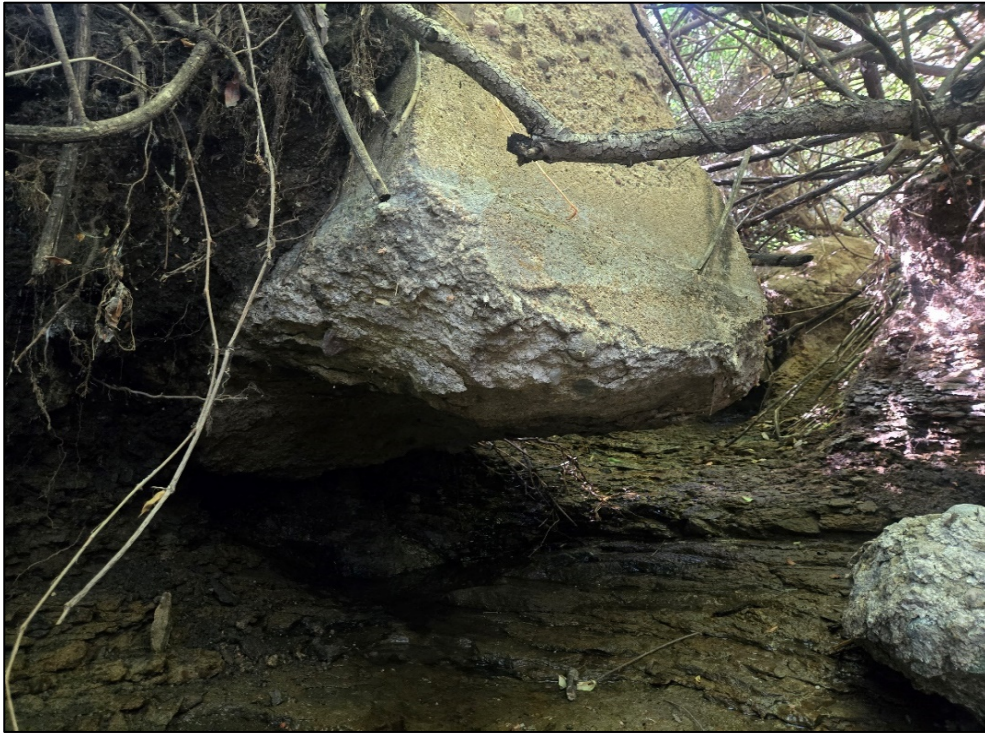
Pier 6 west footing undermined.

Based on these observations, Benesch provided recommendations to stabilize the footings around the undermined pier and install riprap to prevent further erosion. The extent of the foundation support undermining is considered a serious condition that needs to be addressed prior to further undermining that could lead to a potential collapse of the structure in this location. In addition, Benesch recommended repairs of the flume exhibiting holes and leaks that can affect underlying structural components from prolonged moisture exposure and corrosion of the steel members. Furthermore, removal of the vegetation under and around the structure may result in a compromised structure as the vegetation grows.

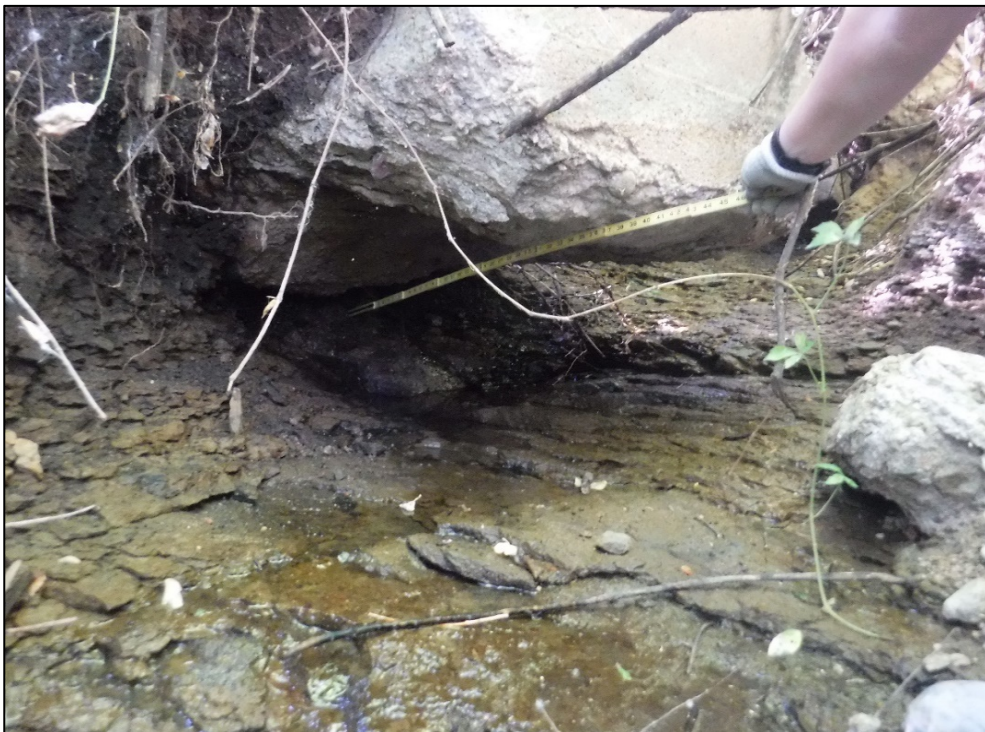
Pier 6 west footing has 10 percent remaining bearing capacity.
