**TO:** Brent Soderlin, PE, CFM, Director of Public Works and Utilities, Littleton, Colorado (City)  
**FROM:** Tim Phelan, PE  
**SUBJECT:** Slaughterhouse Gulch Flume  
**DATE:** December 6, 2024  
**CC:**

## Routine Inspection Flume Structure Inspection and Inventory Report

Bridge Key: Slaughterhouse Gulch

Inspection Date 90: 07/30/2024

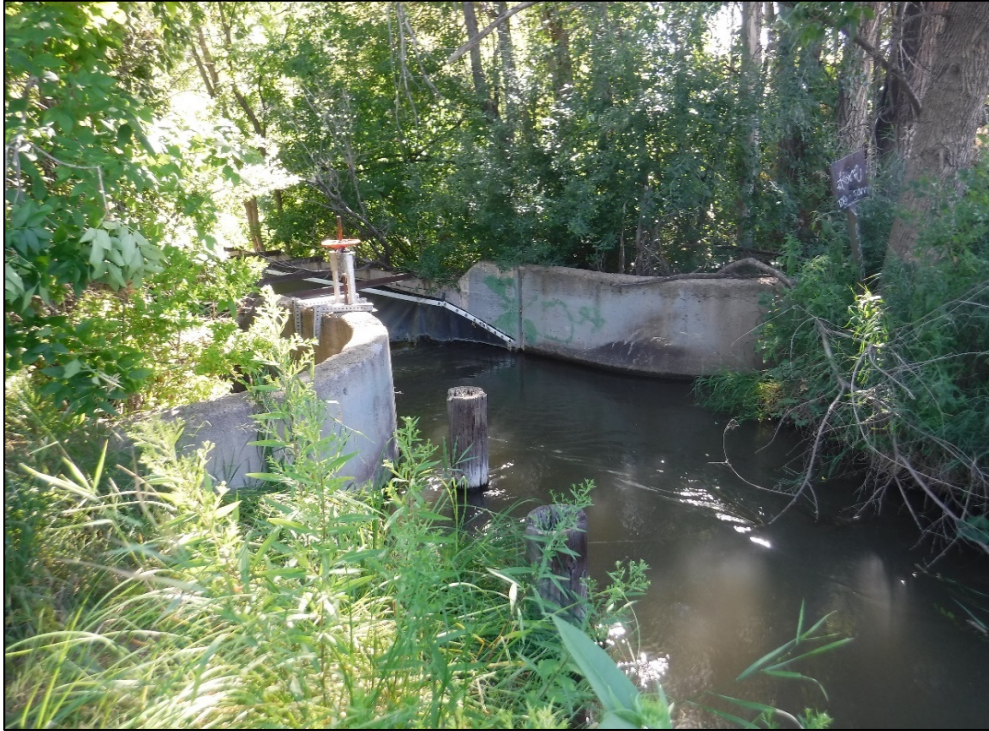
Flume looking northeast.

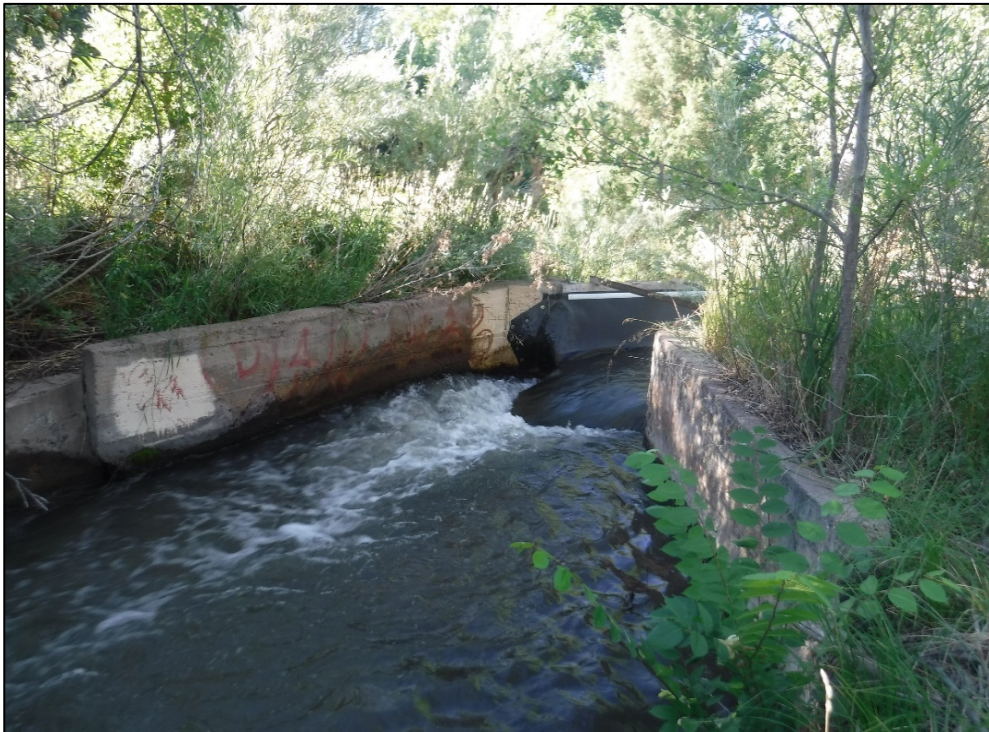
Flume looking southwest.

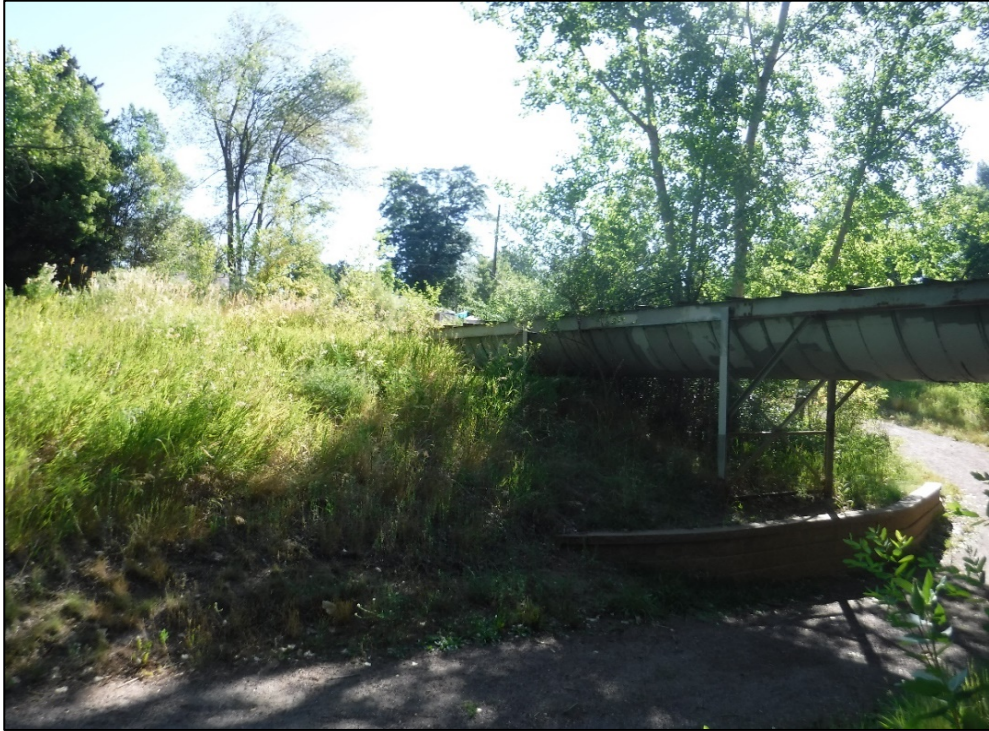
Elevation looking northeast towards Abutment 14.

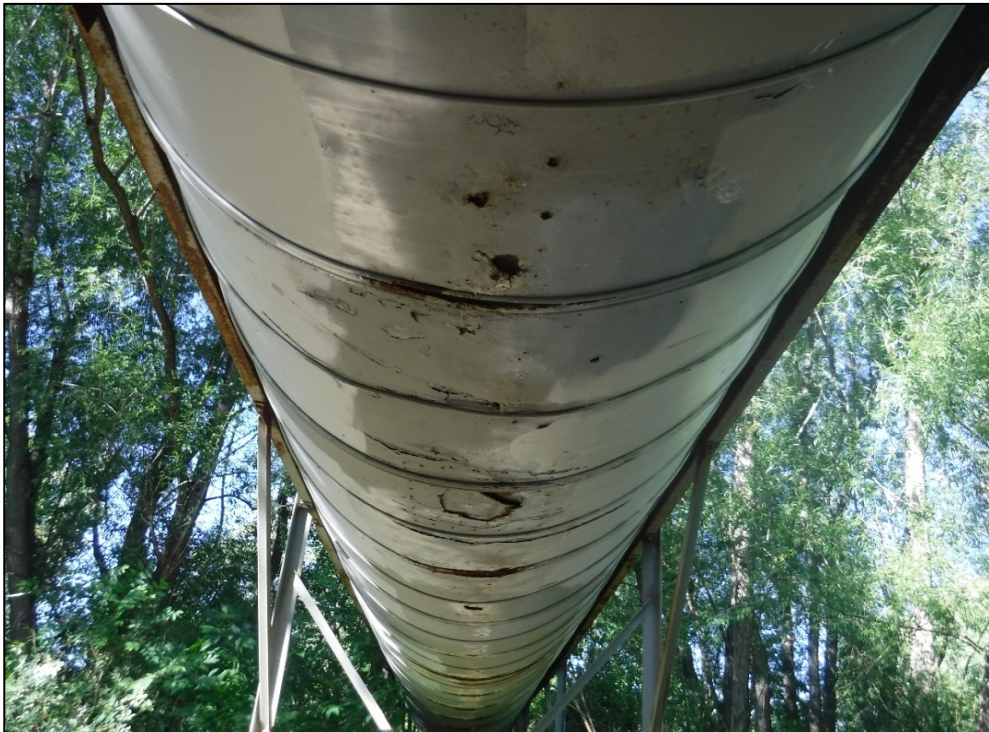
Span 9 underside looking north.

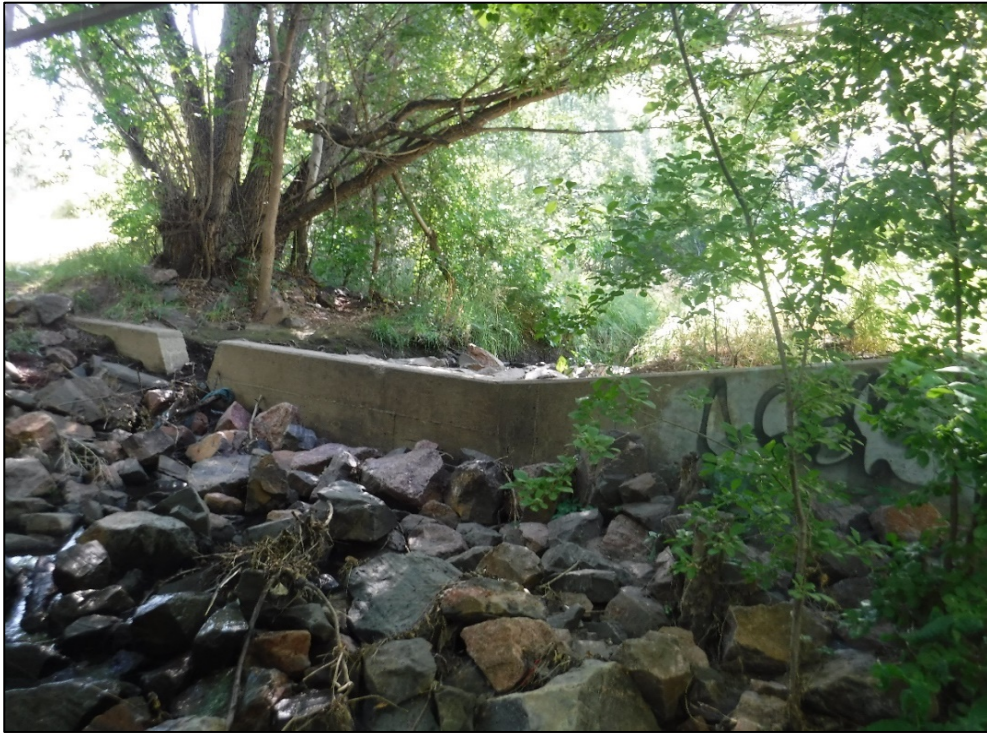
Concrete weir across channel under Span 6.

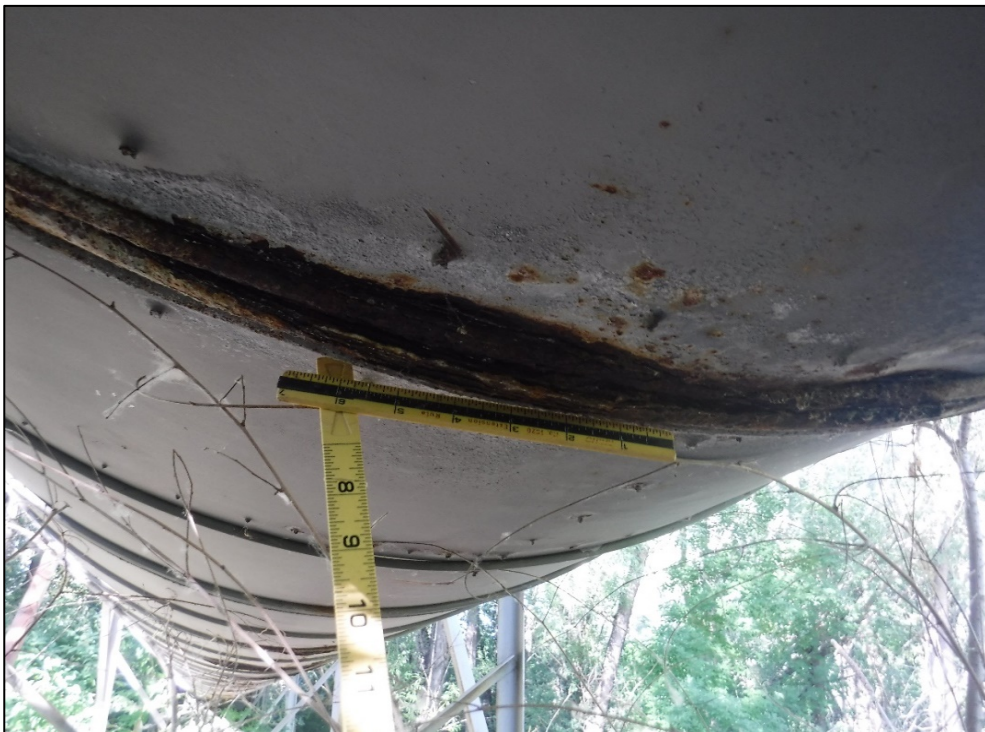
| Elm/Env | Description | Unit | Total Qty | % in 1 | CS 1 | % in 2 | CS 2 | % in 3 | CS 3 | % in 4 | CS 4 |
|---|---|---|---|---|---|---|---|---|---|---|---|
| Deck is a steel open half cylinder flume with rubber liner with (2) bolt bands at each joint and (1) intermediate bolt band at 3 foot spacing; painted gray.<br>Top: Mostly covered with liner filled with water, no major deficiencies noted.<br>Bottom: Paint is peeling off throughout, primarily along joints.<br>Span 5 near Pier 6 has active leakage along joints (1SF CS4).<br>Spans 5 through 13 along bolt banks have isolated R2-R3 corrosion (58SF CS3).<br>Span 6 at 9 feet from Pier 7 has 4.5 feet x 3 feet area of R3-R4 corrosion (14SF CS3).<br>Span 6 near mid-point has 3 feet x 3 feet area of R4 corrosion (9SF CS4).<br>Span 8 has area of pinhole R2 corrosion with rust staining up to 1 inch diameter (9SF CS3).<br>Span 9 has 6 feet long x 3 feet wide area of impact damage and 3 inch diameter (2) corrosion holes (20SF CS4).<br>Span 11 bolt band near Pier 11 has 3 feet x 3 feet area of R4 corrosion (9SF CS4). | | | | | | | | | | | |

Deck underside at bolt bands has R2-R3 corrosion, typical.

| Maintenance Recommendations | Quantity | Date Recommended | Maintenance Category |
|---|---|---|---|
| Patch holes and clean and paint corrosion on deck underside. | | | |

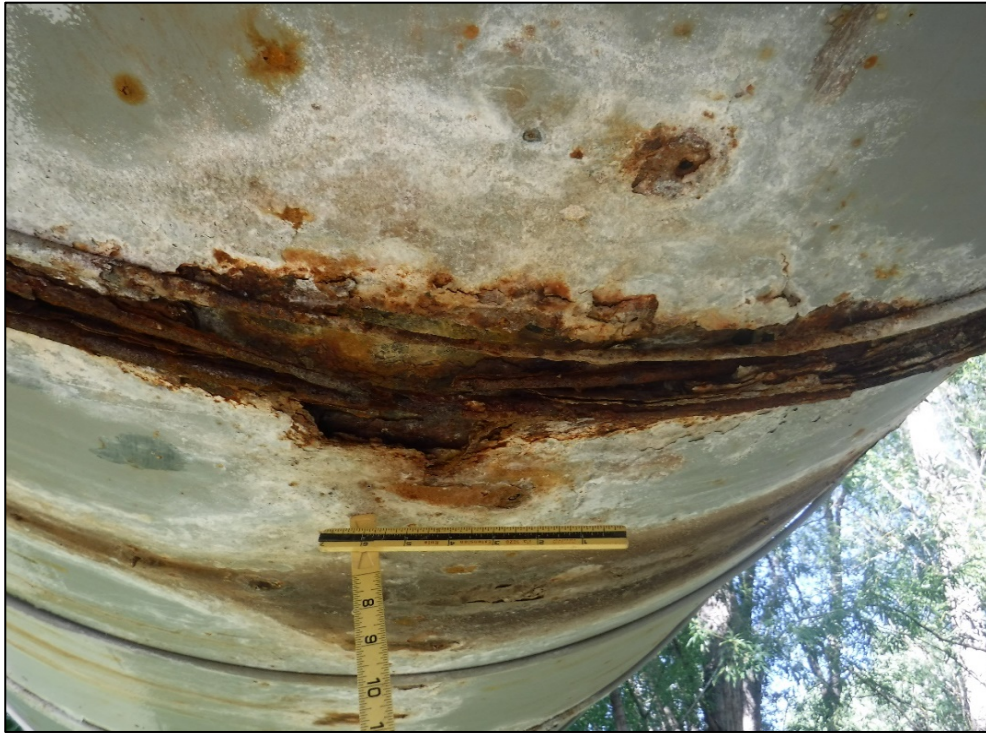
Deck underside in Span 8 along bolt band has R4 corrosion.

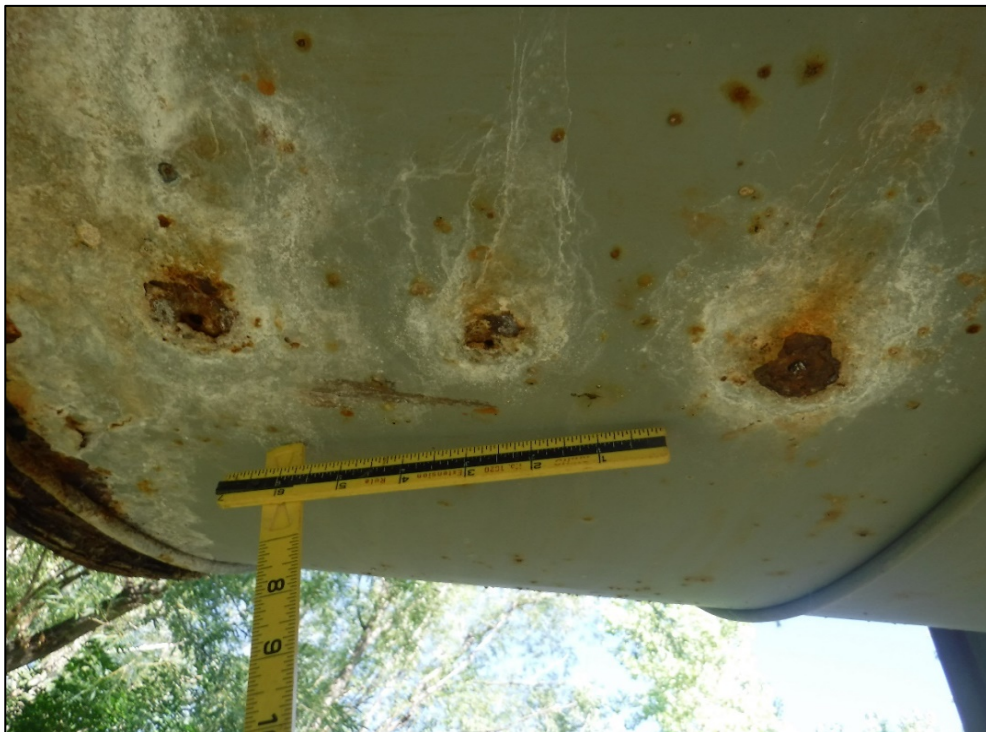
Deck underside in Span 8 has area of pinhole corrosion.

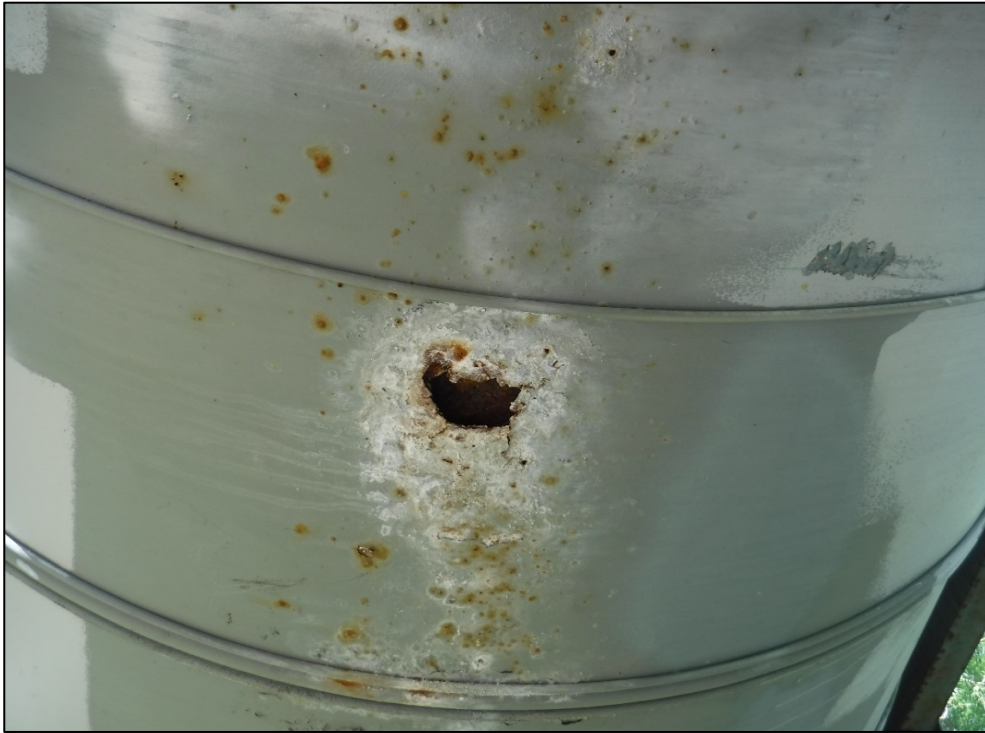
Deck underside in Span 9 has up to 3 inch diameter corrosion holes.

| Repair Recommendations | Maintenance Category | Date Recommende | Description | Unit | Cost/Unit | | Quantity | Total | Notes | Quantity Basis |
|---|---|---|---|---|---|---|---|---|---|---|
| Patch holes on deck underside | High | 7/30/2024 | 78 INCH EQUIVALENT CORRUGATED STEEL PIPE ARCH | LF | \$ 400.00 | \$ 1,100.00 | 27.0 | \$ 40,500.00 | Spans with 3' sections of rusted through areas noted in report at 9 locations for replacement using similar pricing for corrugated steel pipe arch | Report |

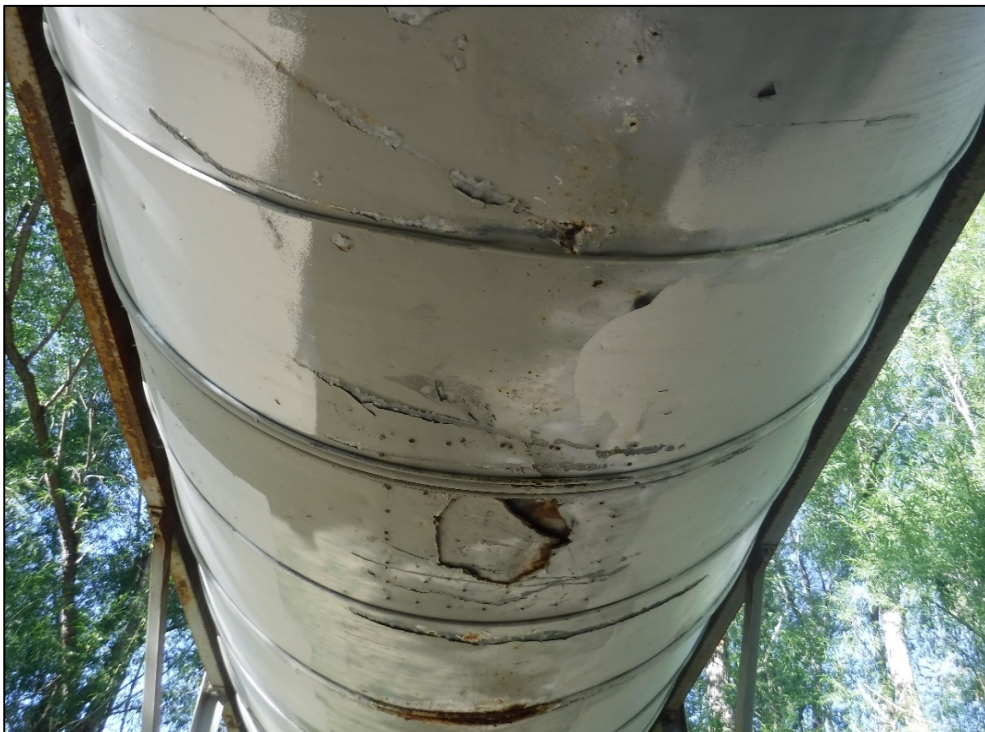
Deck underside in Span 9, 6 feet x 3 feet area of impact damage.

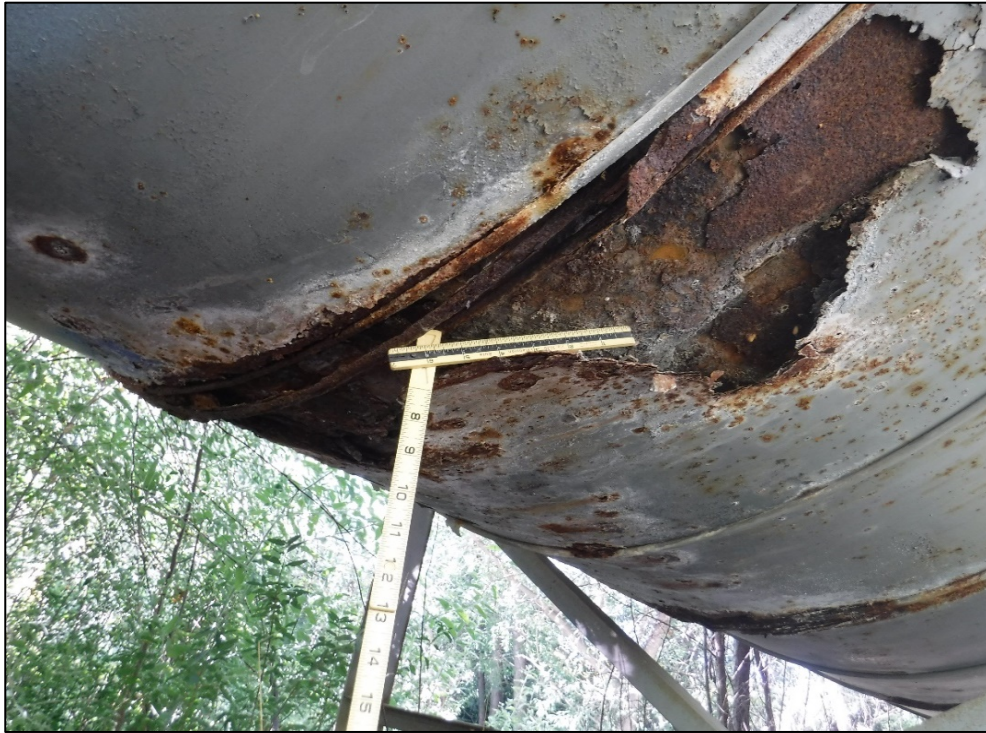
Deck underside in Span 11 has area of R4 corrosion.

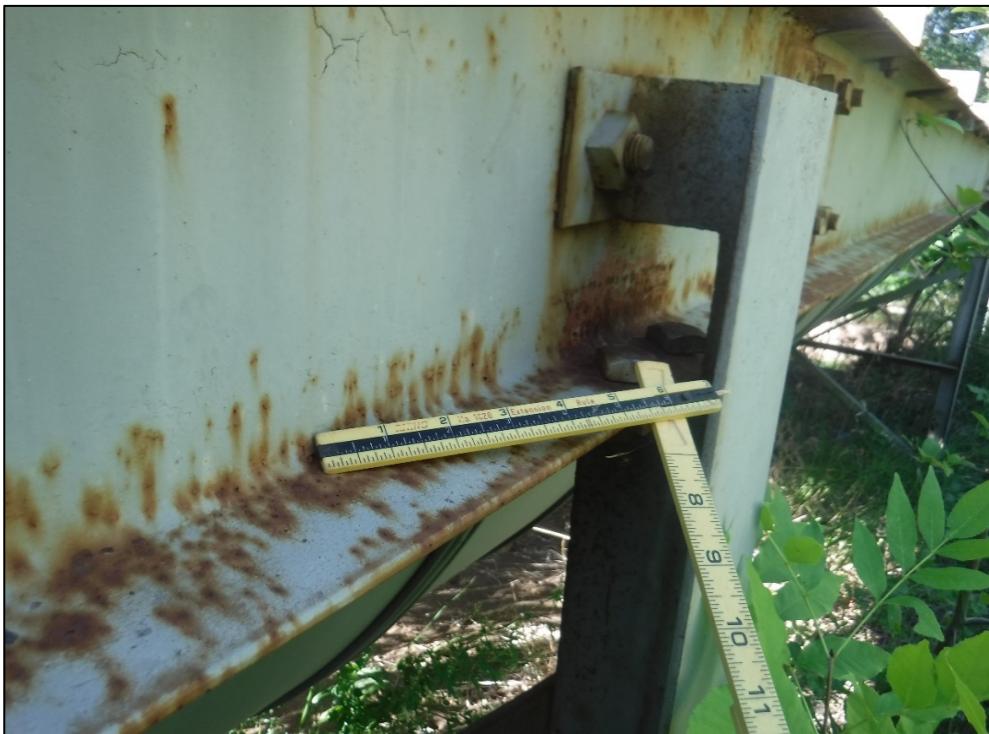
| Elm/Env | Description | Unit | Total Qty | % in 1 | CS 1 | % in 2 | CS 2 | % in 3 | CS 3 | % in 4 | CS 4 |
|---|---|---|---|---|---|---|---|---|---|---|---|
| (2) C-channel beams with frequent web splice plates welded to north beam and bolted to south beam; transverse bracing at 3 feet spacing; painted gray.<br>Beam flanges and webs have R1 corrosion throughout (362LF CS2).<br>Span 12 bottom flange has (2) open holes at (2) locations. | | | | | | | | | | | |

Beam A has R1 corrosion, typical.

| Repair Recommendations | Maintenance Category | Date Recommende | Description | Unit | Cost/Unit | | Quantity | Total | Notes | Quantity Basis |
|---|---|---|---|---|---|---|---|---|---|---|
| Clean and paint corrosion on channel supports | Low | 7/30/2024 | PAINT EXISTING STRUCTURE | SF | \$ - | \$ 25.00 | 604.9 | \$ 15,122.60 | Paint 2 channels outside face = ~20" x 182.2 ft length | Report |

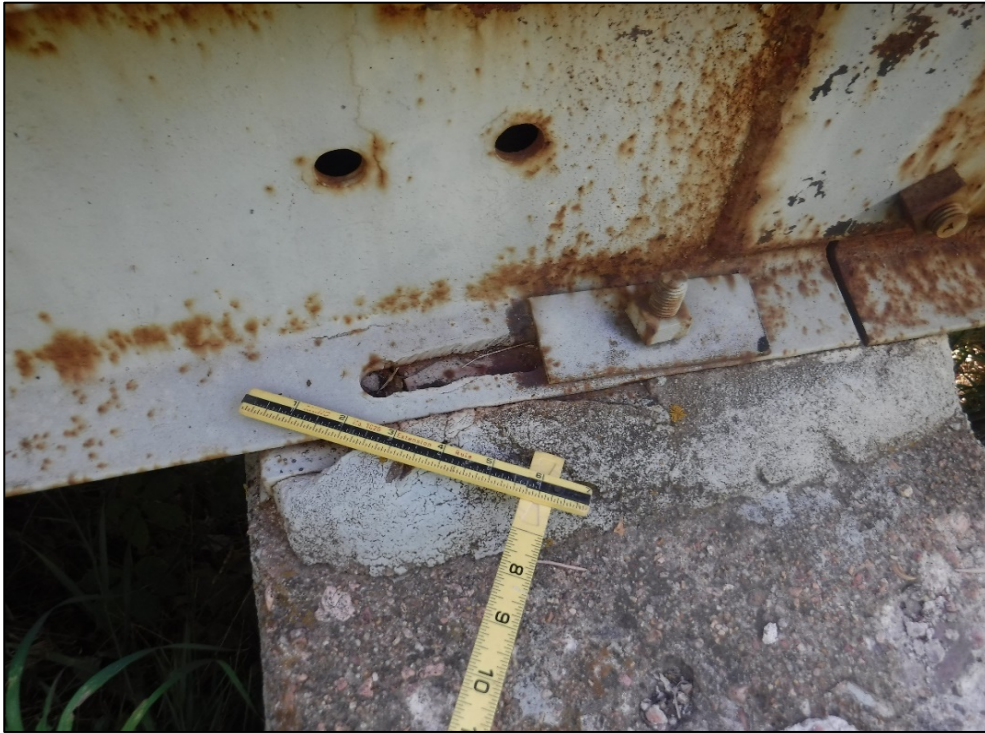
Moveable bearing at Pier 13, typical.

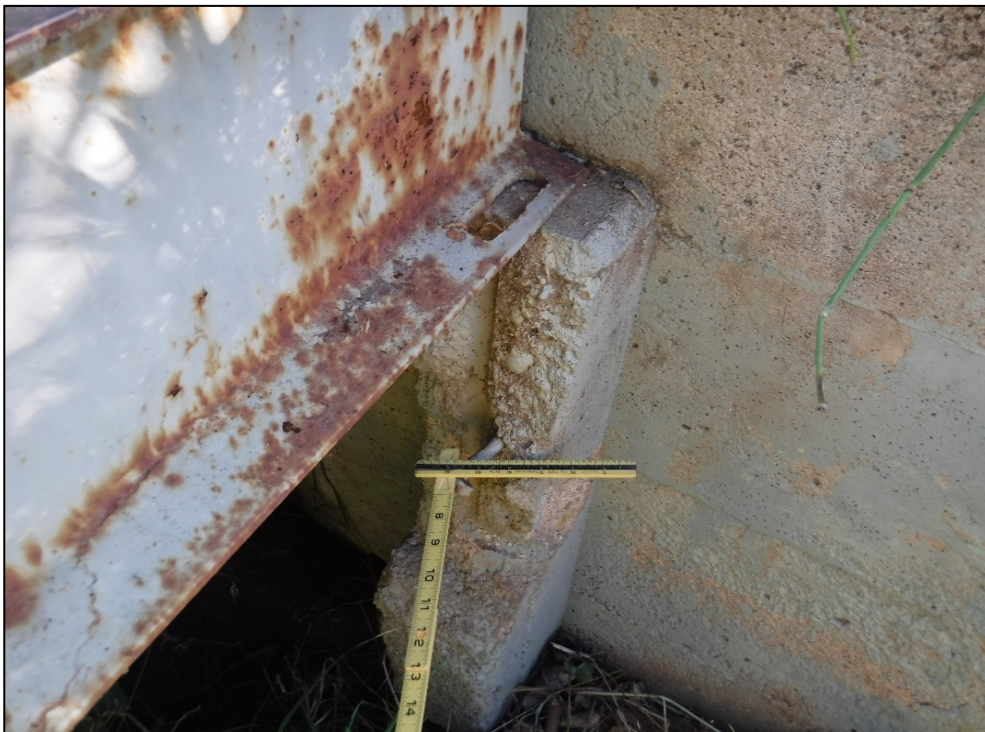
| Elm/Env | Description | Unit | Total Qty | % in 1 | CS 1 | % in 2 | CS 2 | % in 3 | CS 3 | % in 4 | CS 4 |
|---|---|---|---|---|---|---|---|---|---|---|---|
| CIP abutments with step outs for bearings.<br>Abutment 14 along joint has active leakage.<br>Abutment 14 west end has 8 inch x 1 foot x 3 inch deep edge spall (1LF CS3).<br>Abutment 14 east end has 8 inch x 20 inch x 5 inch deep spall (1LF CS3). | | | | | | | | | | | |
| Moveable bearings at both abutments and Pier 13.<br>Abutment 14 east end bearing has missing anchor bolt and up to 40 percent bearing area loss (1EA CS4). | | | | | | | | | | | |

Abutment 14 east end spall with bearing area loss and missing connection.

| Maintenance Recommendations | Quantity | Date Recommended | Maintenance Category |
|---|---|---|---|
| Substructure-Patch Spalls | 120 SF | 07/30/2024 | High |

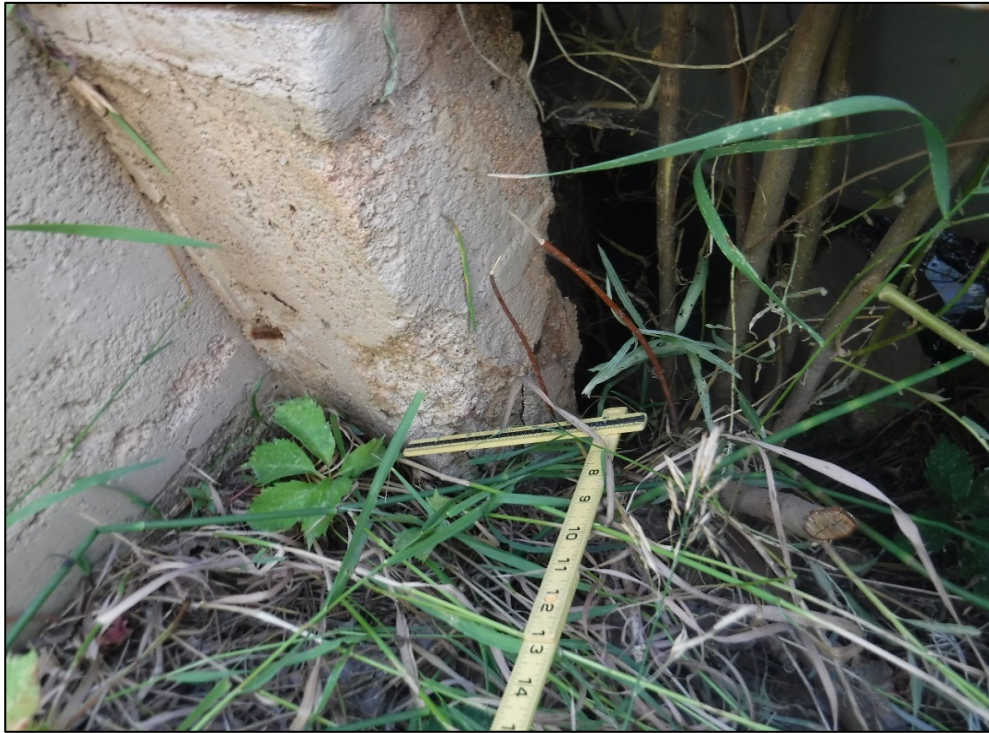
Abutment 14 west end spall.

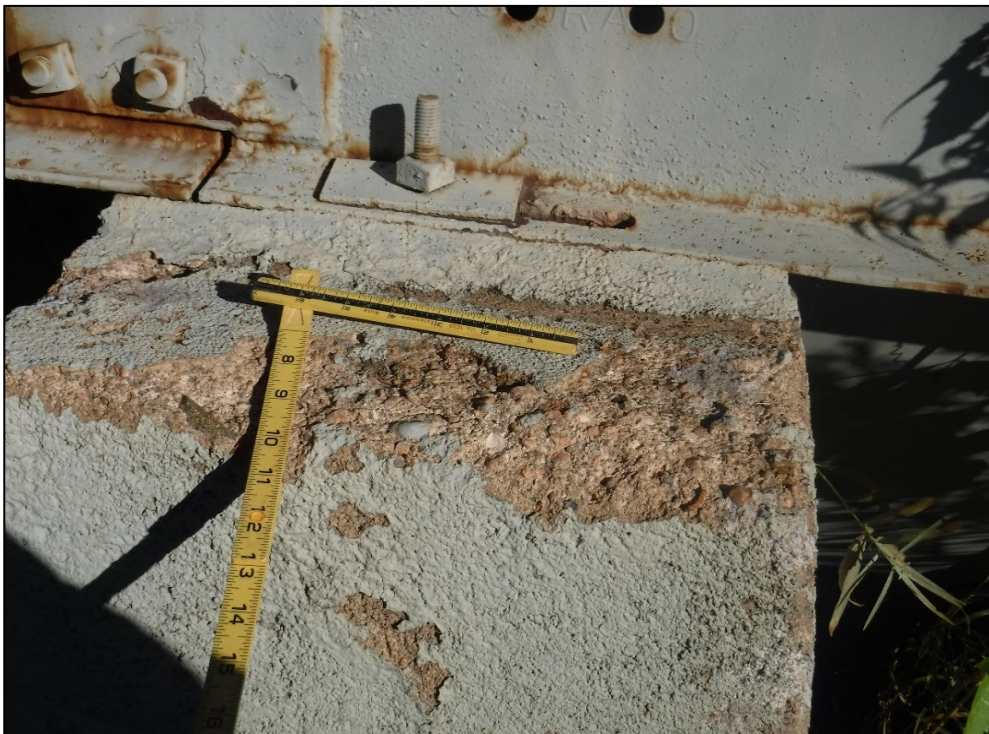
Pier 13 east column at top has S2 scaling.

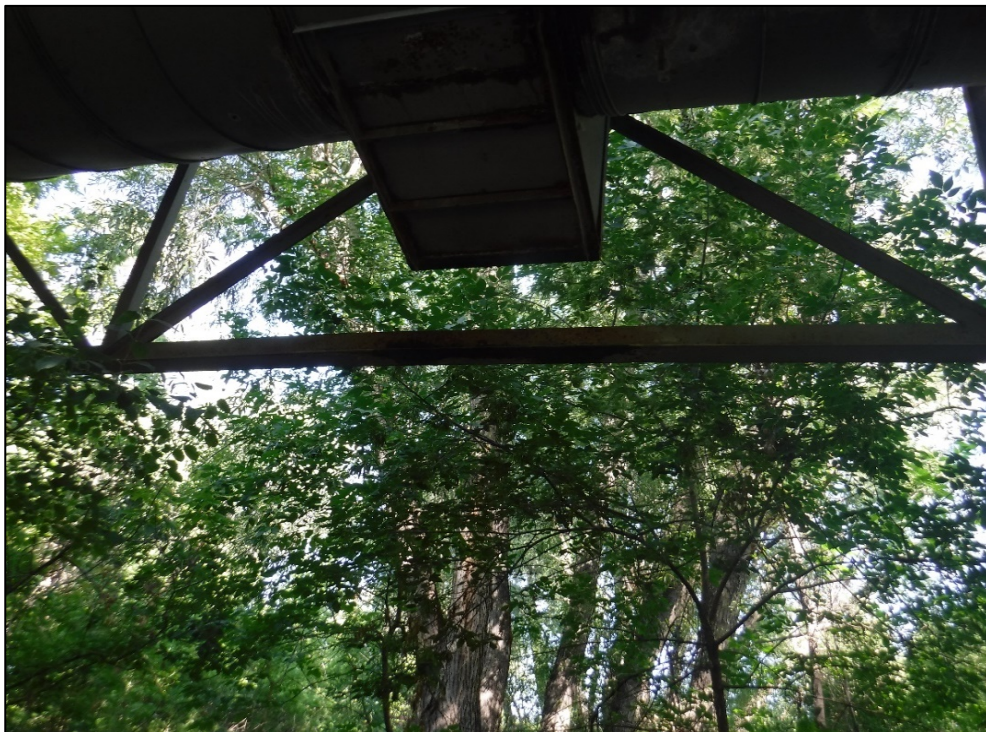
| Elm/Env | Description | Unit | Total Qty | % in 1 | CS 1 | % in 2 | CS 2 | % in 3 | CS 3 | % in 4 | CS 4 |
|---|---|---|---|---|---|---|---|---|---|---|---|
| Span 6 is a welded truss; painted gray.<br>Both trusses lower chords have isolated R1 corrosion throughout (96LF CS2).<br>Active water leakage through diversion and water splashing Truss 6A lower chord.<br>Truss 6A lower chord at mid-point has a 4 foot upward bend (4LF CS2 overlap). | | | | | | | | | | | |

Truss 6A lower chord bent upwards at mid-point looking east.

Truss 6A lower chord bent upwards at mid-point looking west.

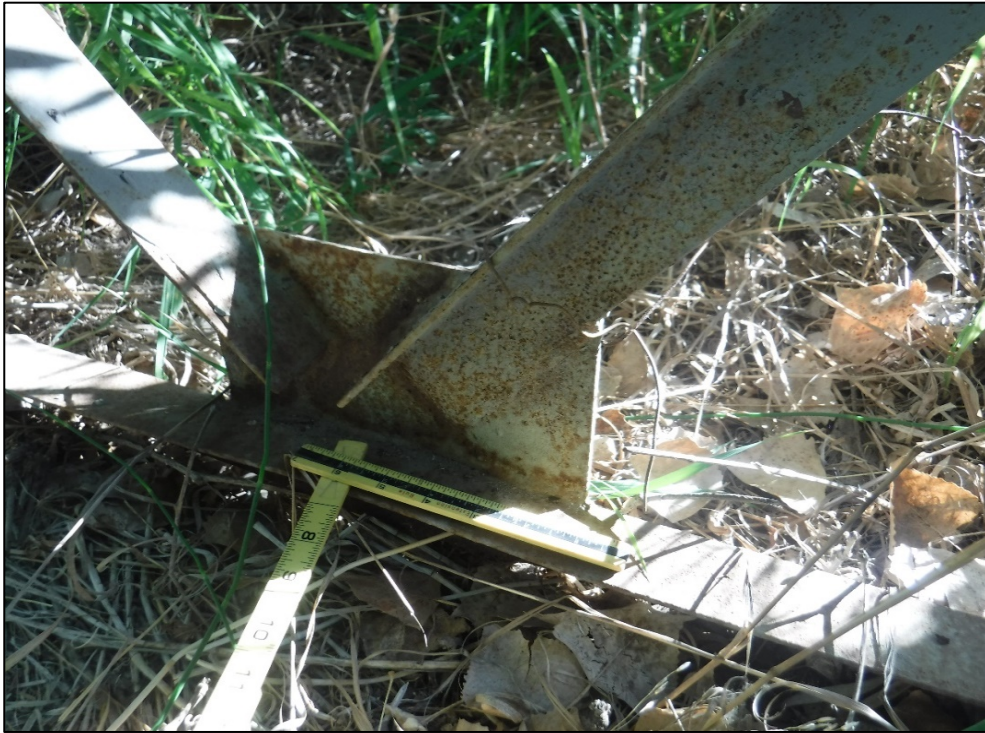
| Elm/Env | Description | Unit | Total Qty | % in 1 | CS 1 | % in 2 | CS 2 | % in 3 | CS 3 | % in 4 | CS 4 |
|---|---|---|---|---|---|---|---|---|---|---|---|
| Steel trestle sitting on concrete footings at all piers except Pier 13.<br>Trestle diagonals, base plates, horizontal and vertical members have isolated R1 corrosion up to 3 foot (33LF CS2).<br>Pier 3 trestle verticals have (2) open holes.<br>Pier 7 middle horizontal member at weld connection is bent north by 0.25 inch (1LF CS2).<br>Piers 9, 10, and 11 trestles have kickers welded between vertical columns and beam bottom flange. | | | | | | | | | | | |

Trestle diagonals have spotty R1 corrosion, typical.

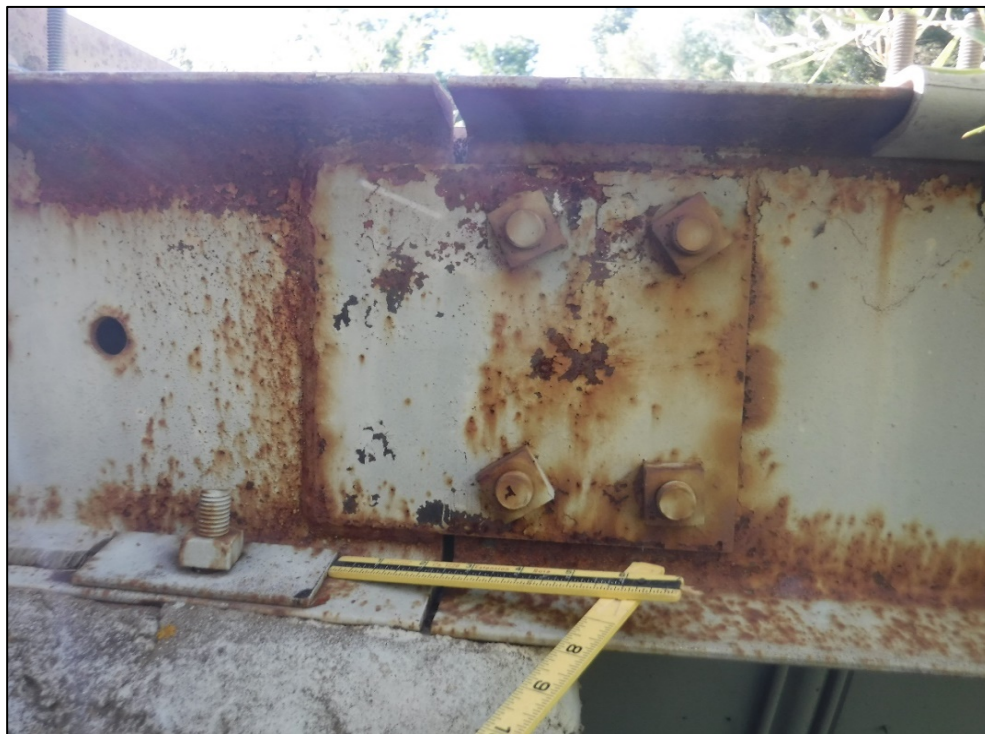
Beam web splice connection at Pier 13, typical.

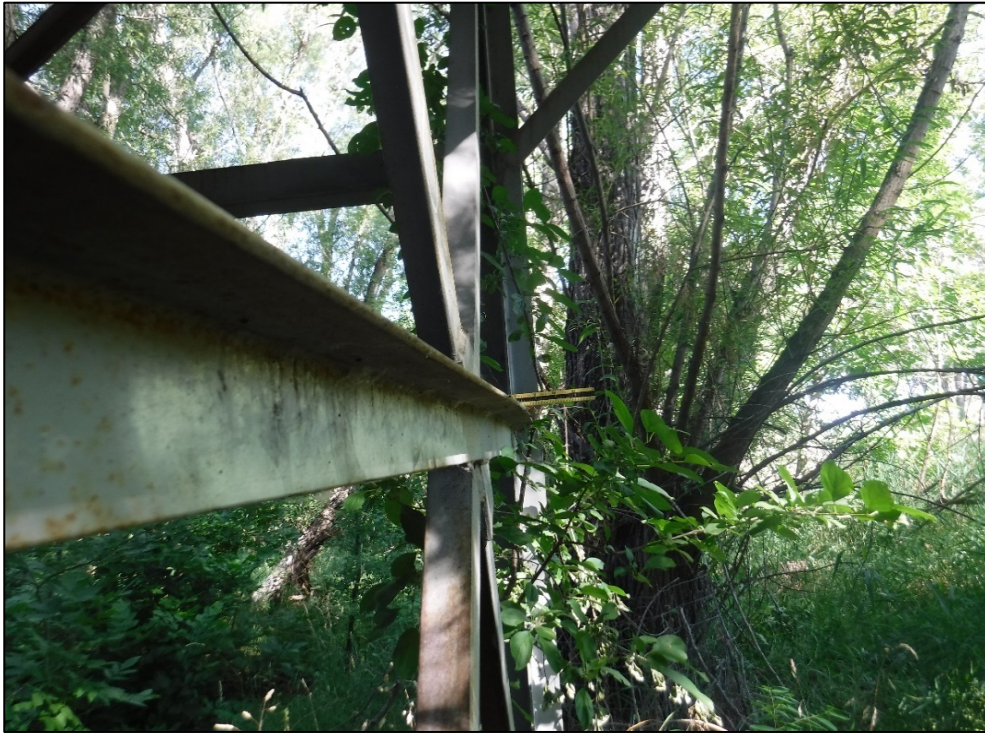
Pier 7 trestle middle horizontal member bent north.

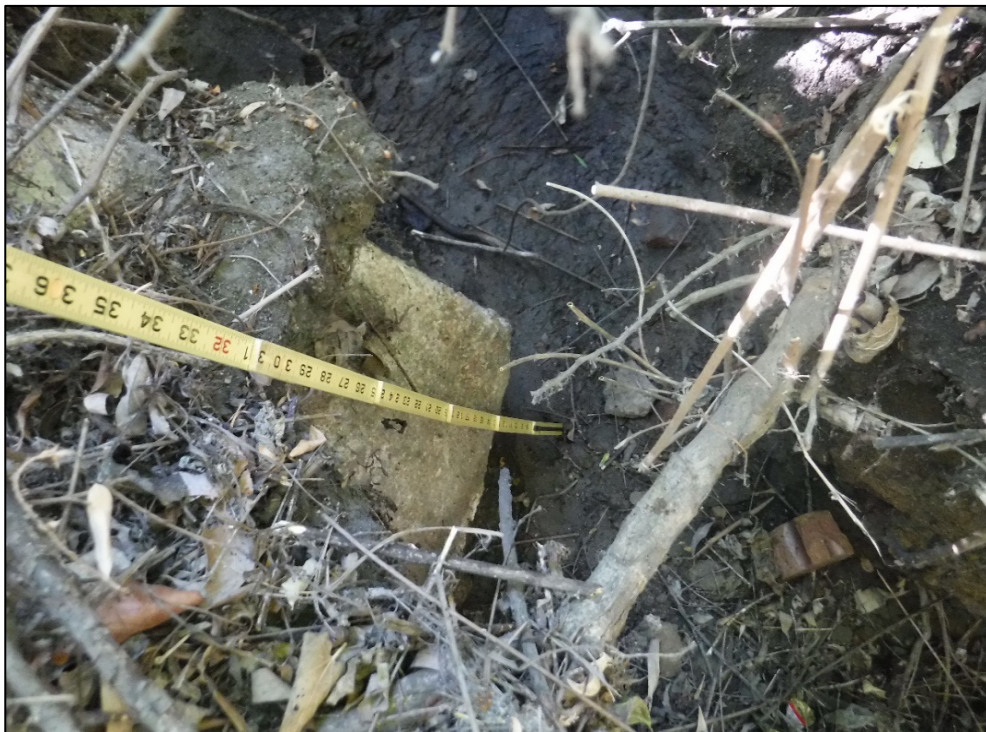
Pier 6 east footing south face fully exposed with no undermining.

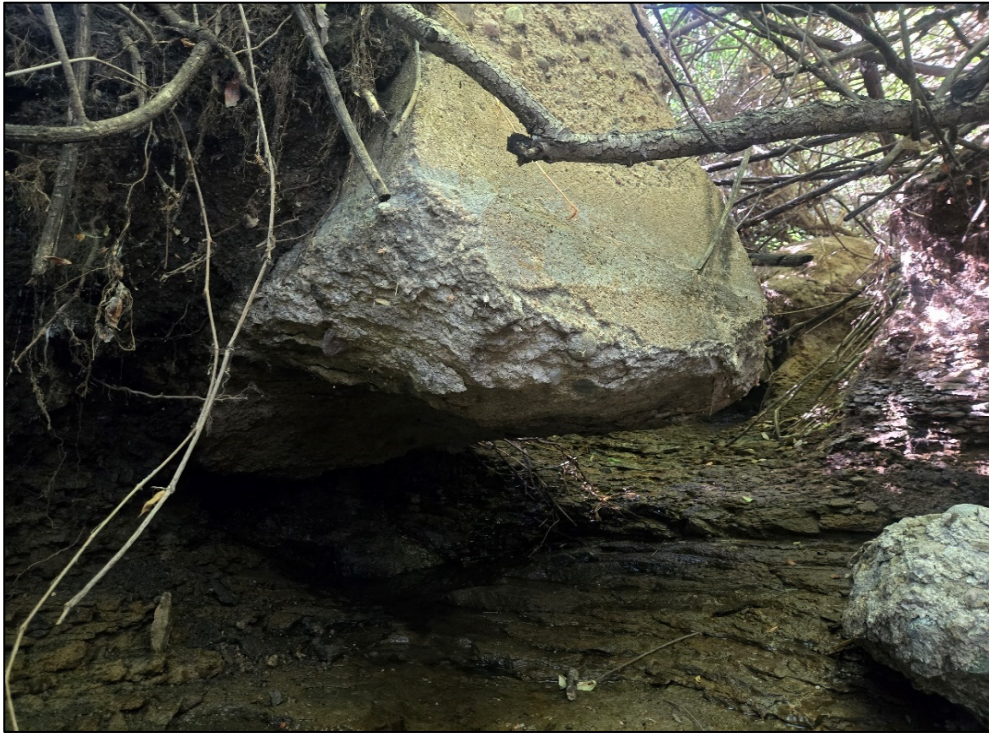
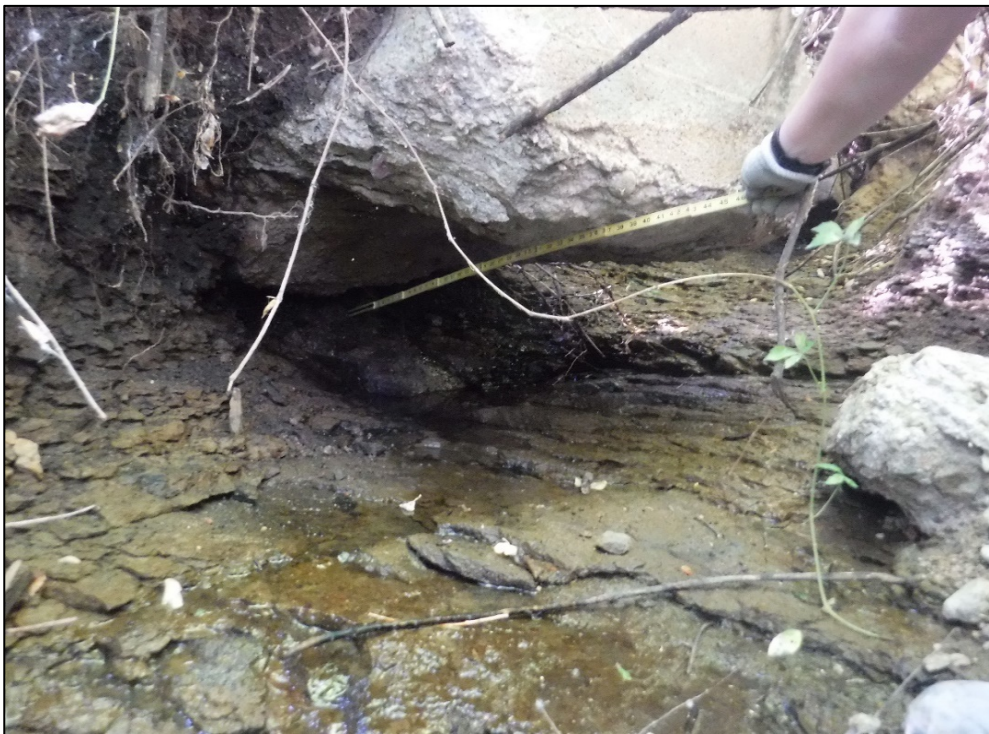
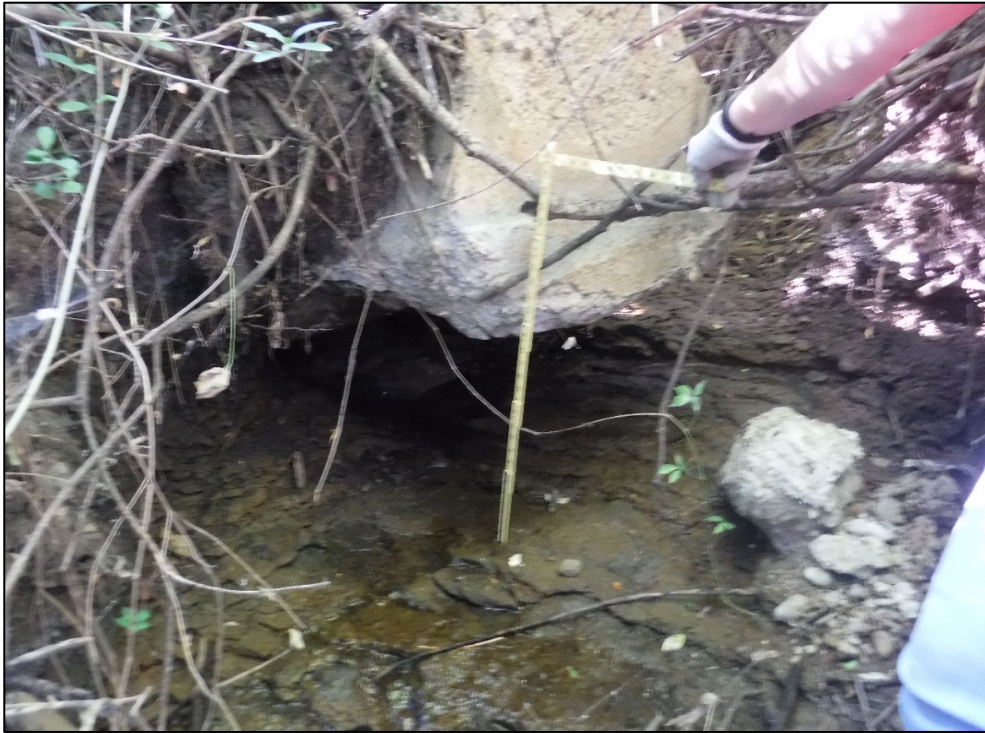
Pier 6 west footing undermined.

Pier 6 west footing has 10 percent remaining bearing capacity.

Pier 6 west footing undermined up to 20 inches vertically.

Based on these observations, Benesch provided recommendations to stabilize the footings around the undermined pier and install riprap to prevent further erosion. The extent of the foundation support undermining is considered a serious condition that needs to be addressed prior to further undermining that could lead to a potential collapse of the structure in this location. In addition, Benesch recommended repairs of the flume exhibiting holes and leaks that can affect underlying structural components from prolonged moisture exposure and corrosion of the steel members. Furthermore, removal of the vegetation under and around the structure may result in a compromised structure as the vegetation grows.

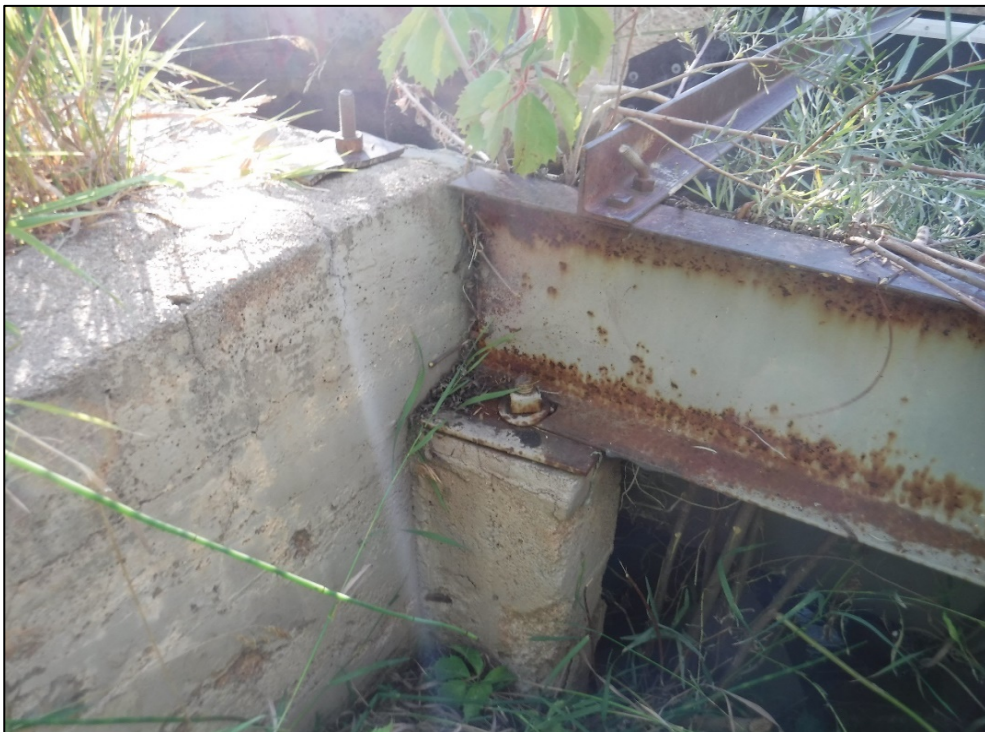
Northwest bearing between beam and abutment.

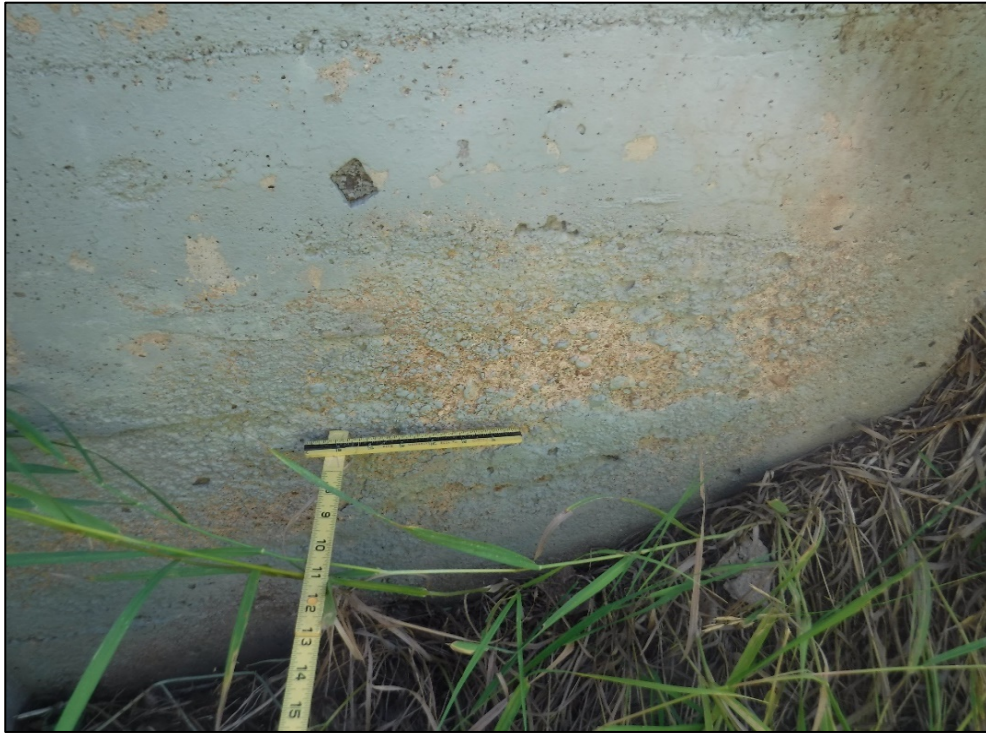
| Elm/Env | Description | Unit | Total Qty | % in 1 | CS 1 | % in 2 | CS 2 | % in 3 | CS 3 | % in 4 | CS 4 |
|---|---|---|---|---|---|---|---|---|---|---|---|
| Concrete wingwalls monolithic with abutments.<br>Wingwalls have insignificant to medium cracks with minor edge spalls.<br>Northeast wingwall has S2 scaling. | | | | | | | | | | | |

Northeast wingwall has S2 scaling.

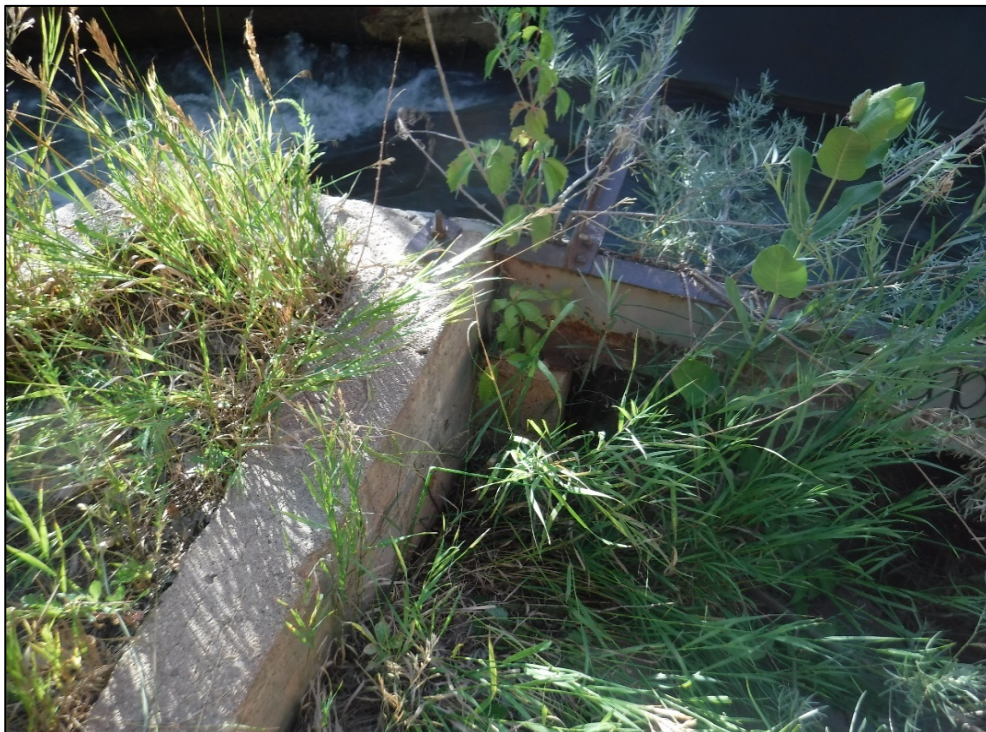
Northwest end of structure with vegetation growth.

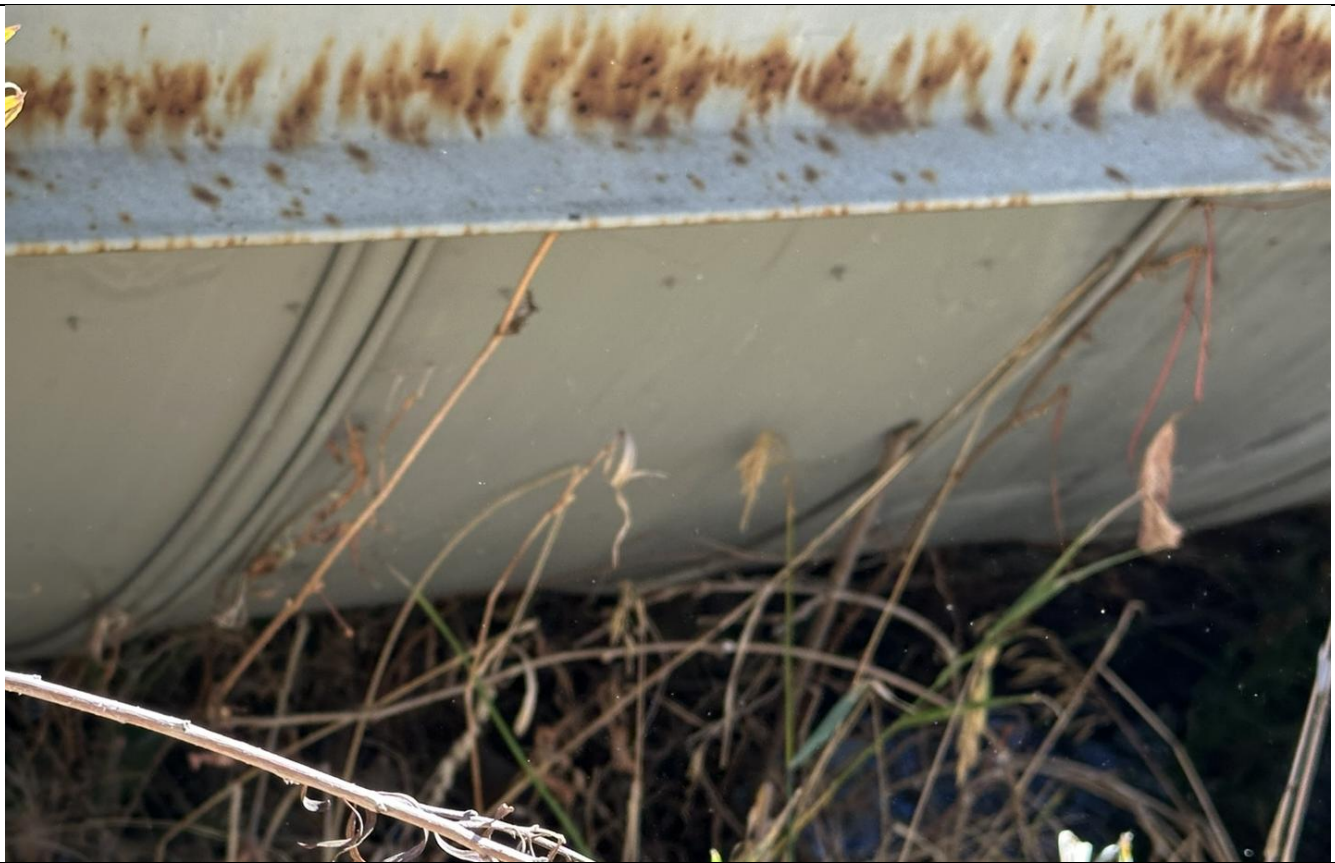
*Close-up of the deck. Contains 2.0 -3.1(mg/cm<sup>2</sup>)*

Regarding the deck, the only tested-positive LBP component, it should be noted that not every sampling of the homogeneous components came back as containing lead-based paint. The two tests that came back positive were on the South end of the flume, the 4<sup>th</sup> and 6<sup>th</sup> segments of the deck from the end, to be exact. However, it is not feasible to delineate the exact locations of LBP segments of the deck due to environmental conditions. Therefore, all segments should be assumed to have lead-based paint on them.
