**TO:** Brent Soderlin, PE, CFM, Director of Public Works and Utilities, Littleton, Colorado (City)  
**FROM:** Tim Phelan, PE  
**SUBJECT:** Slaughterhouse Gulch Flume  
**DATE:** December 6, 2024  
**CC:**

## Routine Inspection Flume Structure Inspection and Inventory Report

Bridge Key: Slaughterhouse Gulch

Inspection Date 90: 07/30/2024

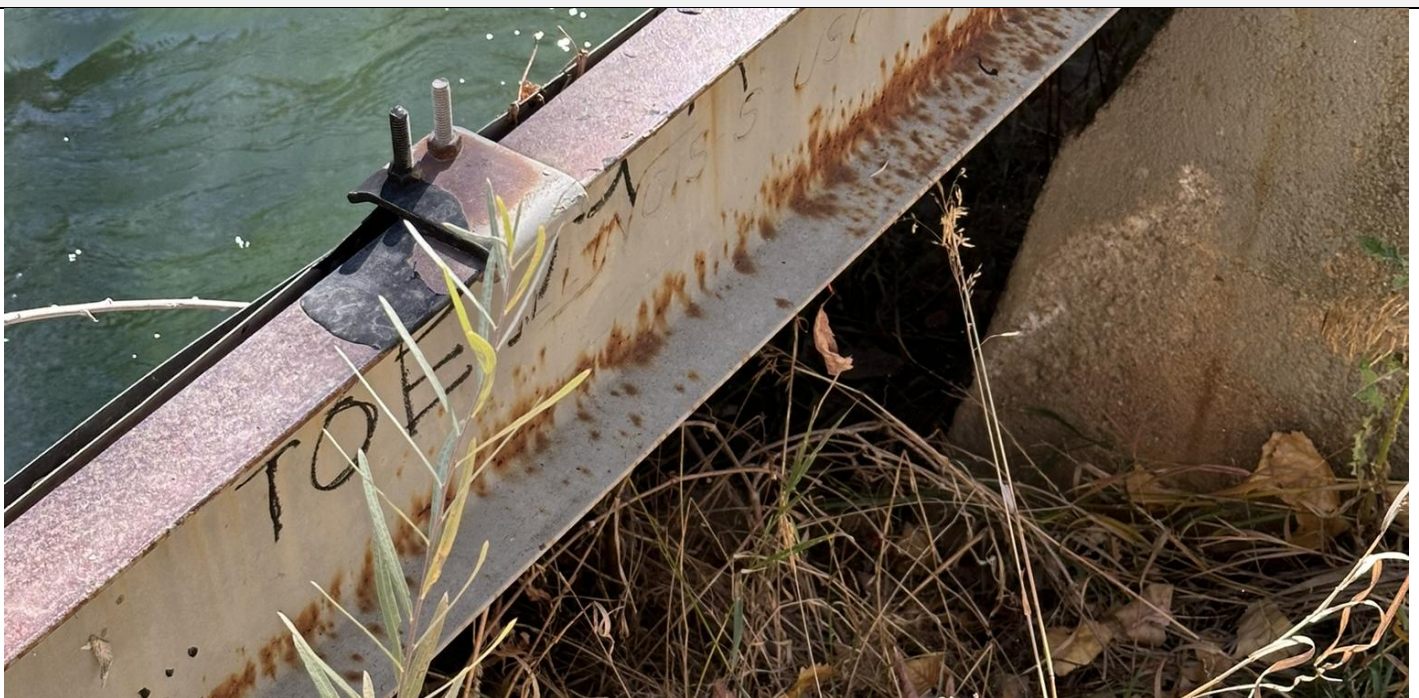
*Close-up of a girder. Negative*

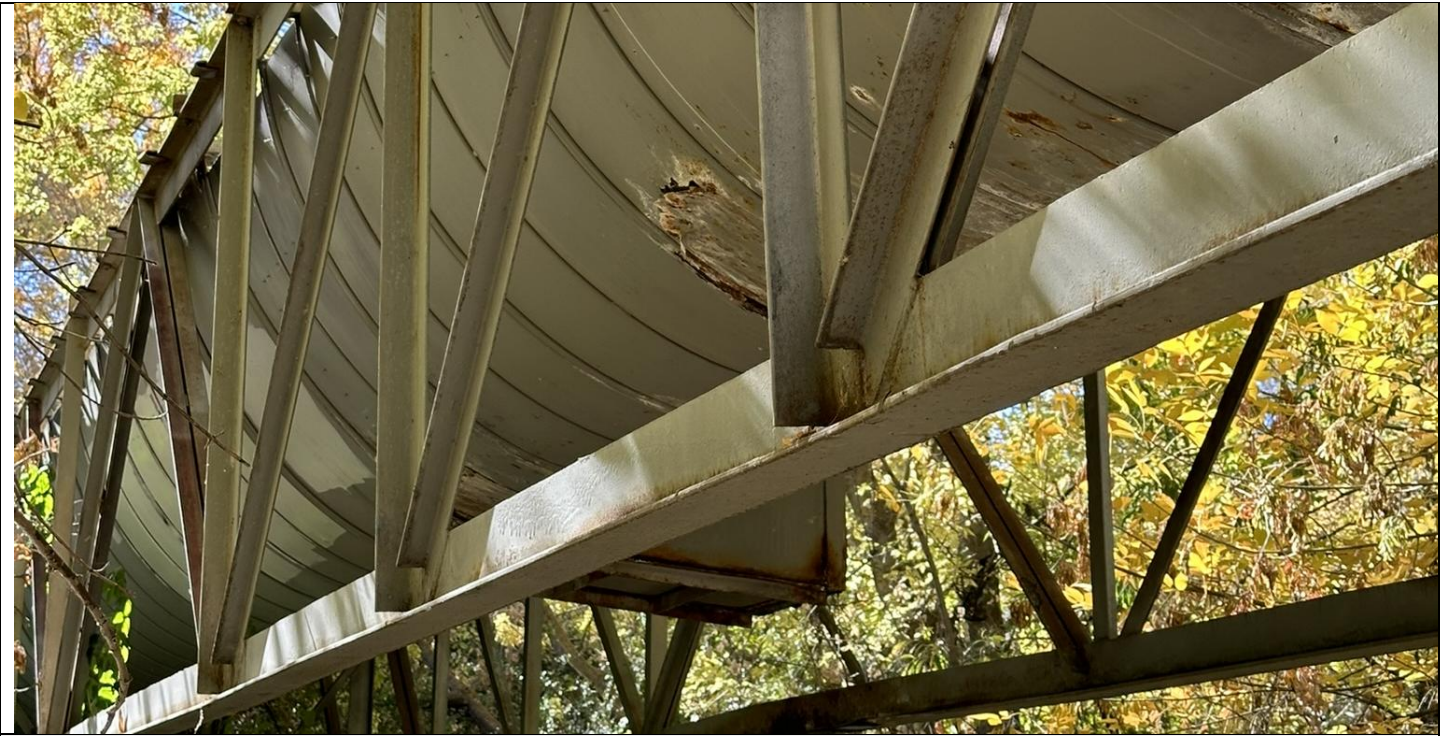
*This component is identified as the Truss in this report. Negative*

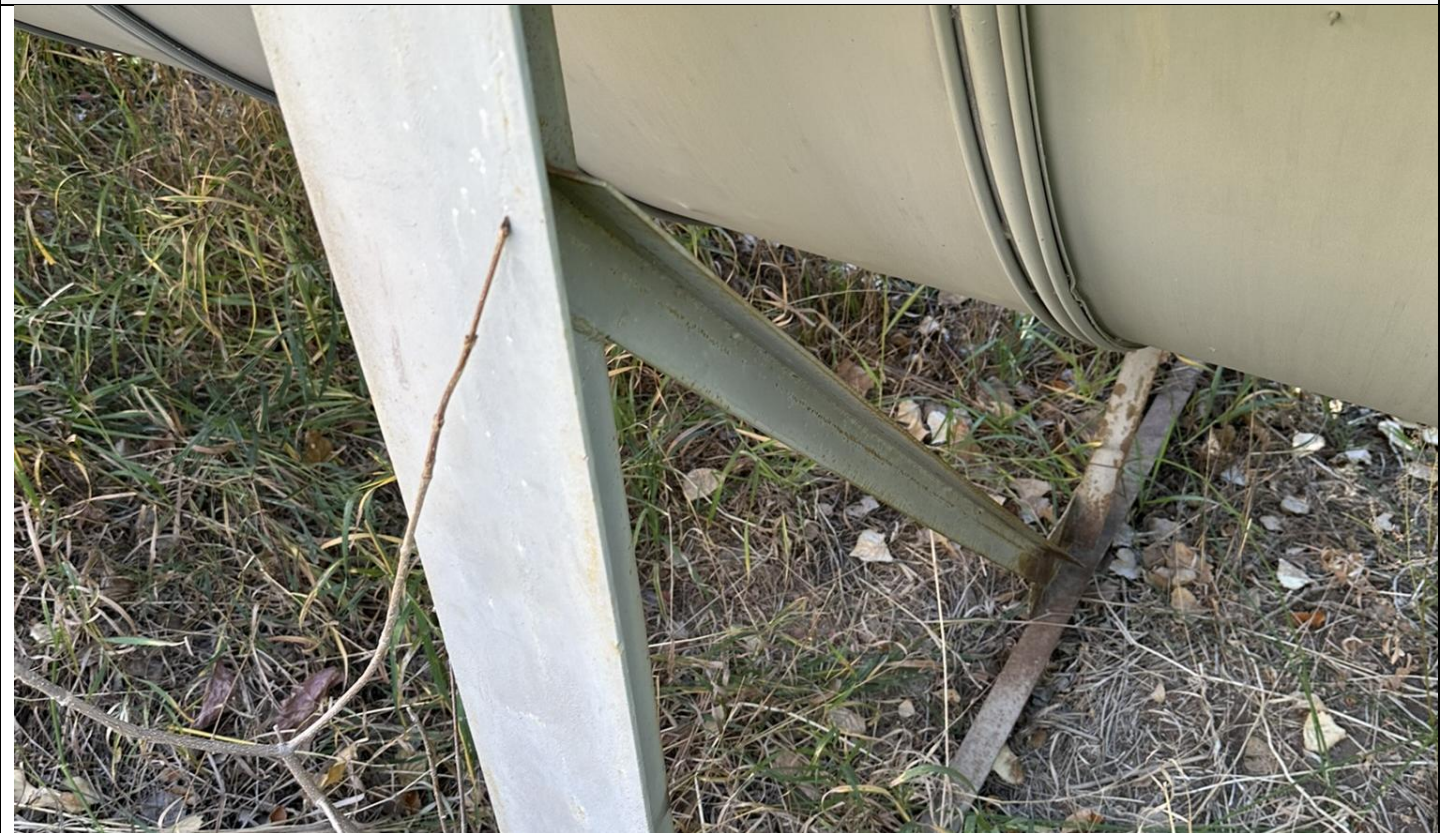
*The vertical supports are identified as Towers in this report. Negative*

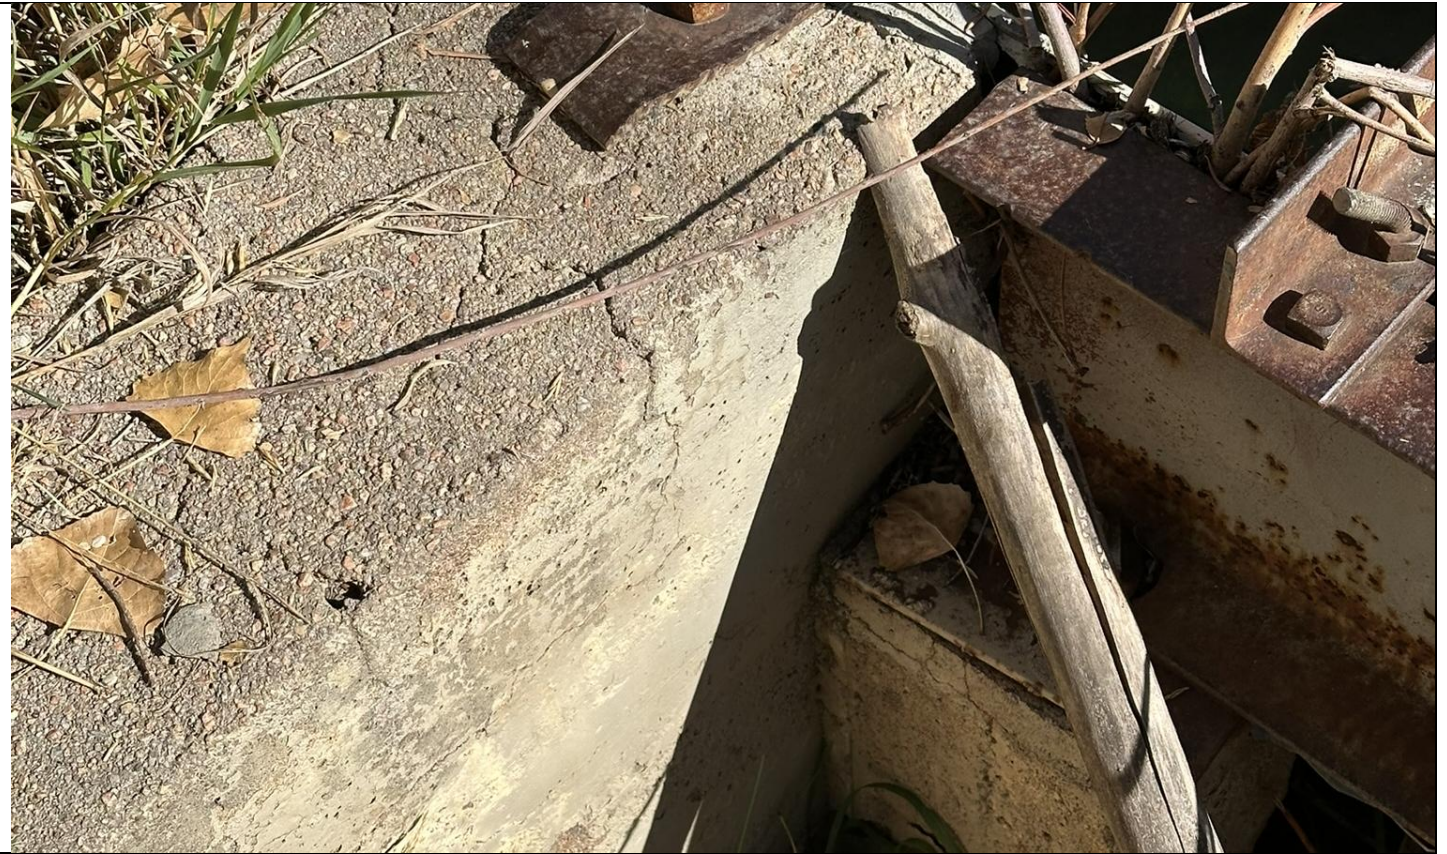
*The wingwall. Negative*

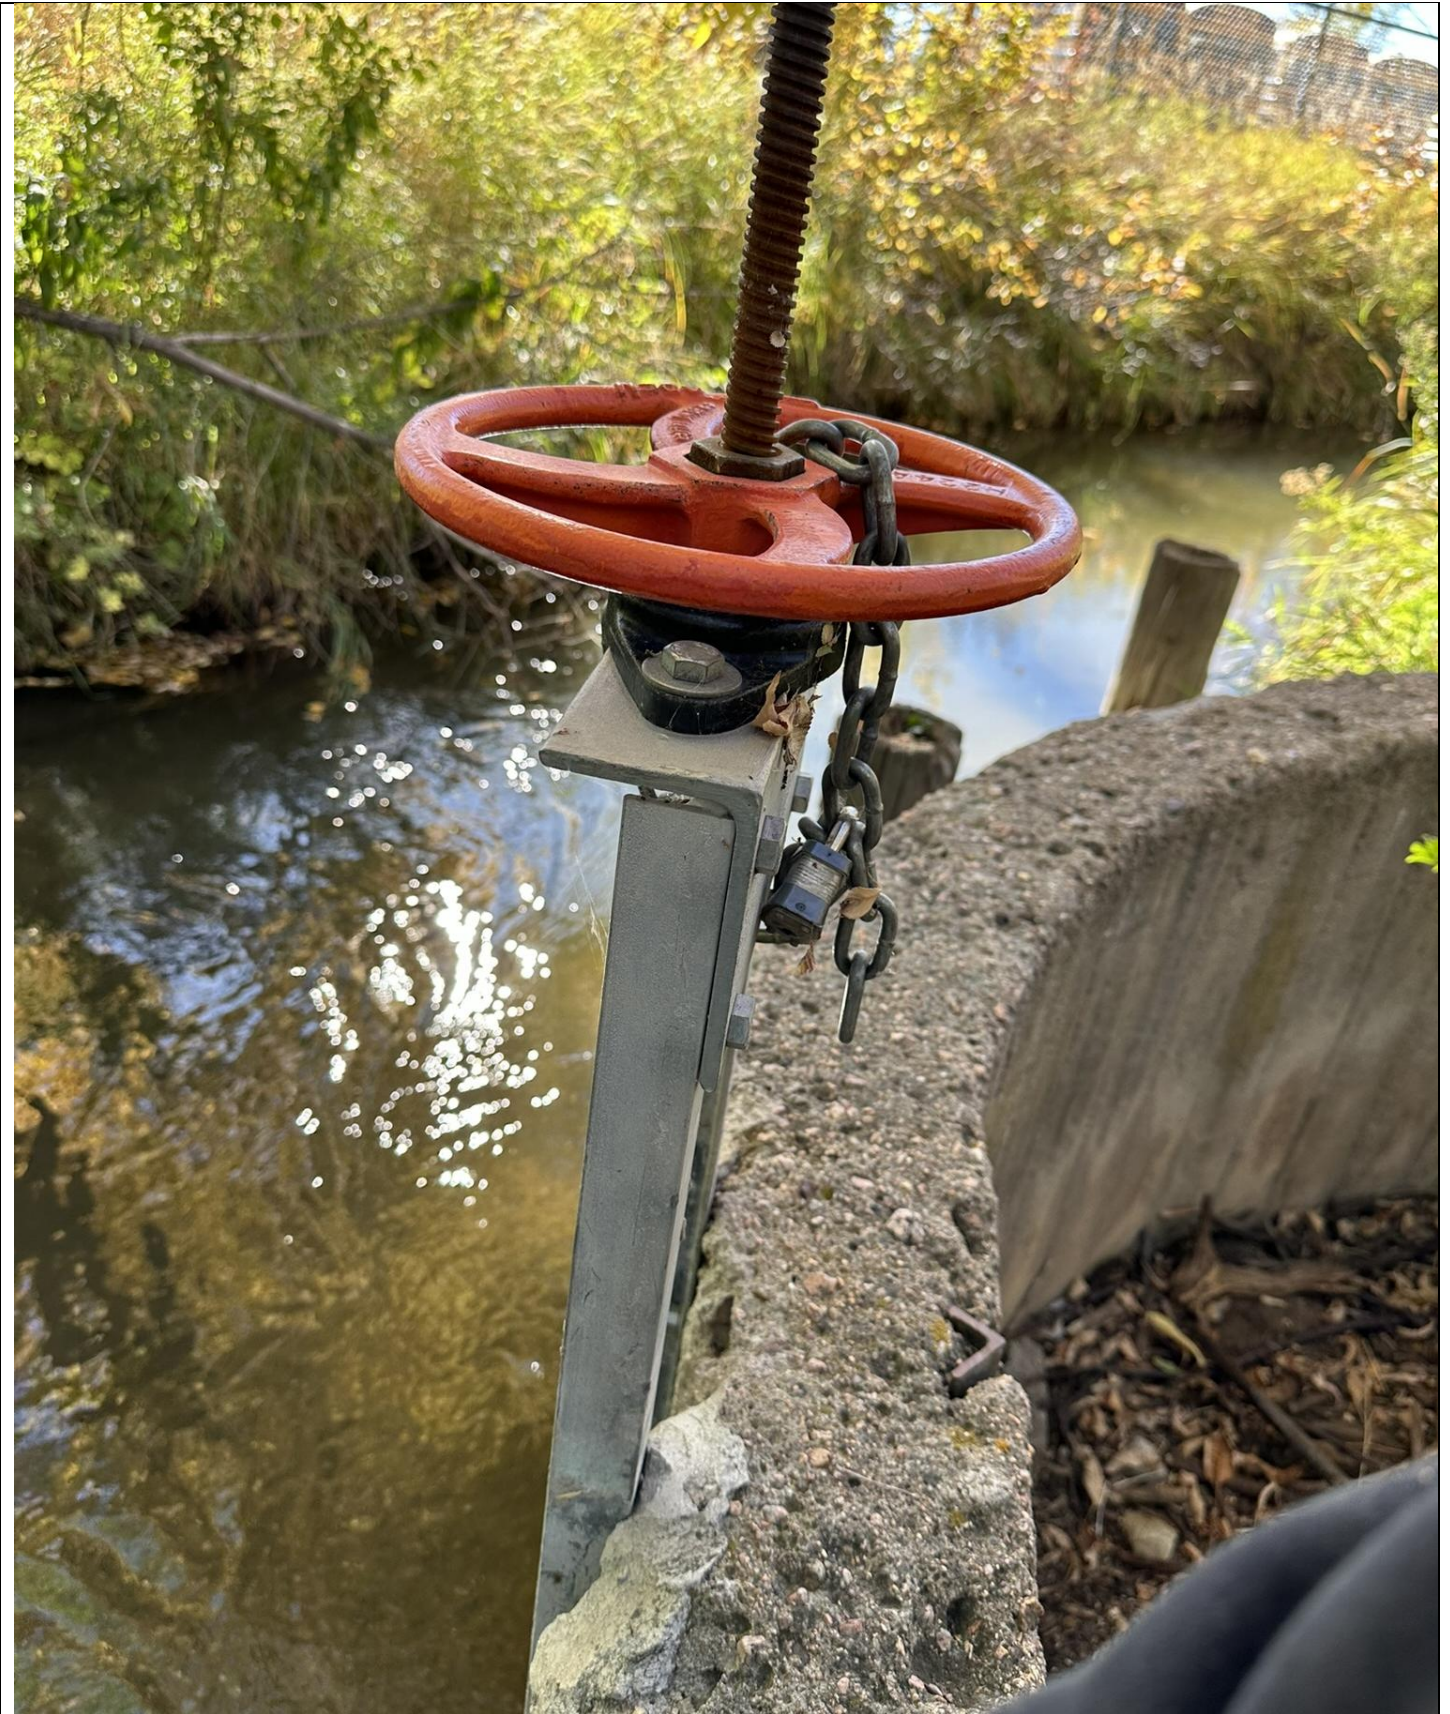
*The accessible sluice gate assembly. Negative*

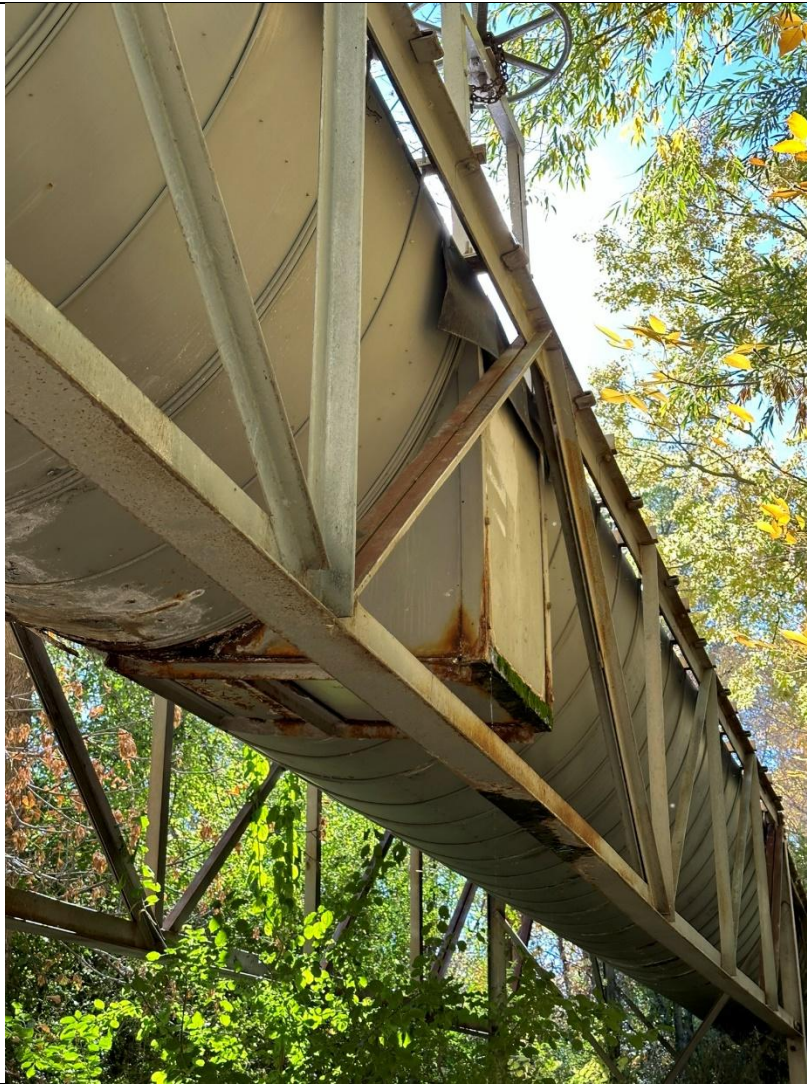
*The sluice mechanism pictured here could not be safely accessed during this inspection and must be assumed to have LBP components. Assumed LBP*
