TO:	Brent Soderlin, PE, CFM, Director of Public Works and Utilities, Littleton, Colorado (City)
FROM:	Tim Phelan, PE
SUBJECT:	Slaughterhouse Gulch Flume
DATE:	December 6, 2024
CC:

Routine Inspection Flume Structure Inspection and Inventory Report

LEAD-BASED PAINT INSPECTION REPORT

Slaughterhouse Gulch Flume

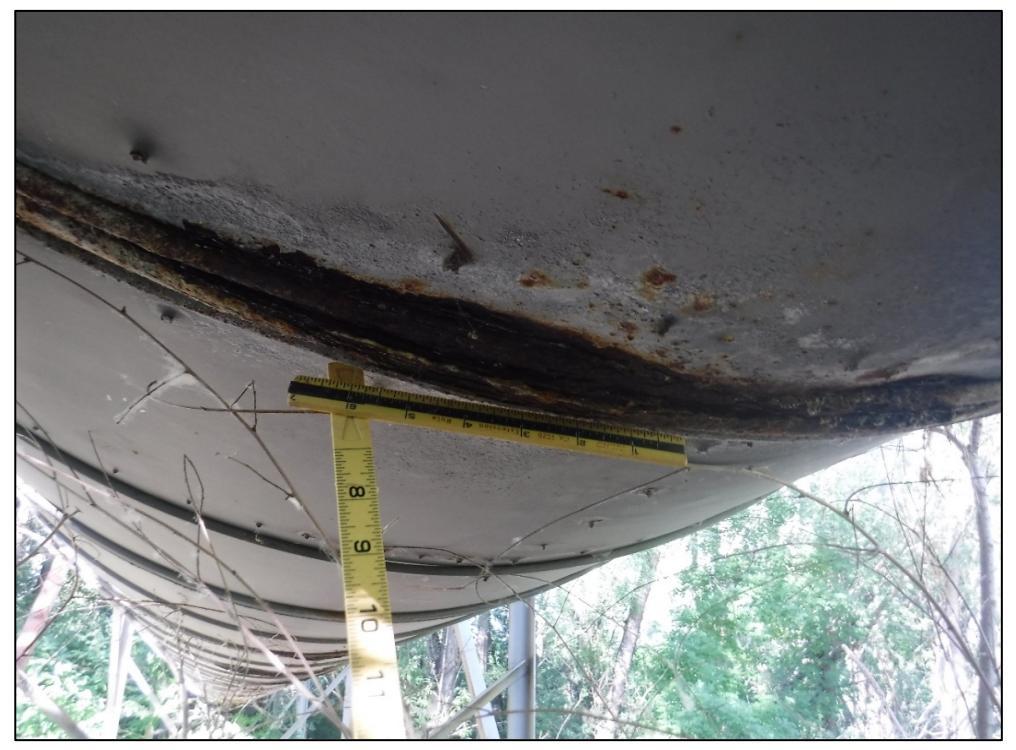
Deck underside at bolt bands has R2-R3 corrosion, typical.

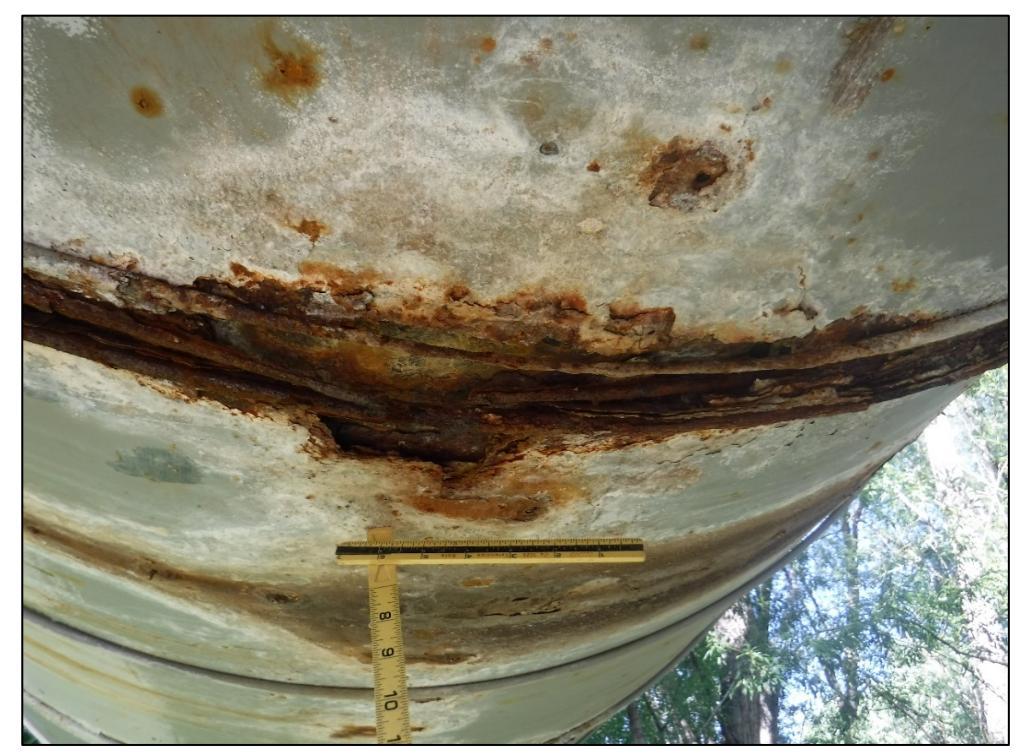
Deck underside in Span 8 along bolt band has R4 corrosion.

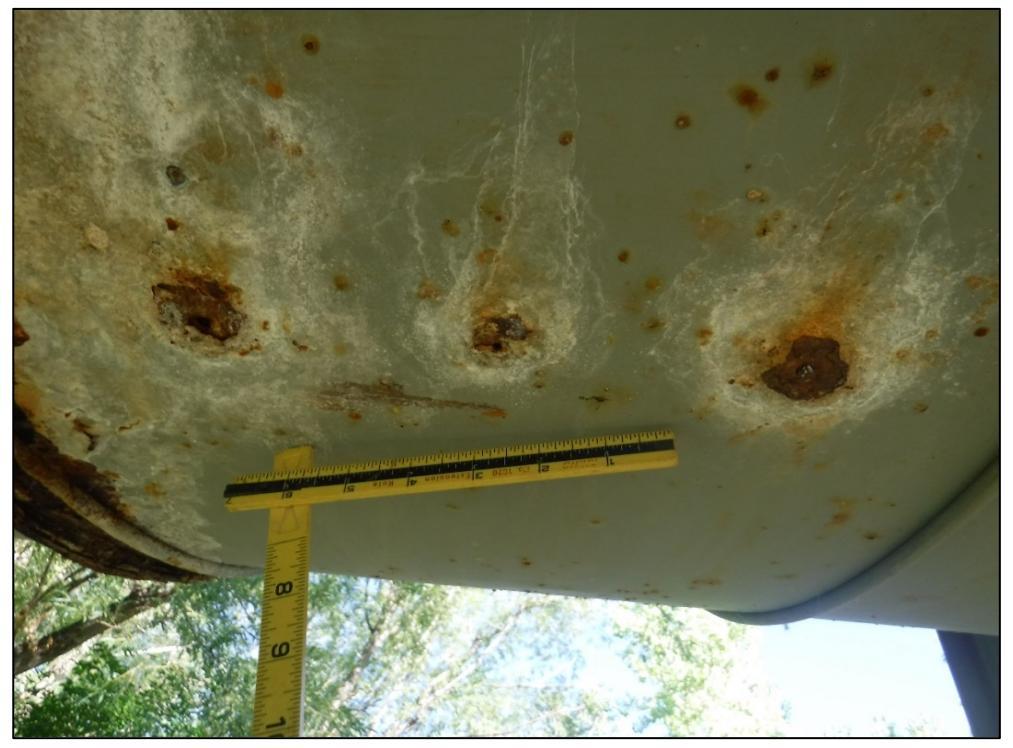
Deck underside in Span 8 has area of pinhole corrosion.

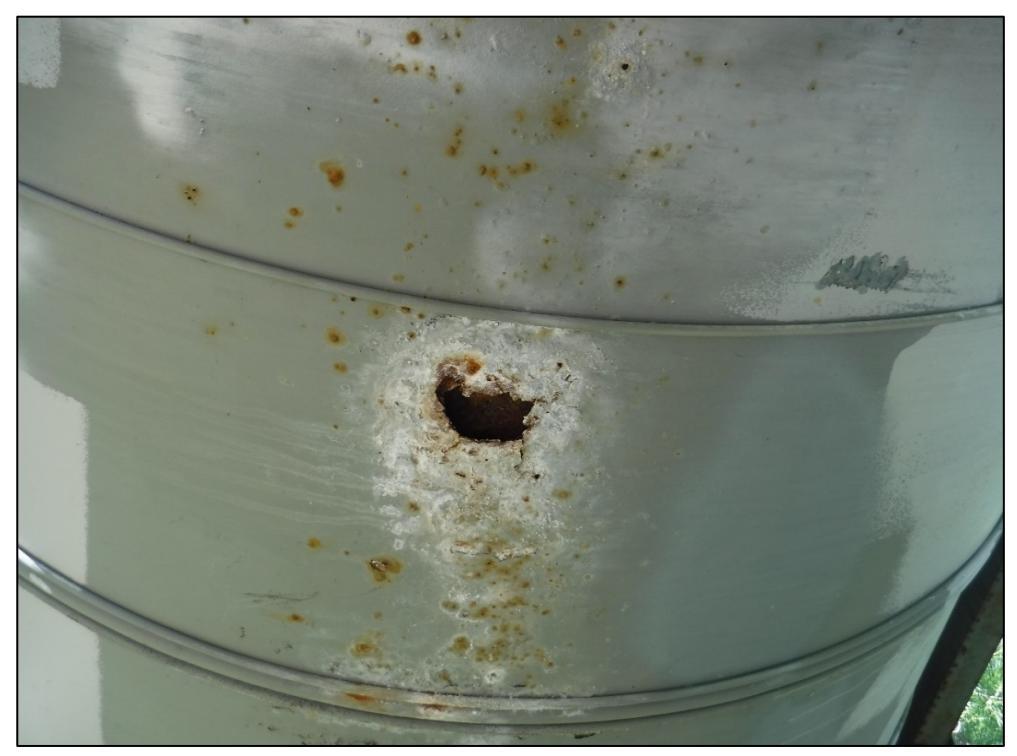
Deck underside in Span 9 has up to 3 inch diameter corrosion holes.

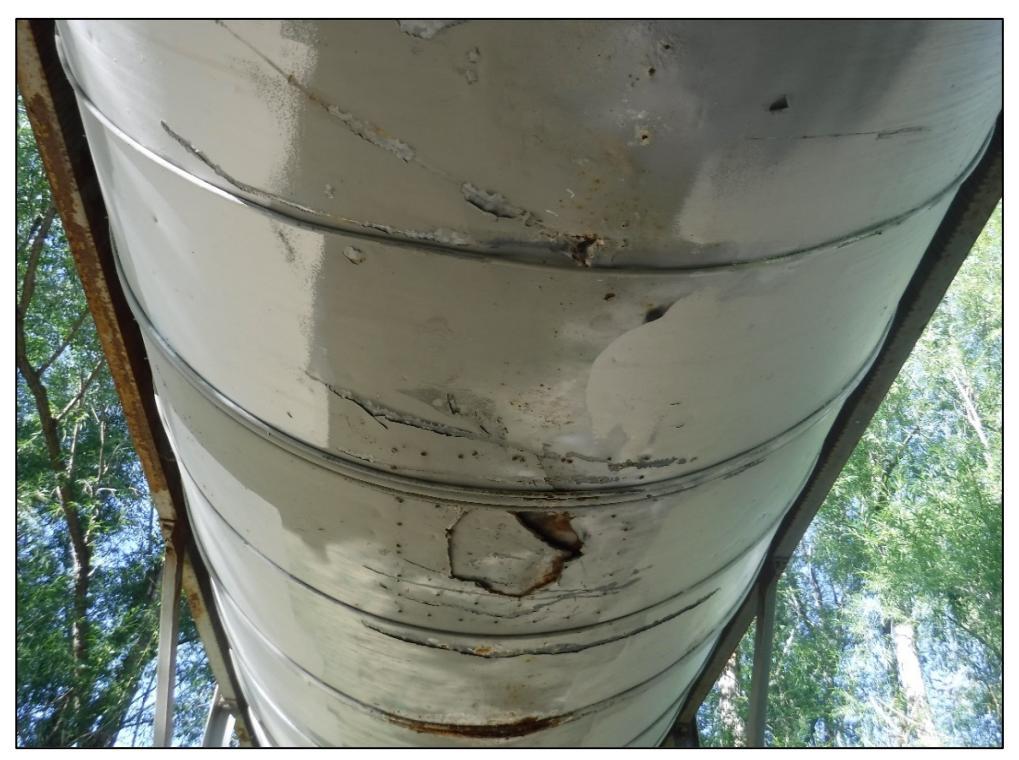
Deck underside in Span 9, 6 feet x 3 feet area of impact damage.

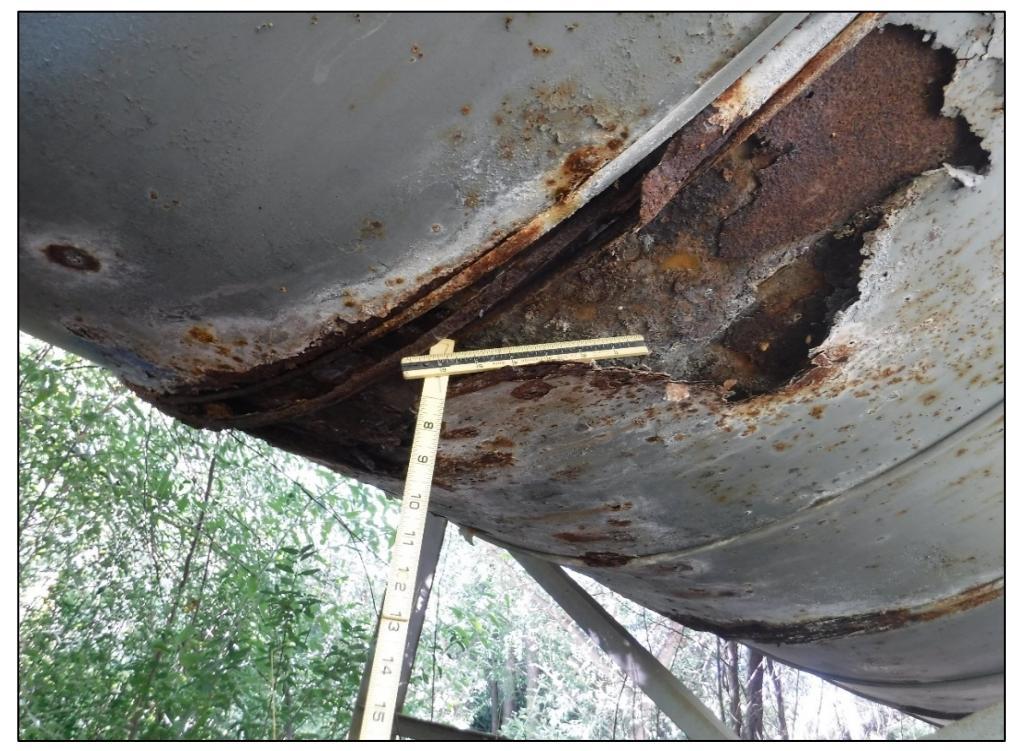
Deck underside in Span 11 has area of R4 corrosion.

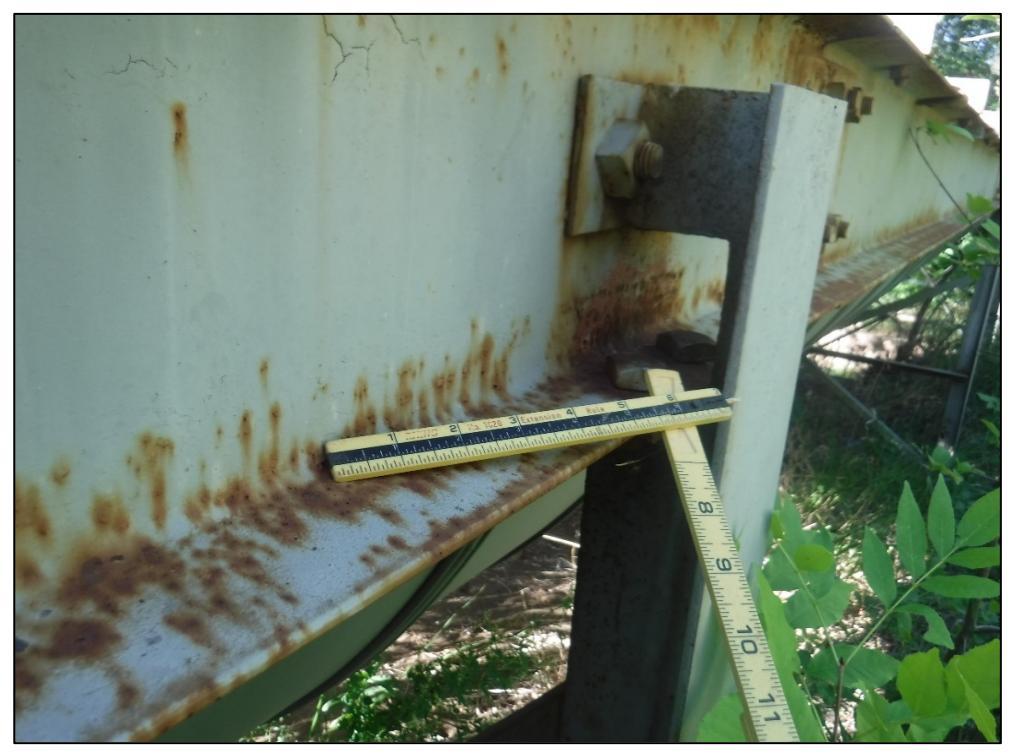
Beam A has R1 corrosion, typical.

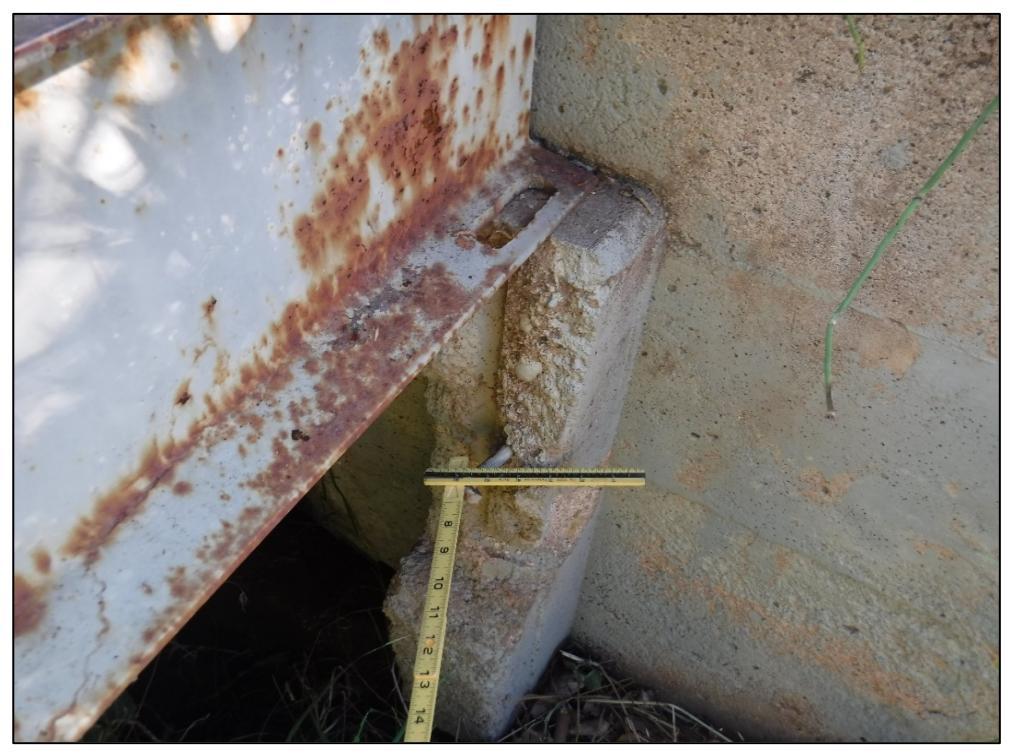
Abutment 14 east end spall with bearing area loss and missing connection.

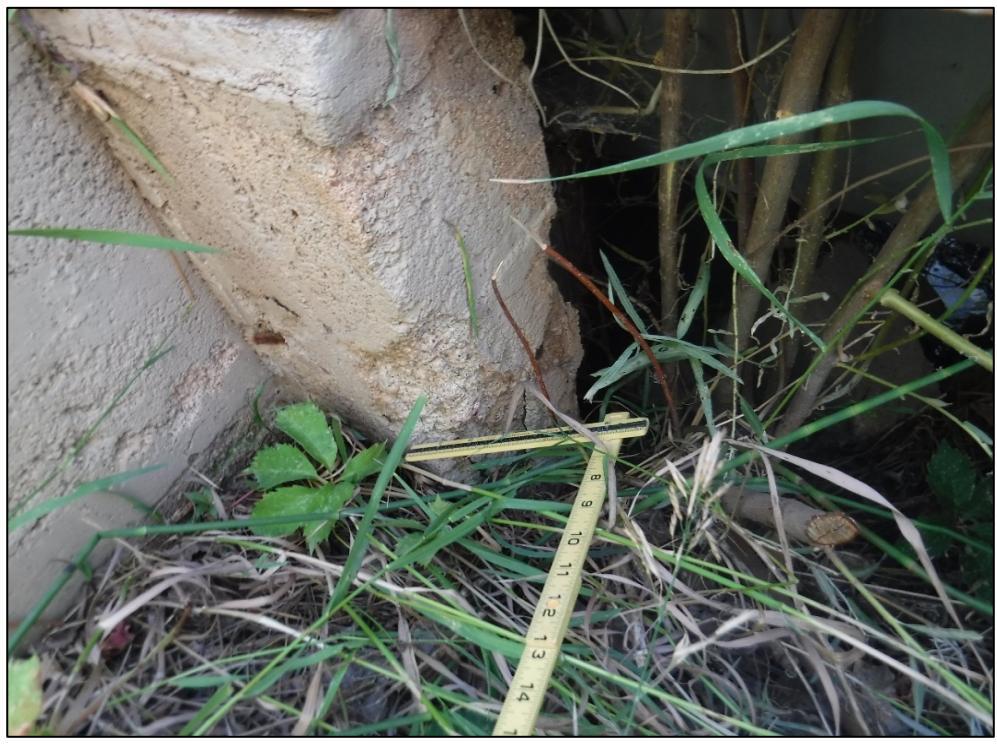
Abutment 14 west end spall.

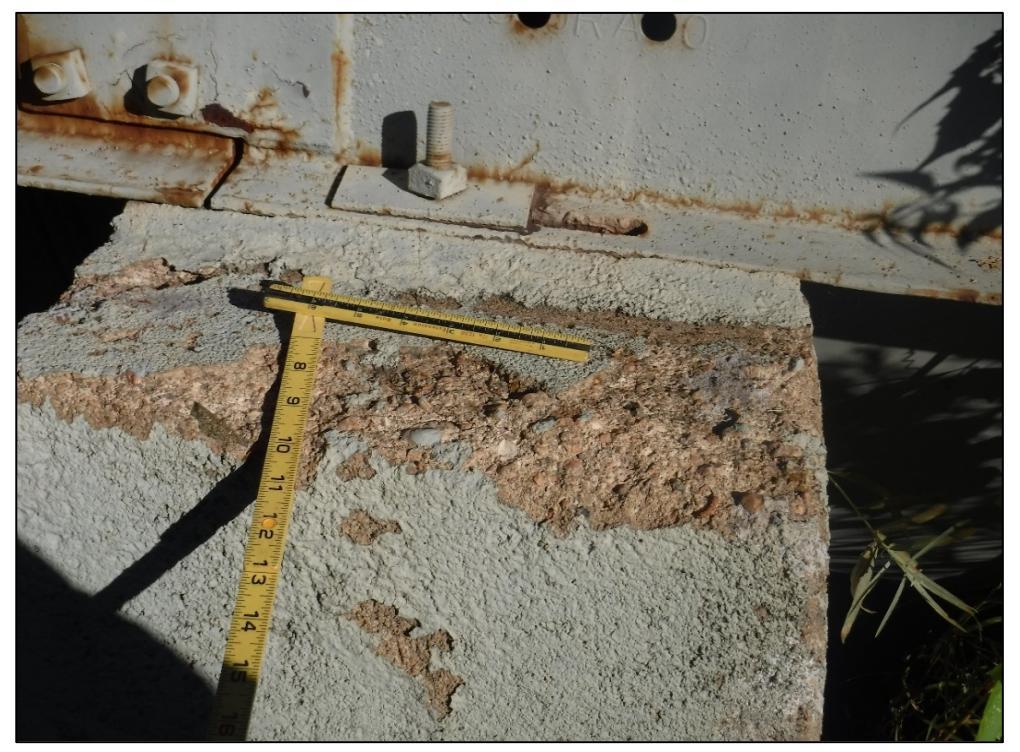
Pier 13 east column at top has S2 scaling.

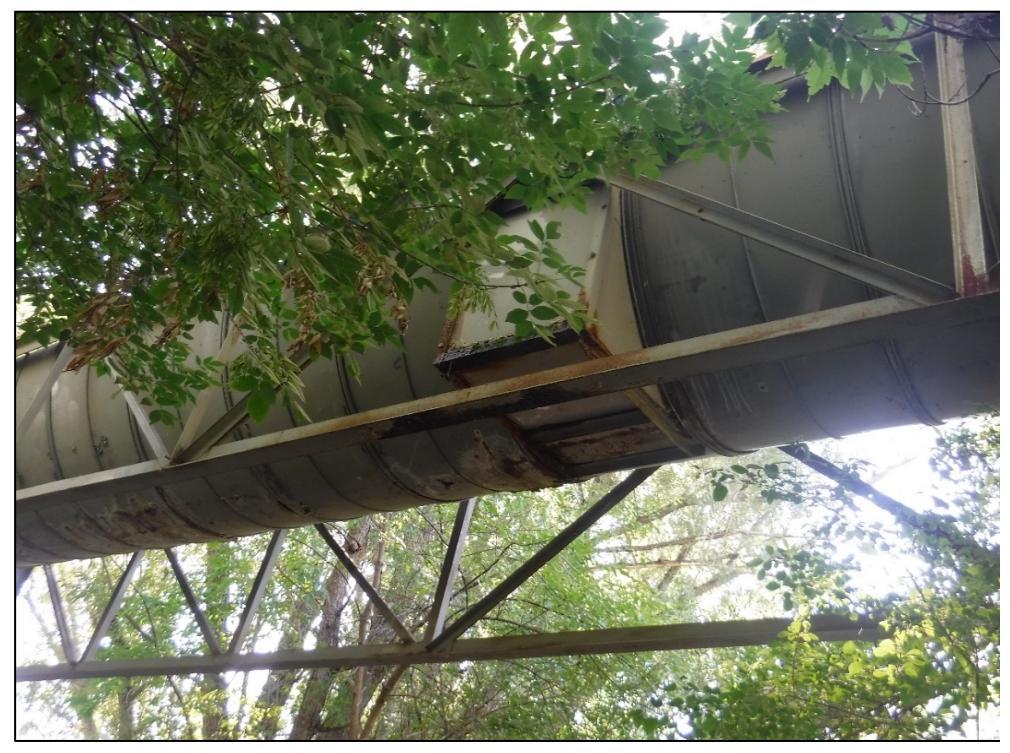
Truss 6A lower chord bent upwards at mid-point looking east.

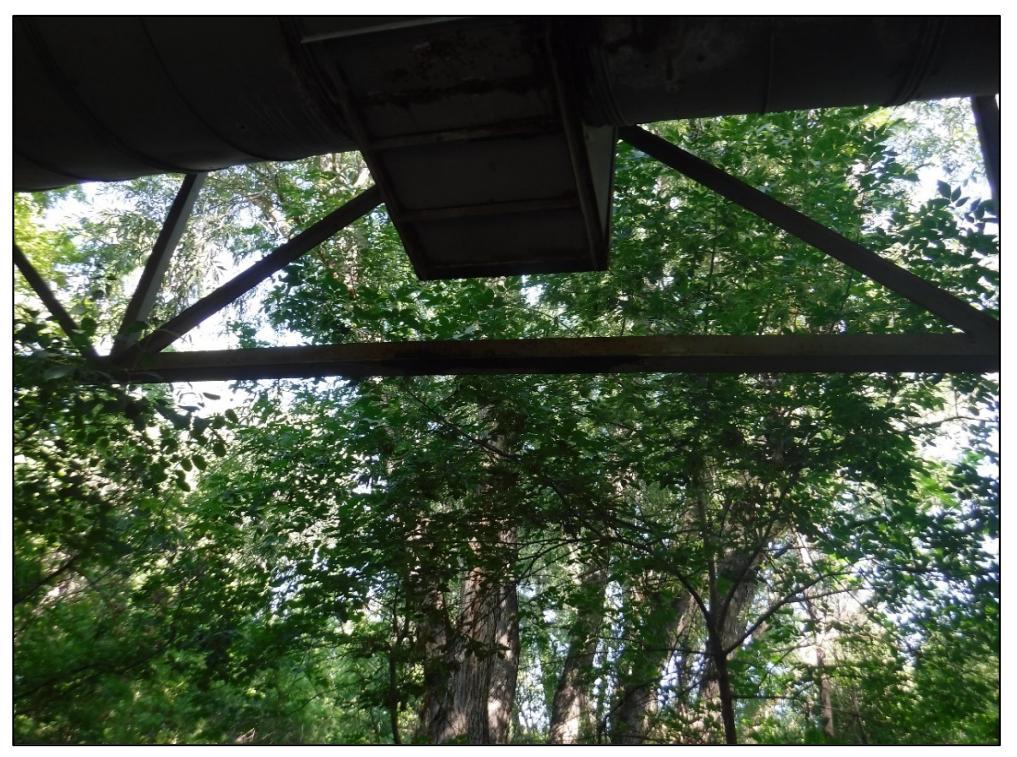
Truss 6A lower chord bent upwards at mid-point looking west.

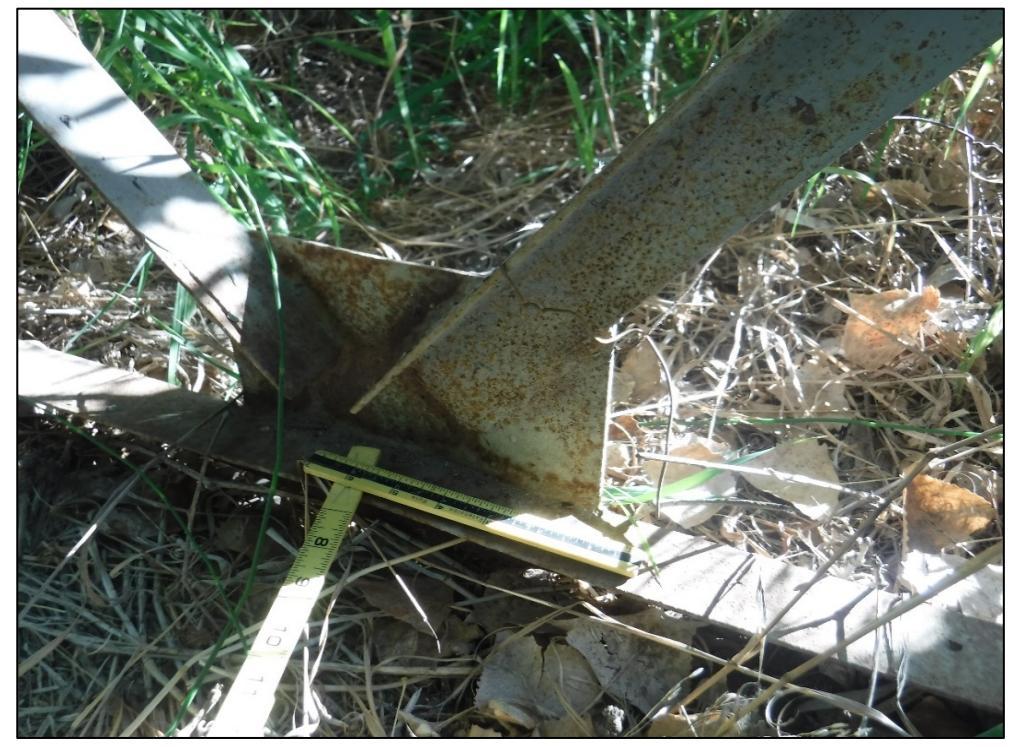
Trestle diagonals have spotty R1 corrosion, typical.

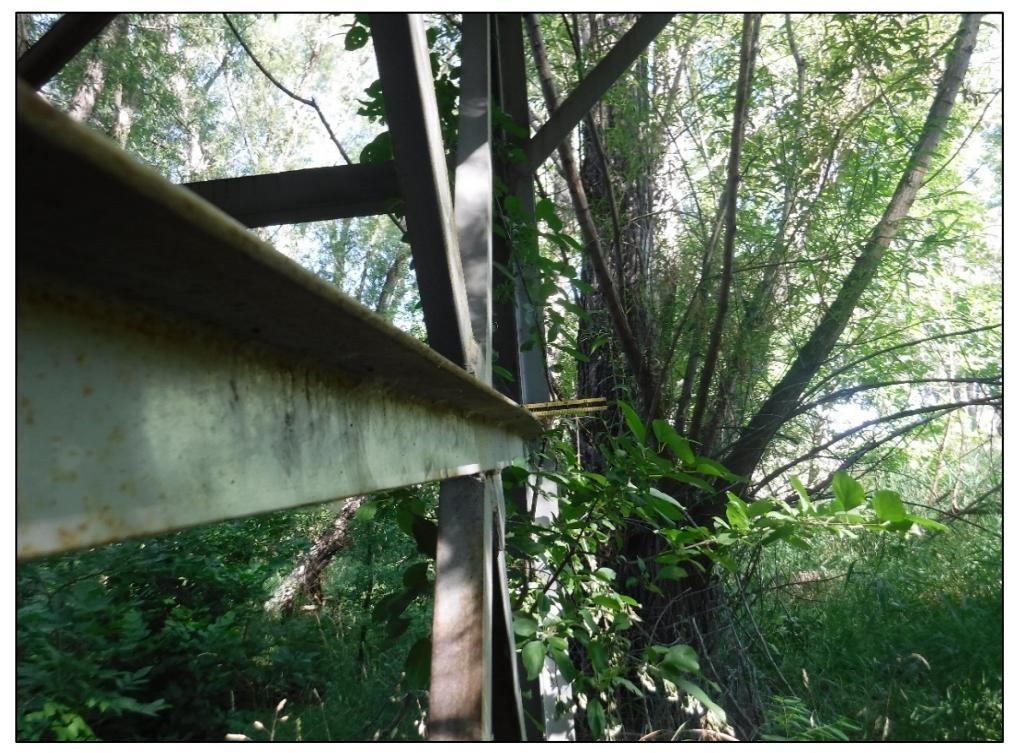
Pier 7 trestle middle horizontal member bent north.

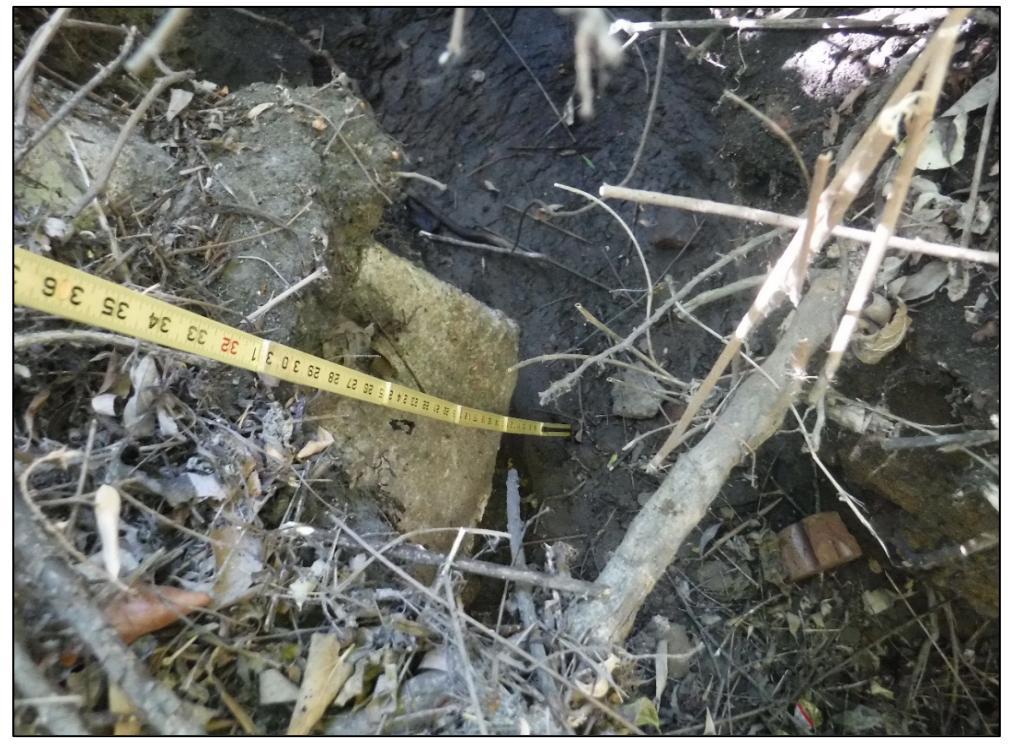
Pier 6 east footing south face fully exposed with no undermining.

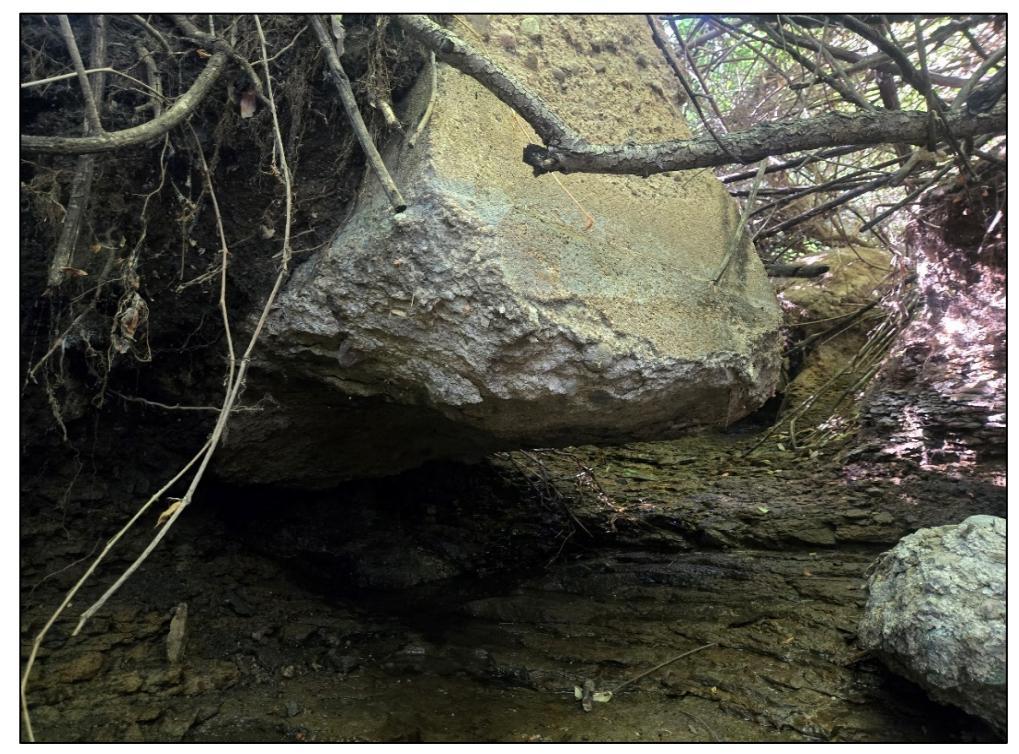
Pier 6 west footing undermined.

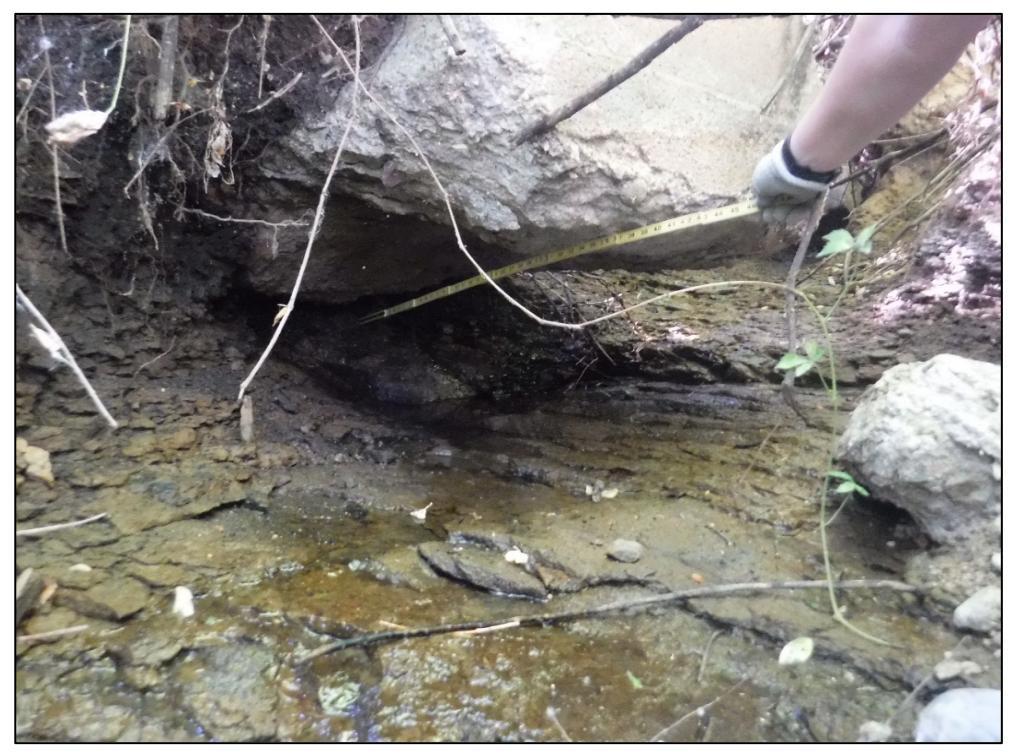
Pier 6 west footing has 10 percent remaining bearing capacity.

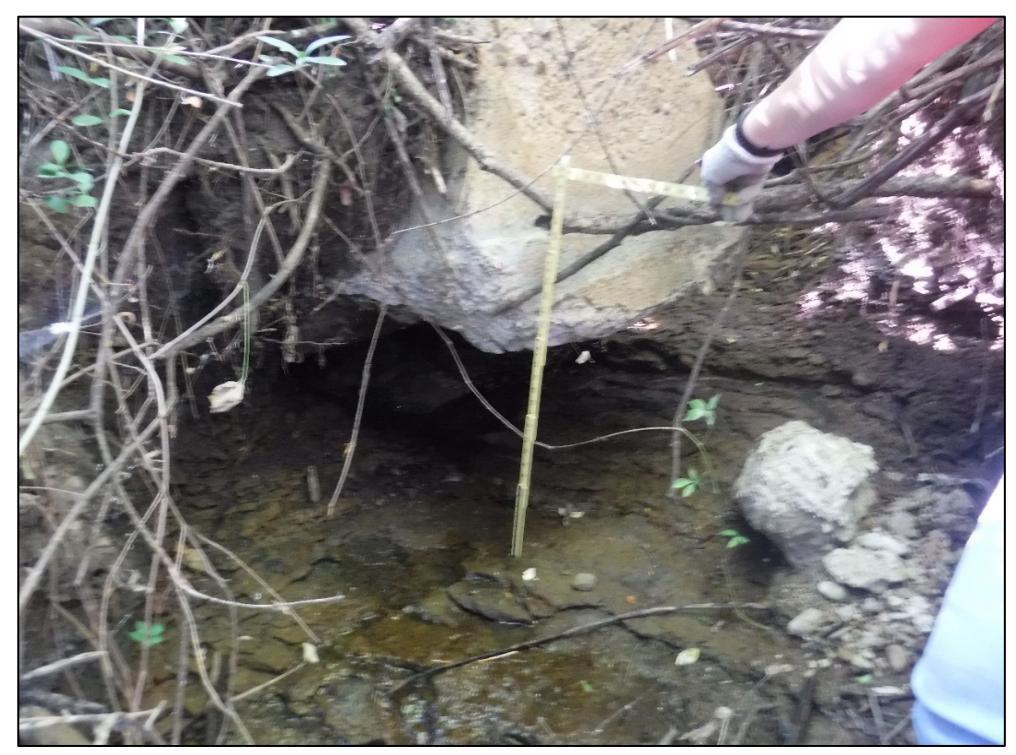
Pier 6 west footing undermined up to 20 inches vertically.

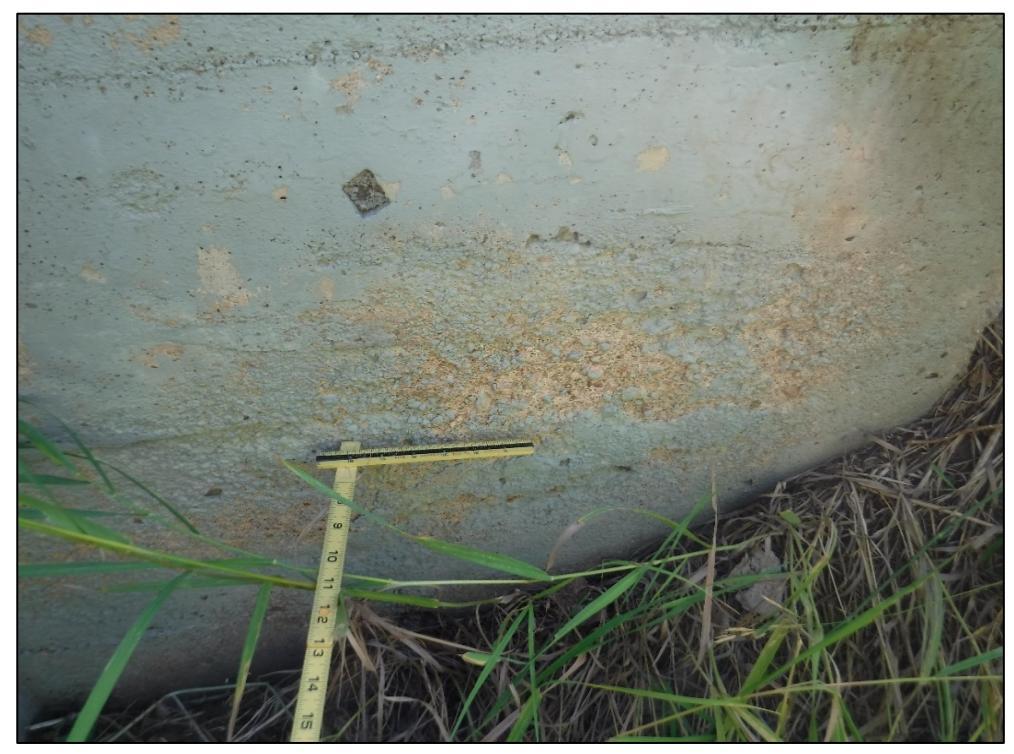
Northeast wingwall has S2 scaling.

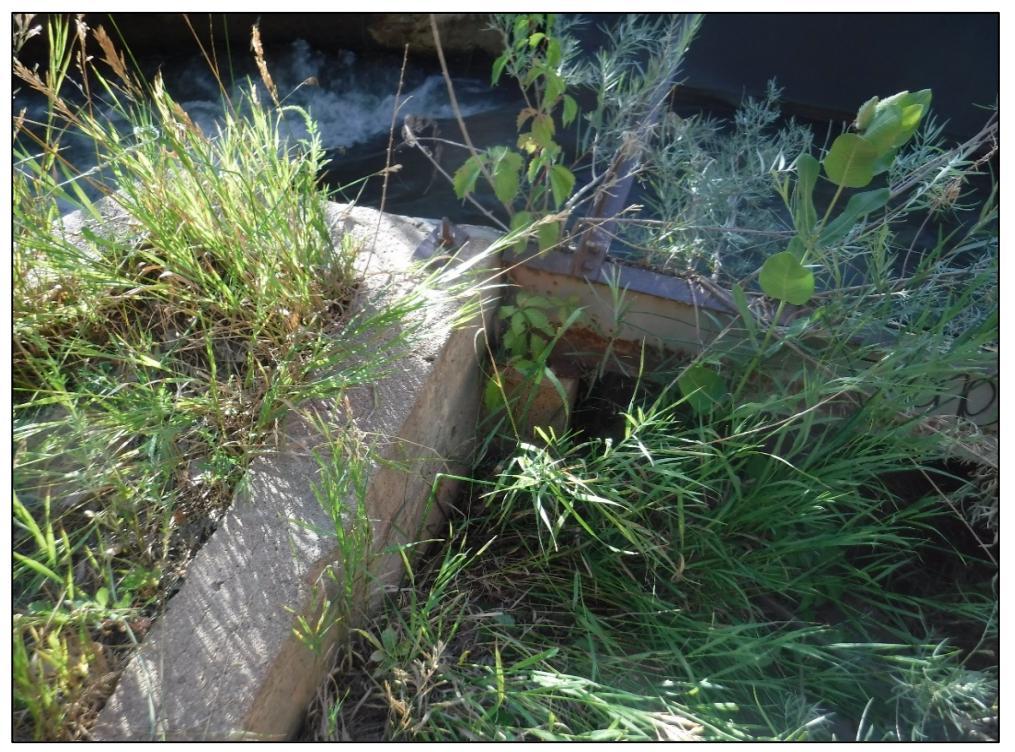
Northwest end of structure with vegetation growth.

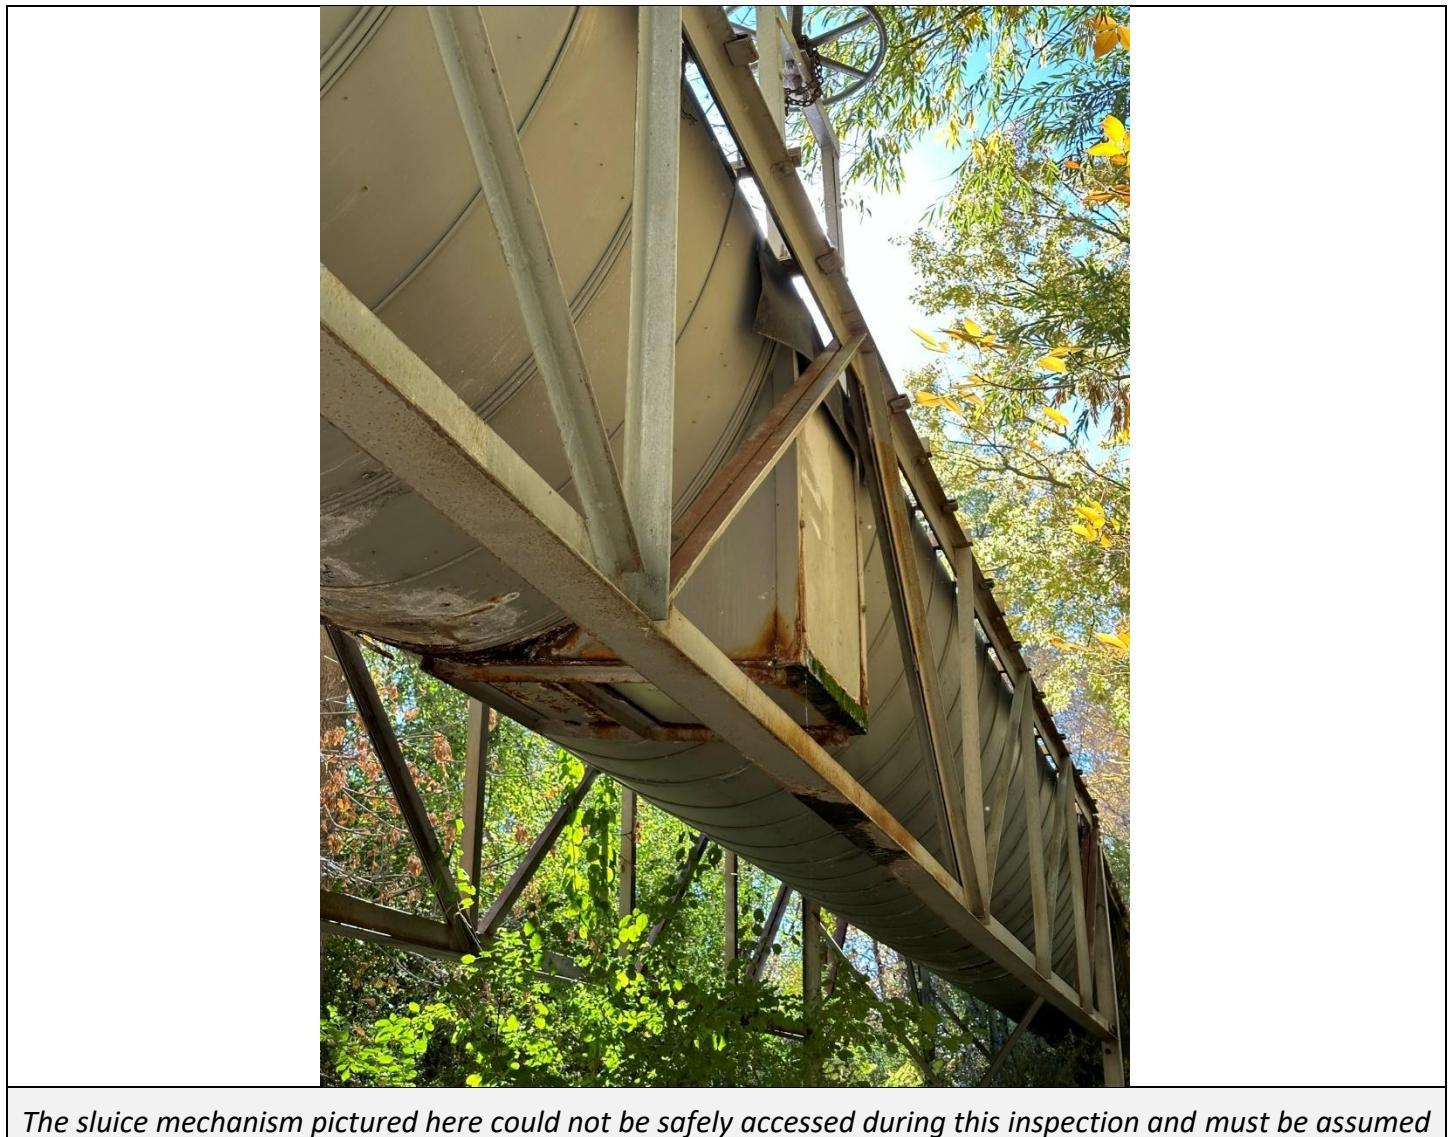
to have LBP components. Assumed LBP
