2600 Main Street
Littleton, CO 80120

Attn: City of Littleton
Decision Criteria for Certificate of Appropriateness
Zoning: DMS

This letter serves as the Decision Criteria Narrative.

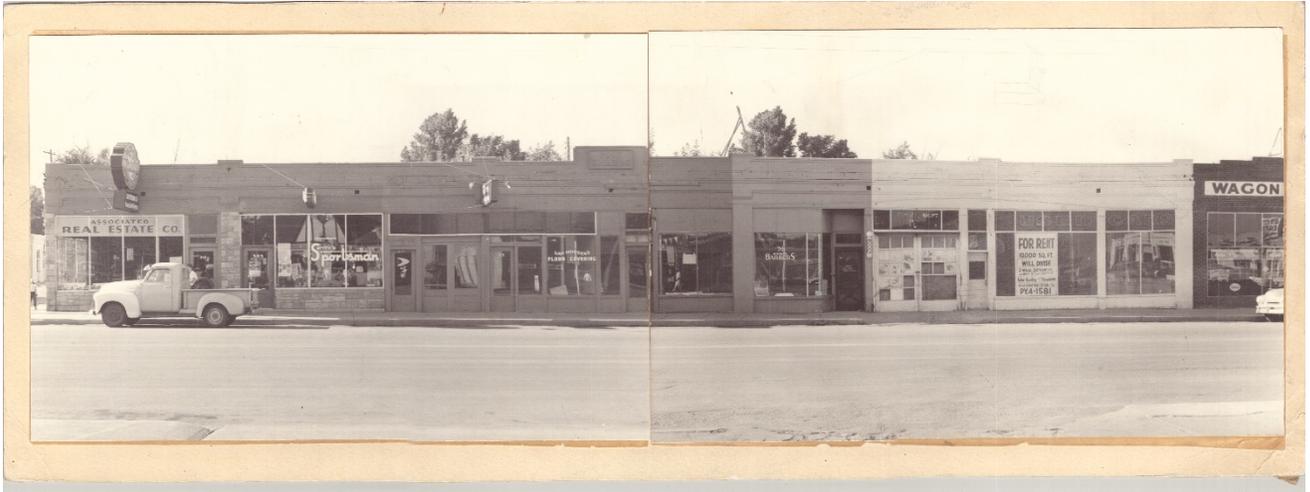
The image below is estimated to have been taken after 1956 based on the truck model. Please note that the storefronts have wood trim detailing at the columns and in some cases at the knee wall panels below the storefronts. The faux stone veneer appears to be in place, but already looks odd and randomly covers part of one column with exposed brick above.

The period of significance of this mercantile building is with the founding of downtown Littleton as a business district, and this building is a classic example of that era in its original form. At some point around the 1950's (before the photograph below was taken) some faux stone veneer was added to the building façade. The large openings at the Curtice street façade were infilled with wood framing, board and batten and wooden doors at an unknown date. This façade also had faux stone veneer applied over the brick at an unknown date. There is no record of when the Mansard roof was added over the façade. The result of these infills and veneers have been to deteriorate the brick behind it and create a disorganized façade that is not typical of any historic era. The

disorganization includes through wall air conditioners in the storefront, broken glass, peeling paint, and cracked stucco.

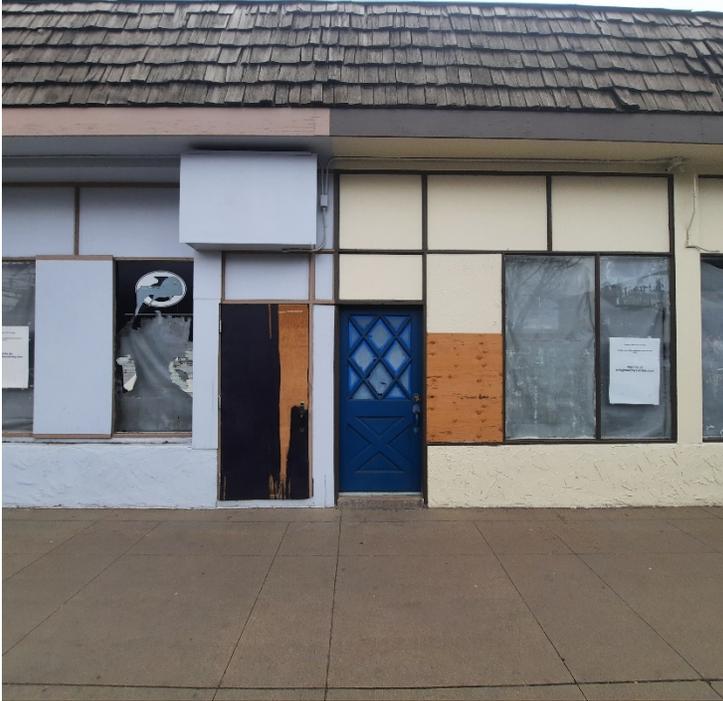
Main Street Storefronts – Existing Conditions

It is the intent of this proposal that the original brick building façade shall be revealed and restored. The primary means to do this would be to remove the Mansard roof and the faux stone covering the brick at the Main Street façade. At the Curtice Street façade this would be accomplished by providing transparency in the original openings that are currently infilled with solid materials and wood doors and removing the faux stone. The removal of the mansard roof that covers much of the original brick façade and the removal of the “planters” and faux stone applied on top of it will be essential to this endeavor. The mansard was added some time after the late 1950’s and is currently concealing the essential structure and true façade of the building. The mansard is in poor condition, as the trim is warped, the paint is peeling and it is constructed with wood shingles known for fire danger, over the property line in the ROW. Removal of these elements will expose the underlying original façade and return it to its original intended aesthetic. The original wood trimmed panels will be replaced with similar wood trim and cementitious siding. They will look like the original wood trimmed columns but are easier to maintain. The storefront shall be replaced in kind with modern aluminum storefront systems. The historic storefronts are not desirable or useable with modern energy codes and building codes.

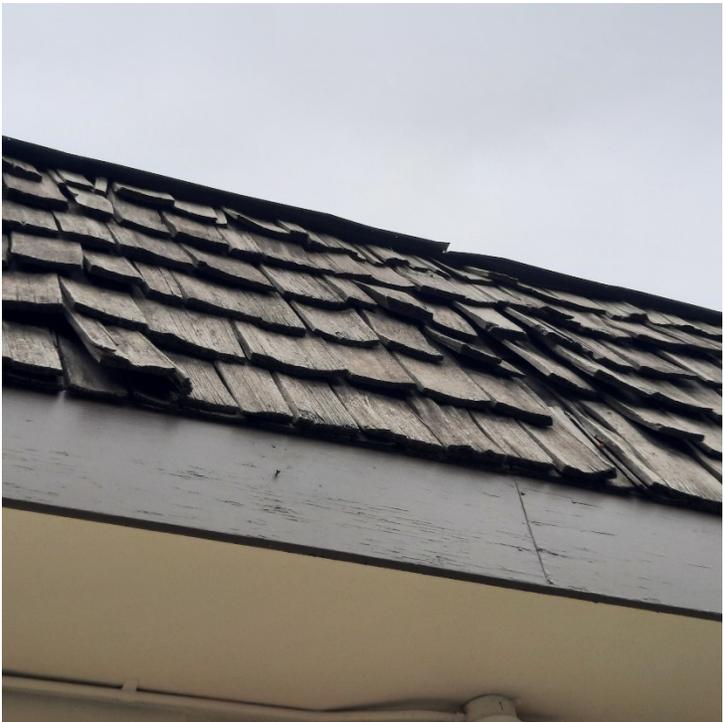
Main Street Mansard roofing – Existing Conditions

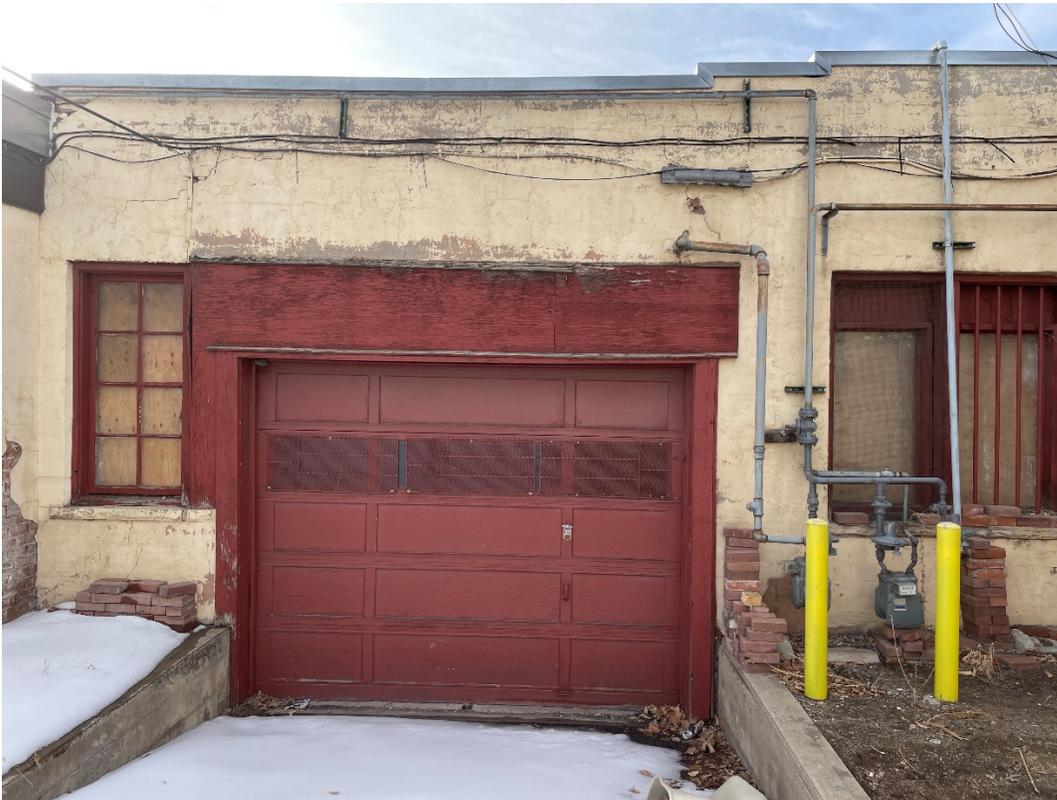
Courtyard Stucco and Existing Infilled Garage Door

This passage applies primarily to the condition of the existing stucco and masonry. The storefront system will be replaced by a new storefront system. The stucco applied at the courtyard is adhered directly to the brick, and its removal will damage the brick surface. The stucco has cracked in many locations and is currently letting water into the wall assembly with no means of escape. This creates a negative cycle of deterioration that the project scope would remediate. Per the comments under item 5 the Faux stone veneer is exacerbating the deterioration of the brick. To preserve the brick façade of the building we propose to repair/reapply stucco at the existing stucco areas, and to remove the stone veneer covering the brick. Some tuck pointing on the brick will be required, and then it shall be repainted. If the damage is too extensive the option B stucco façade would be used. The brick has previously been painted, and it shall be repainted or coated with stucco to preserve the finish.

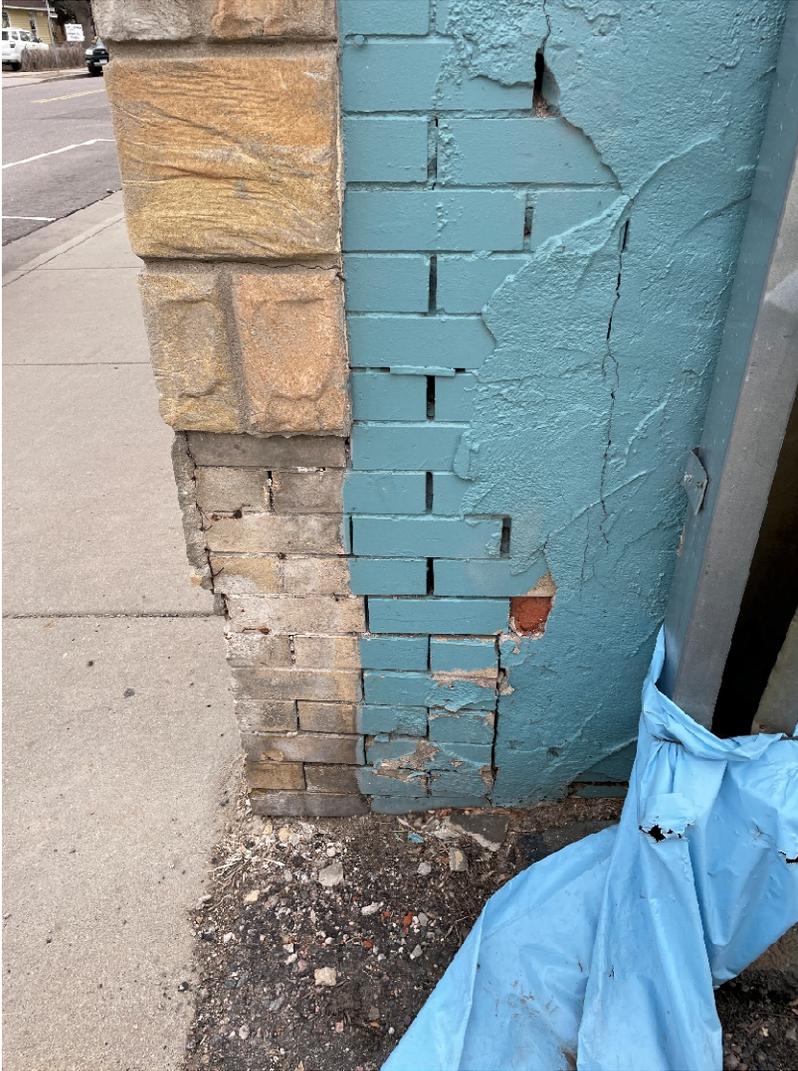
Curtice Faux Stone Veneer/Brick
