CITY FACILITIES INVENTORY AND CONDITION ASSESSMENT REPORT

Julie Rotter, Facilities Manager

Brent Soderlin, Director of Public Works & Utilities

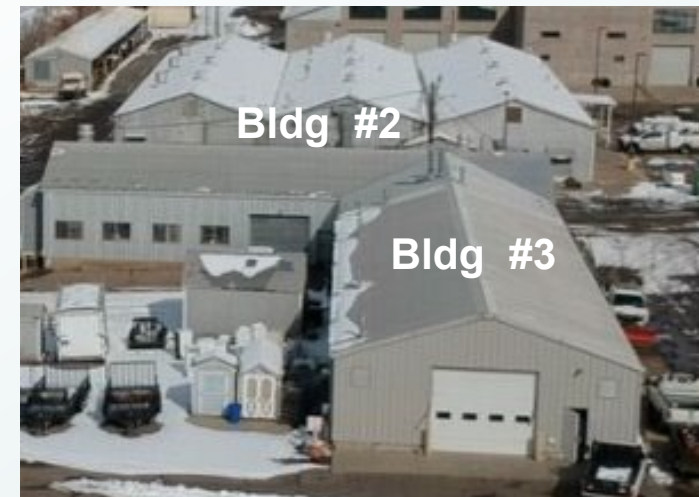
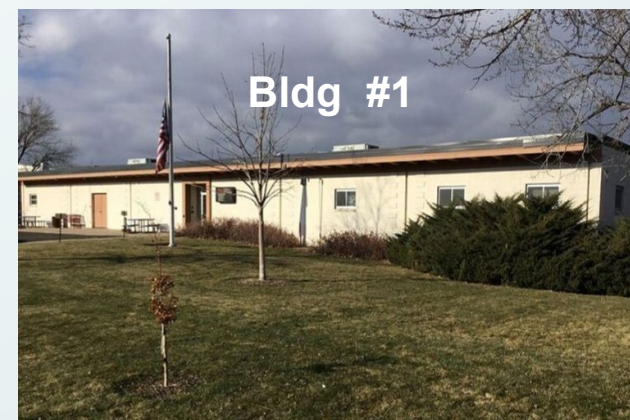
Bellevue Service Center Site – Buildings #2 and #3

- Size: 19,608 (#2) and 8,683 (#3) SF

- Replace with New Facilities – approx. 44,000 SF of new space is needed to replace 2 buildings and plan for future growth.
- An RFP to begin design is expected to launch Q4, 2025.
- This is an opportunity for COPs – the ROM estimates and benchmarking with other municipalities suggest \$40M will be required.
- Add Building-Admin #1 Evaluation to maximize occupancy, as temporary spaces will be needed during construction.

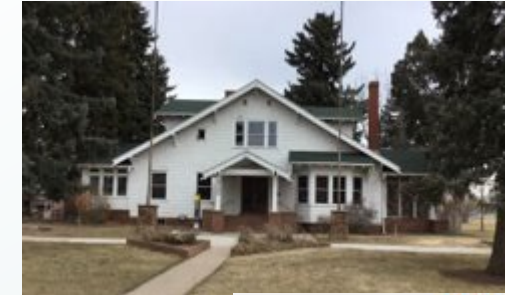
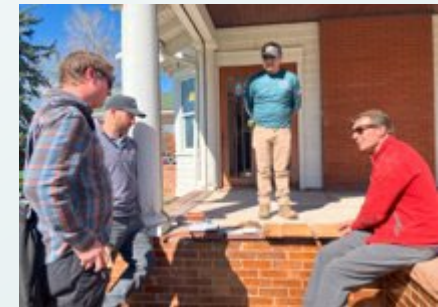
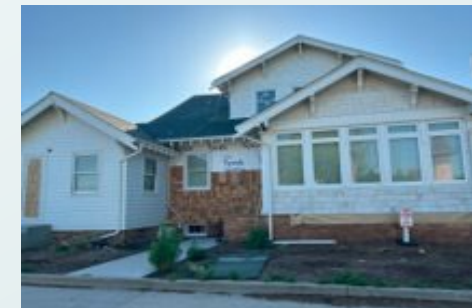
Geneva Lodge

- Size: 6,400 on 3.32 acres
- Historic Designation: Nationally Registered in 1999
- CIRSA Insurance Value (Building only): \$1,554,000
- In the Final Stages of Exterior Rehab Construction Work including:
 - 105 Window replacements
 - Masonry repairs
 - Site Grade repairs
 - Siding – Shingles
 - Architectural Exterior Details from era – Rafter Tails
- State Historic Grant Reimbursement will be received by end of 2025.
 - \$800,000 project with a \$250,000 State Grant Awarded

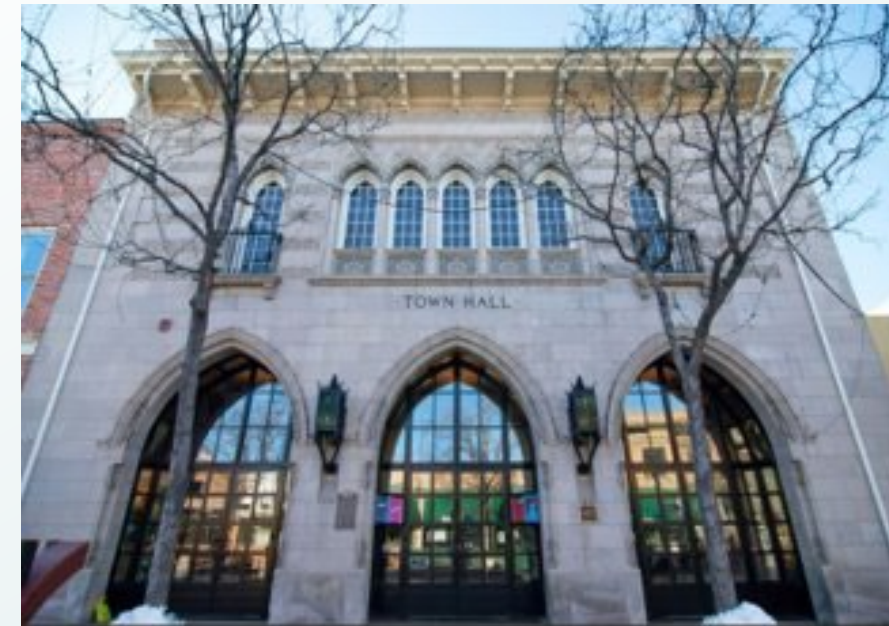
Town Hall Arts Center

- Size: 12,811 on .152 Acres
- CIRSA Insurance Value (Building only): \$4,244,730
- **Maintenance Backlog:** Identified a minimum of \$2M of end-of-life equipment in these categories:
 - HVAC
 - Interior Systems and Finishes
 - Electrical
 - Elevator
- Mechanical Modernizations are needed to support Workplace Comfort and Sustainability Initiatives
- **Modernization Estimates** from THAC Staff – Approximately \$10M to remodel and modernize including Finishes, Fixtures, Furnishings, Fire Life Safety, Security, Elevator, Technology, and accessibility solutions
- Recommendation - Support the efforts of THAC Organizations **Planned Remodel** at this site. COL Contribute to this future remodel.

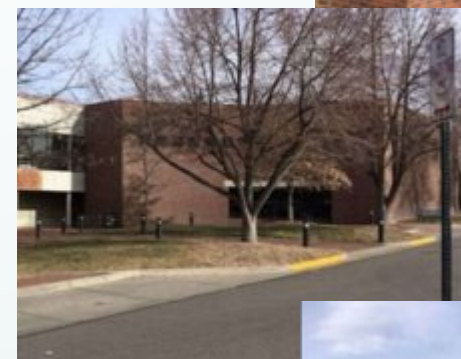
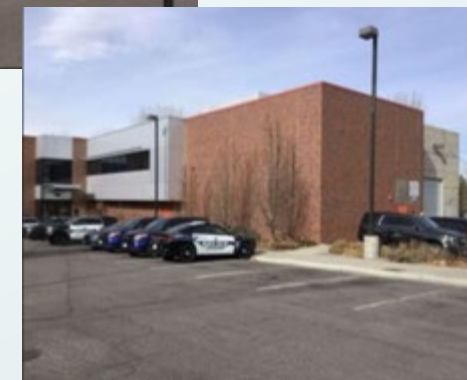
Littleton Center - including Fire Dept and Police Dept

- Size: 100,520 (15.25 Acres)
- CIRSA Insurance Value (Building only): \$33,584,940
- **Maintenance Backlog:** Identified a minimum of \$5-6M of end-of-life equipment in these categories:
 - HVAC
 - Electrical
 - Fire Life Safety
 - Elevator
- Mechanical Modernizations are needed to support Workplace Comfort and Sustainability Initiatives
- **Interior Modernization Estimates** – In addition, approximately \$200 per SF to modernize including Finishes, Fixtures, Furnishing, Technology, and accessibility solutions. This could total up to \$8-11M to update City area and Police Dept.
- Recommendation - Evaluate and Estimate **Renovating vs. Replacement** at this location.
- Adjacent Geneva Village property is under review.

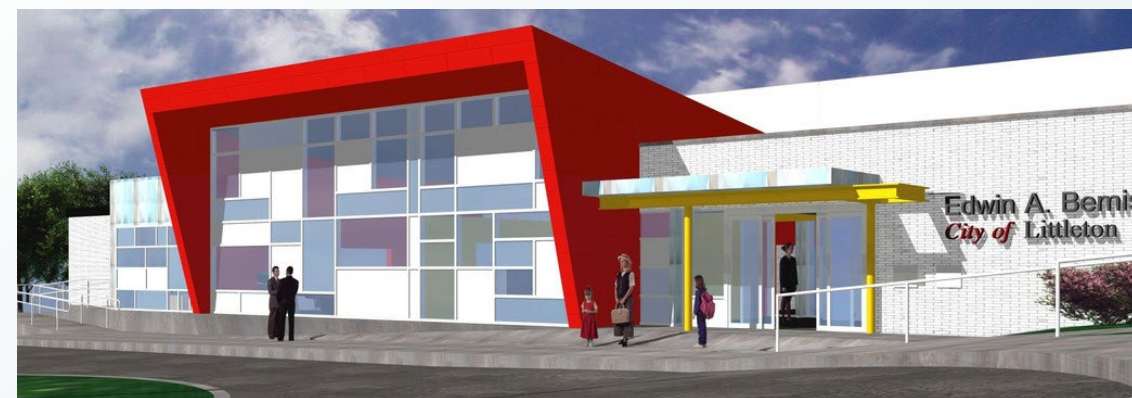
Bemis Public Library

- Size: 36,195 on 2.53 Acres
- CIRSA Insurance Value (Building only): \$9,378,075
- **Maintenance Backlog:** Identified a minimum of \$1.8M of end-of-life equipment (by 2030) in these categories:
 - HVAC
 - Interior Systems and Finishes
 - Electrical
 - Fire Life Safety
 - Conveyance
 - Egress and Accessibility
- Mechanical Modernizations are needed to support Workplace Comfort and Sustainability Initiatives
- Recommendation - Evaluate and Estimate **Renovating vs. Replacement** at this location.

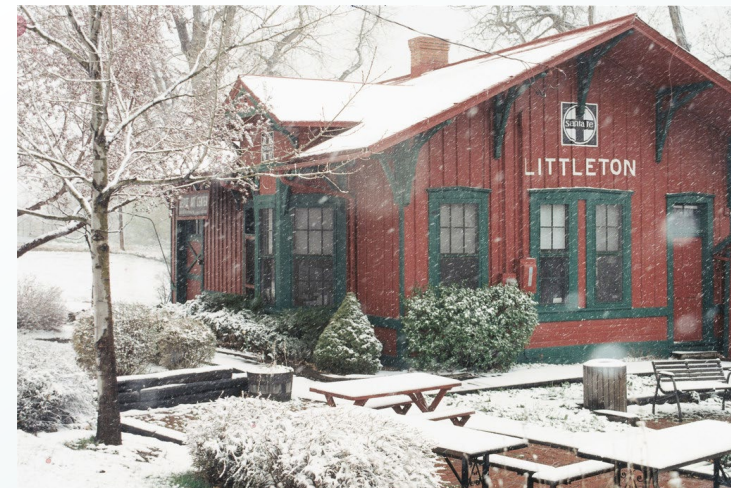
Art Depot and Caboose Site

Exterior Landscaping to improve the Safety and use of the outdoor spaces

Approximately \$100,000

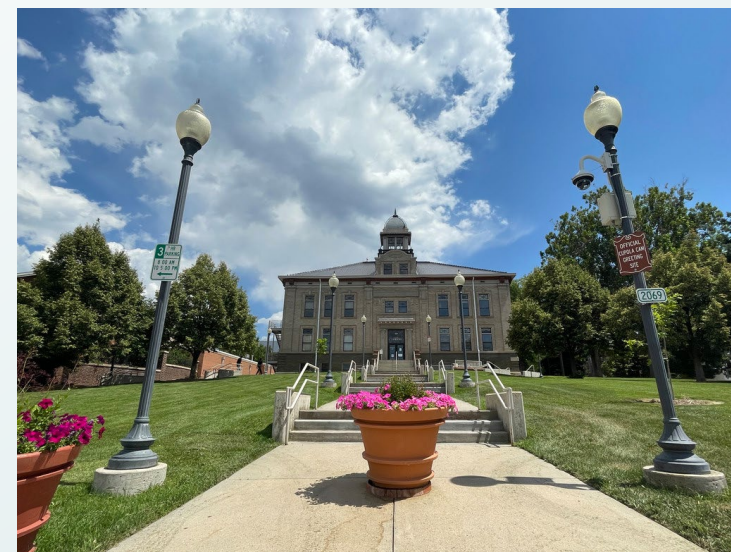
Courthouse

Exterior South Stairs – Rebuild “like for like”

Approximately \$750,000, RFP launch in 2026
