City of Littleton Survey Plan and Reconnaissance Survey Report

Pinyon Project No.:
124169901

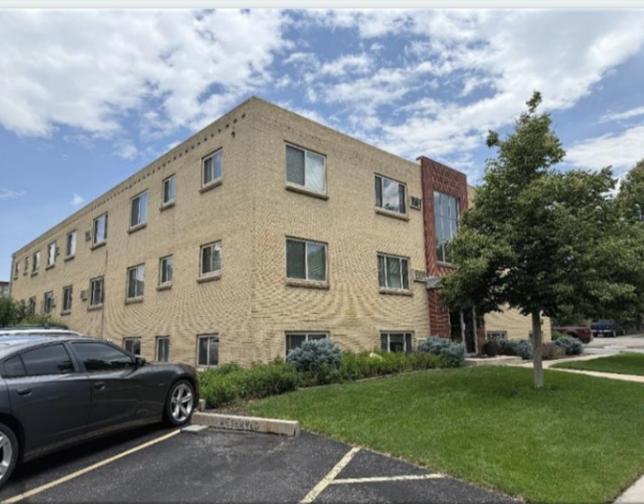
Broadmoor Plaza Apartments	1151 West Ida Avenue	1960	N/A	N/A	Not Eligible

By 1960, the Broadmoor Plaza Apartments at 1151 West Ida Avenue introduced a distinctly suburban interpretation of the walk-up apartment form. Its blonde brick veneer and geometric façade details evoke a restrained Art Deco influence while signaling a shift toward more decorative yet still functional design. Although altered over time, the building retains some of its characteristic materials and massing but is recommended as not eligible due to diminished integrity.

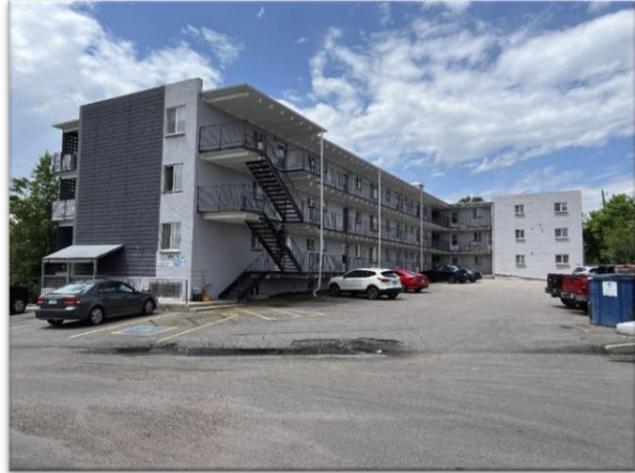
Property Name	Address	Date of Construction	Significance Criteria	Retains Integrity?	NRHP Eligibility Recommendation	Thumbnail Photograph
Broadmoor Village Apartments	137 West Broadmoor Drive	1962	N/A	N/A	Not Eligible

The early 1960s saw further experimentation in multi-family design with developments like the Broadmoor Village Apartments, completed in 1962 at 137 West Broadmoor Drive. The T-shaped, low-rise complex incorporated decorative concrete block and landscaped open spaces typical of the garden-style apartment trend that flourished across Colorado’s Front Range. While illustrative of this popular post-WWII form, Broadmoor Village has undergone substantial material replacement and is recommended as not eligible. Around the same time, the Royal Garden Apartments

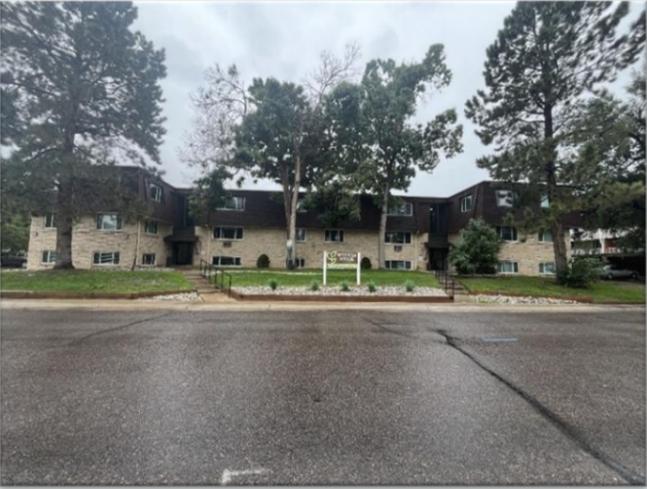
Property Name	Address	Date of Construction	Significance Criteria	Retains Integrity?	NRHP Eligibility Recommendation	Thumbnail Photograph
Weston Ridge North Apartments	1314 West Shepperd Avenue	1972	C	Y	Eligible

Other notable developments from this period include the Weston Ridge North Apartments at 1314 West Shepperd Avenue, constructed in 1972. This complex reflects the shift toward larger, garden-style suburban housing and retains excellent integrity. Weston Ridge North has been recommended as eligible under Criterion C for its well-preserved architectural character. Together, the Ocelot Apartments, Weston Ridge North Apartments, and Amity Plaza illustrate the culmination of nearly a century of multi-family development in Littleton—from early duplexes and modest postwar walk-ups to larger, purpose-built complexes that integrated design, amenities, and social function. These resources collectively document the City's ongoing adaptation to suburbanization, evolving architectural tastes, and changing housing needs in the latter half of the Twentieth Century.

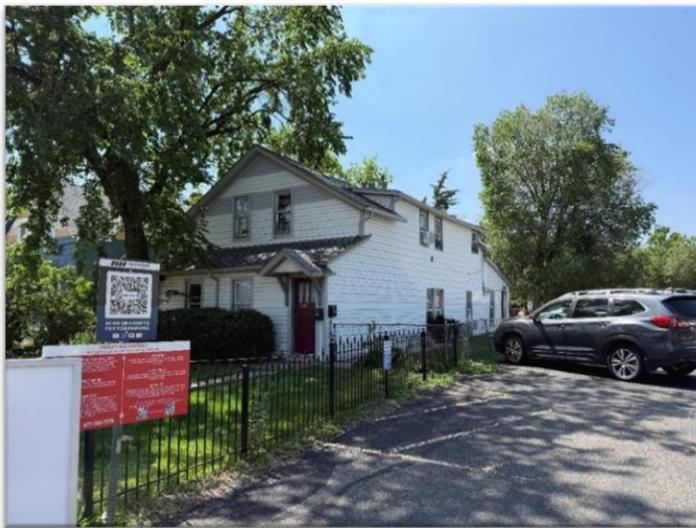
Photo 1: Cromley/White Residence

Littleton’s earliest examples of multi-family housing emerged at the turn of the Twentieth Century, reflecting both the town’s modest but growing population and the diversification of its housing stock during a period of civic and economic expansion. The Cromley/White Residence (2526 West Alamo Avenue, 5AH.179), constructed circa 1889, represents one of the community’s first known duplexes. Though the building has been altered over time and does not retain sufficient integrity for NRHP eligibility, its original form conveys the practical approach to dual-occupancy housing typical of the late-Nineteenth Century—simple, functional dwellings that accommodated

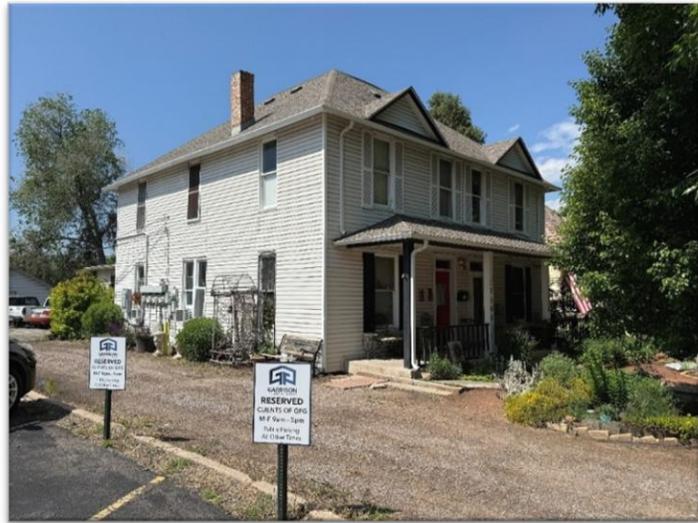
Photo 2: Caley/Broemmel Residence

By the early-Twentieth Century, the trend toward modestly scaled multi-family dwellings was further exemplified by the Caley/Broemmel Residence (2570–2574 West Alamo Avenue, 5AH.1180), built in 1903. This duplex, historically associated with prominent civic figures Franklin R. Caley and Casper Broemmel, illustrates how multi-unit housing could serve not only working residents but also members of the city’s professional and leadership class. Architecturally, it reflects early-Twentieth Century residential design through its hipped roof, overhanging eaves, and broad front porch, features typical of the transitional vernacular styles of the period. The property retains relatively good integrity and is recommended as eligible for listing under NRHP Criterion A for its association with the early development of multi-unit housing in Littleton.

12. **Condition (describe):** The Caley/Broemmel Residence is in good condition. At the time of its initial recording in 1997, Simmons and Simmons noted that the siding and balustrade were composed of replacement materials and that the shutters on the residence were not original. In the time since it was recorded in 1997, the siding was once again replaced, as was the roof. The primary entrance doors appear to be original aside from replacement hardware. The original windows remain extant on the residence and select windows have been fronted with storm window units. No additional alterations to the building are apparent since it was first recorded in 1997.

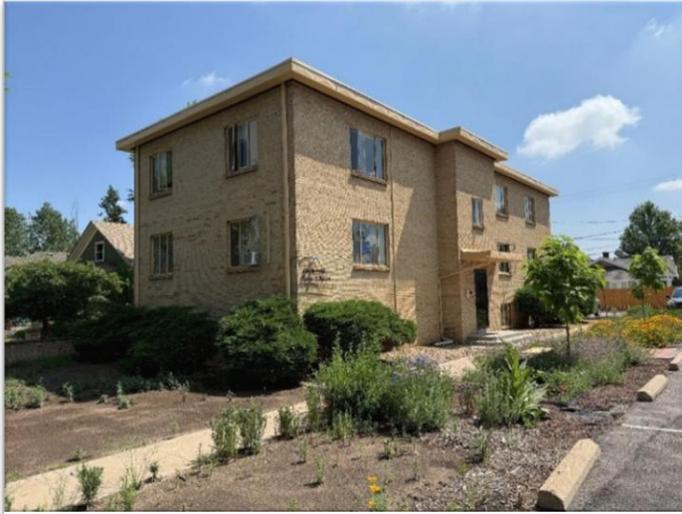
Photo 3: Nor-Mar Apartments

One of the earliest and most significant examples of this shift is the Nor-Mar Apartments at 5686 South Crocker Street, constructed in 1956. Built by former mayor Norman H. Granes, Nor-Mar was Littleton's first true apartment building and remains emblematic of mid-Twentieth Century, post-WWII design. Its flat roof, steel casement windows, and minimal ornamentation exemplify the Modern or International Style that came to define much of the City's post-WWII architecture. The building retains a high degree of integrity and has been recommended as eligible for listing under NRHP Criterion A for its association with Littleton's post-WWII

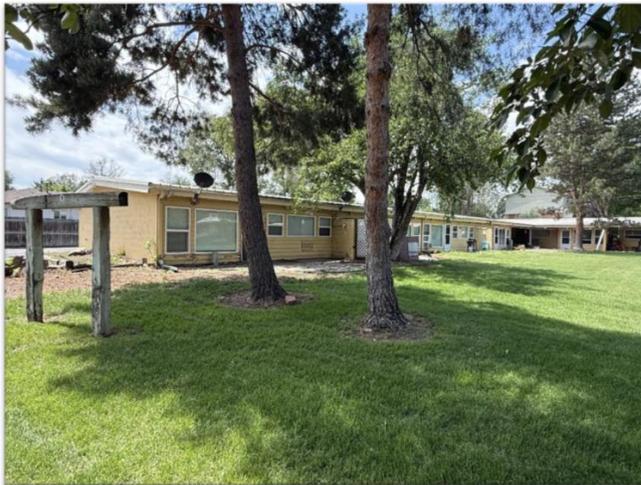
Photo 7: Parkway Apartments

A particularly notable addition during this period was the Parkway Apartments, designed in 1962 by prominent Colorado Modernist architect Eugene Sternberg, whose work across Littleton—including Geneva Village, the Bemis Public Library, and portions of Arapahoe Community College—helped define the community’s mid-century architectural character. The Parkway Apartments introduced modest level of architectural refinement to Littleton’s emerging suburban apartment landscape, pairing Sternberg’s characteristic attention to site design and landscaping intended to promote community.

The complex retains strong integrity and is recommended as eligible for listing under Criterion C for its association with Eugene D. Sternberg.

Parkway Apartments	6061-6095 South Sterne Parkway	1963	C	Y	Eligible

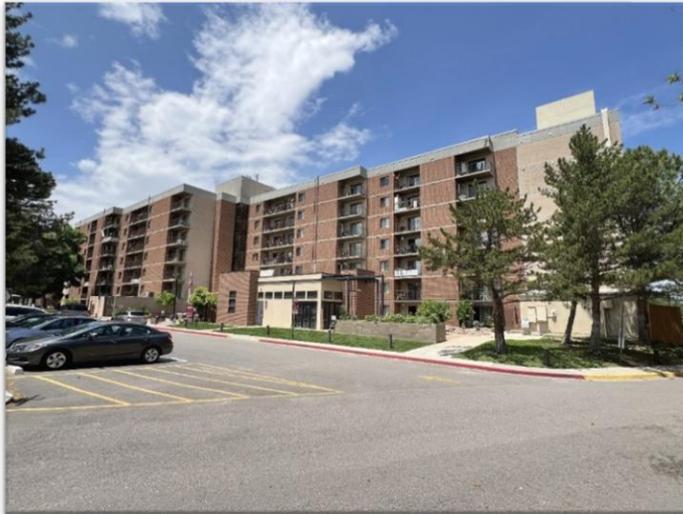
Photo 9: Amity Plaza

The period's emphasis on accessible and specialized housing options is further illustrated by the construction of Amity Plaza at 200 West Sterne Parkway in 1978. Developed as a seven-story senior living facility financed through the Colorado Housing Finance Authority (CHFA), Amity Plaza represents both a physical and social evolution in Littleton's residential landscape. Its vertical form, concrete construction, and programmatic focus on senior residents demonstrate the City's engagement with state-supported housing initiatives and its recognition of changing demographic and social needs. Although it remains an important marker of late-Twentieth Century housing diversification, Amity

Plaza has undergone interior and exterior modifications and the surrounding setting has been heavily developed and is therefore recommended as not eligible.

Property Name	Address	Date of Construction	Significance Criteria	Retains Integrity?	NRHP Eligibility Recommendation	Thumbnail Photograph
Amity Plaza	200 West Sterne Parkway	1978	N/A	N/A	Not Eligible

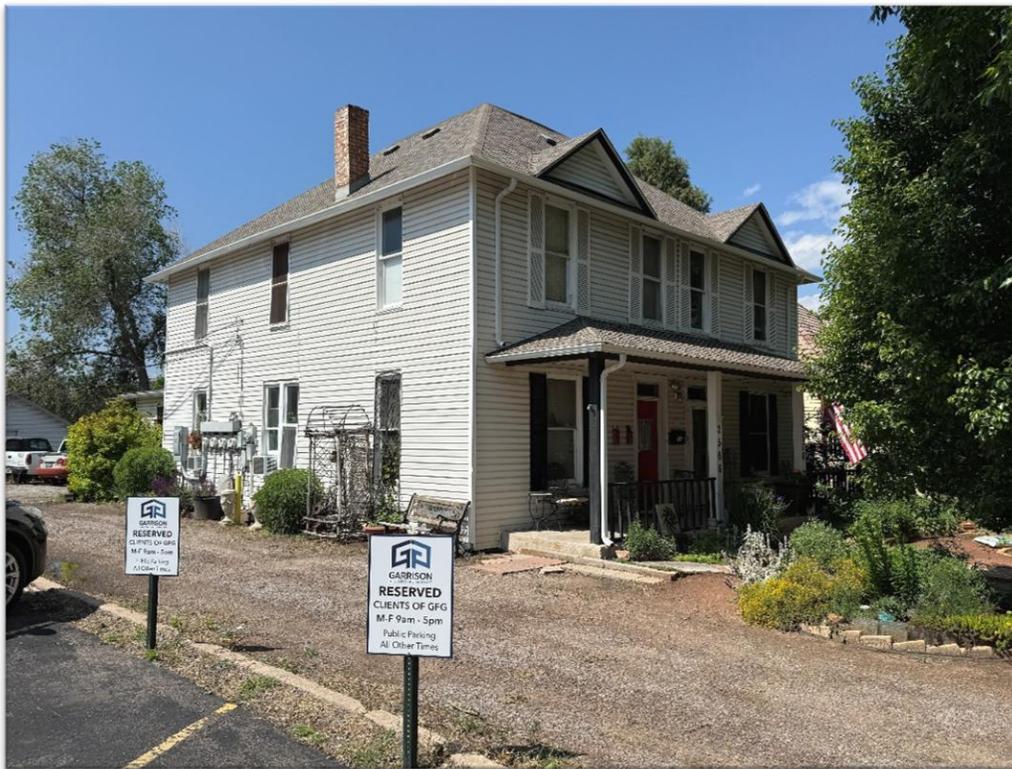
Photo Number: 5AH.1180_1

Description: The east and primary (north) elevations of the Caley/Broemmel Residence. Note the wood window units as well as the non-original shutters.

View: Southwest

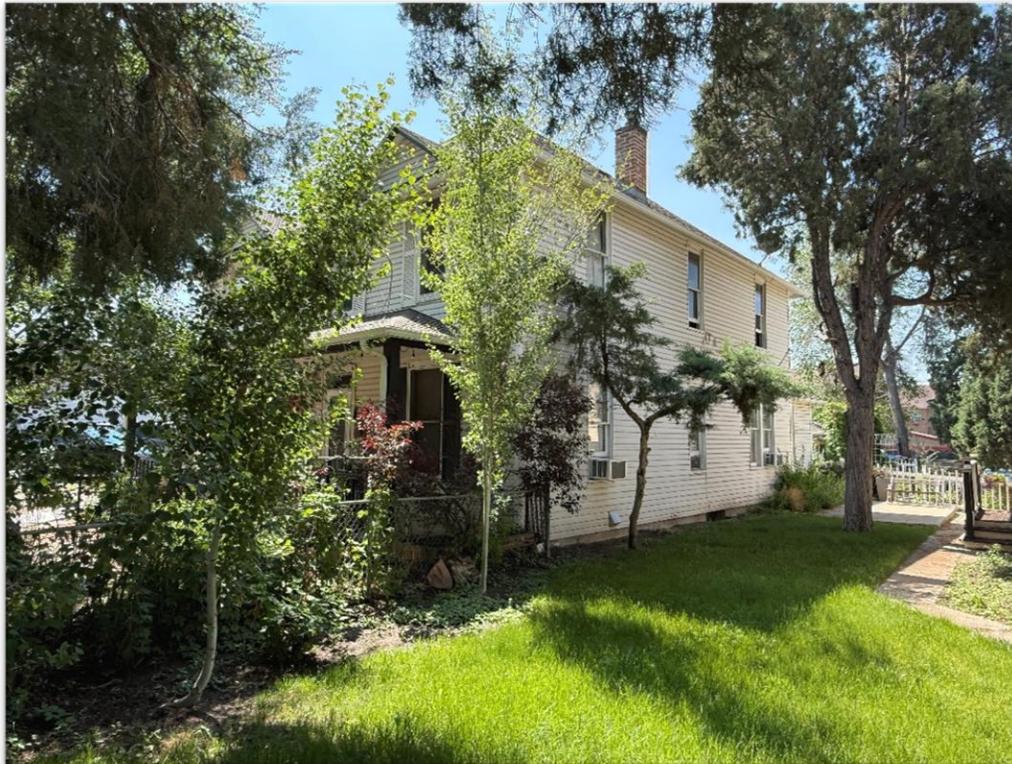
Photo Number: 5AH.1180_2

Description: Partial views of the primary (north) and west elevations of the Caley/Broemmel Residence.

View: Southeast

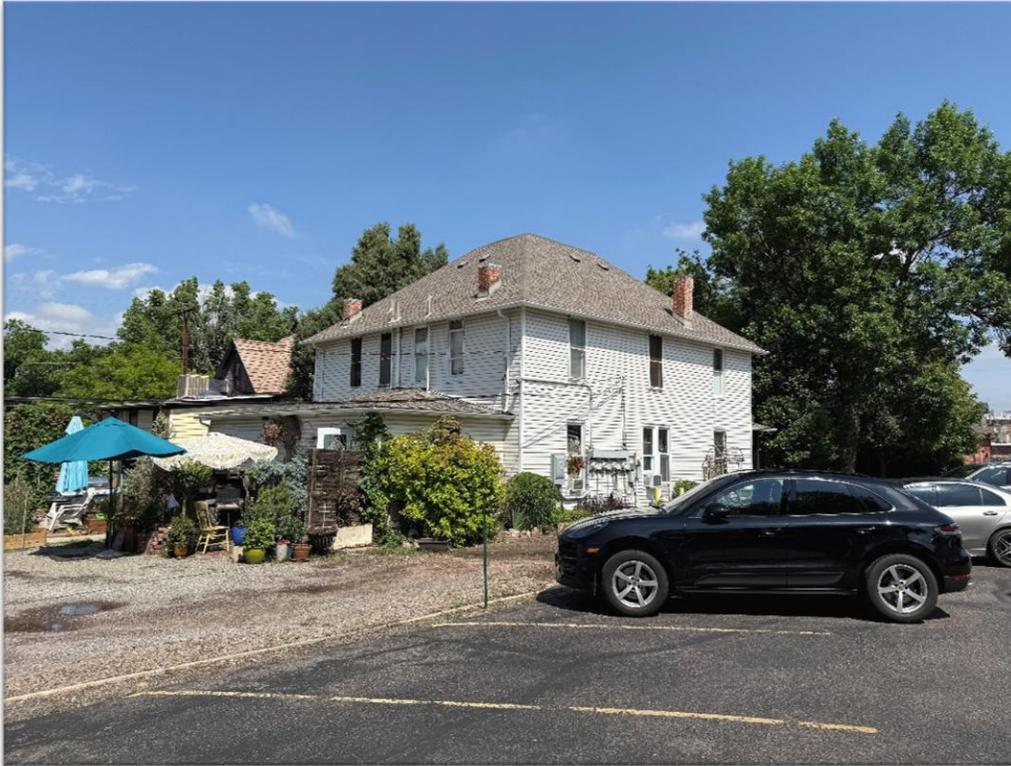
Photo Number: 5AH.1180_3

Description: The south and east elevations of the Caley/Broemmel Residence.

View: Northwest

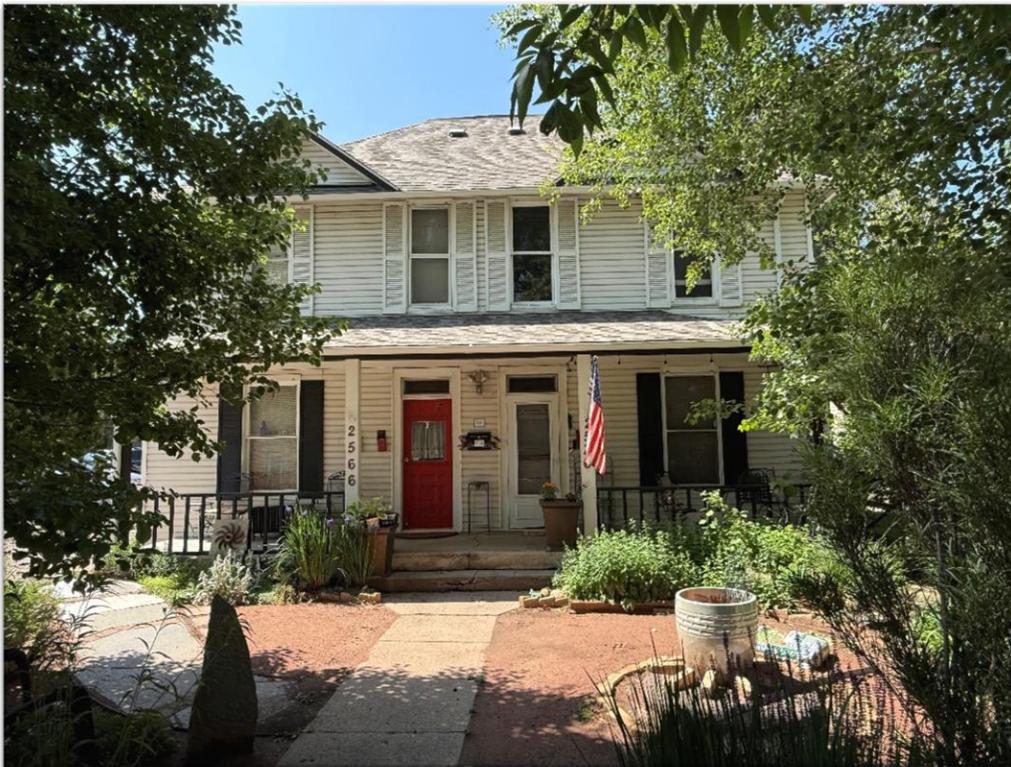
Photo Number: 5AH.1180_4

Description: The primary (north) elevation of the Caley/Broemmel Residence.

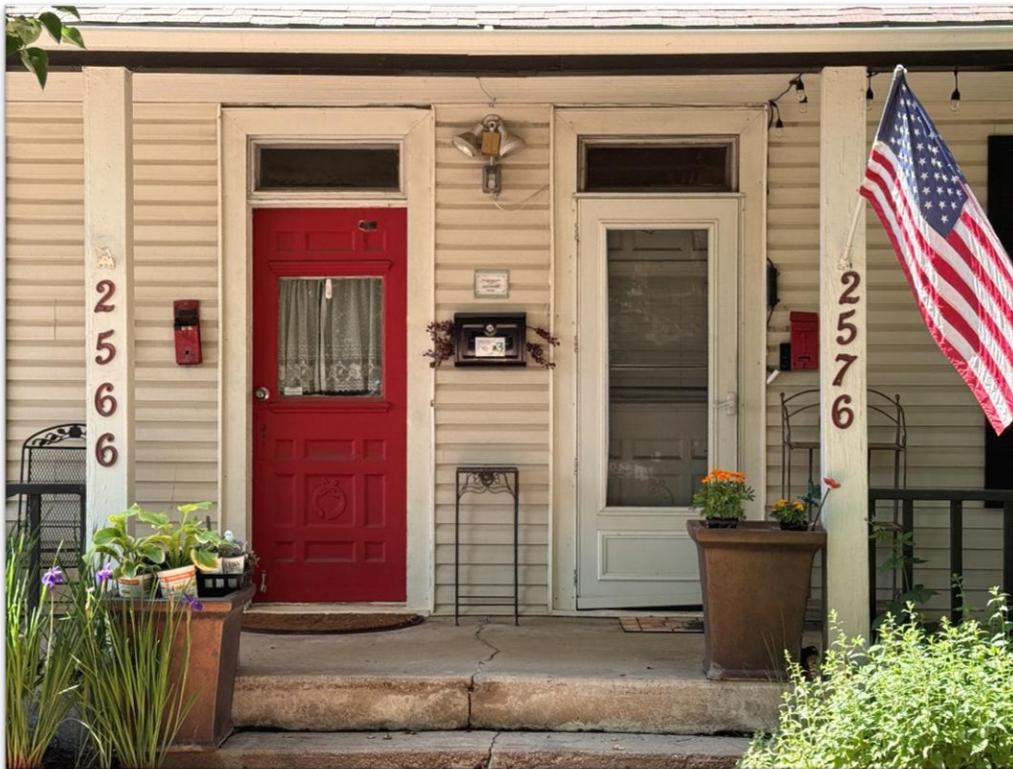
Photo Number: 5AH.1180_5

Description: Detail view of the primary entrances on the north elevation of the Caley/Broemmel Residence. Note that although the hardware has been replaced and a storm door has been added to the western unit, the doors appear to be original and match each other.

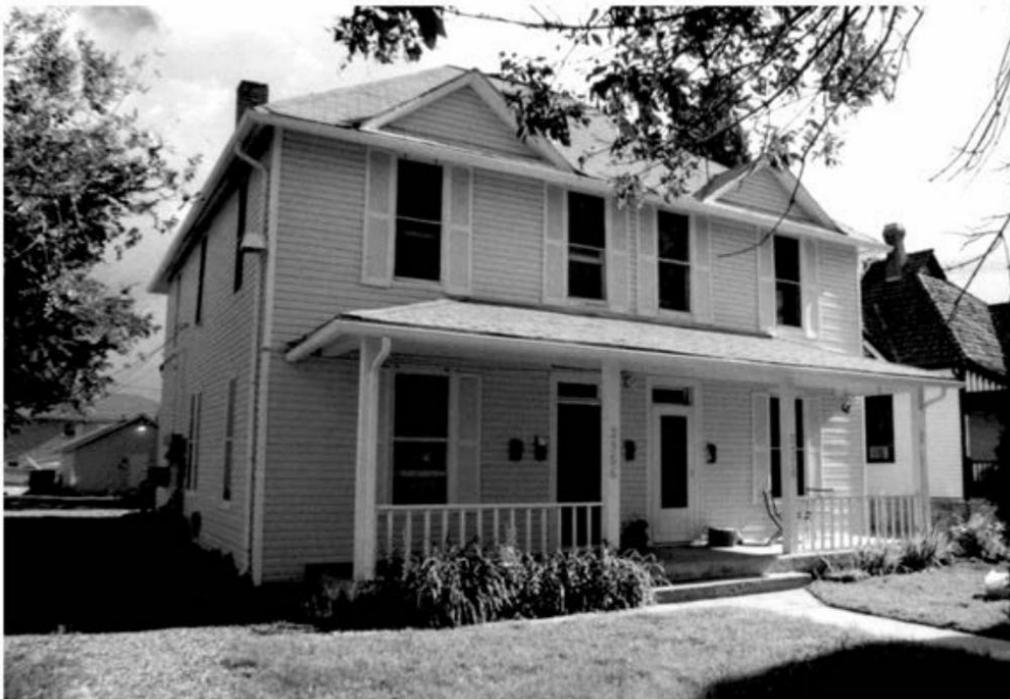
Reference Photo 1

Description: A 1997 photograph of the Caley/Broemmel Residence from the site form completed by Simmons and Simmons of Front Range Research Associates.

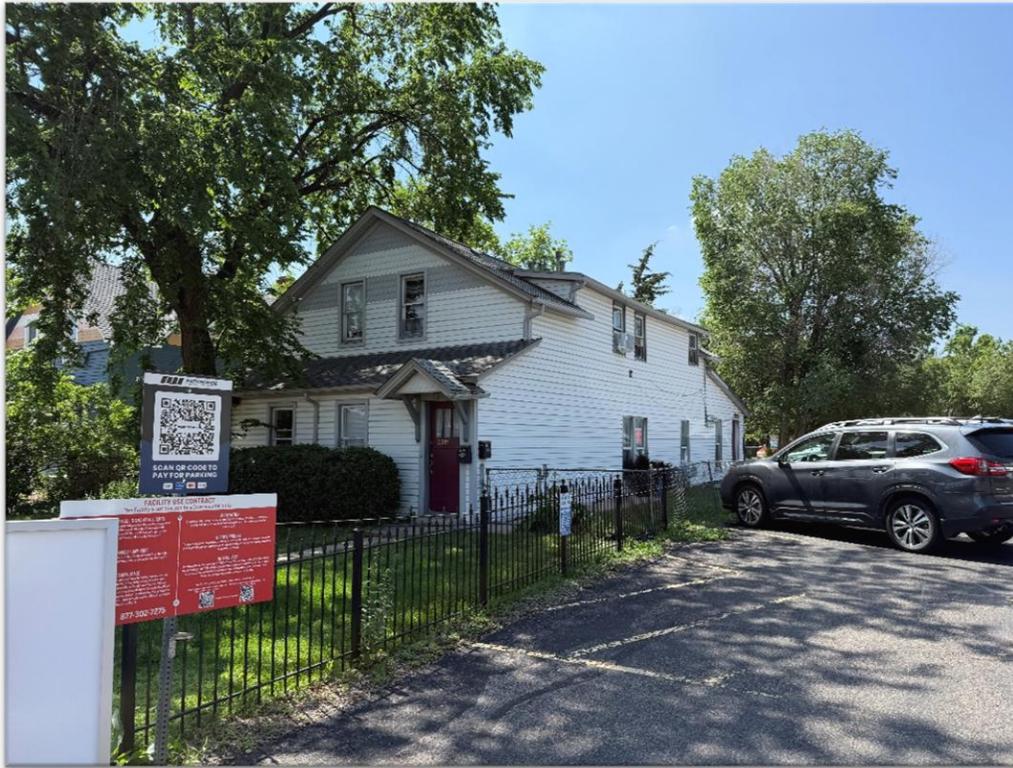
Photo Number: 5AH.179_1

Description: The primary (north) and west elevations of the Cromley/White Residence. Note the replacement windows, doors, and siding.

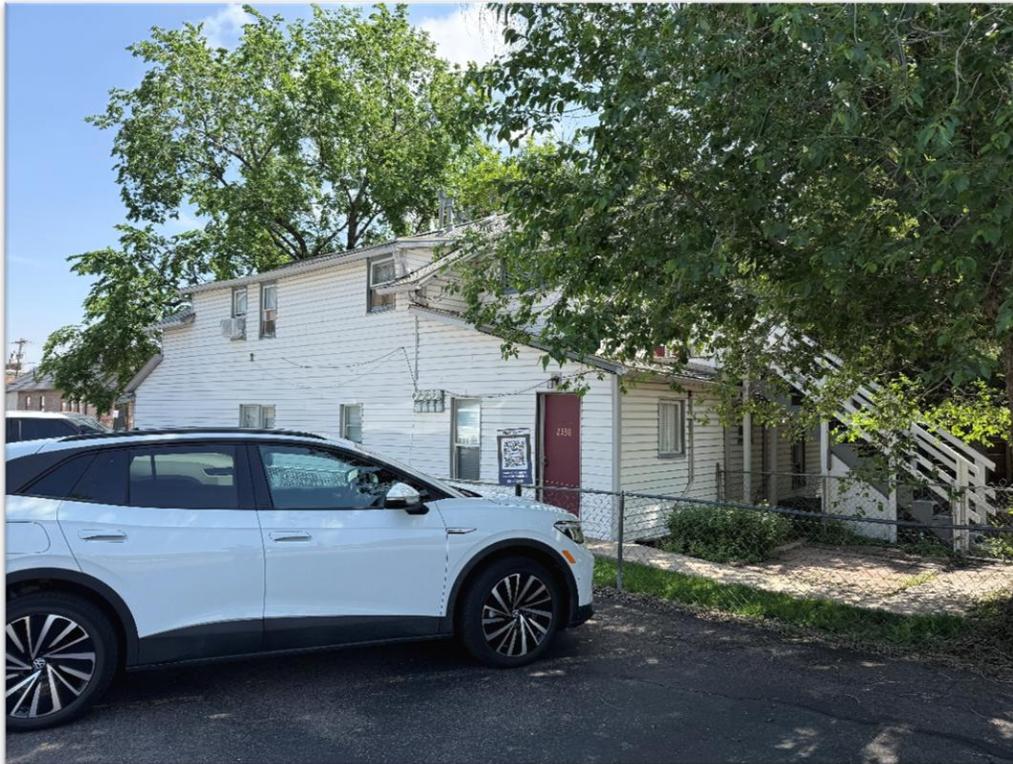
Photo Number: 5AH.179_2

Description: The west elevation and partial view of the south elevation of the Cromley/White Residence. Note the additional residential unit entryways indicating that the building has been converted from a duplex into a four-unit residential building.

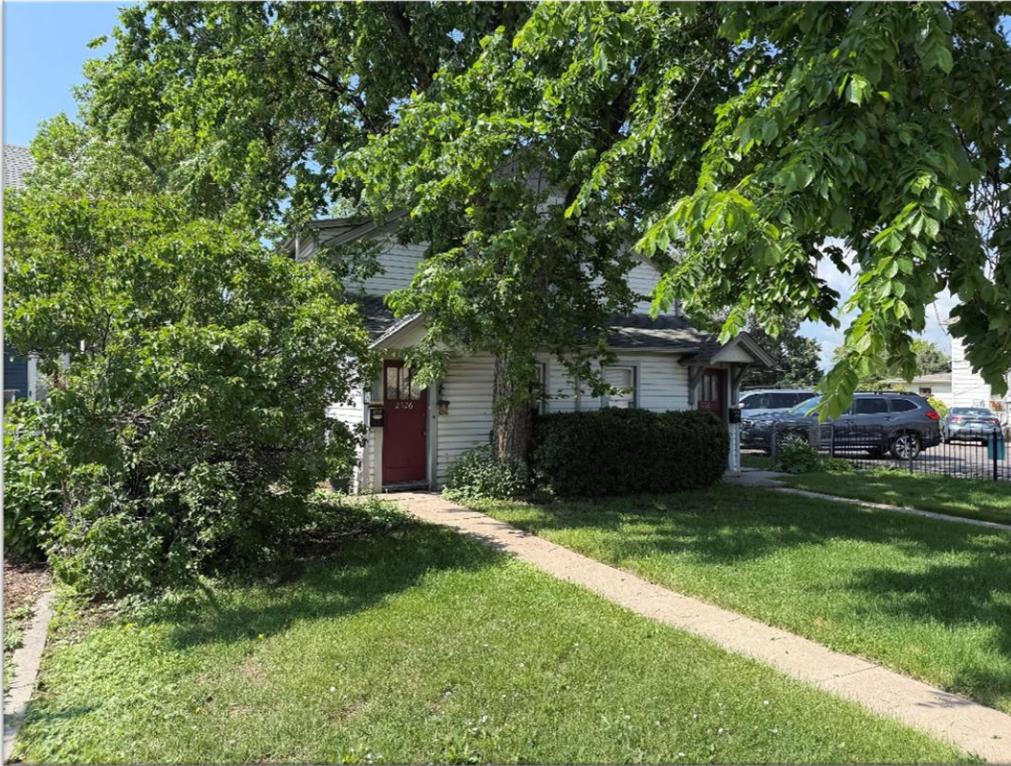
Photo Number: 5AH.179_3

Description: Partial view of the primary (north) elevation of the Cromley/White Residence.

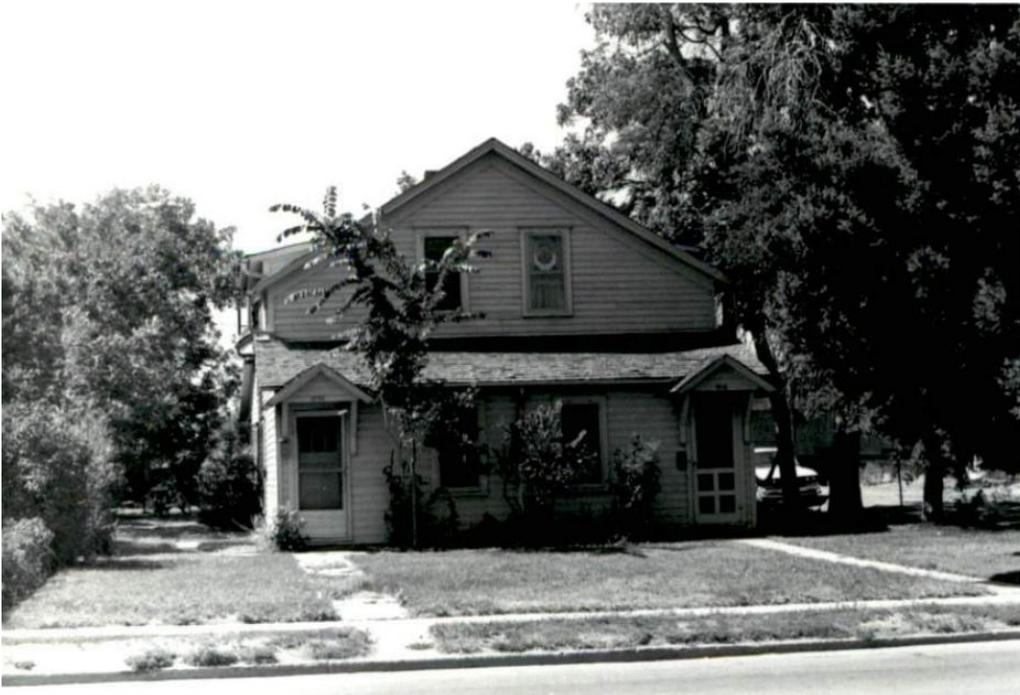
Reference Photo 1

Description: A 1982 photograph of the residence from the site form prepared by Sally Pearce. Note that the siding present in the photo has since been replaced, as have the doors, windows, and roofing materials.

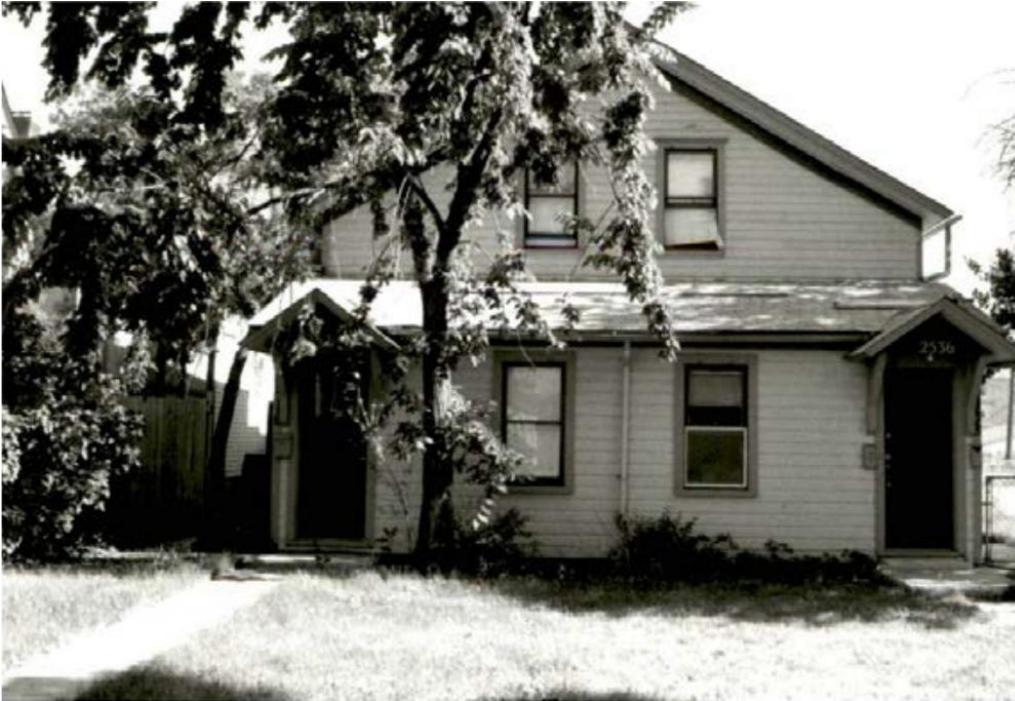
Reference Photo 2

Description: A 1997 photograph of the residence from the site form prepared by Simmons and Simmons. Note the replacement windows, doors, and siding.

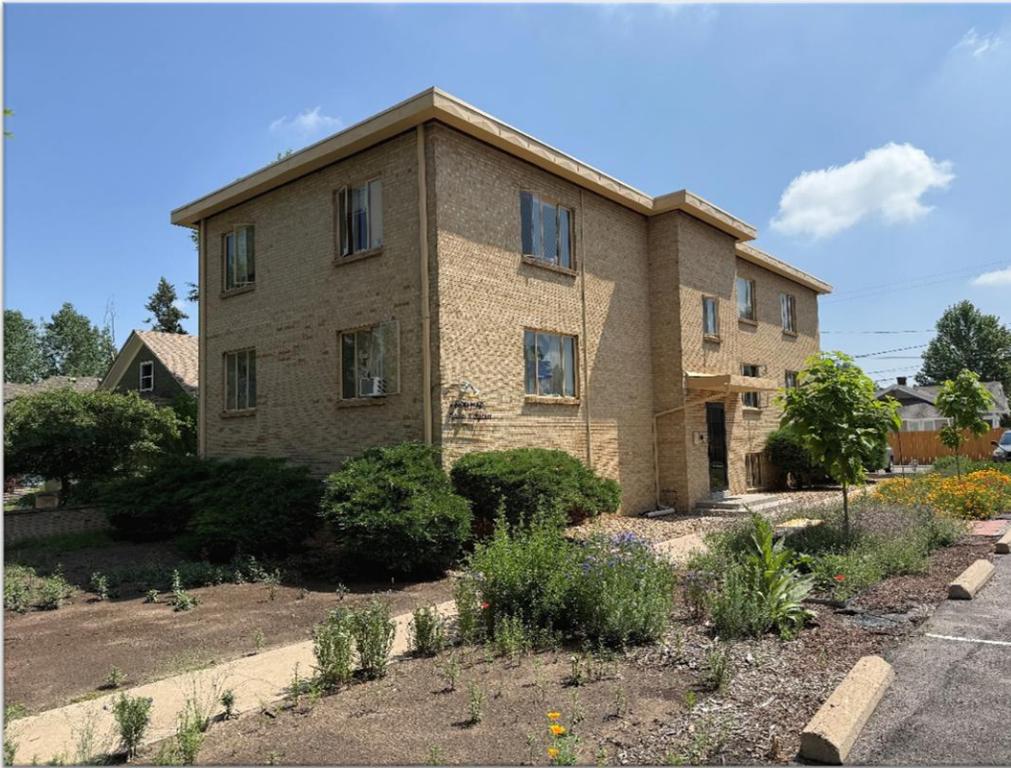
Photo Number: 5AH.1776_1

Description: The west and primary (south) elevations of the Nor-Mar Apartments.

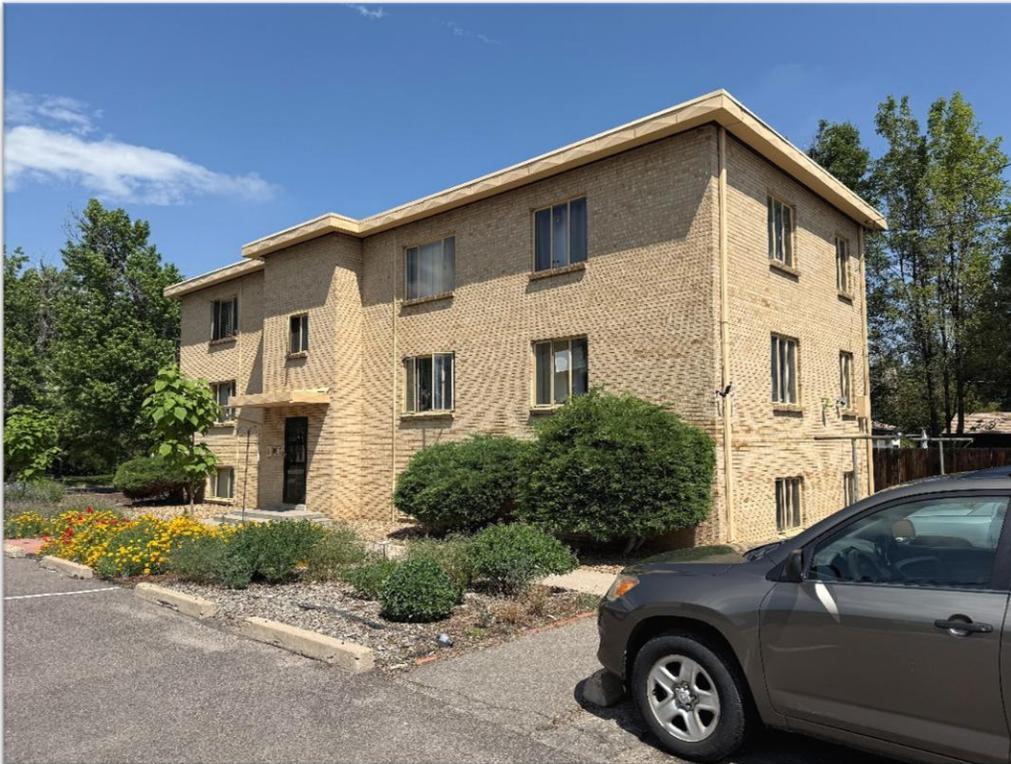
Photo Number: 5AH.1776_2

Description: The primary (south) and east elevations of the Nor-Mar Apartments.

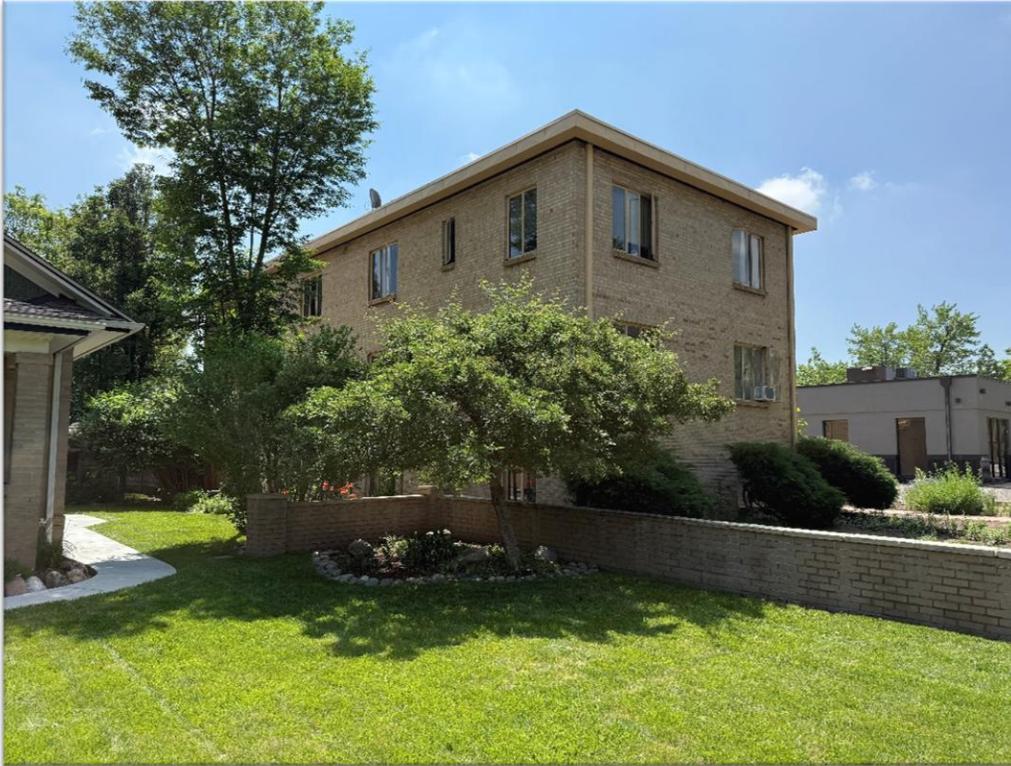
Photo Number: 5AH.1776_3

Description: Partial views of the north and west elevations of the Nor-Mar Apartments.

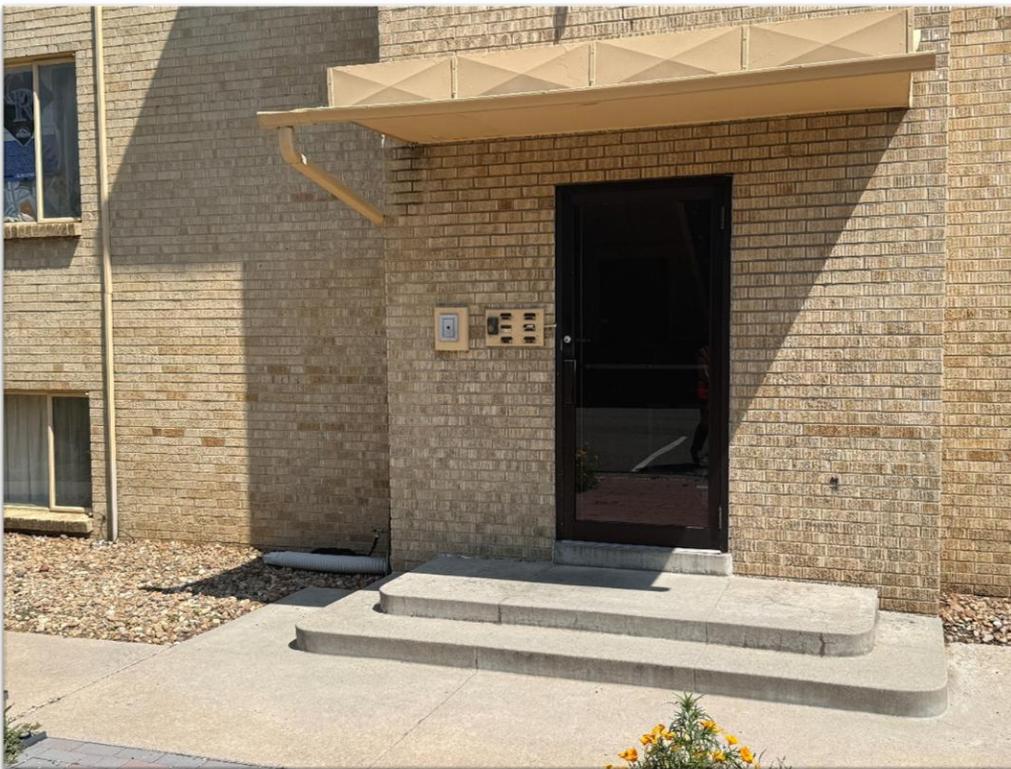
Photo Number: 5AH.1776_4

Description: Detail view of the primary entrance to the Nor-Mar Apartments. Note the replacement entry door as well as the partially visible replacement windows on the left side of the image.

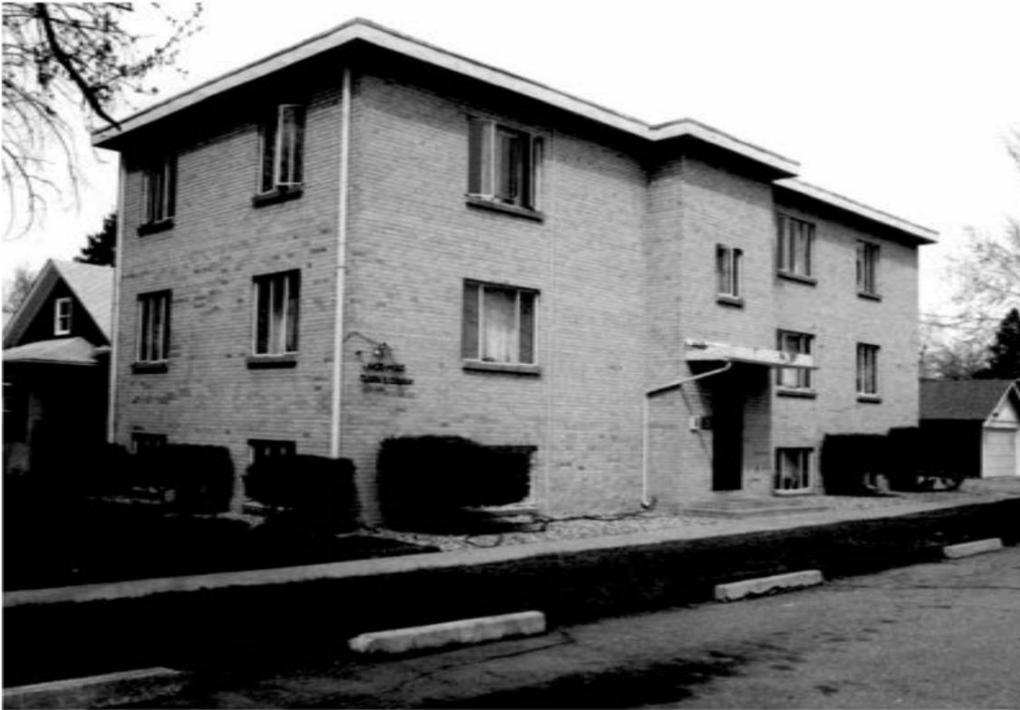
Reference Photo 1

Description: A 2001 photograph of the Nor-Mar Apartments from the site form completed by Simmons and Simmons of Front Range Research Associates, Inc.

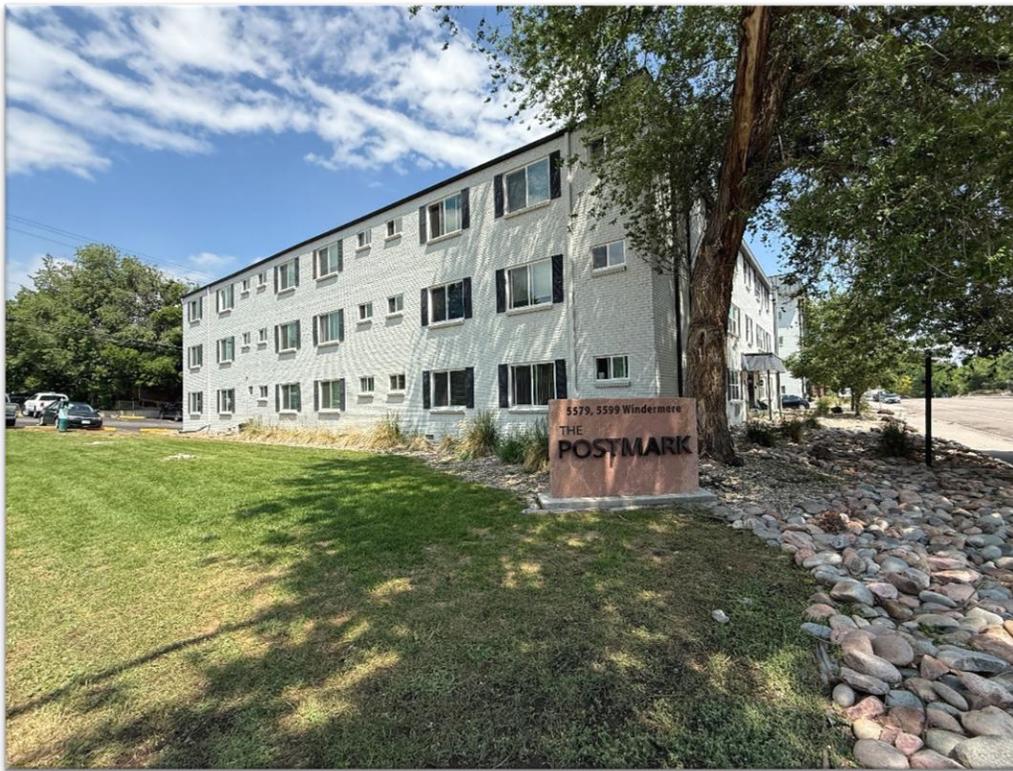
Photo Number: 5AH.2175_1

Description: View of the south and primary (east) elevations of the Ocelot Apartments. The photograph was taken at the northwest corner of the South Windermere Street and West Powers Avenue intersection.

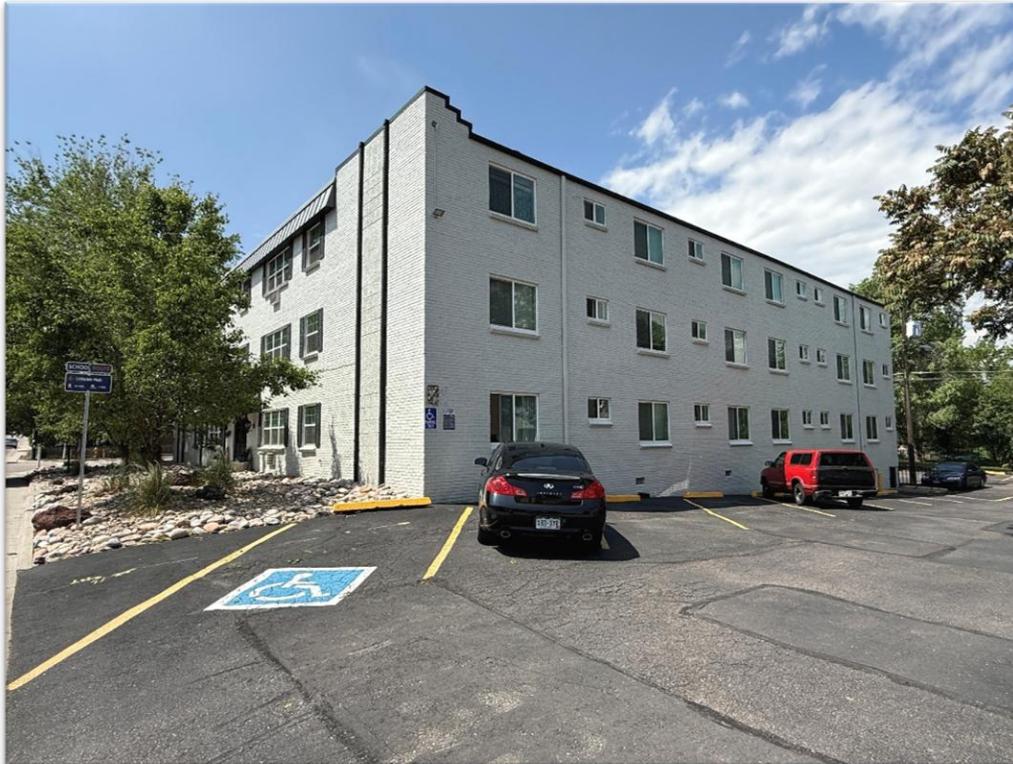
Photo Number: 5AH.2175_2

Description: View of the primary (east) and north elevations of the Ocelot Apartments.

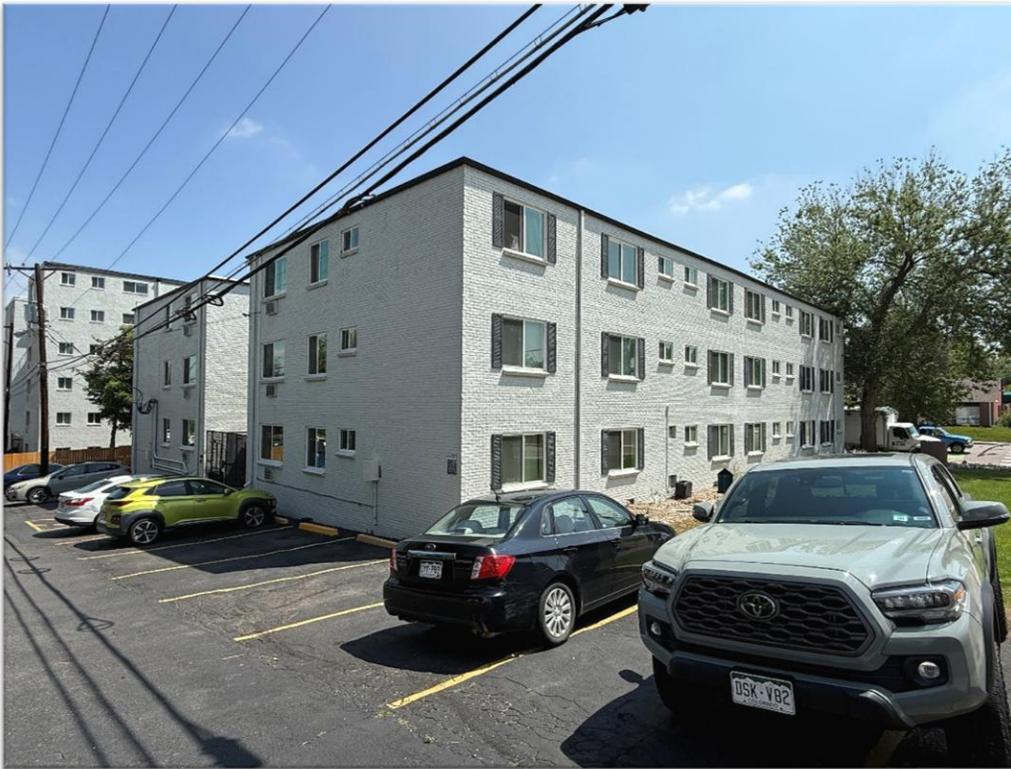
Reference Photo 1

Description: A 2001 photograph of the Ocelot Apartments from the site form completed by Simmons and Simmons of Front Range Research Associates, Inc.

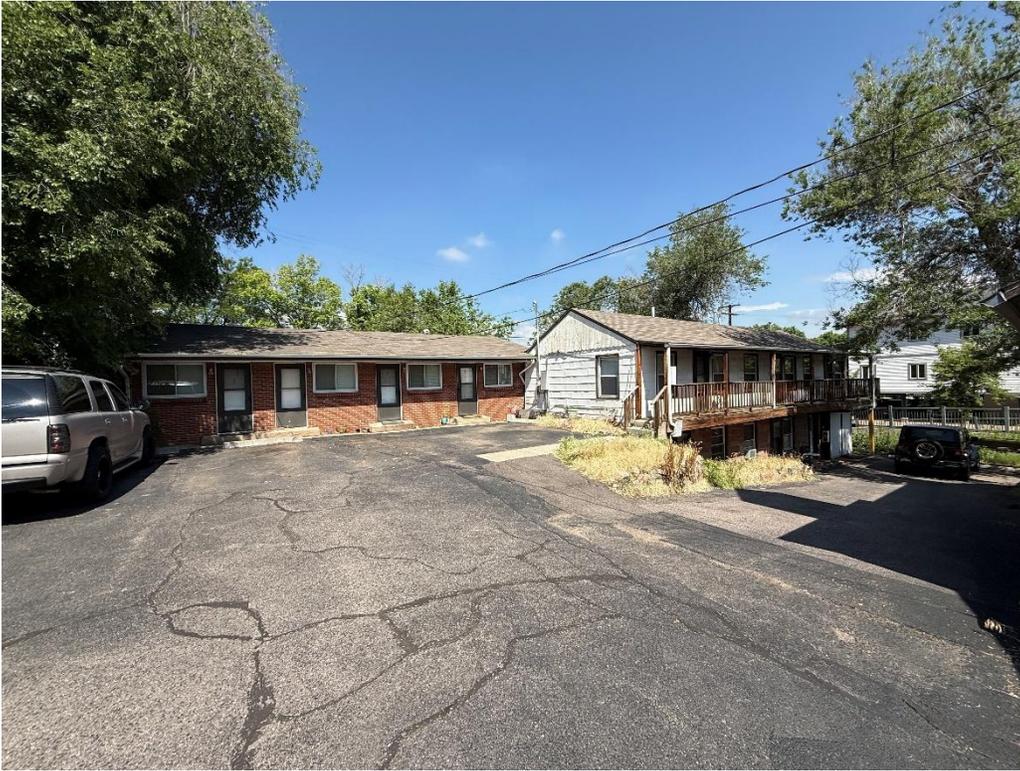
Photo Number: 5AH.1382_1

Description: Context view of the primary (east) elevation of the Rapp Street Apartments.

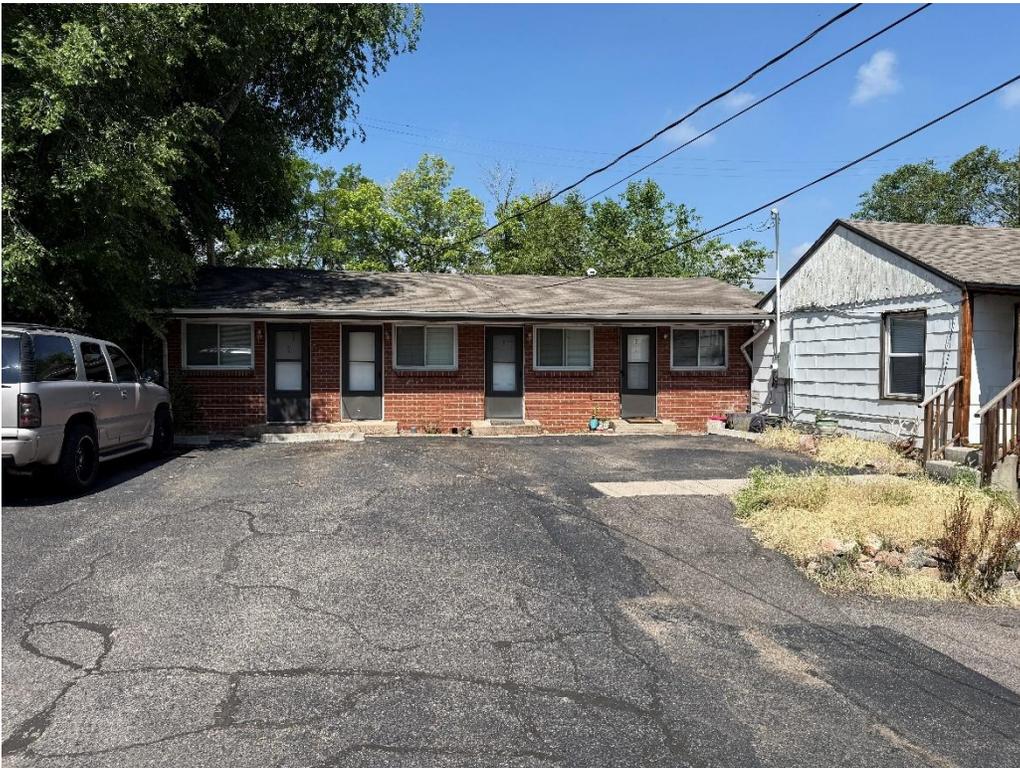
Photo Number: 5AH.1382_2

Description: Looking at the left side of the primary (east) elevation. Note the one-by-one sliding windows that replaced the tripartite casement windows noted in 1997.

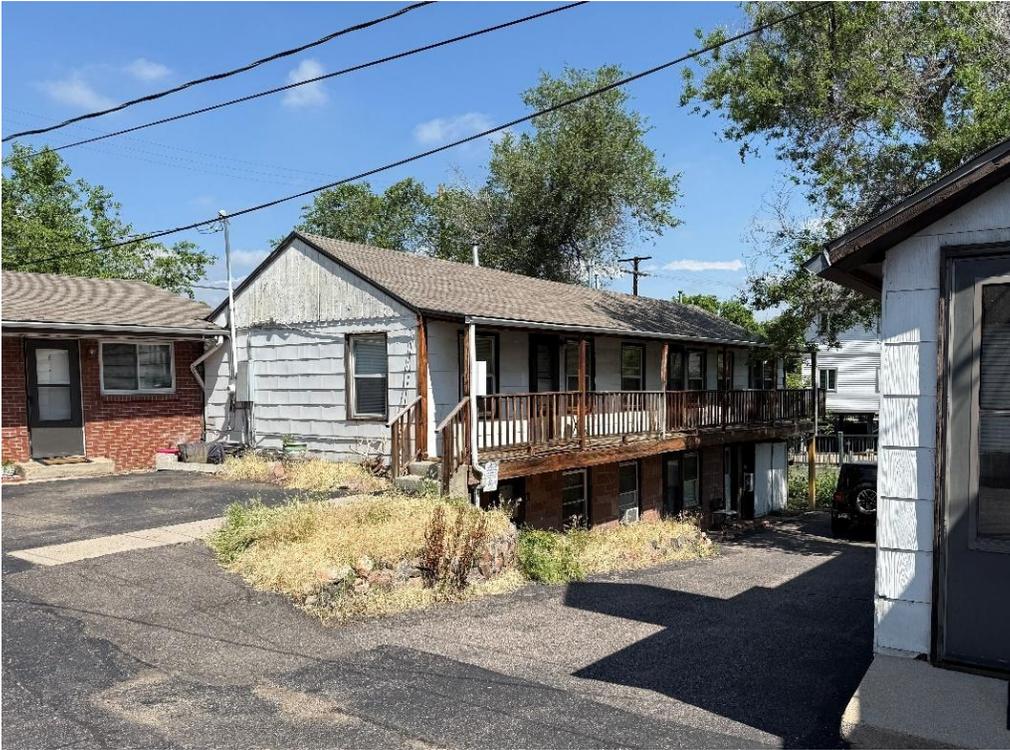
Photo Number: 5AH.1382_3

Description: Looking at the right side of the primary (east) elevation.
