City of Littleton Survey Plan and Reconnaissance Survey Report

Pinyon Project No.:
124169901

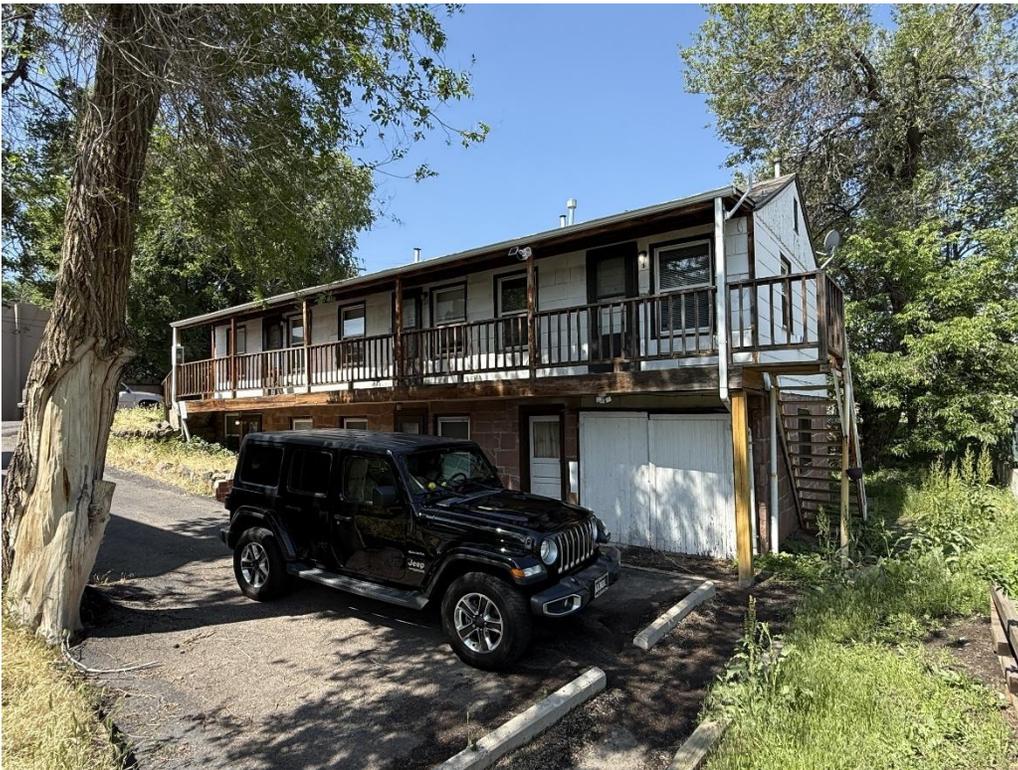
Photo Number: 5AH.1382_4

Description: View of the right side of the primary (east) and north elevations of the Rapp Street Apartments.

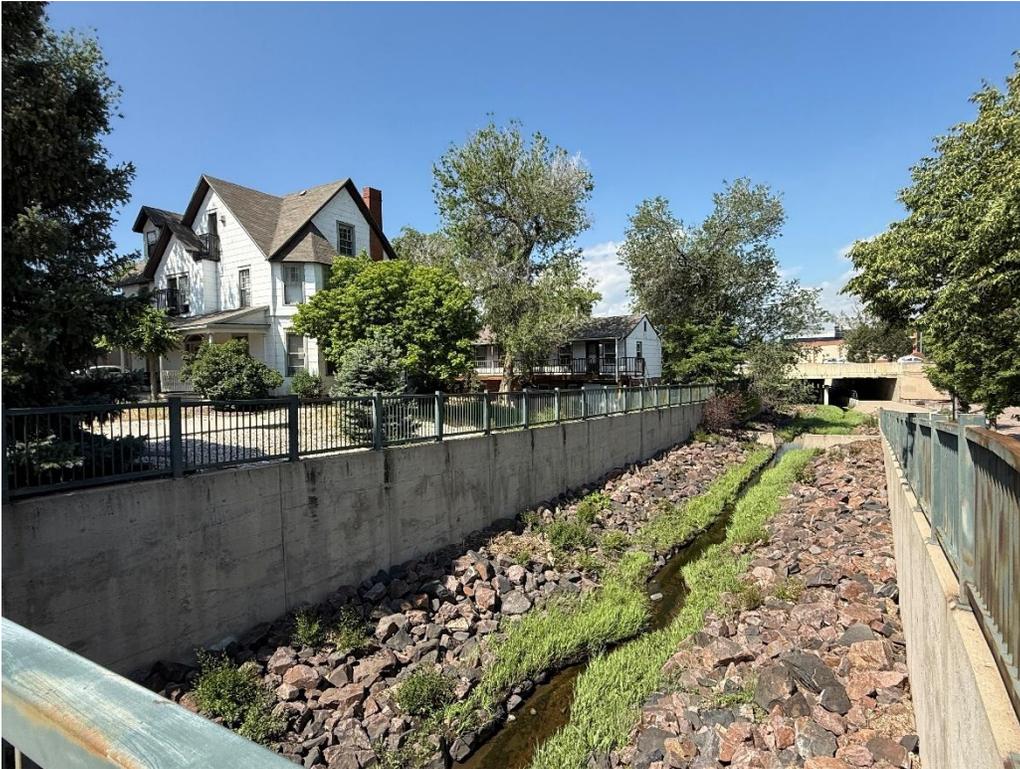
Photo Number: 5AH.1382_5

Description: Context view of the Rapp Street Apartments from the South Rapp Street bridge crossing over Little Creek.

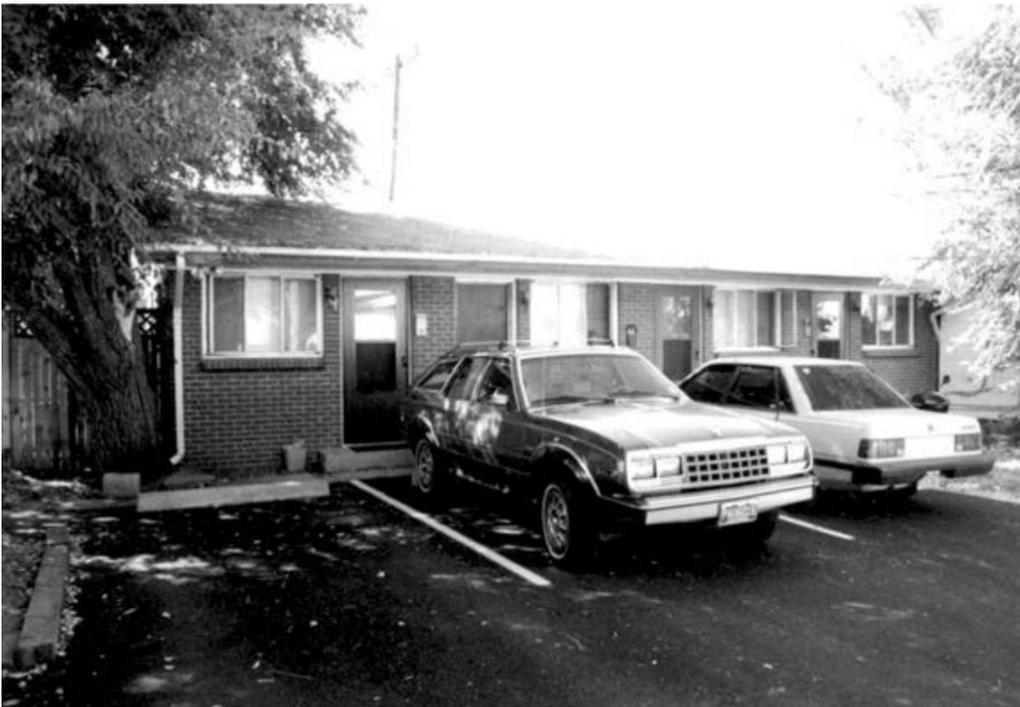
Reference Photo 1

Description: A 1997 photograph of the Rapp Street Apartments from the site form completed by Simmons and Simmons of Front Range Research Associates, Inc.

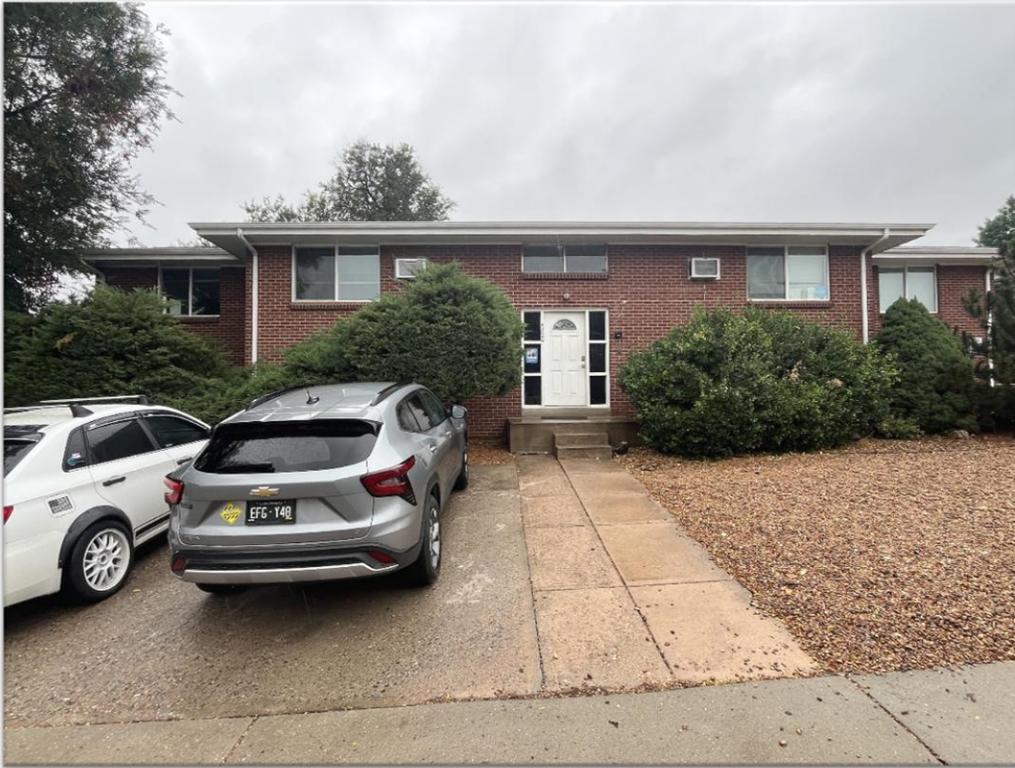
Photo Number: 1

Description: Primary (west) elevation of the building at 5320 South Elati Street featuring the mid-level main entrance.

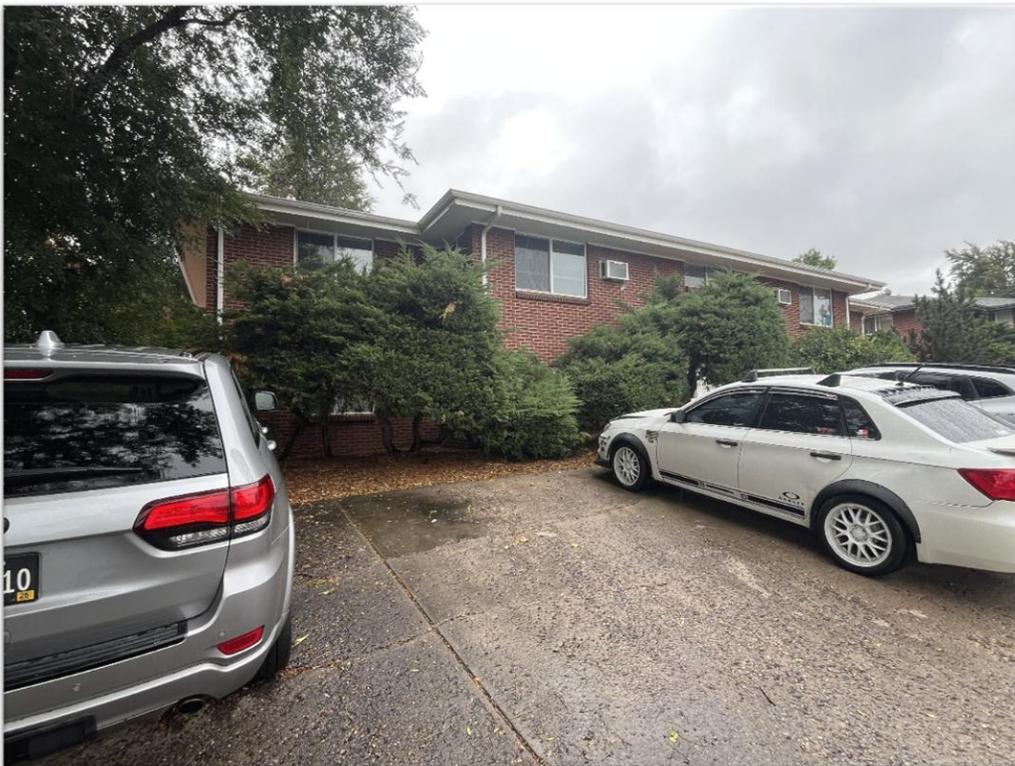
Photo Number: 2

Description: North elevation obscured by mature vegetation.

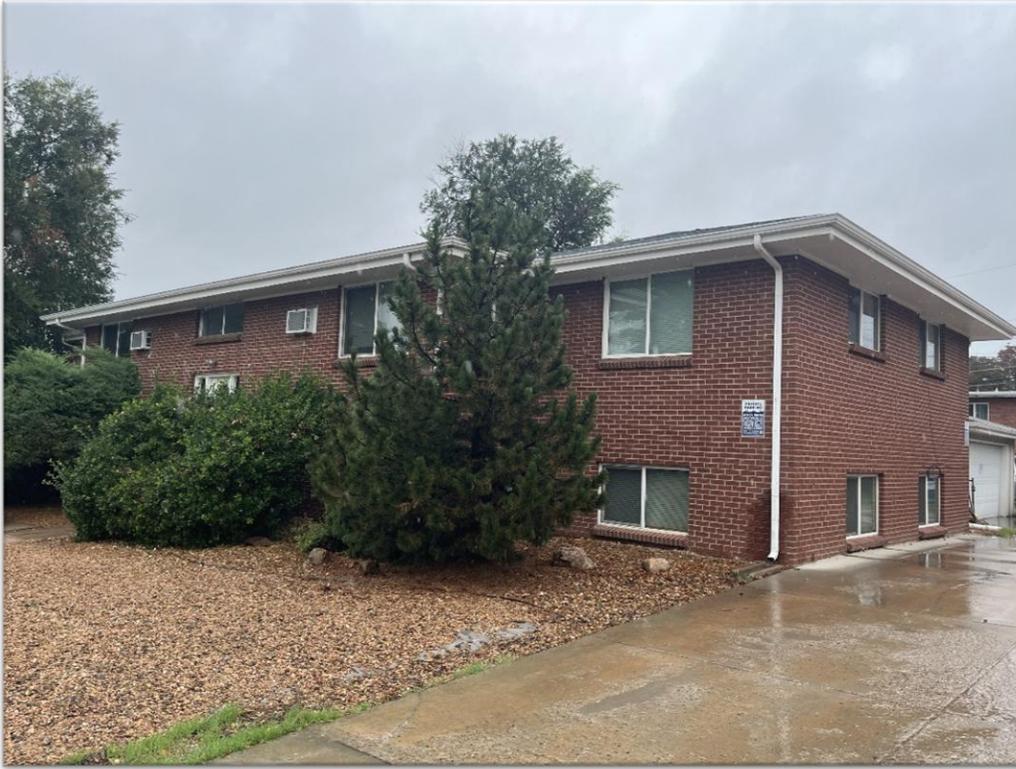
Photo Number: 3

Description: West and south elevations featuring typical windows. South elevation of the detached garage in the background.

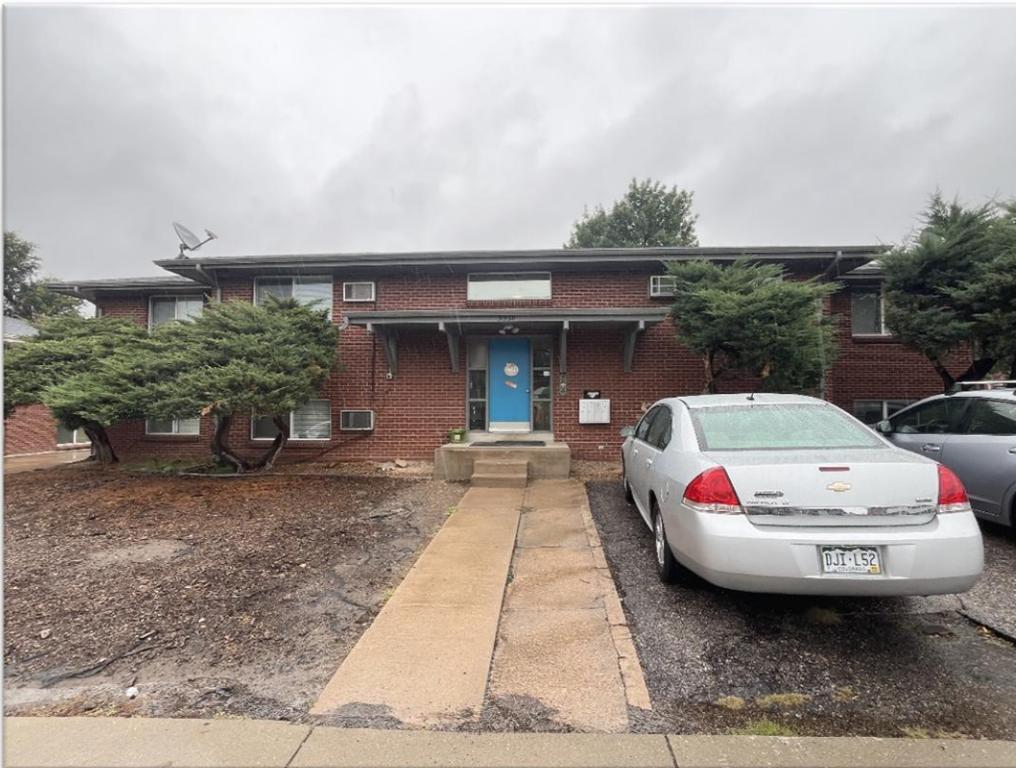
Photo Number: 4

Description: Primary (west) elevation of the building at 5330 South Elati Street featuring the flat roof over the entrance supported by brackets.

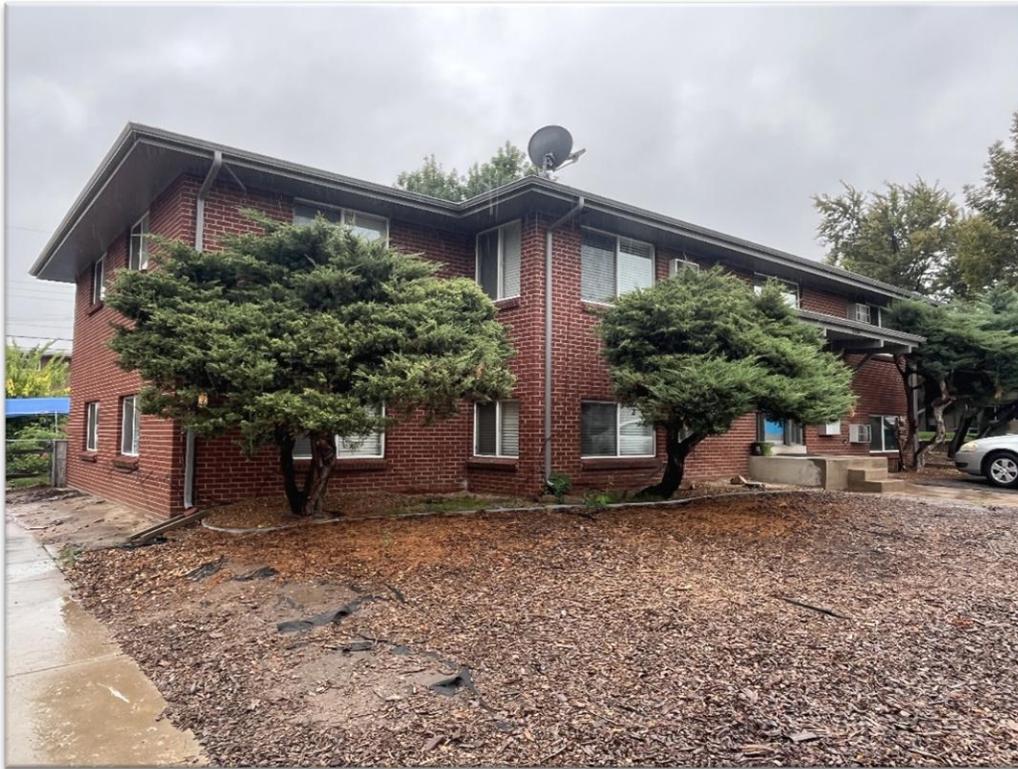
Photo Number: 5

Description: West and north elevations featuring typical windows.

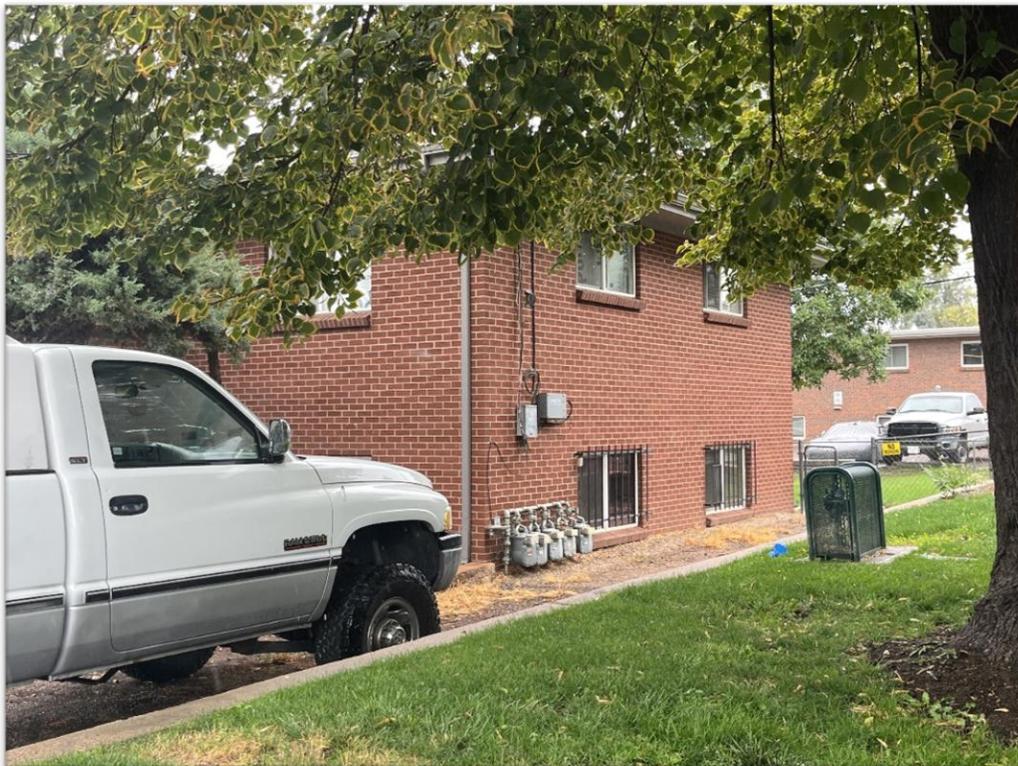
Photo Number: 6

Description: South elevation featuring metal bars on the first story windows.

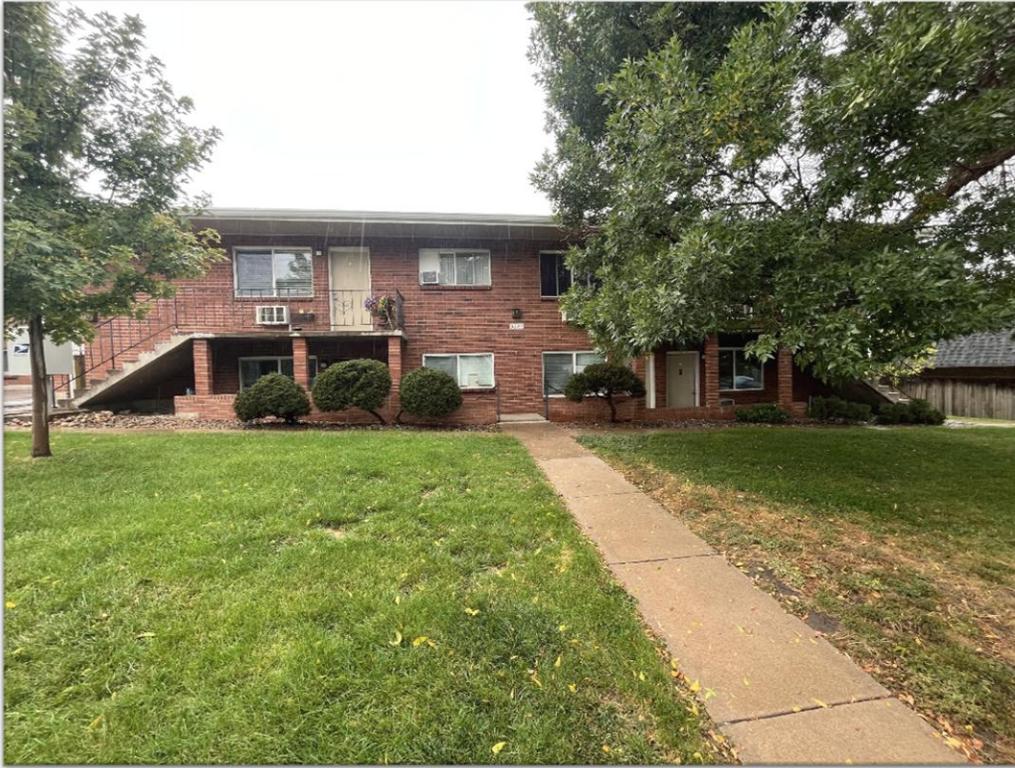
Photo Number: 1

Description: Primary (east) elevation of the building at 5321 South Delaware Street featuring the entrances on the below-grade first story and second story.

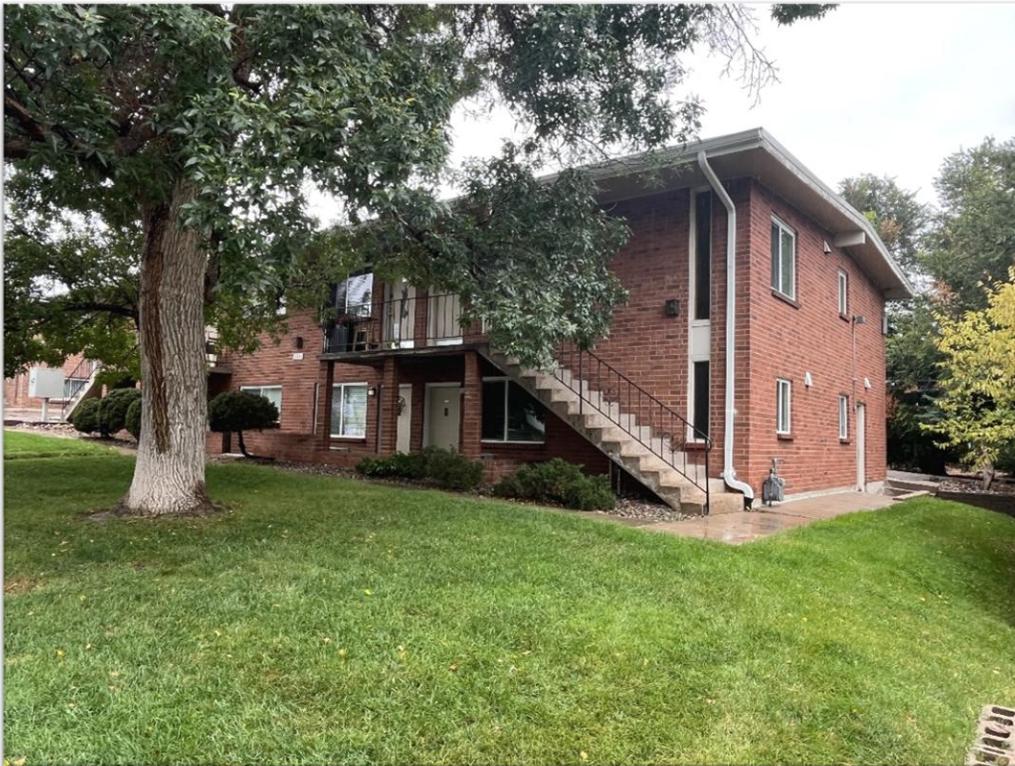
Photo Number: 2

Description: North elevation featuring the secondary entrance. Additionally, the sidelight is present at the north end of the east elevation.

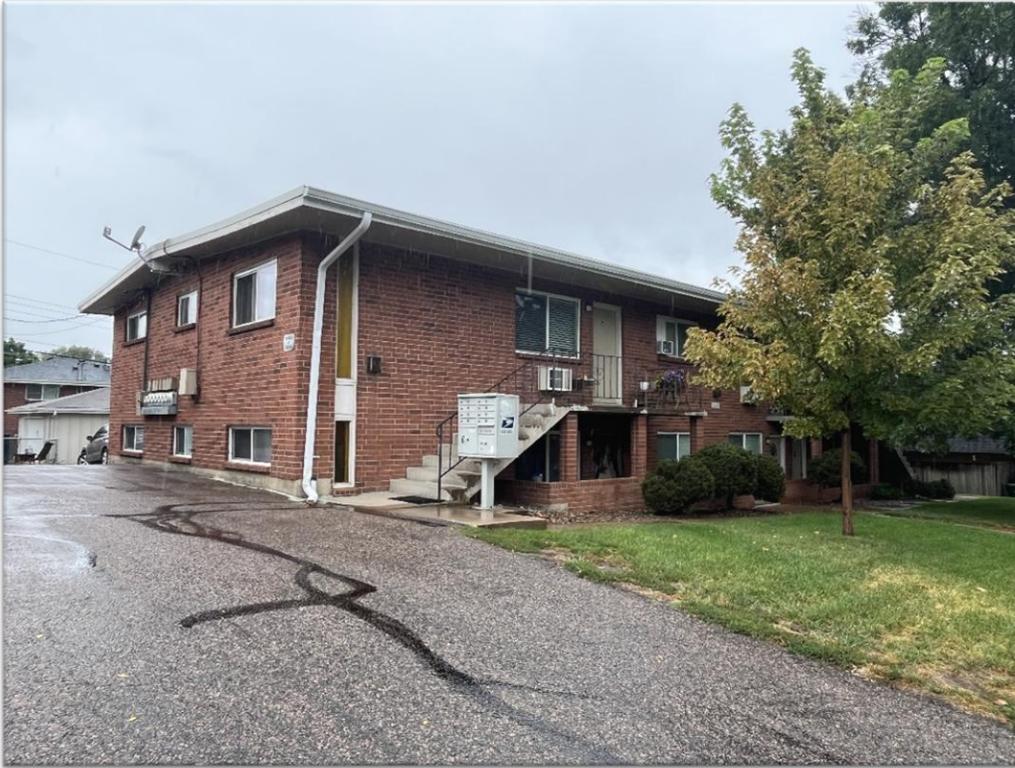
Photo Number: 3

Description: South elevation featuring three typical windows on each story.

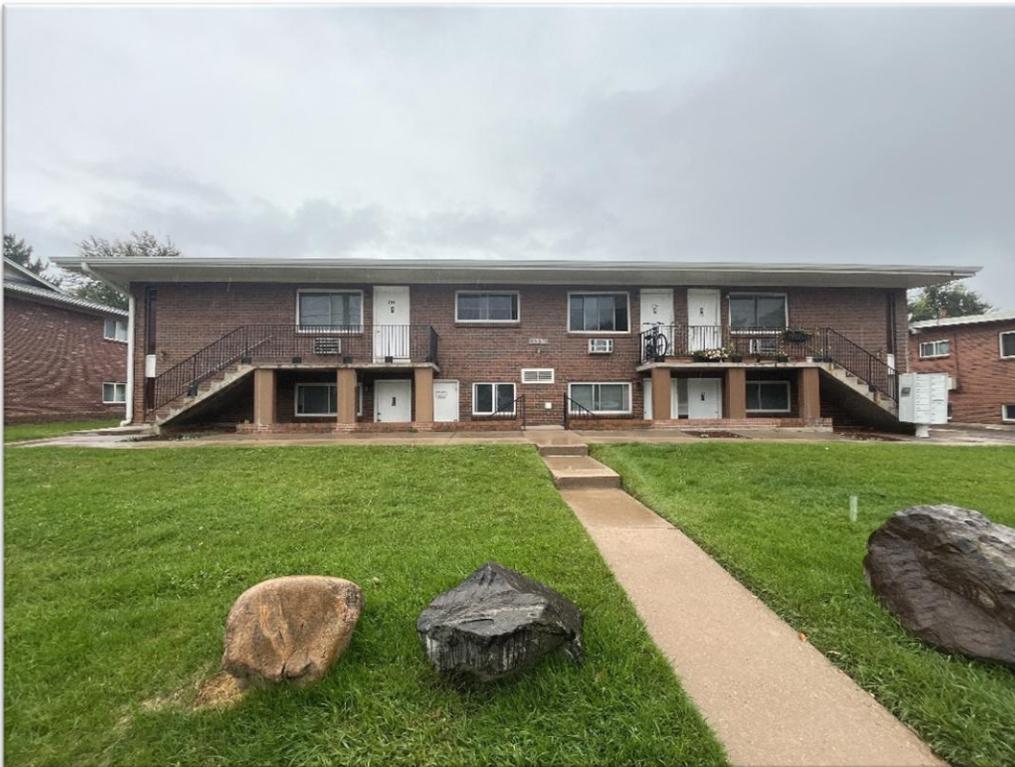
Photo Number: 4

Description: Primary (east) elevation of the building at 5331 South Delaware Street featuring the additional entrance on the first story next to the entrance at the south end of the elevation.

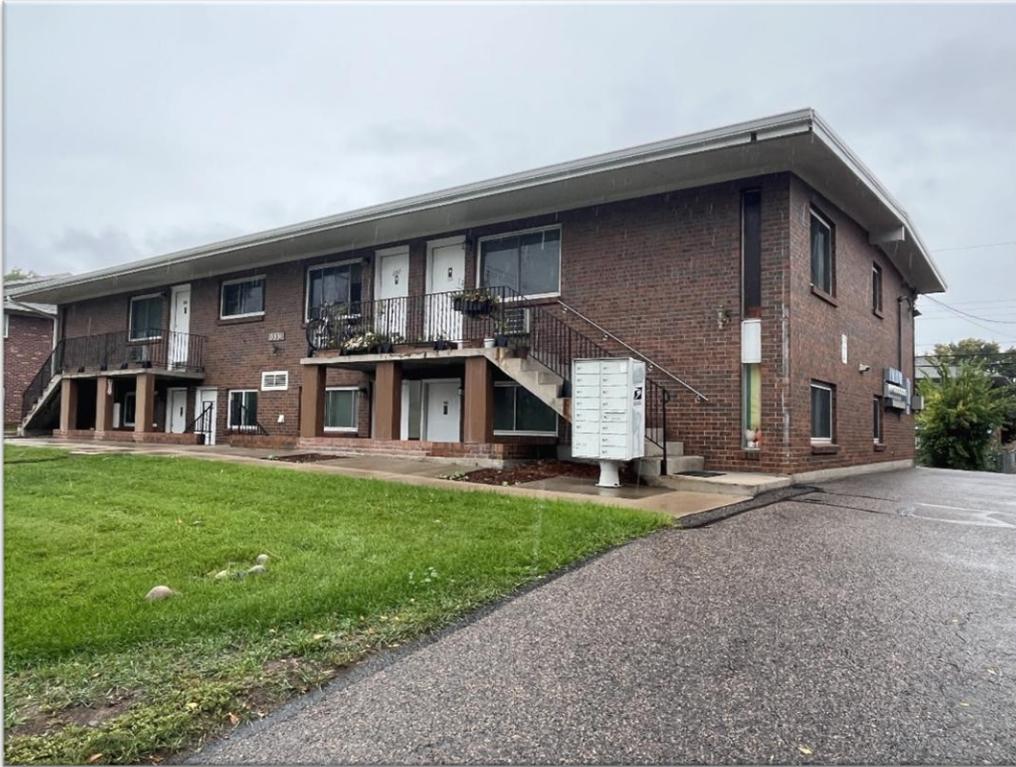
Photo Number: 5

Description: North elevation featuring two typical windows on each story.

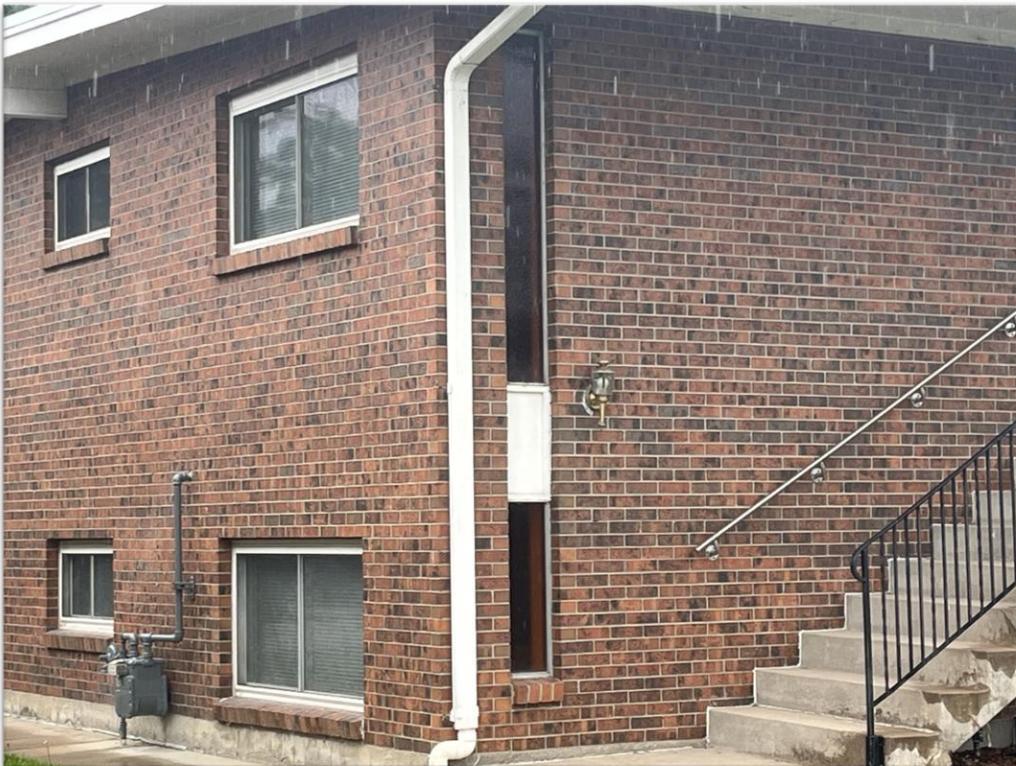
Photo Number: 6

Description: Detail of the sidelight at the south end of the east elevation.

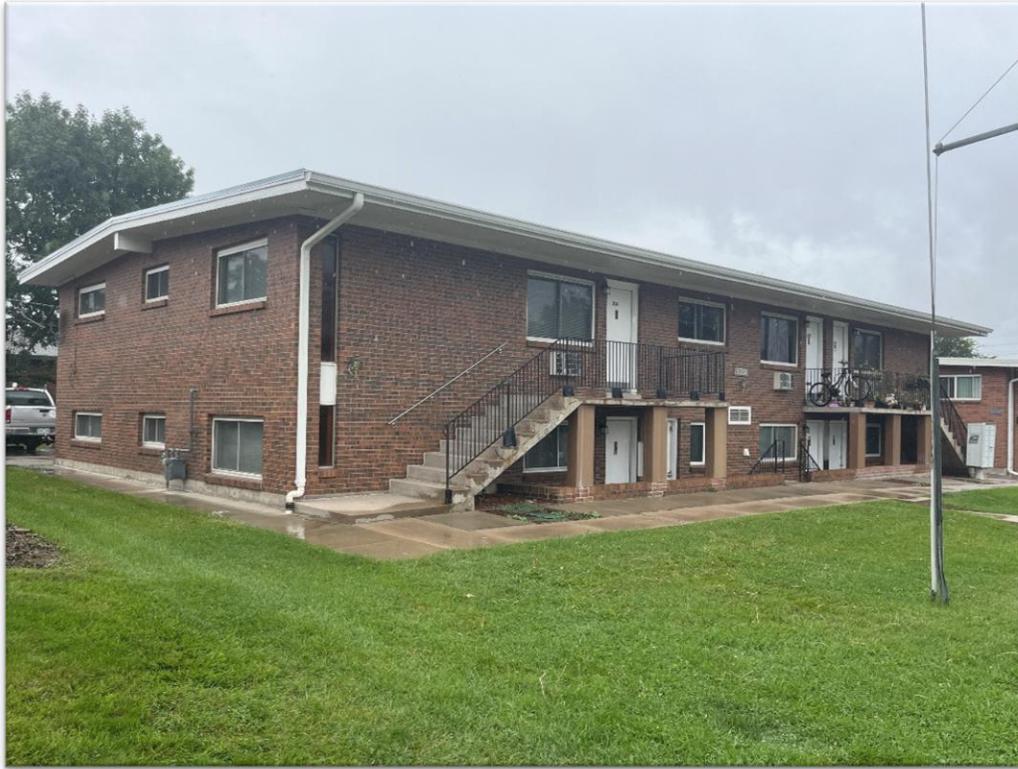
Photo Number: 7

Description: South elevation of the building featuring three typical windows on each story.

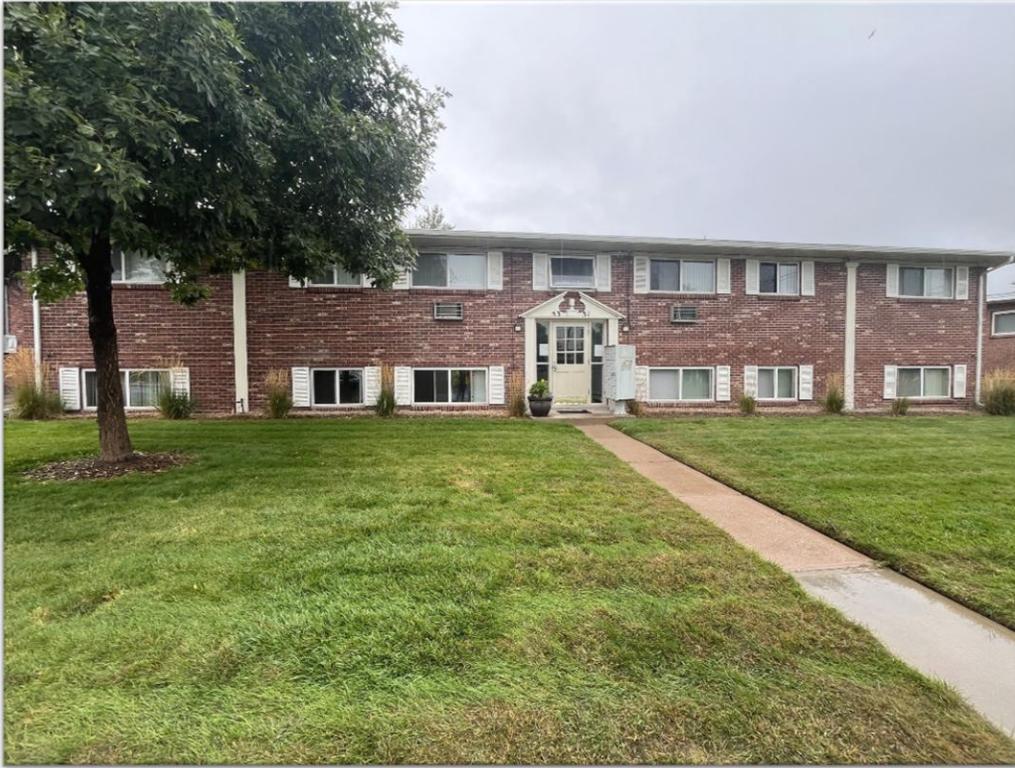
Photo Number: 1

Description: Primary (east) elevation of the building at 5351 South Delaware Street featuring the central main entry

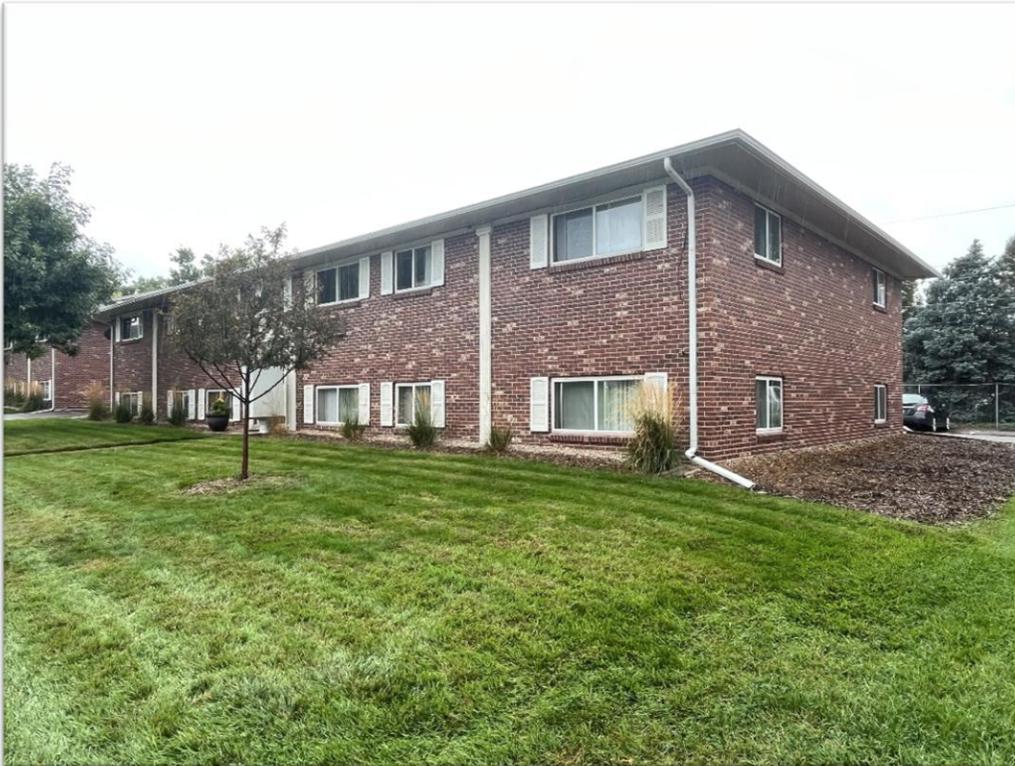
Photo Number: 2

Description: North elevation and east elevation featuring the typical windows and the pilaster with a Doric capital.

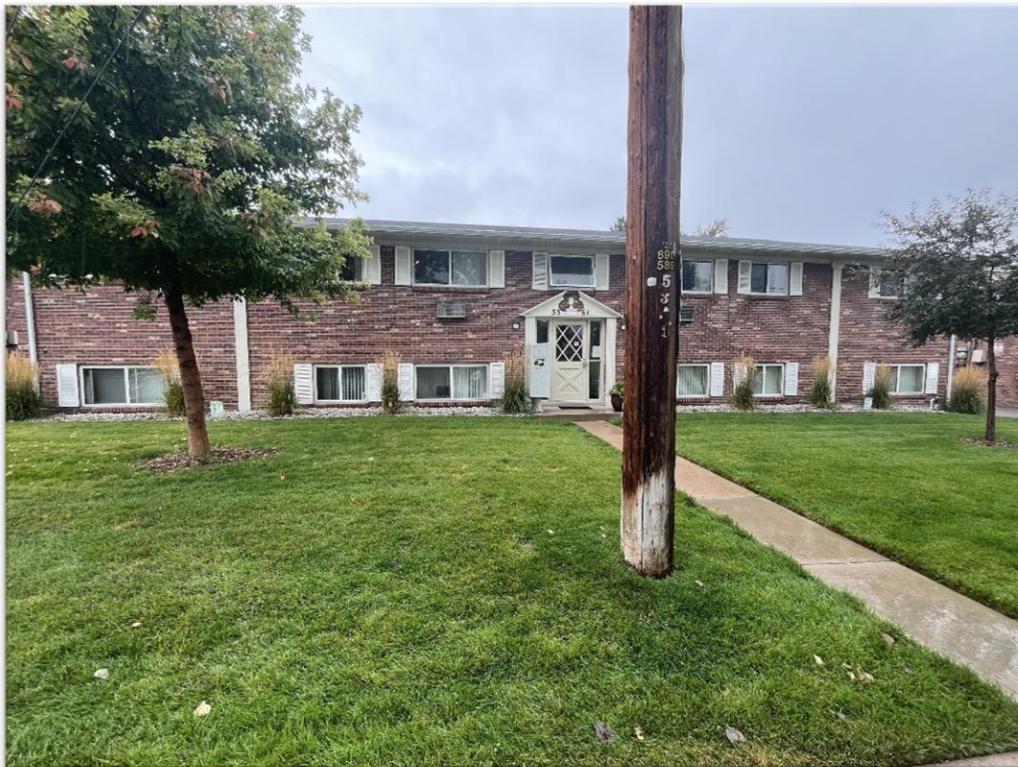
Photo Number: 4

Description: Primary (east) elevation of the building at 5361 South Delaware Street featuring typical windows on each floor.

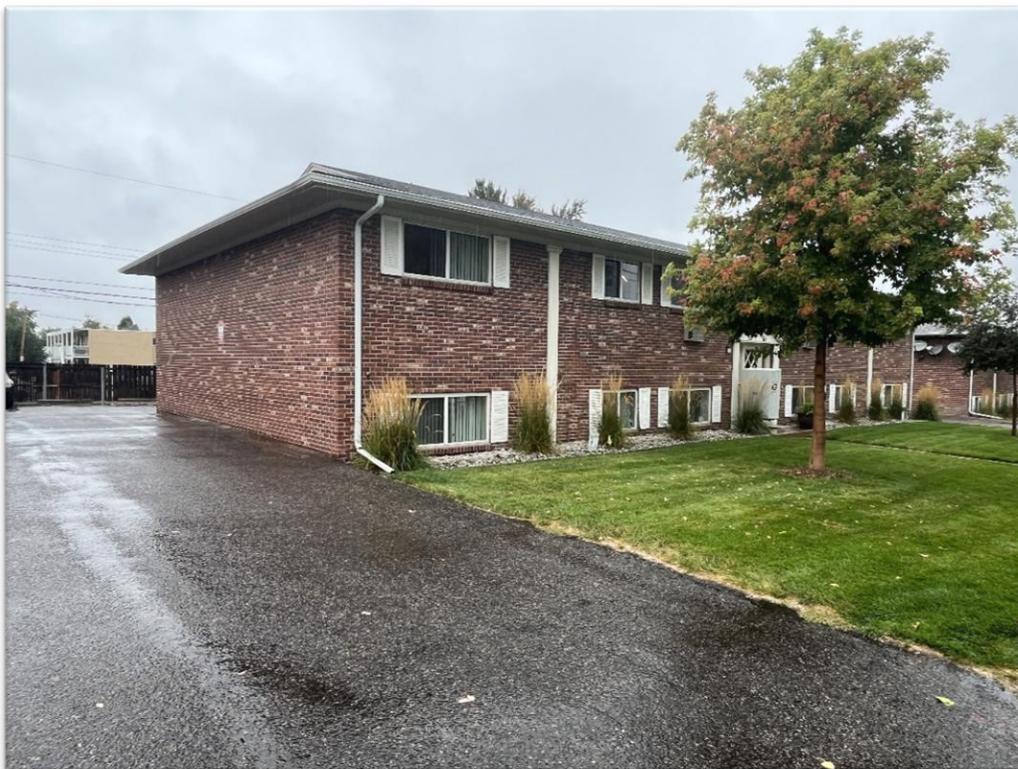
Photo Number: 6

Description: South elevation featuring no fenestration.

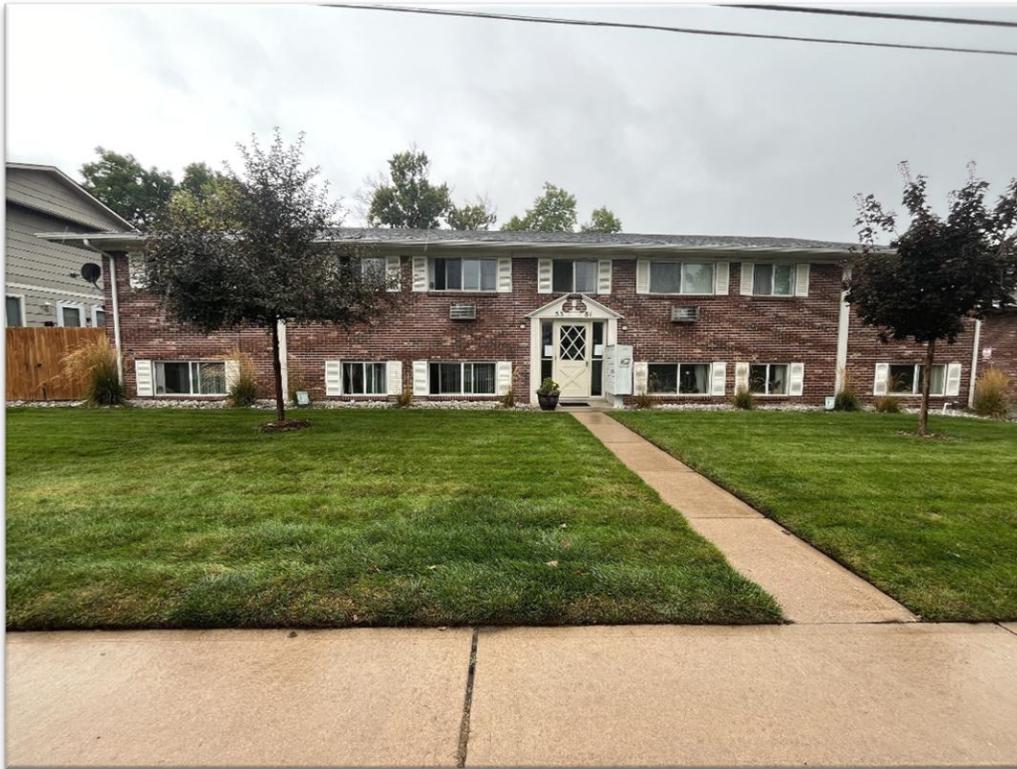
Photo Number: 7

Description: Primary (east) elevation of the building at 5381 South Delaware Street.

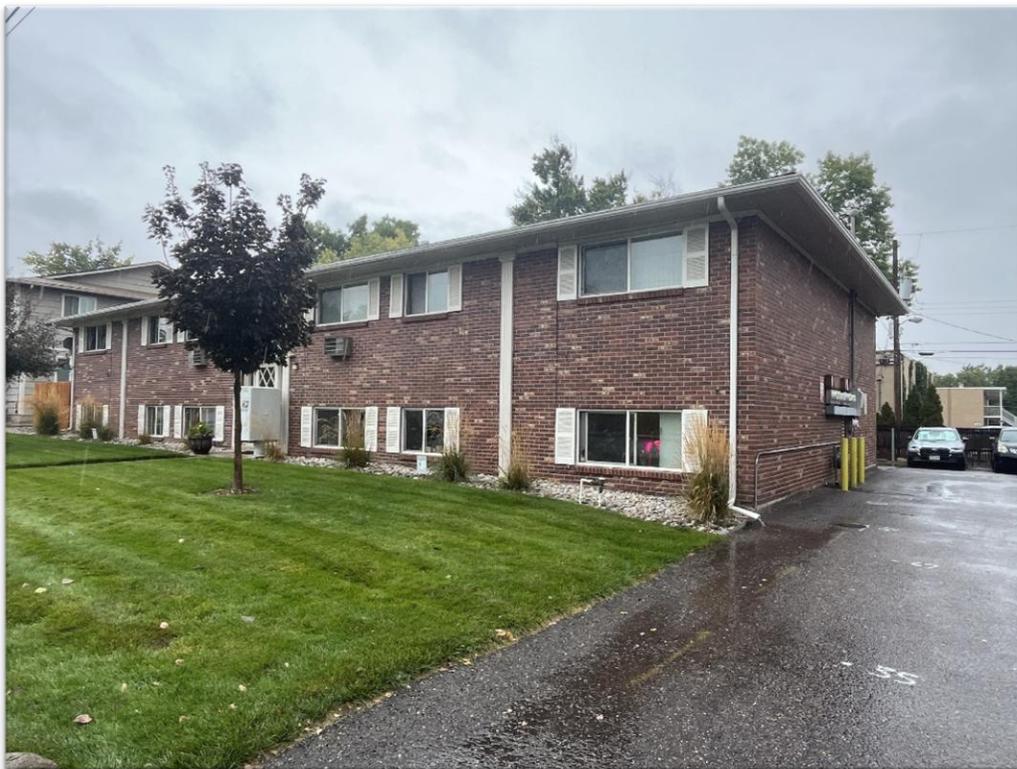
Photo Number: 8

Description: North elevation featuring no fenestration.

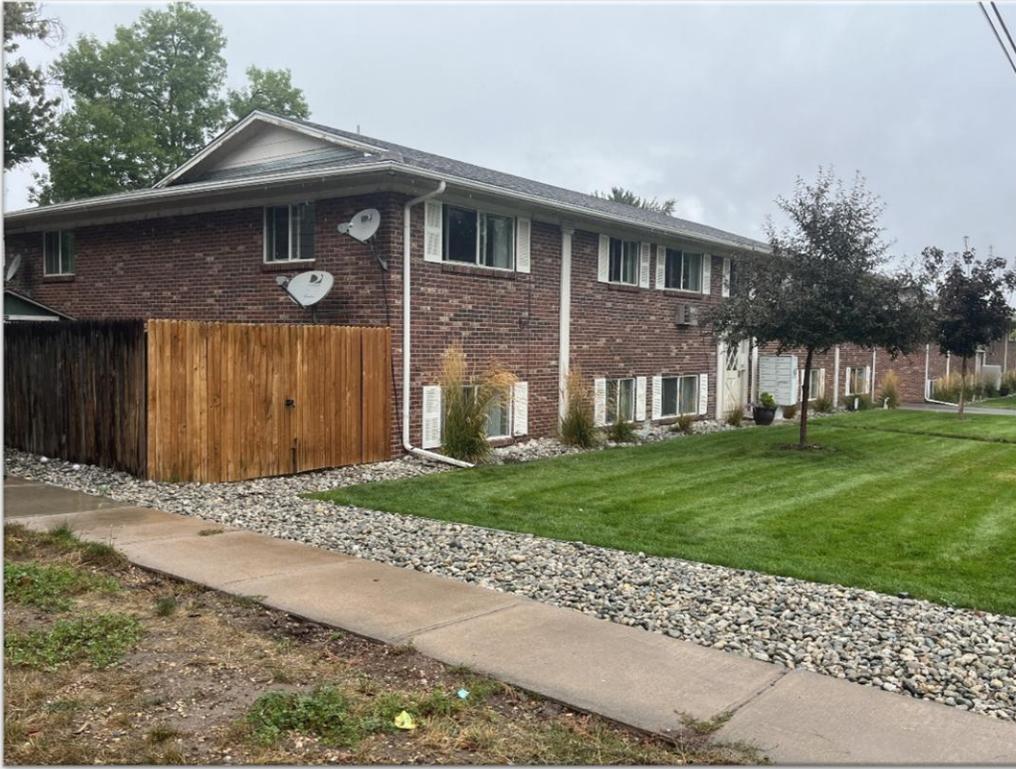
Photo Number: 9

Description: South elevation featuring vinyl one-by-one light sliding windows and a tall wood fence.

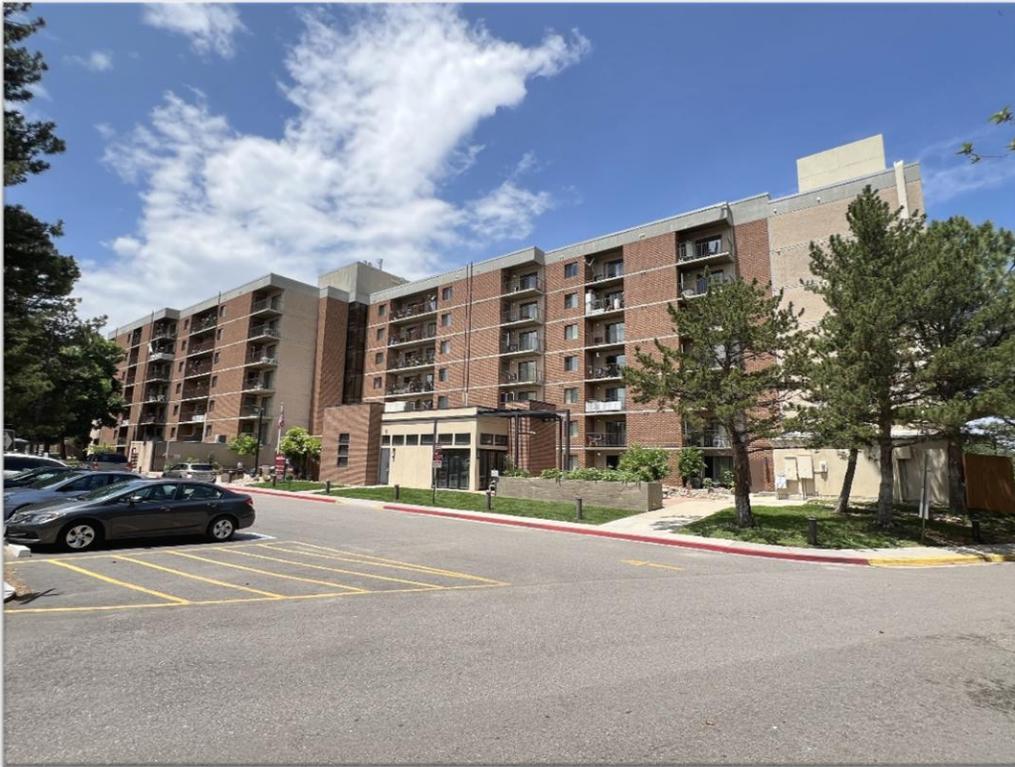
Photo Number: 1

Description: Primary (southeast) elevation of the Amity Plaza assisted living facility featuring the secondary building.

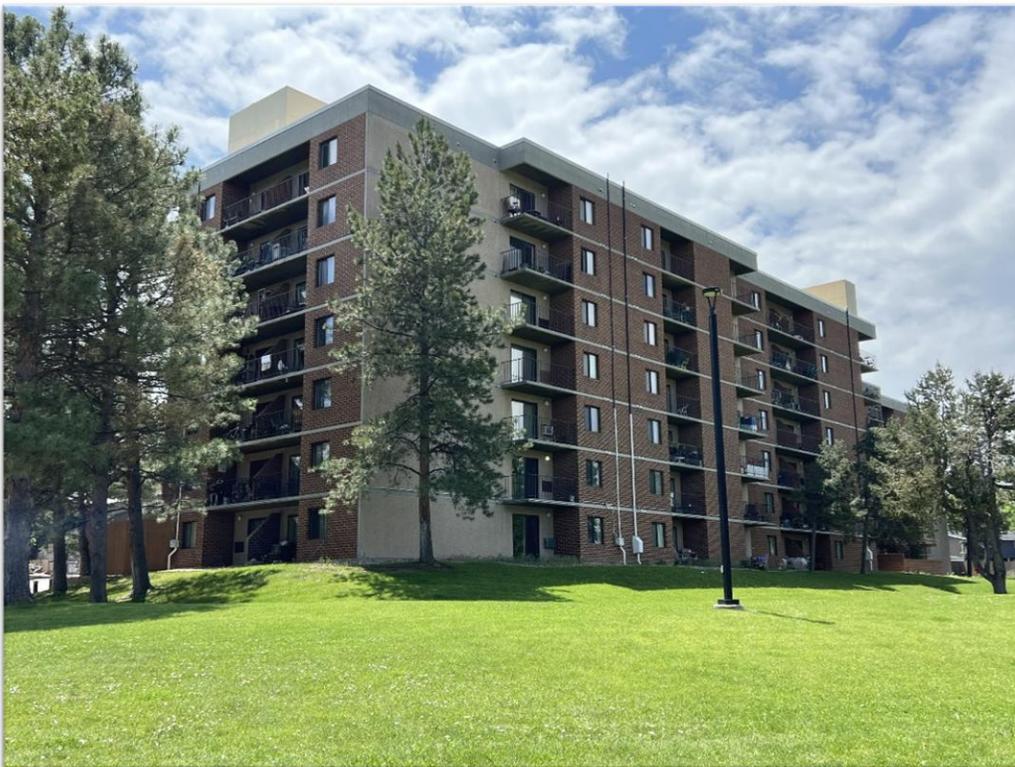
Photo Number: 2

Description: Northeast and northwest elevations of the buildings featuring the balconies on each floor.

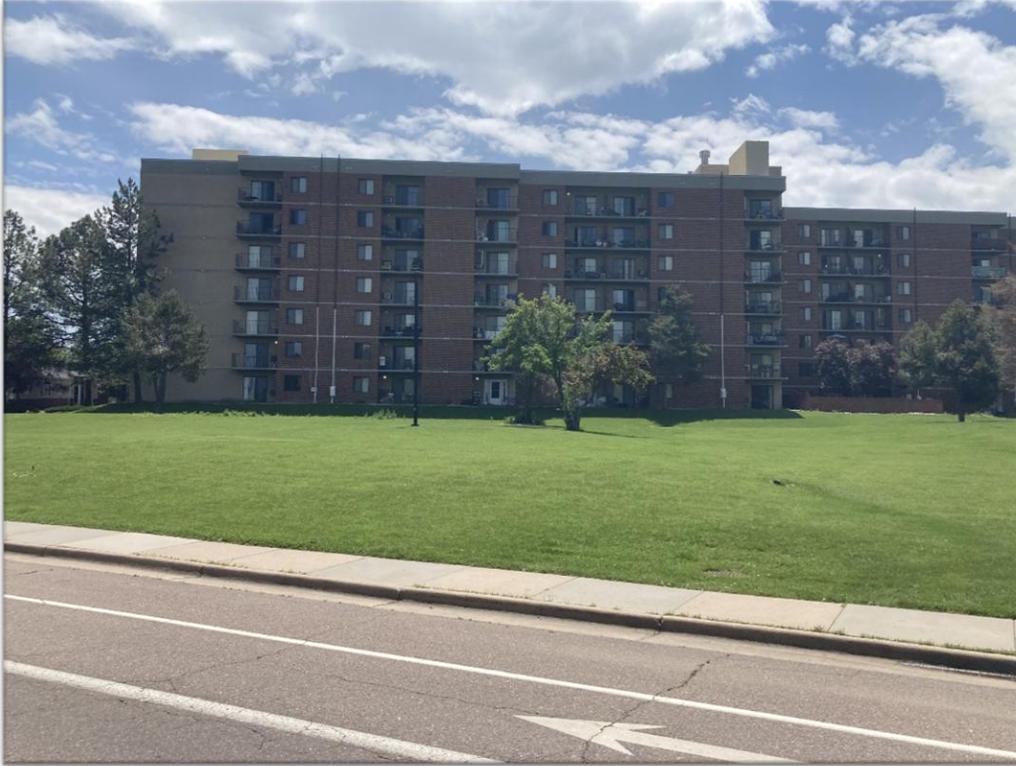
Photo Number: 3

Description: Northwest elevation of the Amity Plaza assisted living facility.

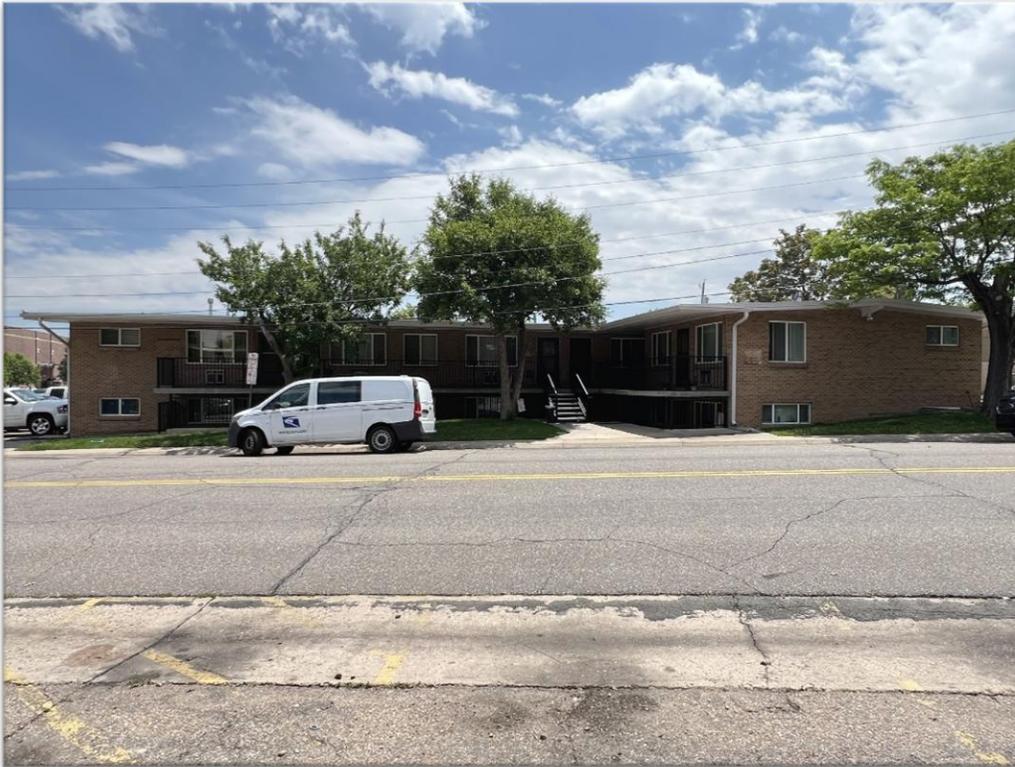
Photo Number: 1

Description: Primary (west) and north elevations of the Broadmoor Apartments building.

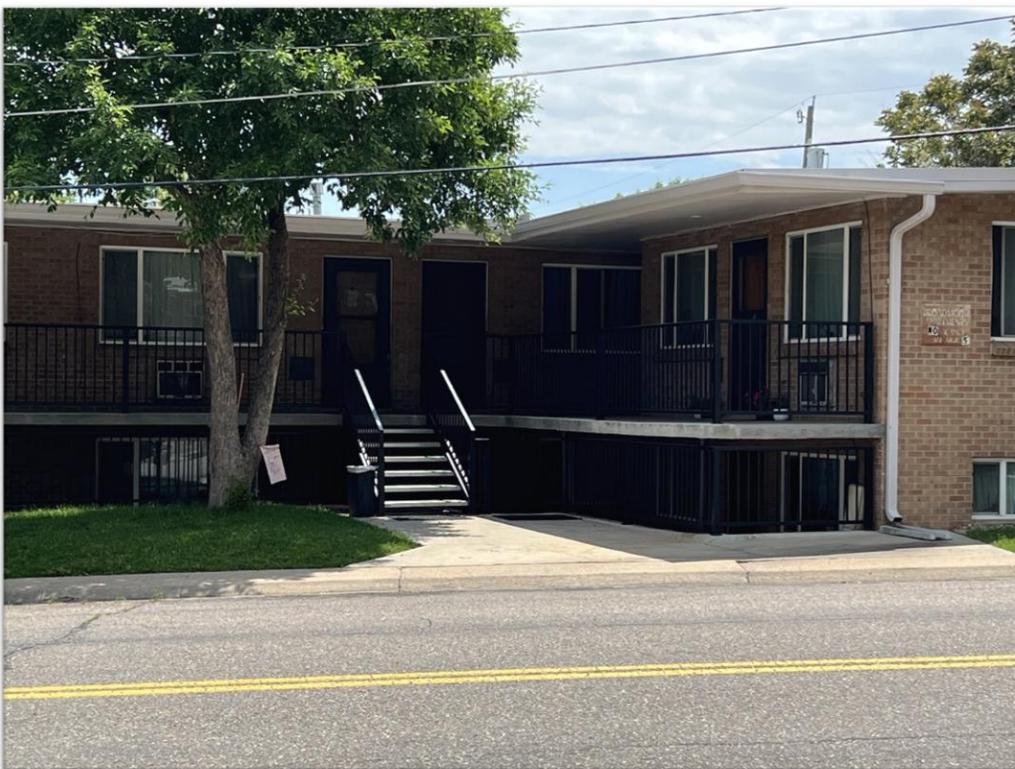
Photo Number: 2

Description: Detail of the stairs leading up to the porch along the second story.
