City of Littleton Survey Plan and Reconnaissance Survey Report

Pinyon Project No.:
124169901

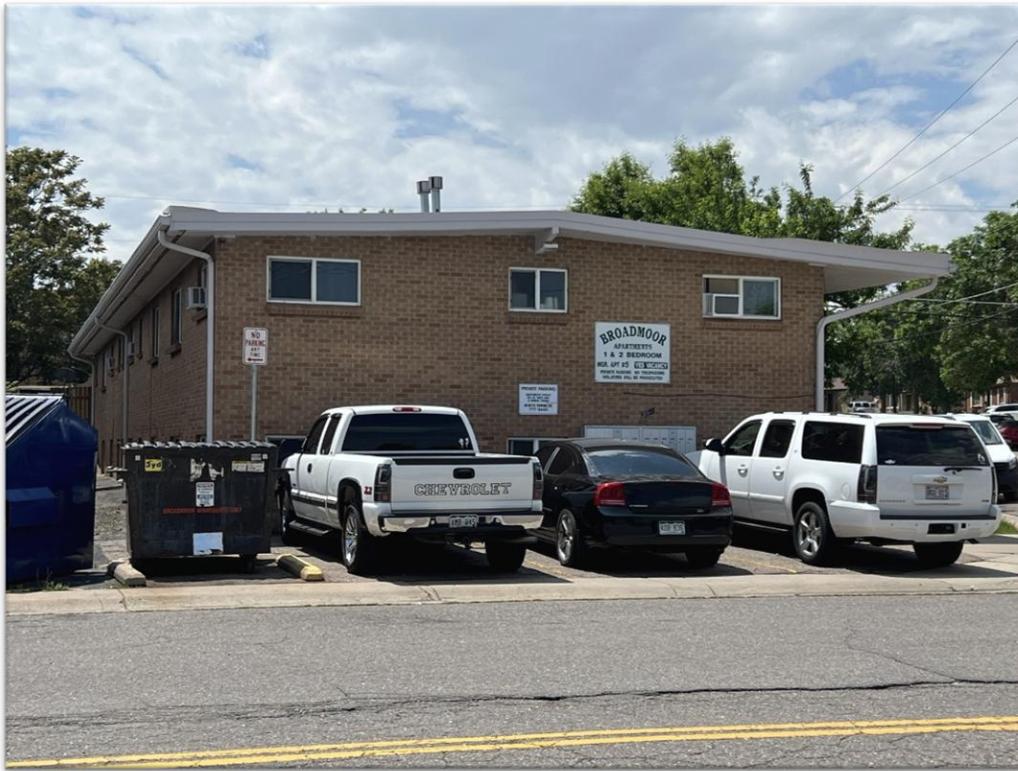
Photo Number: 3

Description: North and east elevations of the building featuring vinyl one-by-one light sliding windows on the second story.

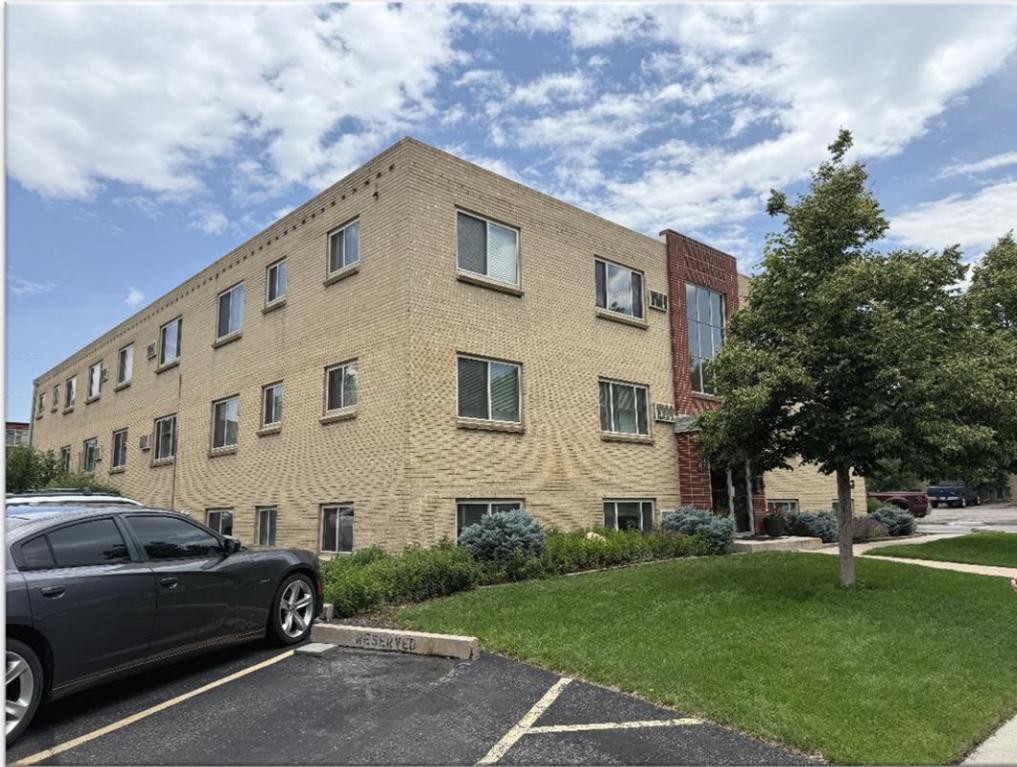
Photo Number: 1

Description: Primary (south) elevation featuring the main entrance and the large, wood nine-light fixed pane windows. West elevation.

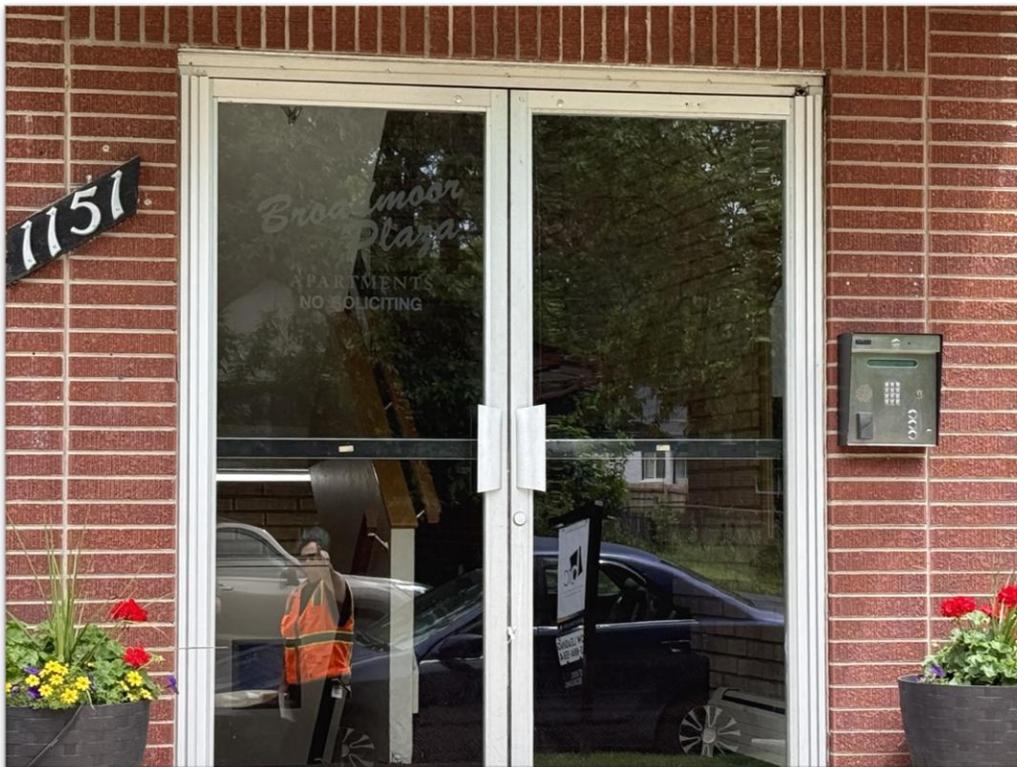
Photo Number: 2

Description: Detail of the main entrance double glass doors featuring a sign reading "Broadmoor Plaza."

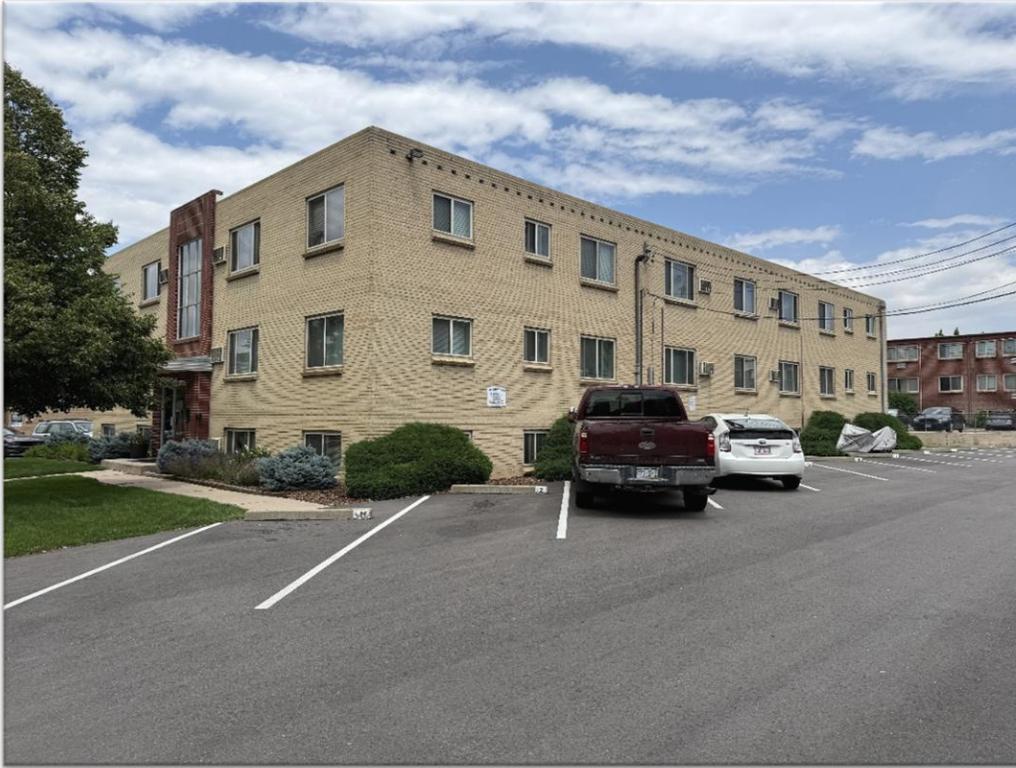
Photo Number: 3

Description: East elevation of the building beyond the parking lot.

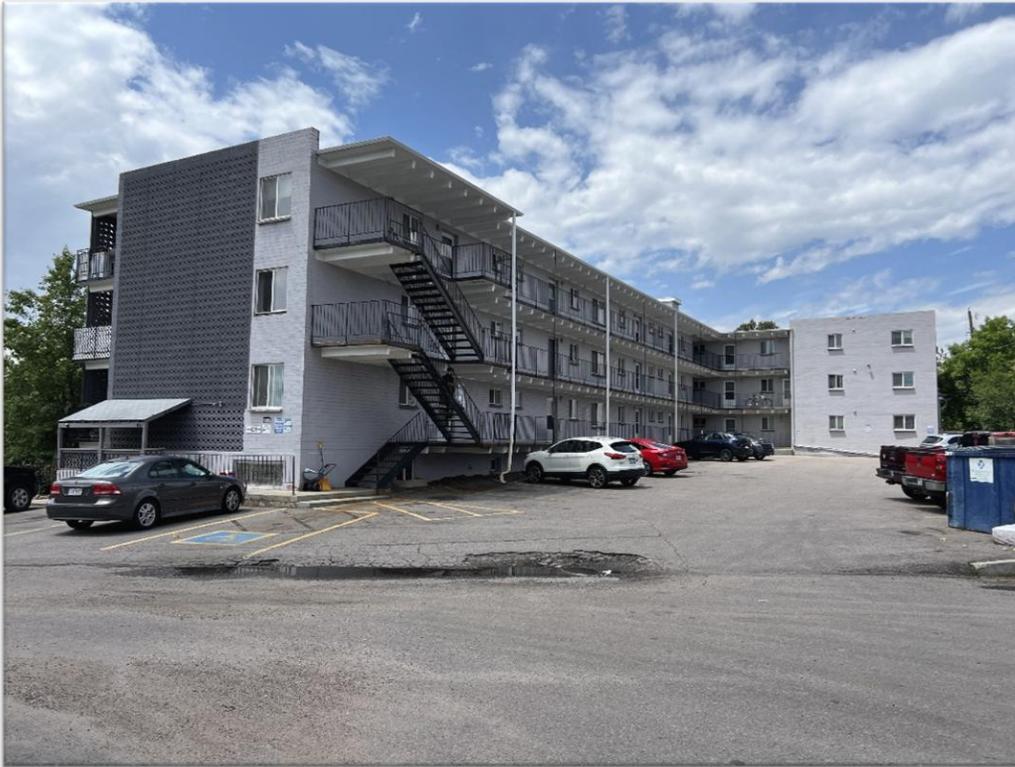
Photo Number: 1

Description: Primary (north and east) elevations of the Broadmoor Village Apartments building.

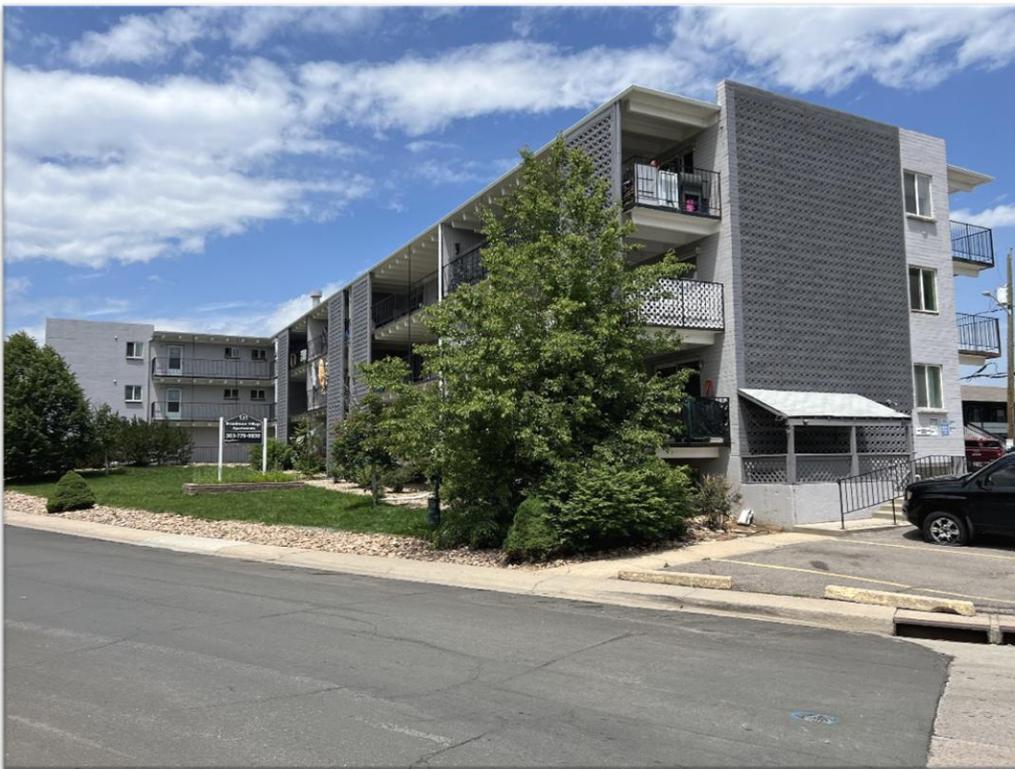
Photo Number: 2

Description: East elevation of the east portion of the building featuring the decorative concrete block.

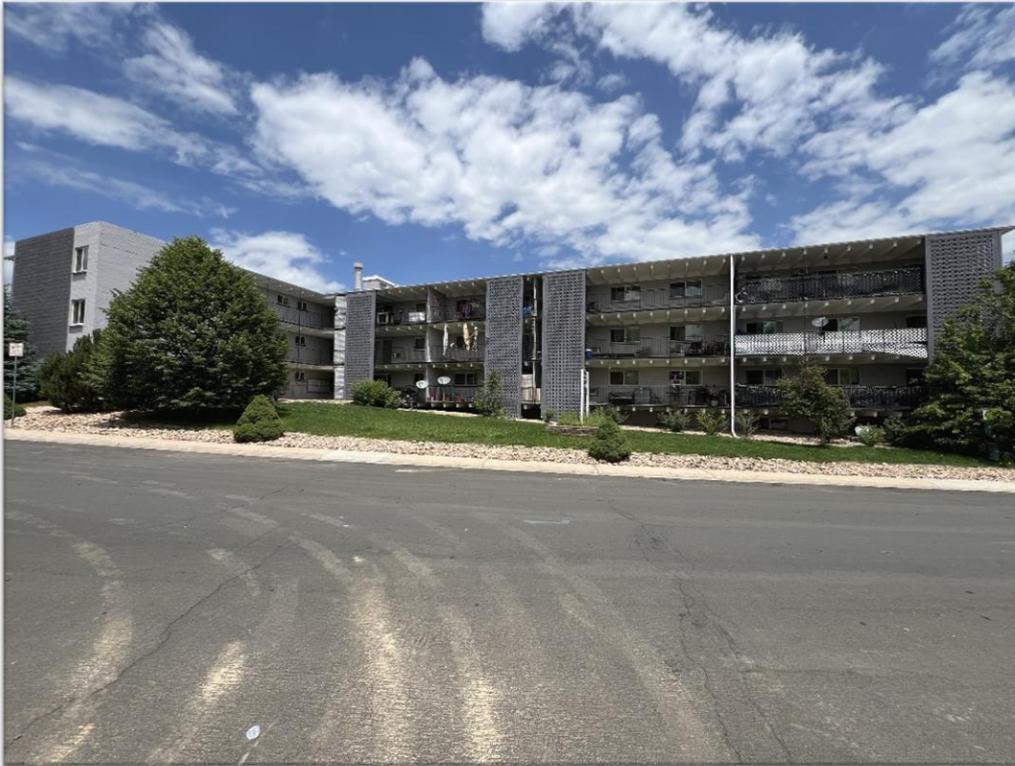
Photo Number: 3

Description: South elevation of the building featuring the four balconies on each floor.

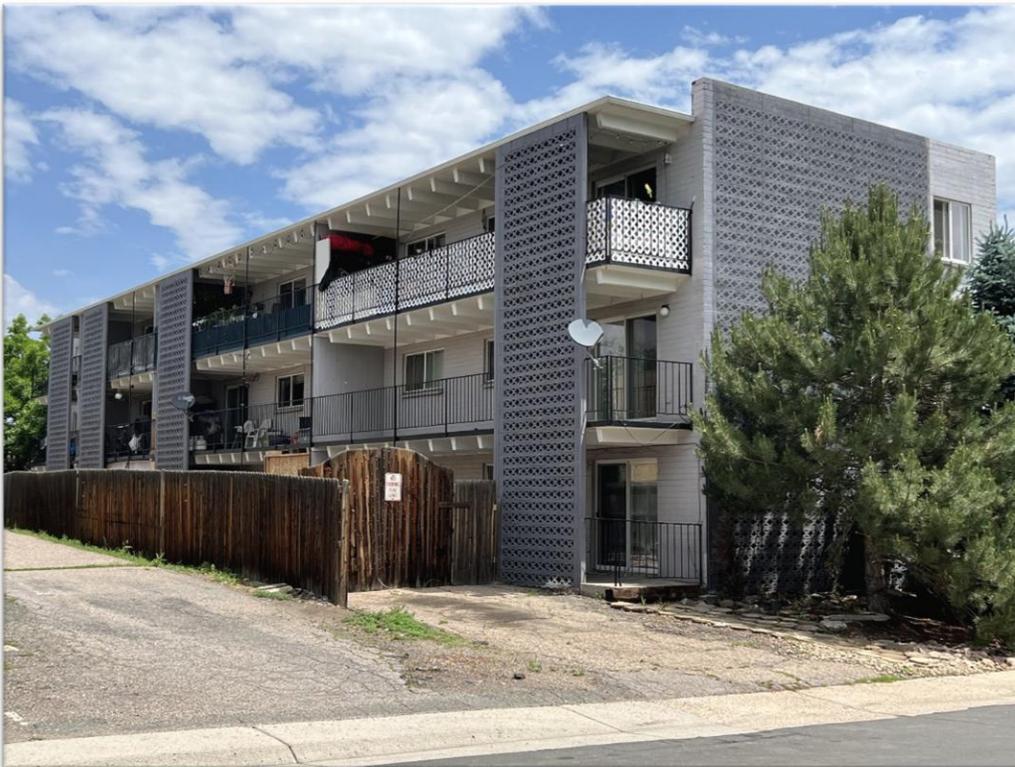
Photo Number: 4

Description: West elevation of the apartment building.

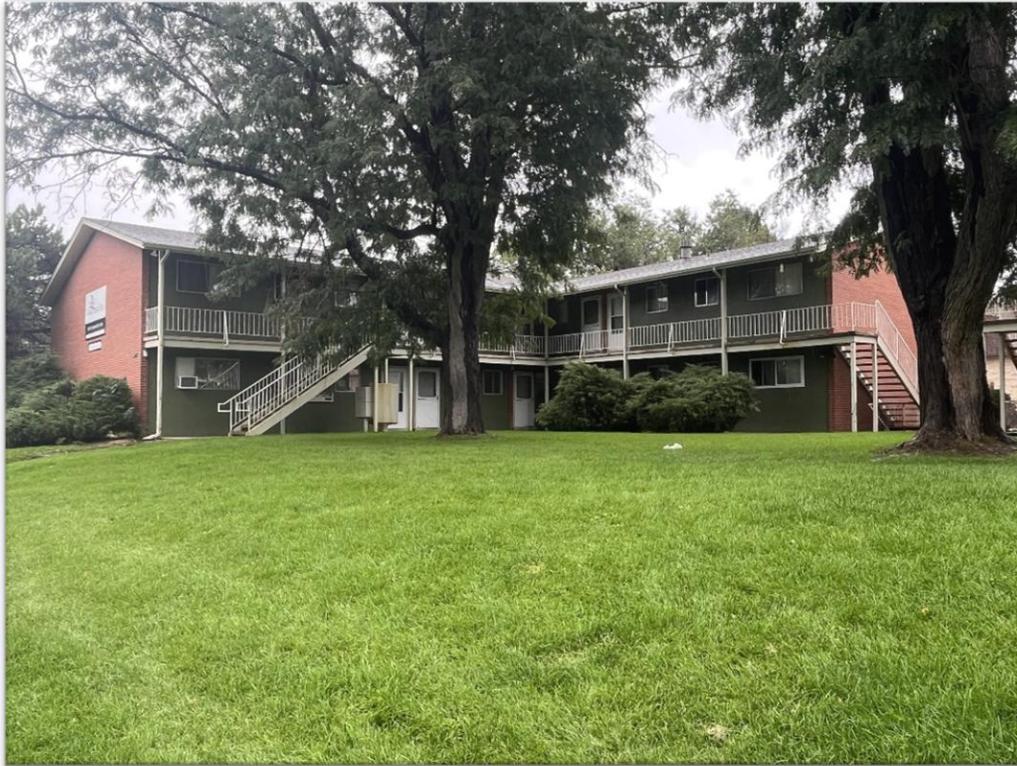
Photo Number: 1

Description: Primary elevations (west and south) of the Courtyard at Weston Ridge Apartments building at 5904 South Datura Street featuring the exterior corridor on the second floor.

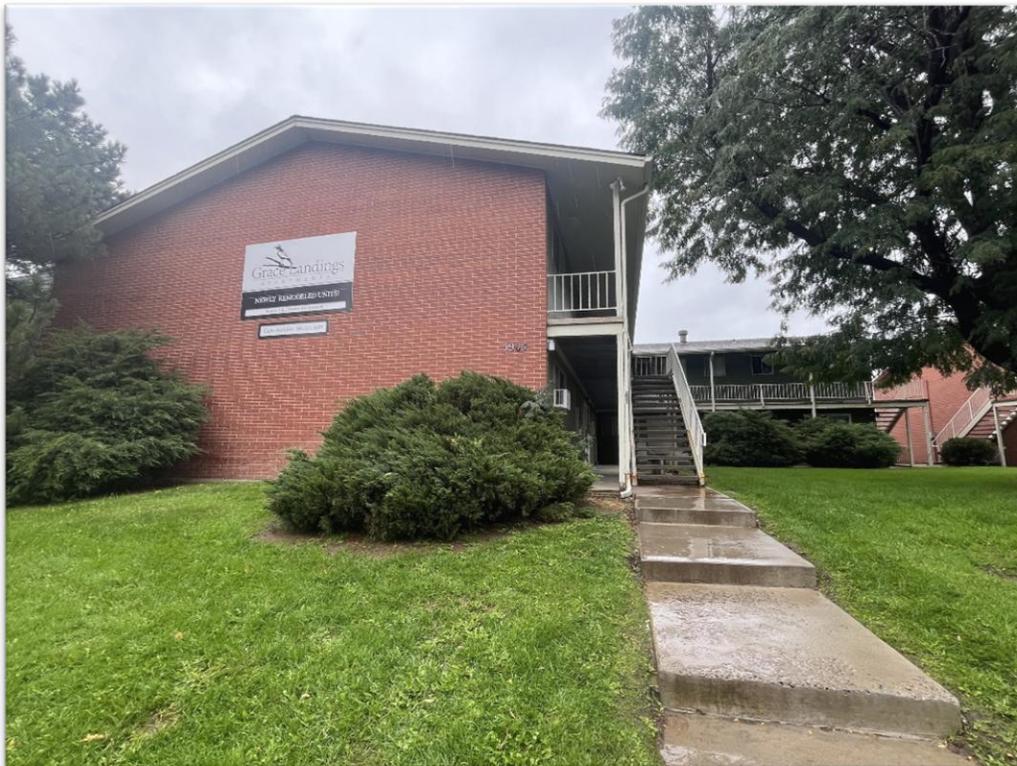
Photo Number: 2

Description: West elevation featuring the metal staircase leading to the second floor.

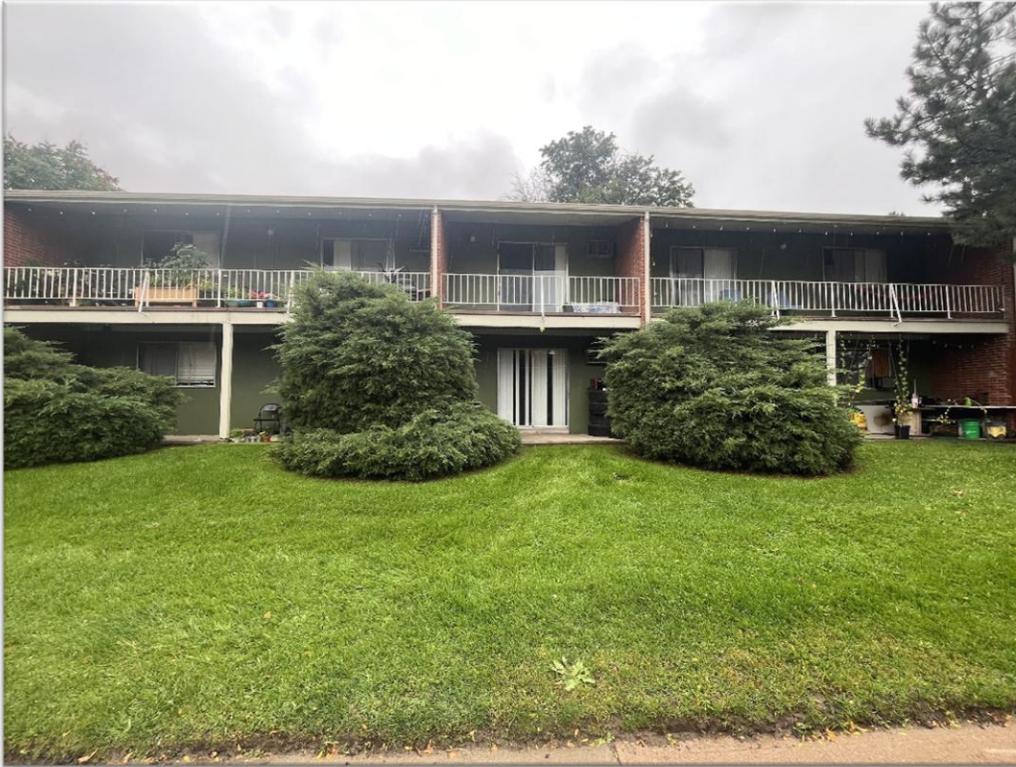
Photo Number: 3

Description: North elevation featuring three balconies on the second floor.

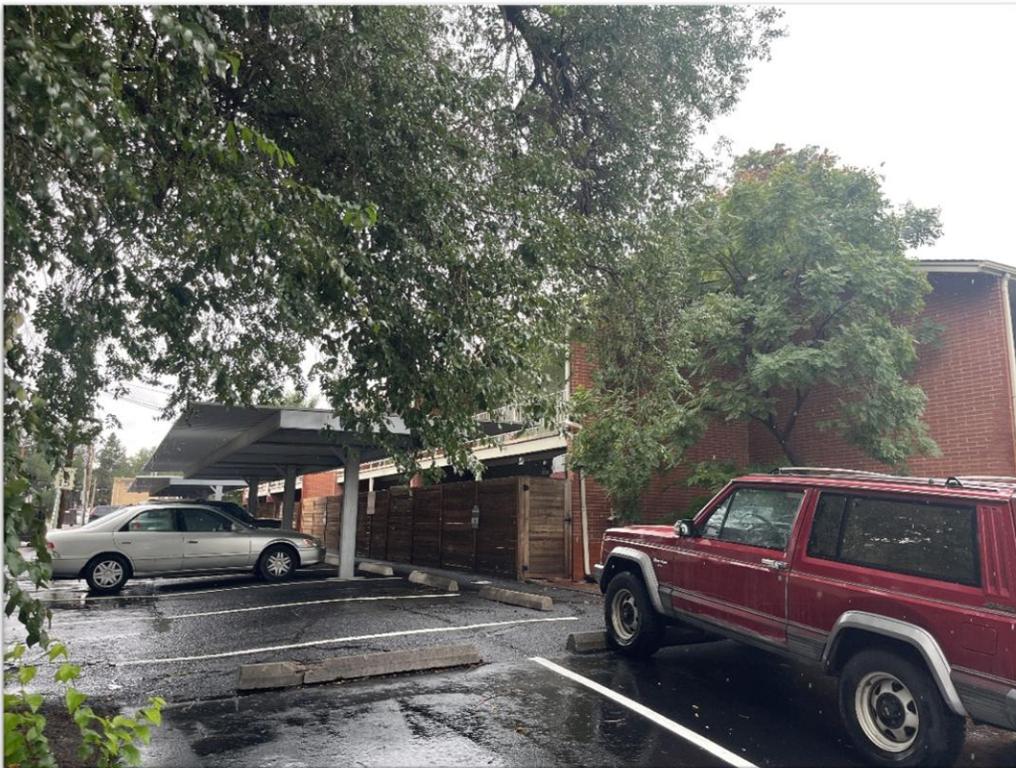
Photo Number: 4

Description: East elevation behind the metal carports.

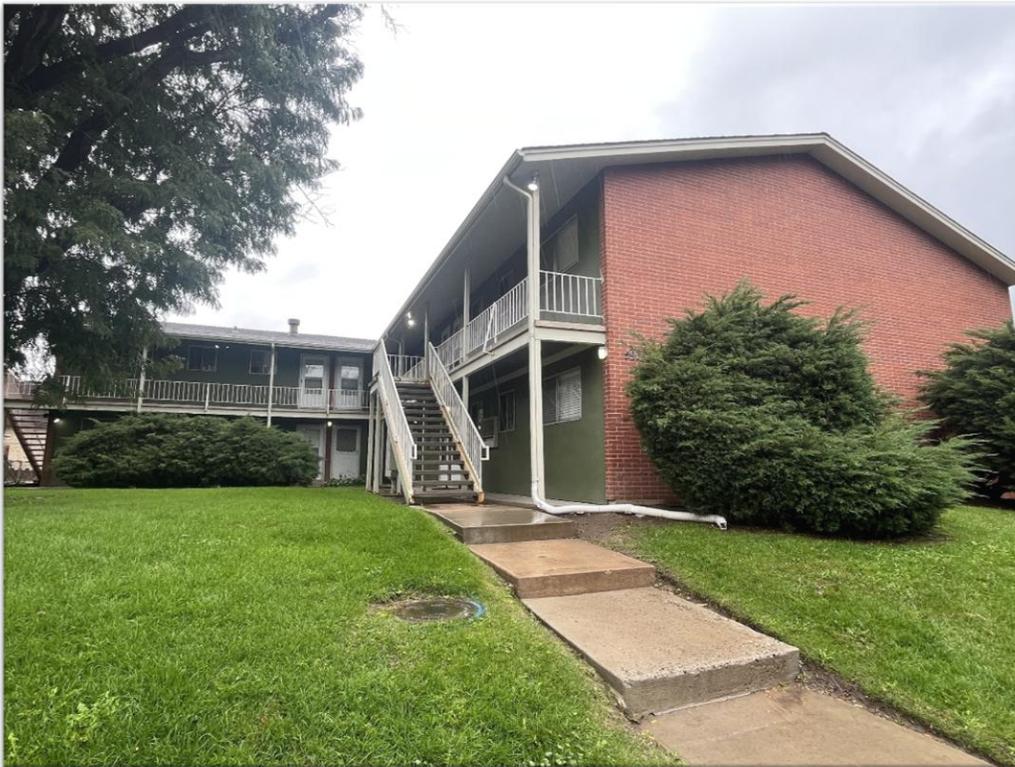
Photo Number: 5

Description: Primary (north and west) elevations of the building at 5914 South Datura Street featuring the metal staircase leading up to the second floor.

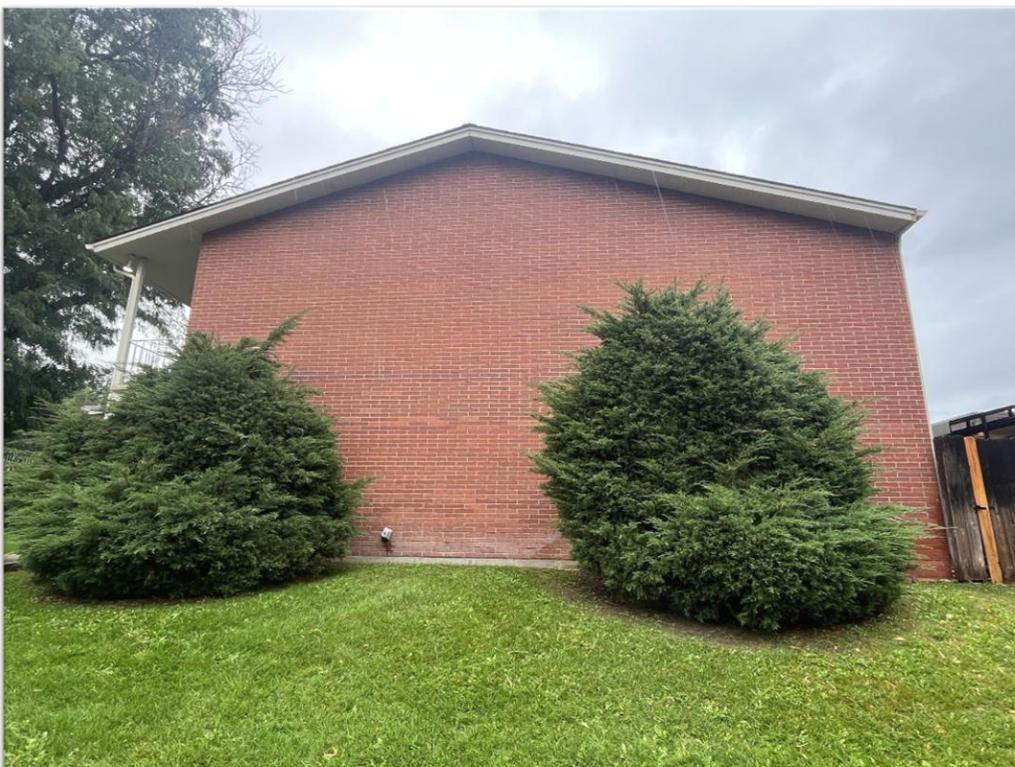
Photo Number: 6

Description: West elevation featuring no fenestration.

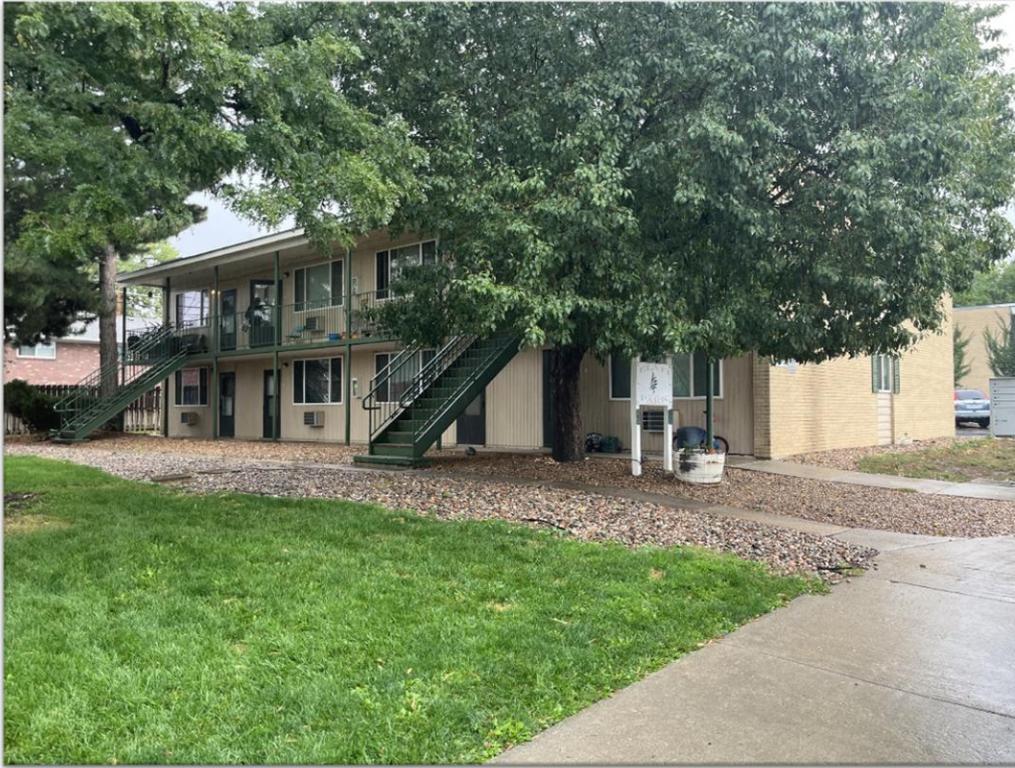
Photo Number: 1

Description: Primary (north) elevation of the building at 5360 South Elati Street featuring the replacement windows and replacement staircases and breezeway.

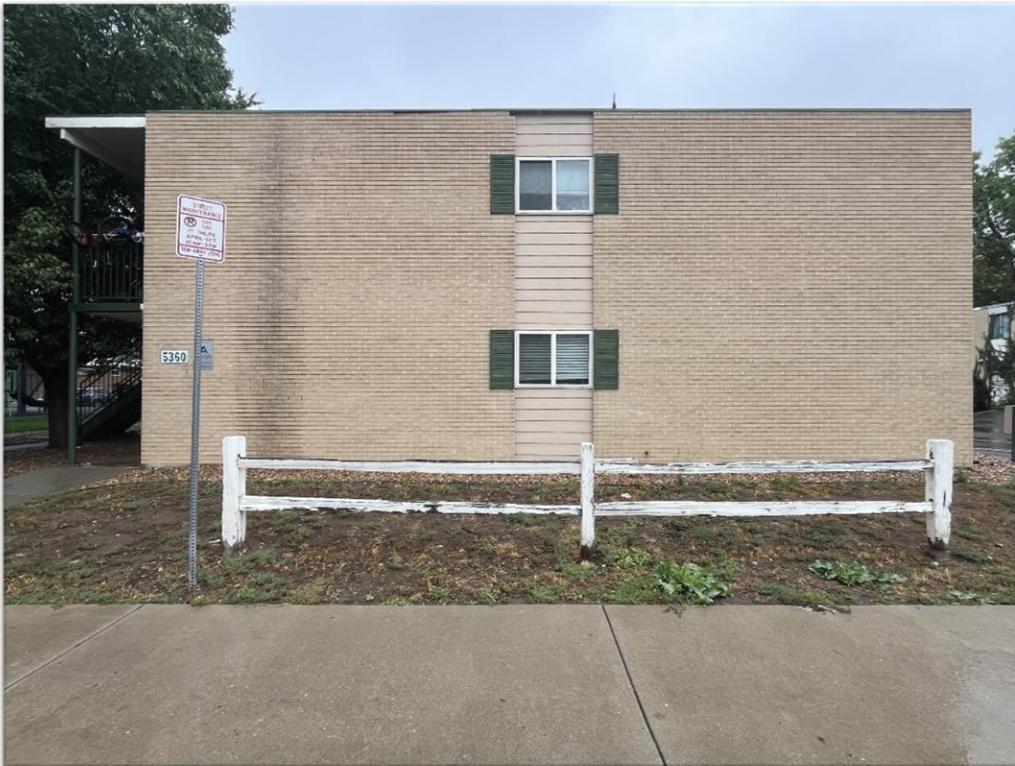
Photo Number2

Description: West elevation featuring replacement windows flanked by shutters.

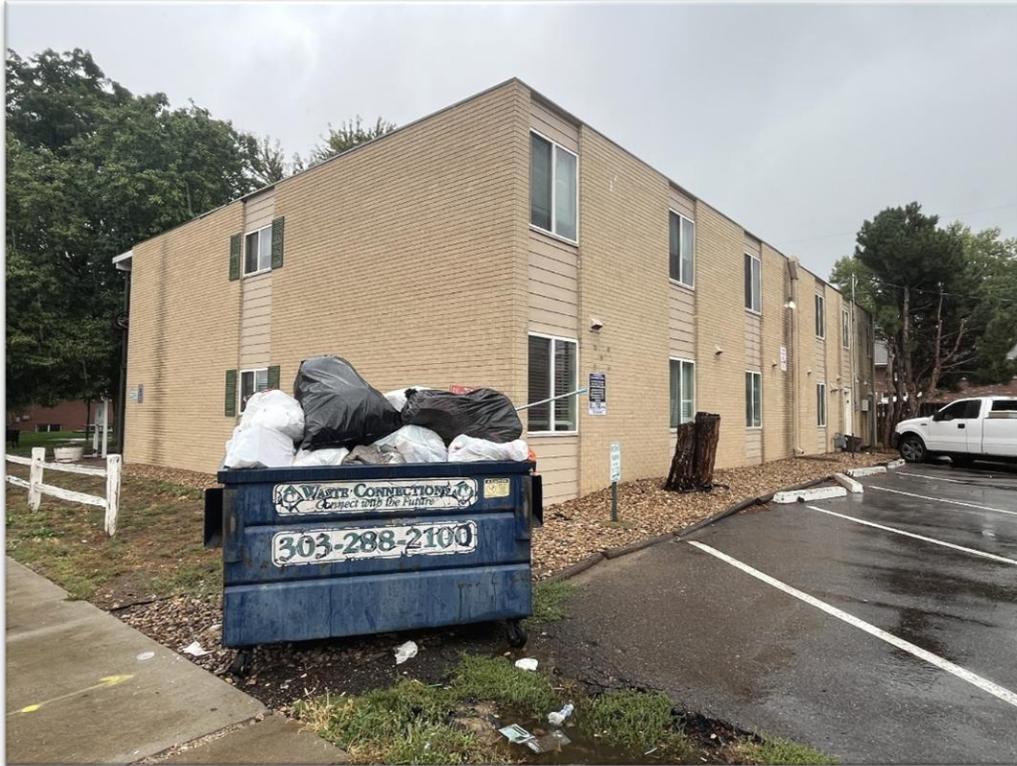
Photo Number: 3

Description: West and south elevations of the building featuring the replacement vinyl one-by-one light sliding windows.

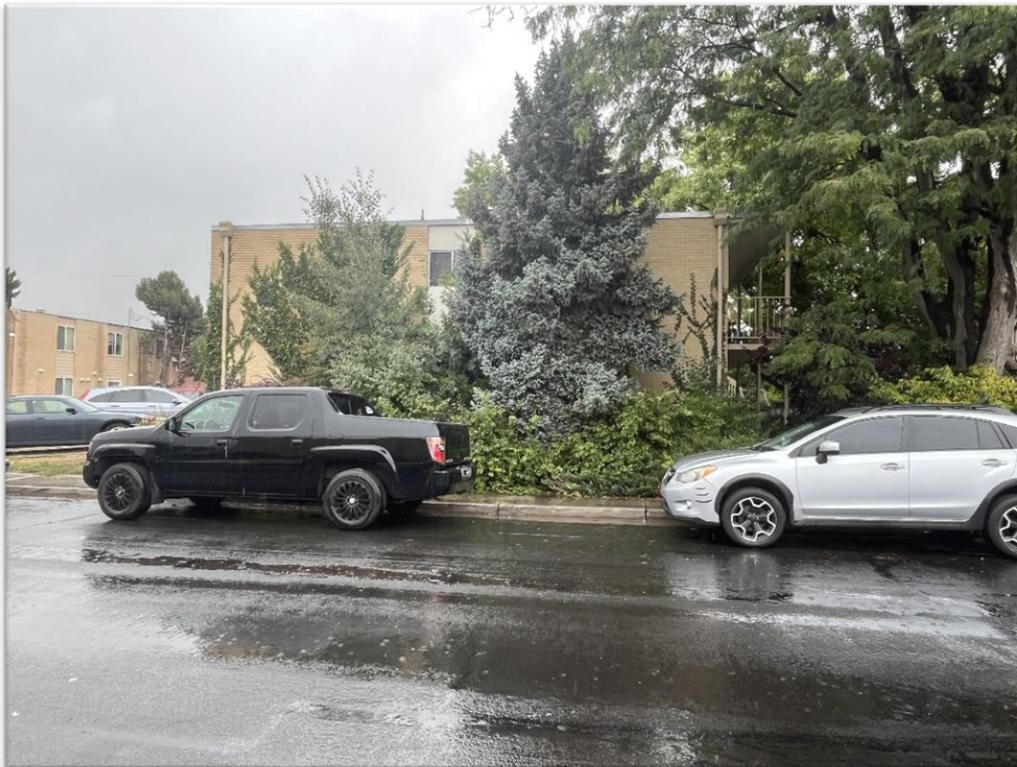
Photo Number: 4

Description: West elevation of the building obscured by mature vegetation.

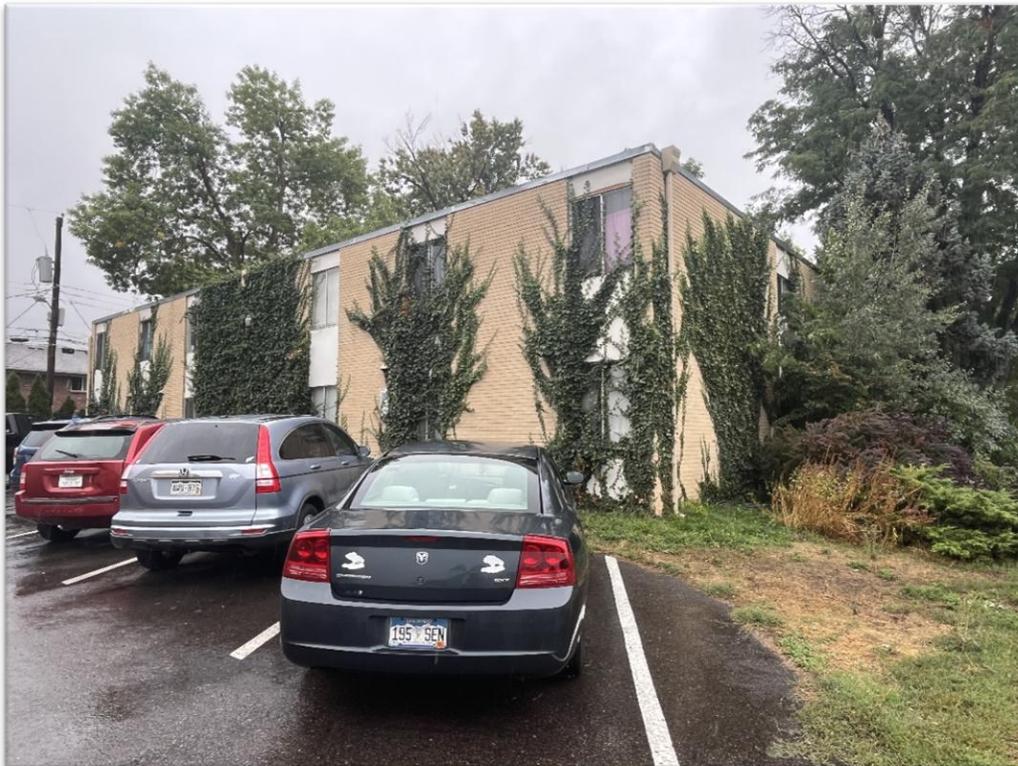
Photo Number: 6

Description: North elevation featuring original metal windows.

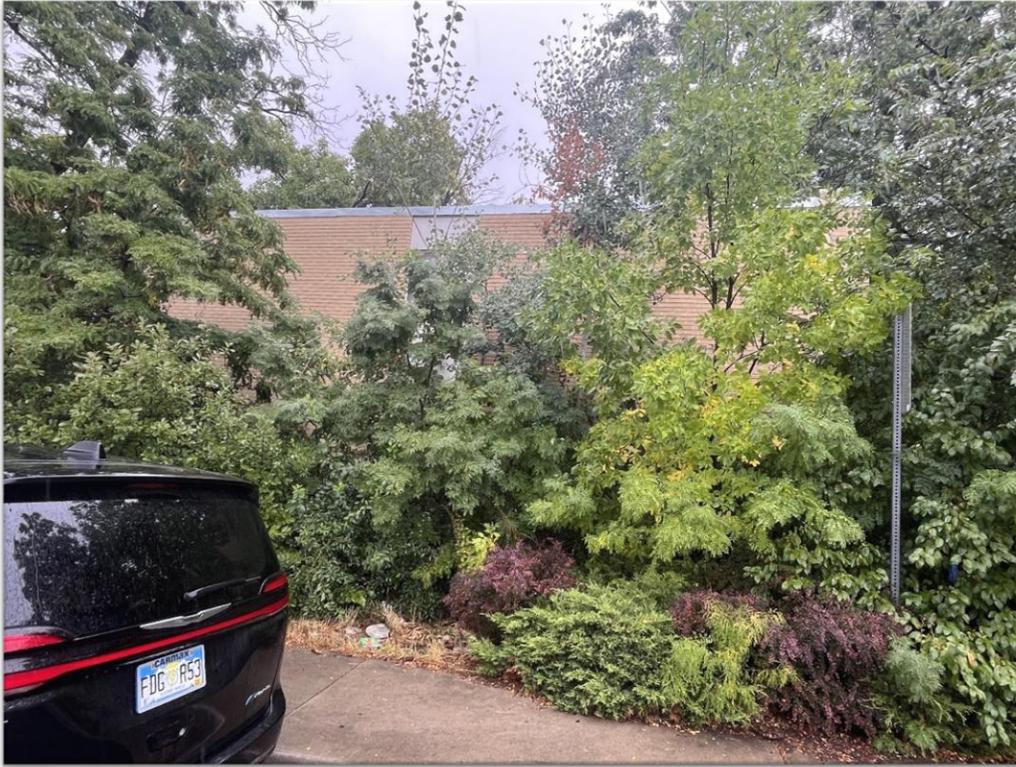
Photo Number: 7

Description: West elevation obscured by mature vegetation.

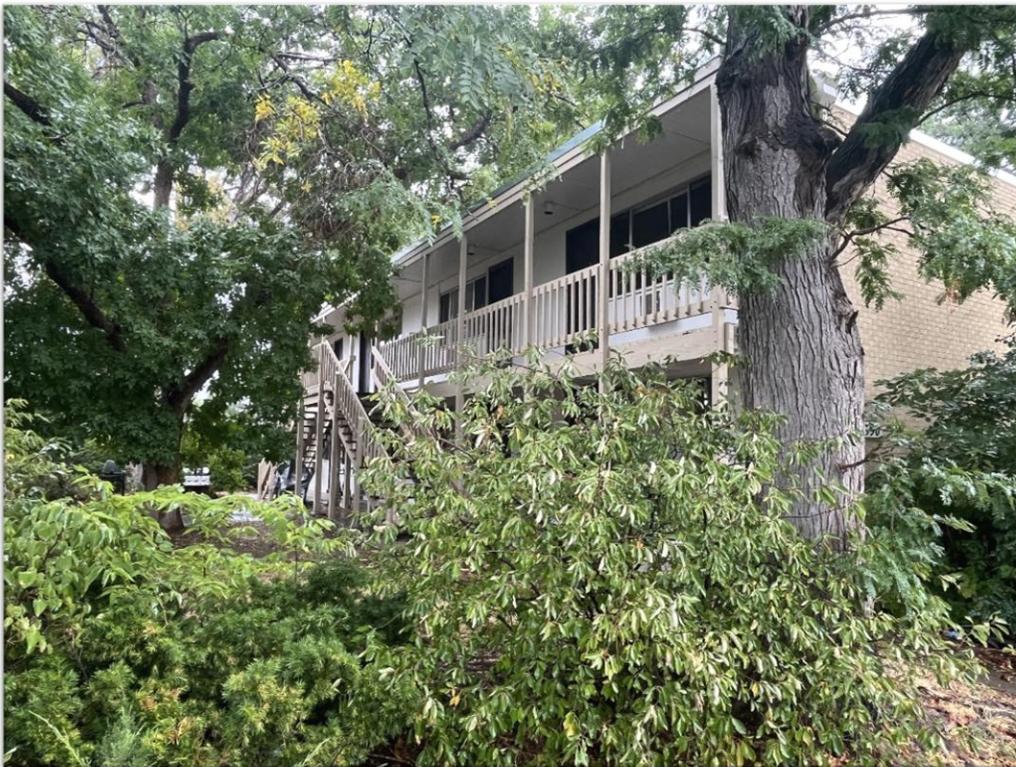
Photo Number: 8

Description: Primary (north) elevation of the building on 5390 South Elati Street featuring a wood breezeway and staircases.

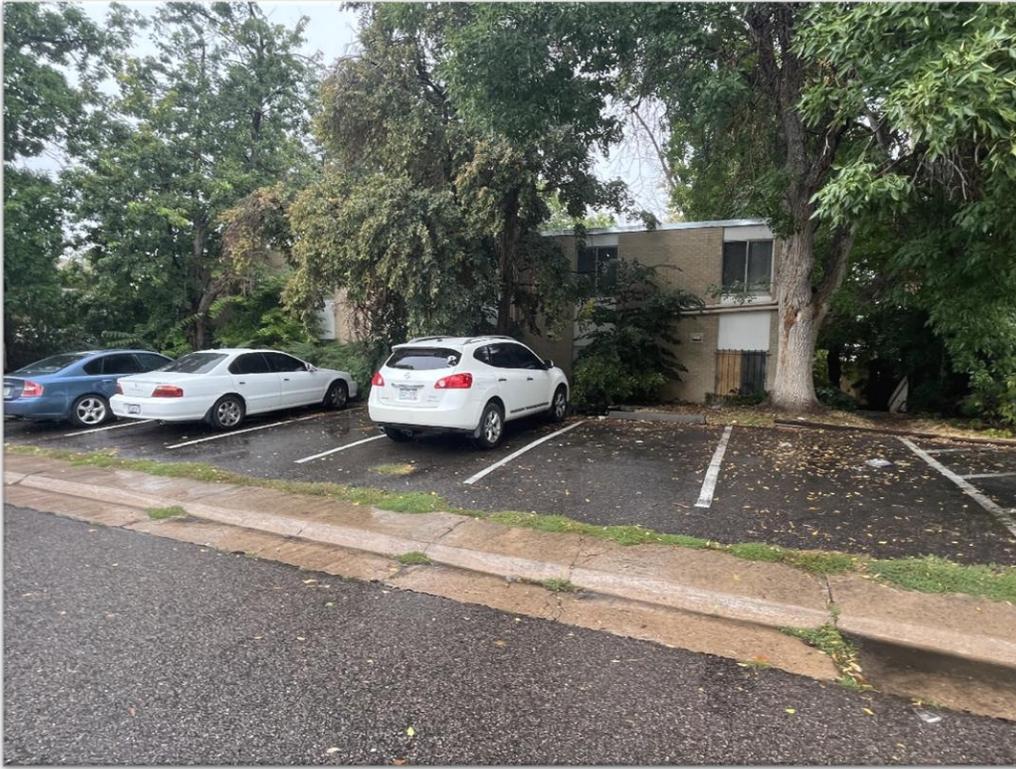
Photo Number: 9

Description: South elevation obscured by mature vegetation.

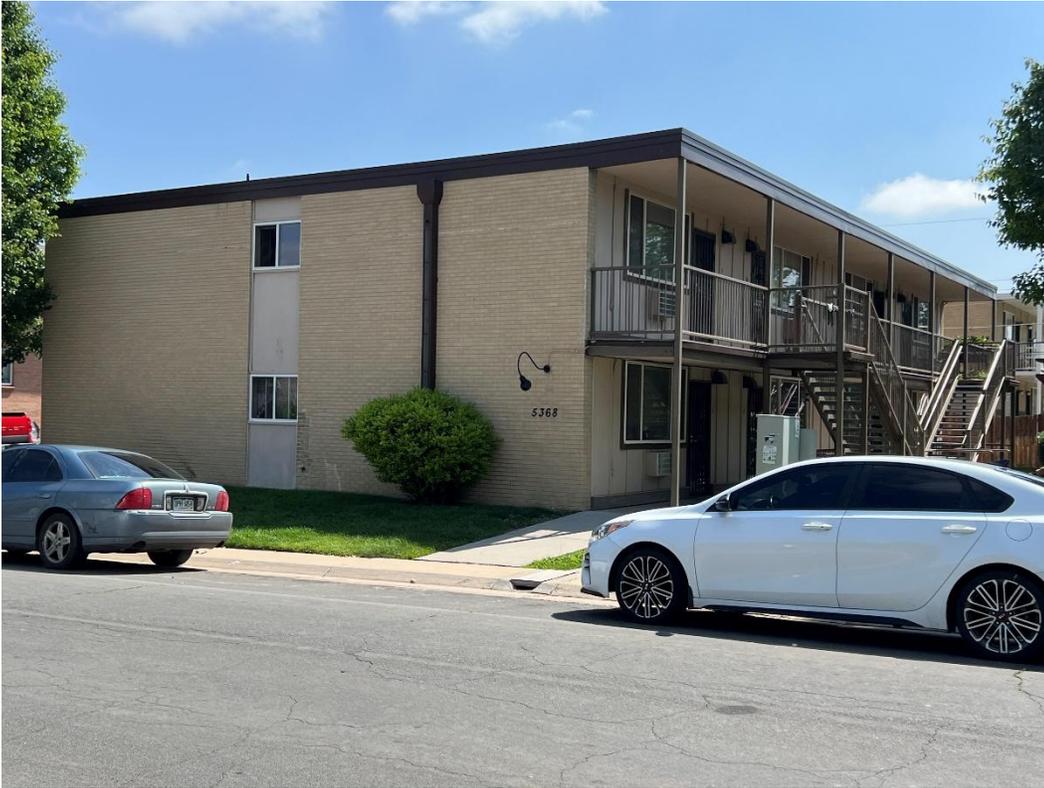
Photo Number: 1

Description: Looking at the primary (south) and west elevations of the building at 5368 South Fox Street.

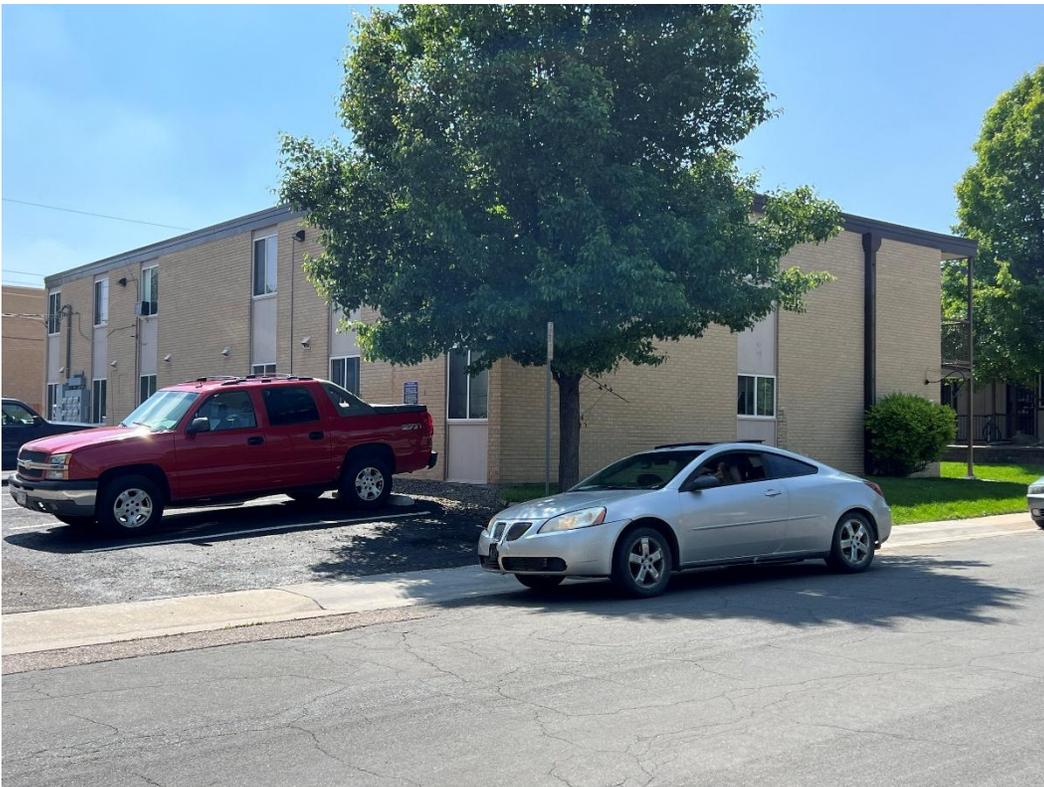
Photo Number: 2

Description: Looking at the west and north elevations of the building at 5368 South Fox Street.

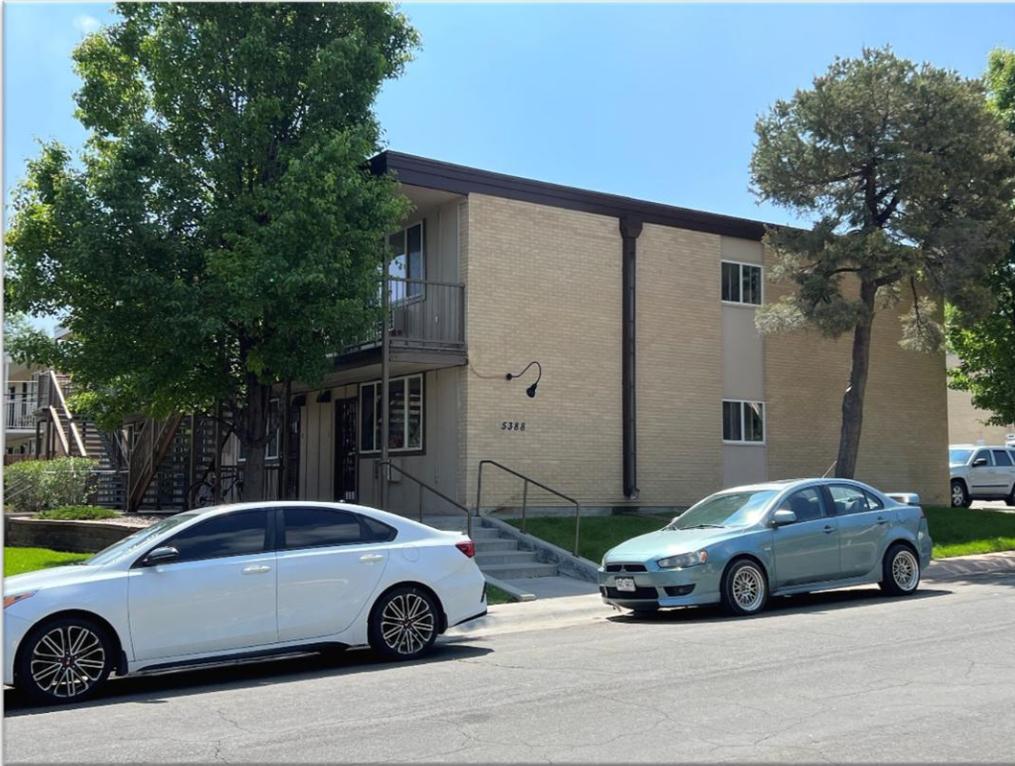
Photo Number: 3

Description: Looking at the primary (north) and west elevations of the building at 5388 South Fox Street.

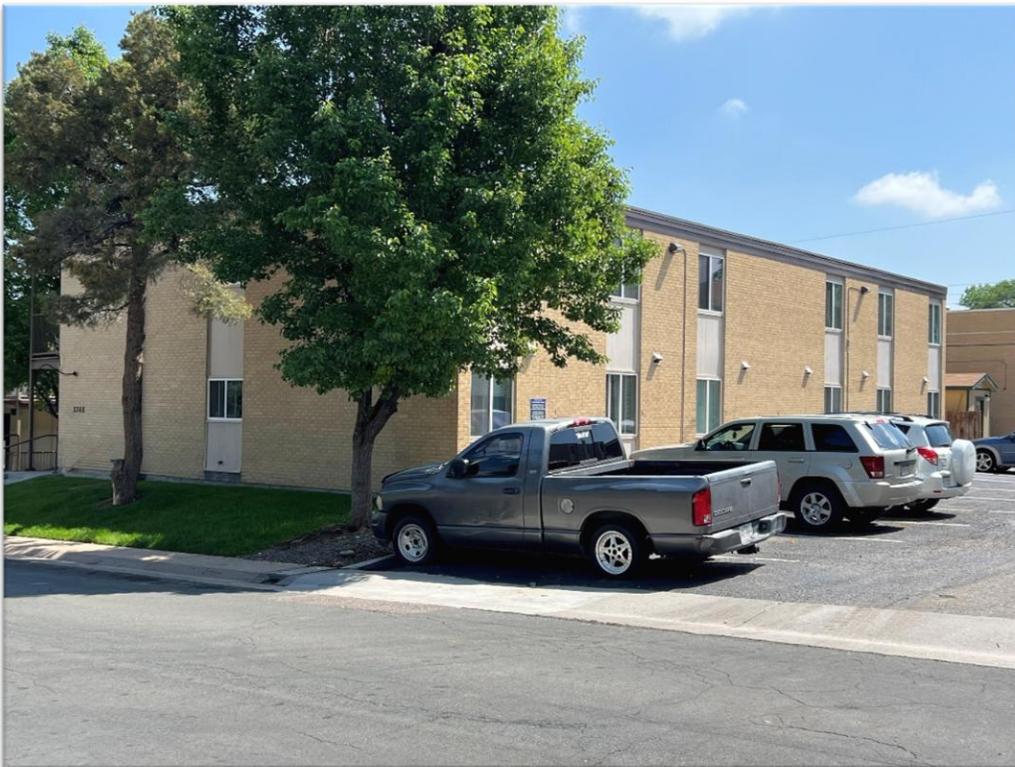
Photo Number: 4

Description: Looking at the west and south elevations of the building at 5388 South Fox Street.

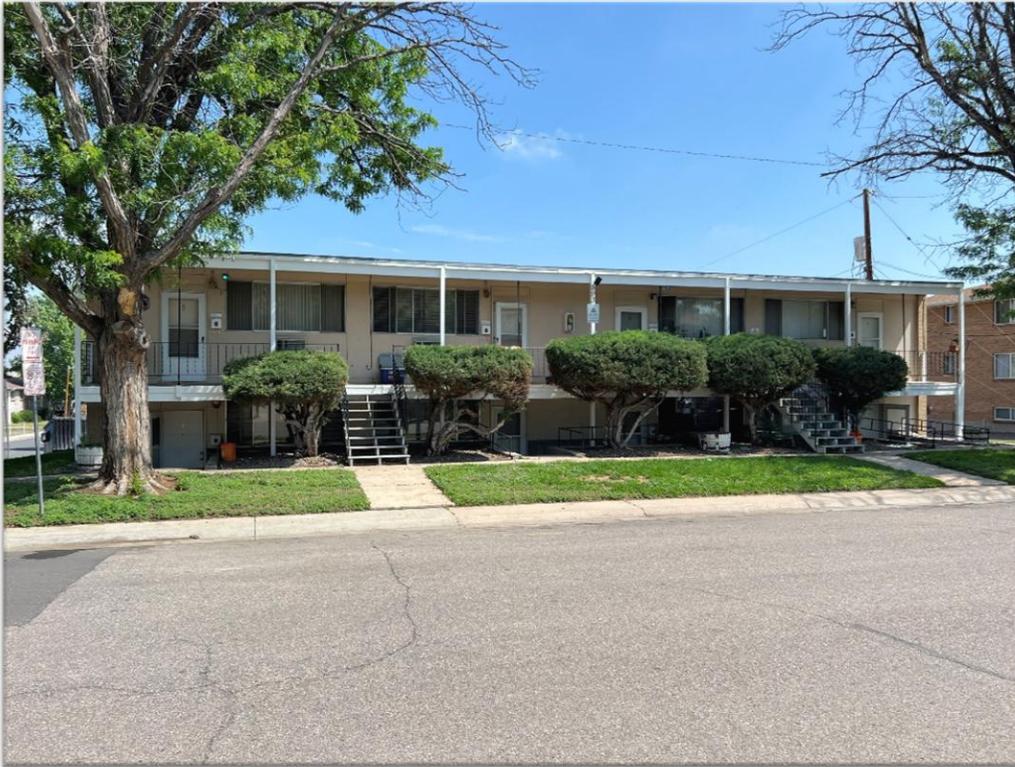
Photo Number: 5

Description: Looking at the primary (south) elevation of the building at 593 West Crestline Avenue.

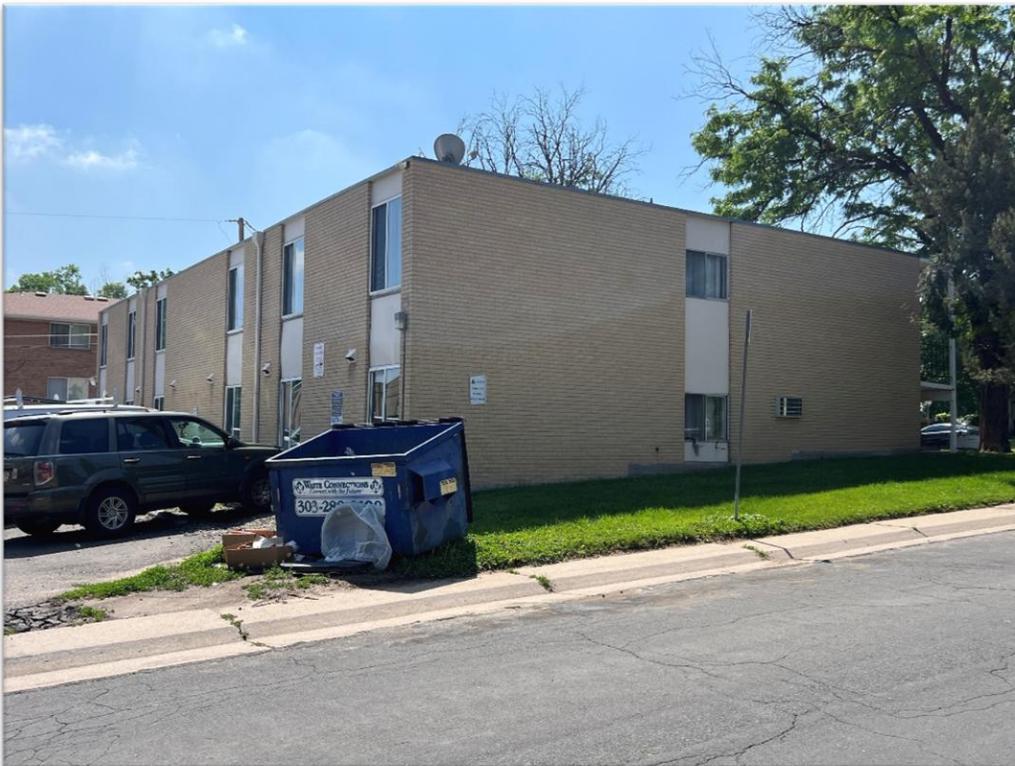
Photo Number: 6

Description: Looking at the north and west elevations of the building at 593 West Crestline Avenue.
