City of Littleton Survey Plan and Reconnaissance Survey Report

Pinyon Project No.:
124169901

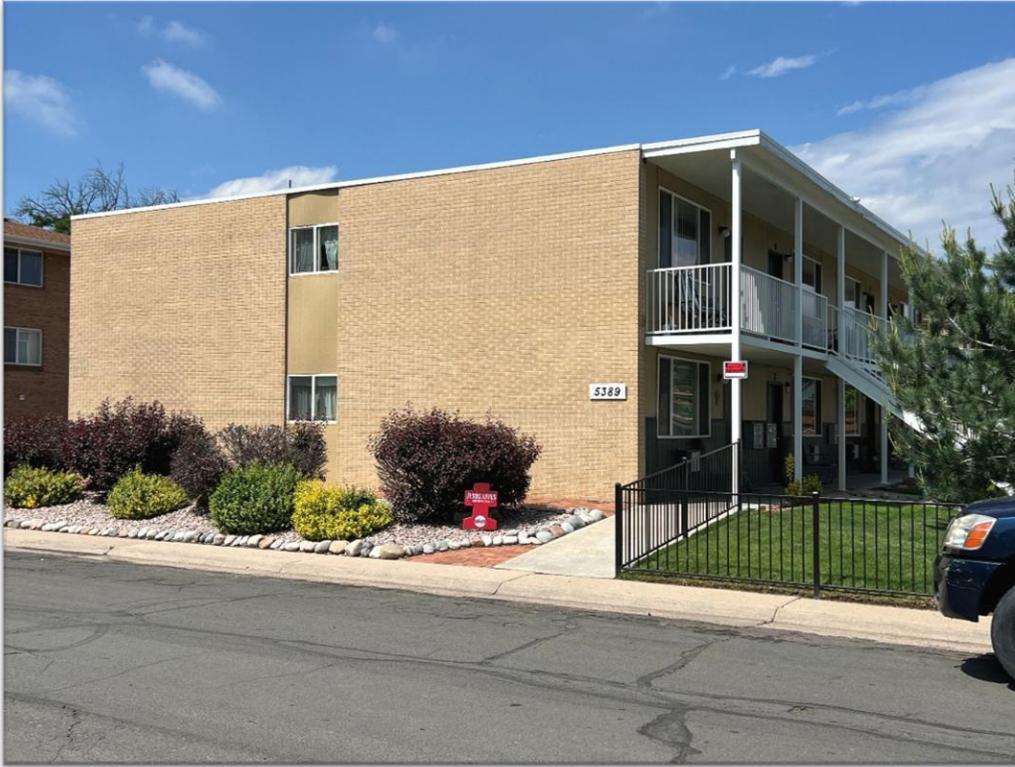
Photo Number: 8

Description: Looking at the south and east elevations of the building at 5389 South Elati Street.

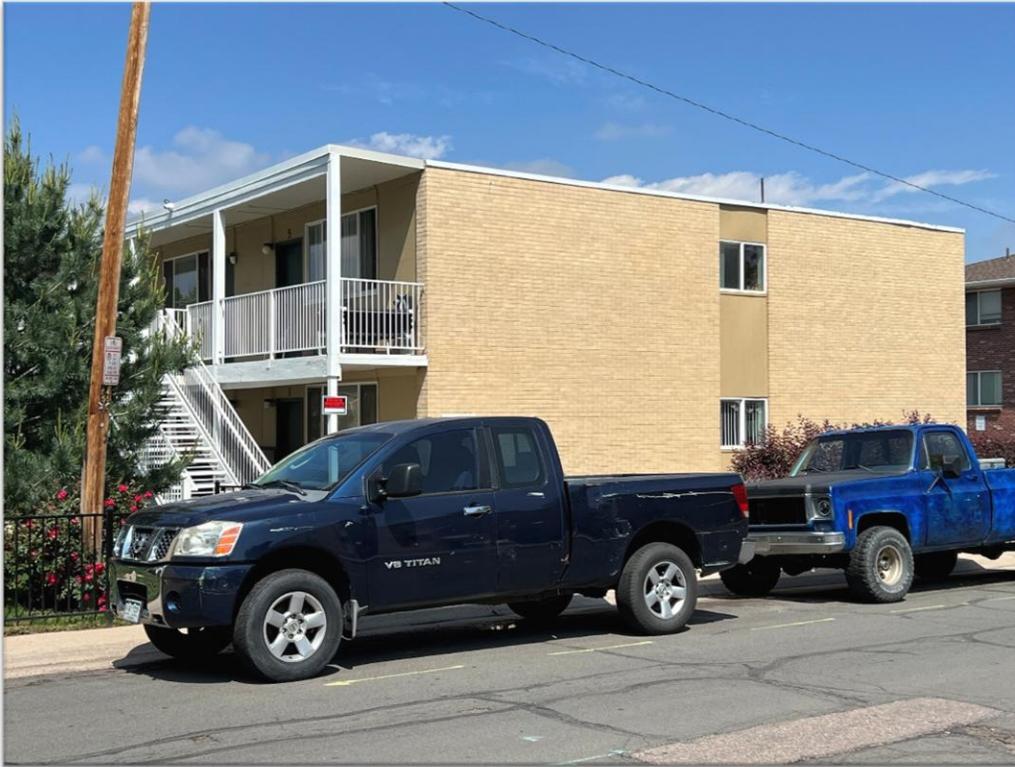
Photo Number: 9

Description: Looking at the primary (south) and east elevations of the building at 5369 South Elati Street.

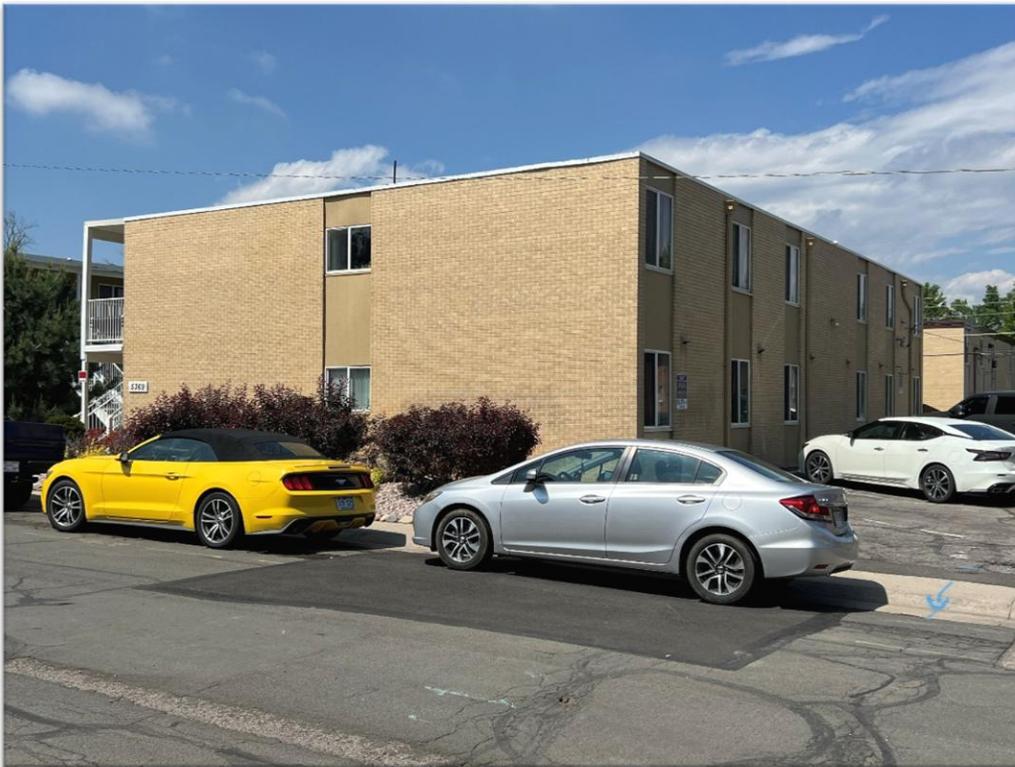
Photo Number: 10

Description: Looking at the east and north elevations of the building at 5369 South Elati Street.

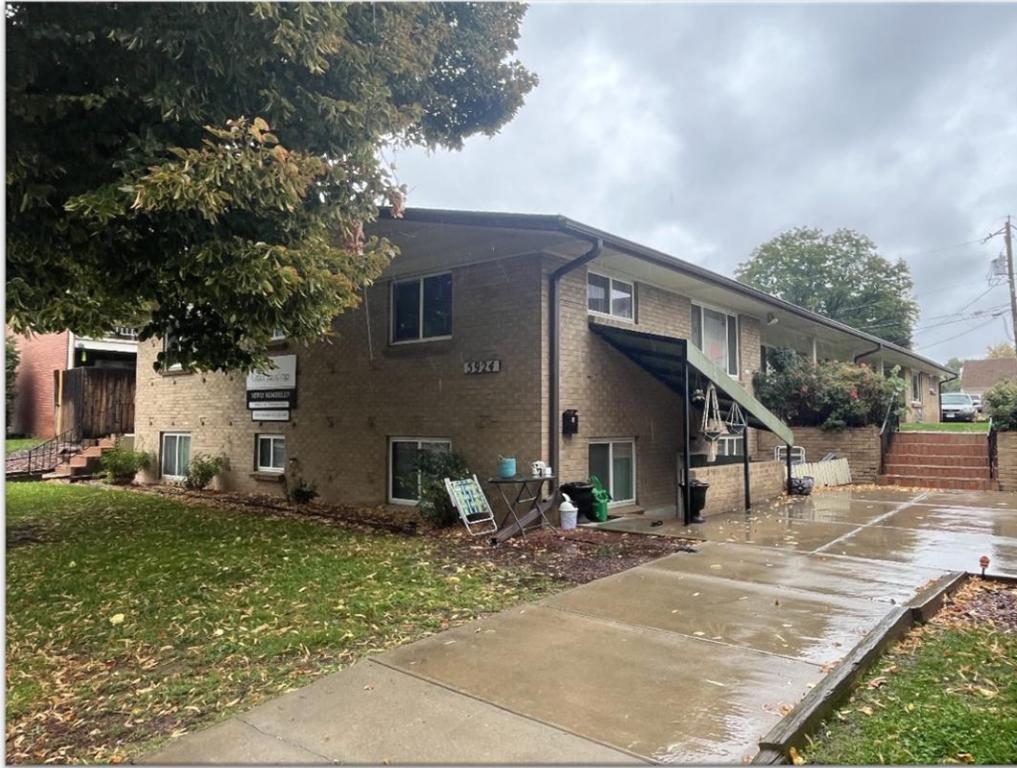
Photo Number: 1

Description: Primary (south) elevation of the building at 5924 South Datura Street featuring the retaining wall supporting the lawn abutting the second story, and the below-grade first story.

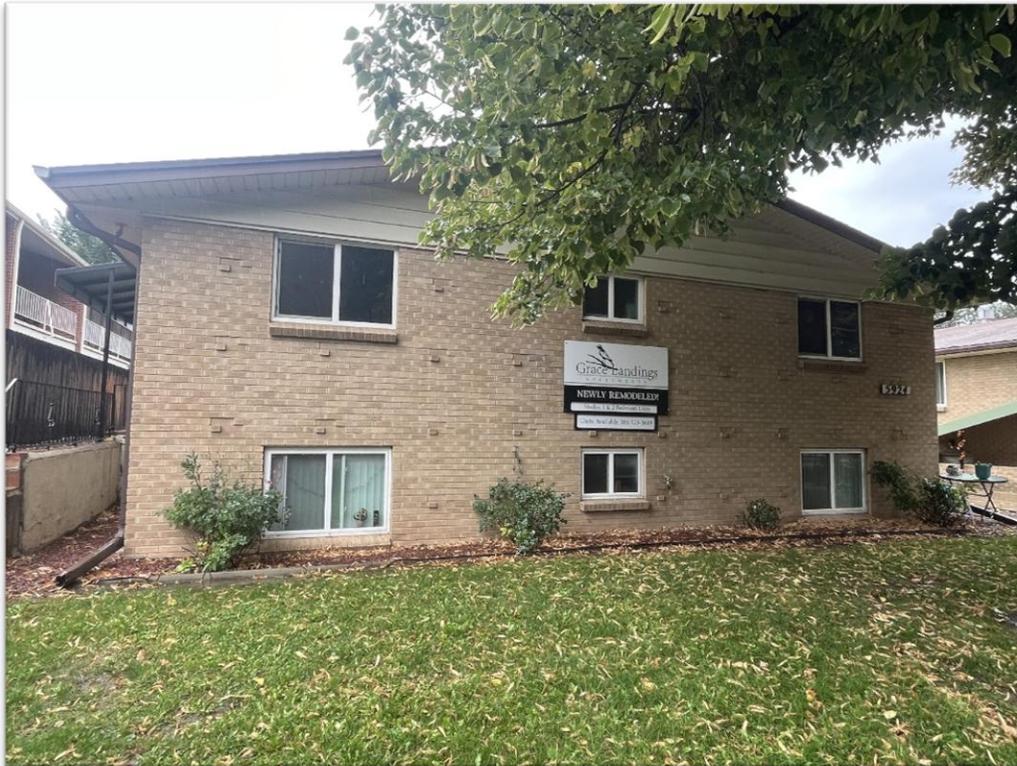
Photo Number: 2

Description: West elevation featuring typical windows and the articulated brick decorating the façade.

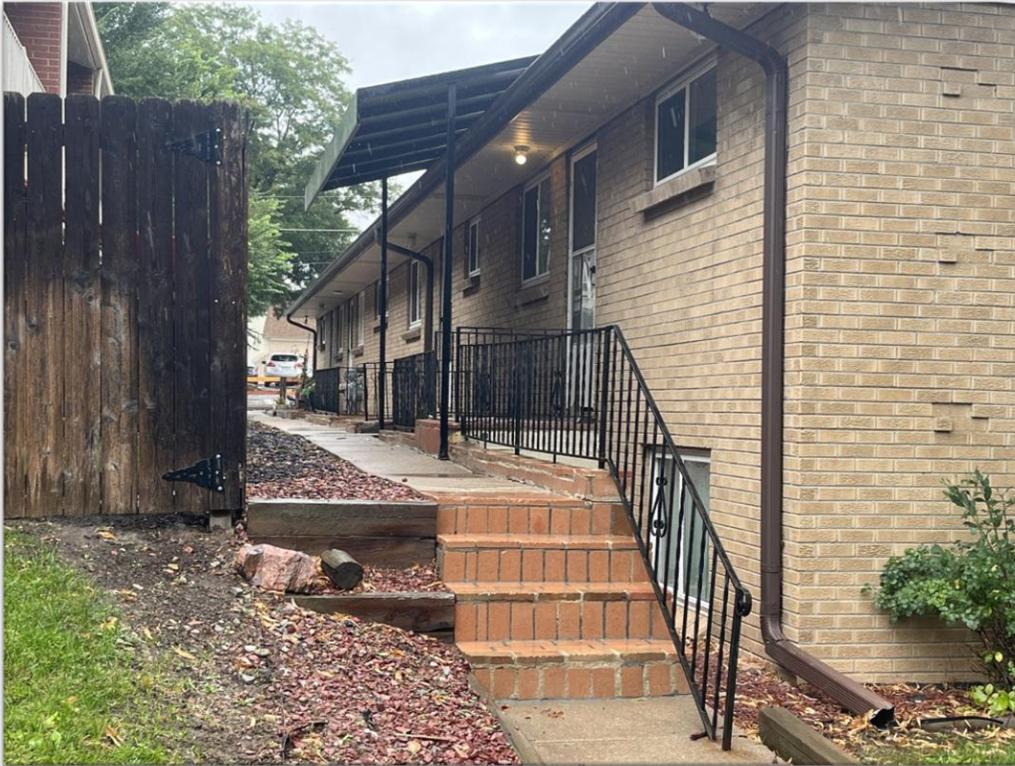
Photo Number: 3

Description: North elevation featuring the secondary entrances on the second story and the typical window on the first story.

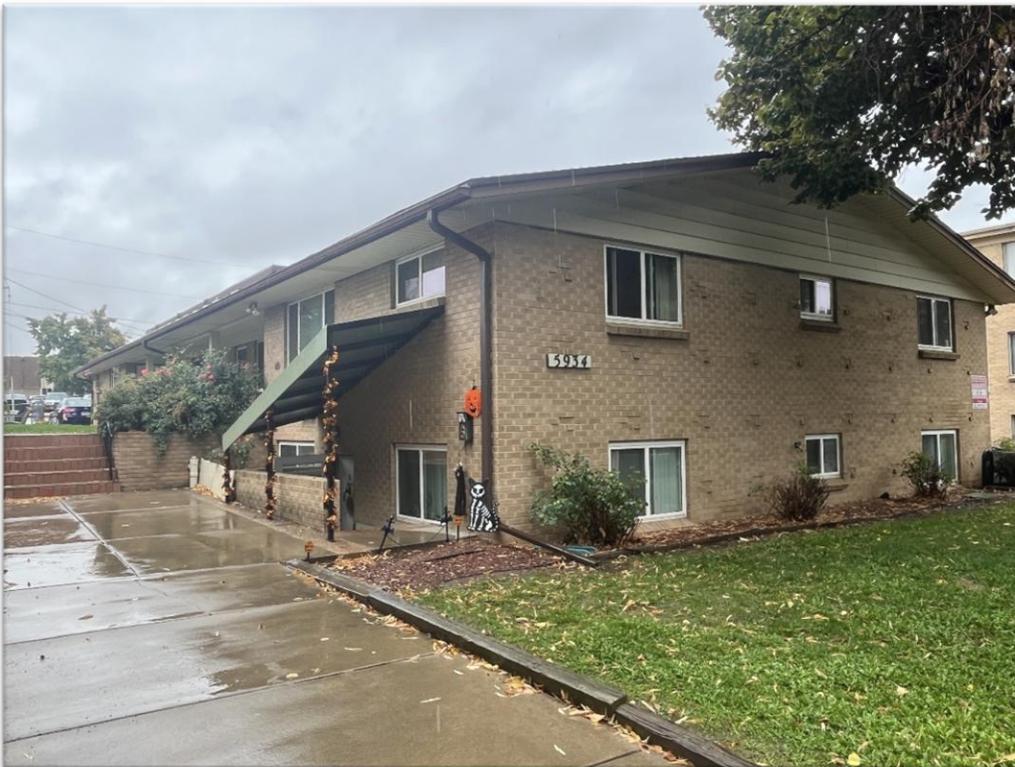
Photo Number: 4

Description: Primary (north) and west elevation of the building at 5934 South Datura Street featuring typical windows and the awning above the stairs leading to the below-grade first story.

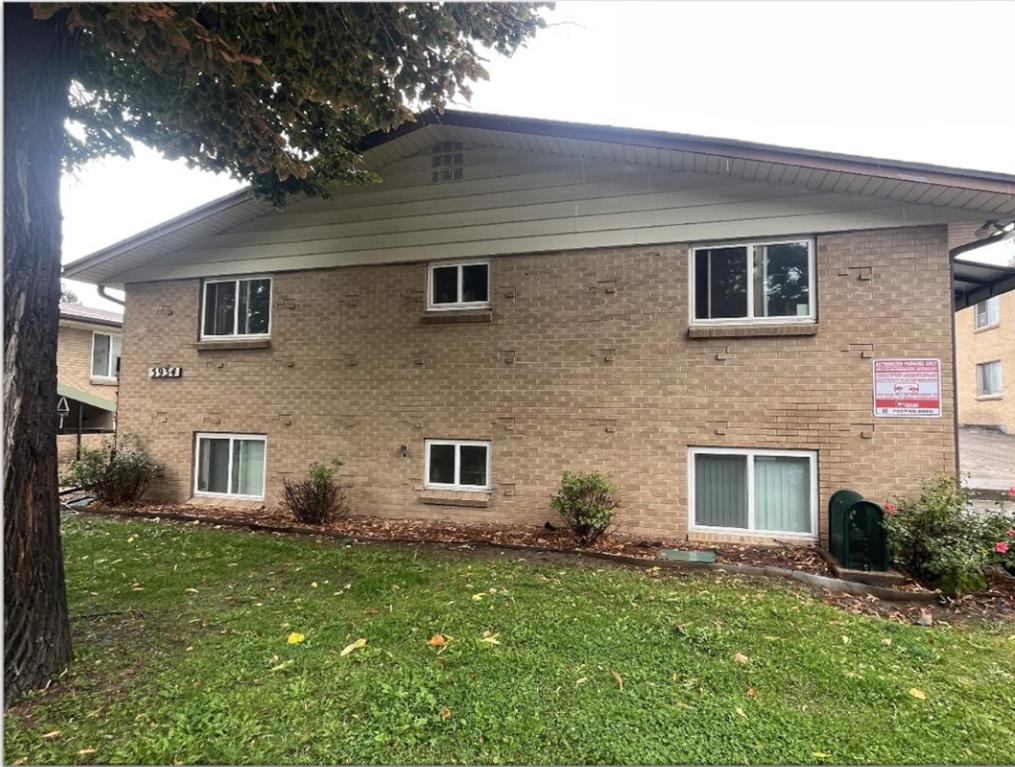
Photo Number: 5

Description: West elevation featuring typical windows and articulated brick decorating the façade.

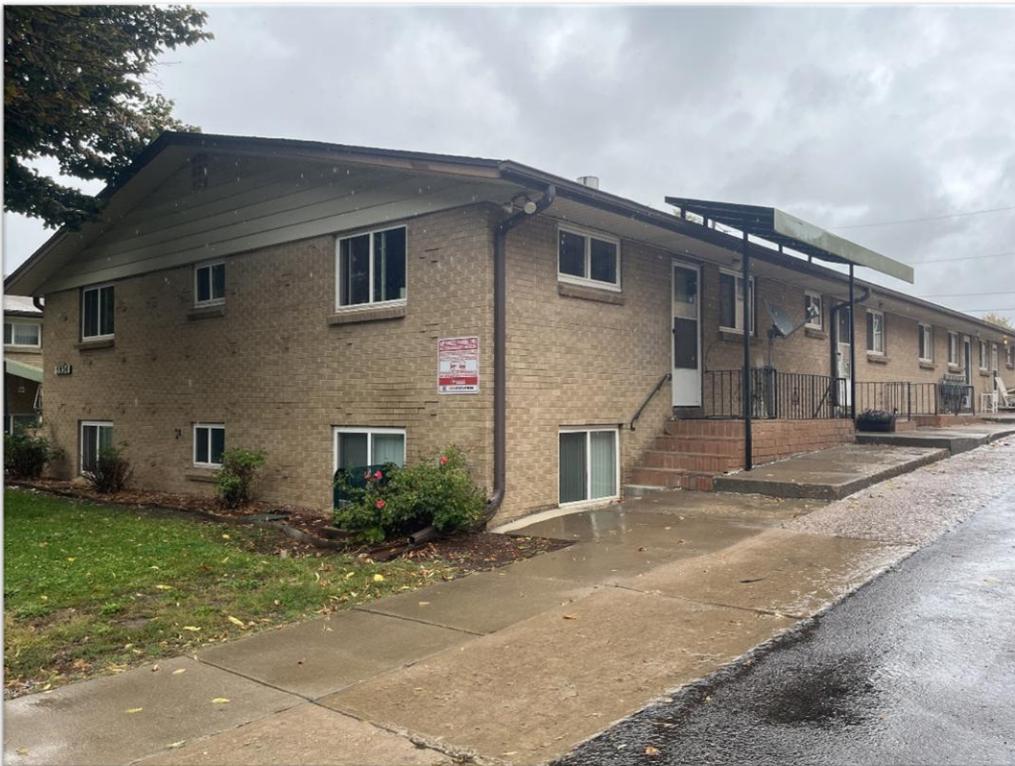
Photo Number: 6

Description: South elevation featuring the secondary entrances.

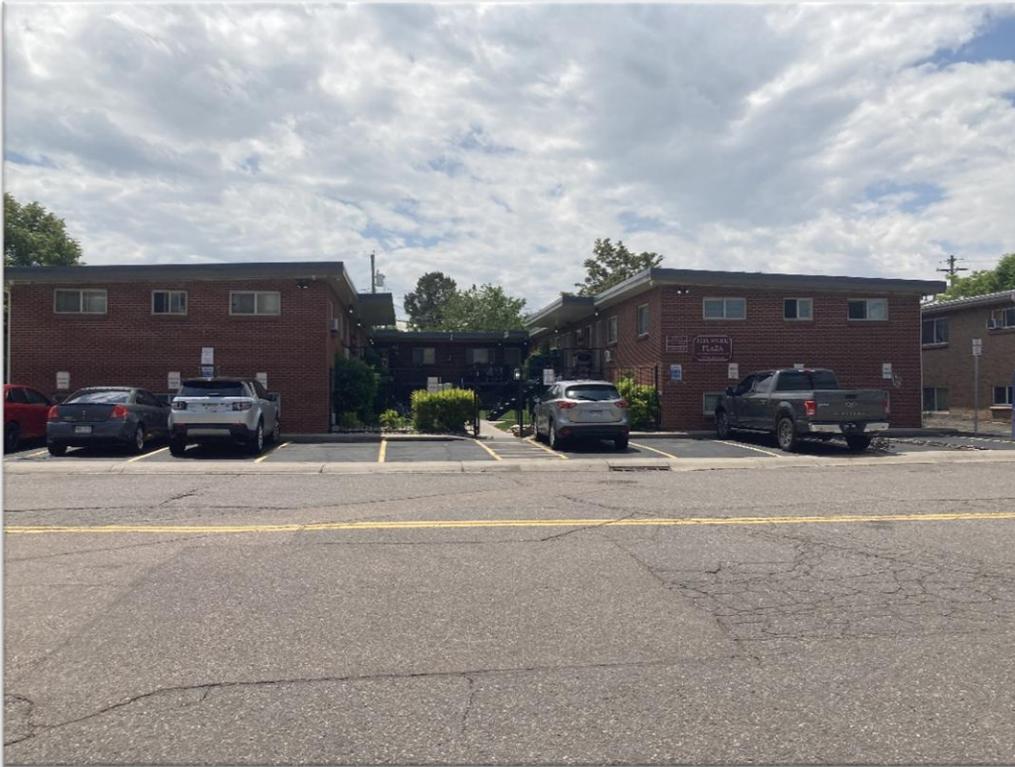
Photo Number: 1

Description: Primary (north) elevation featuring the courtyard at the center of the U-shape plan.

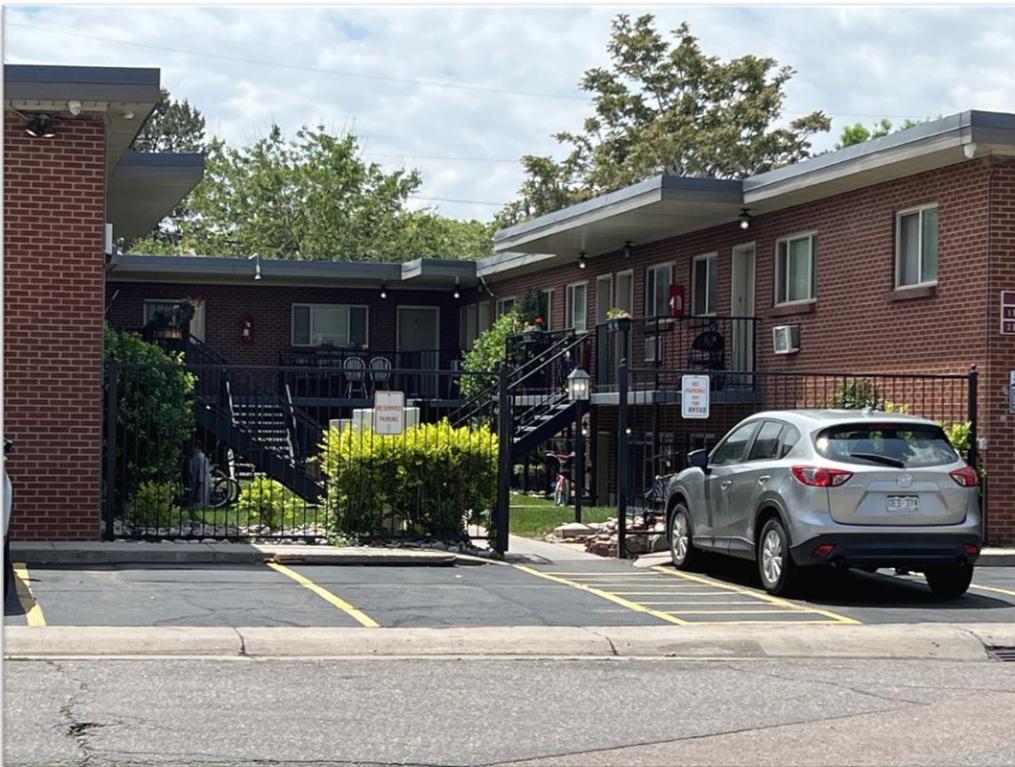
Photo Number: 2

Description: West elevation at the center of the U-shape plan featuring the metal staircase leading to the second story and the roof extending over the entrances.

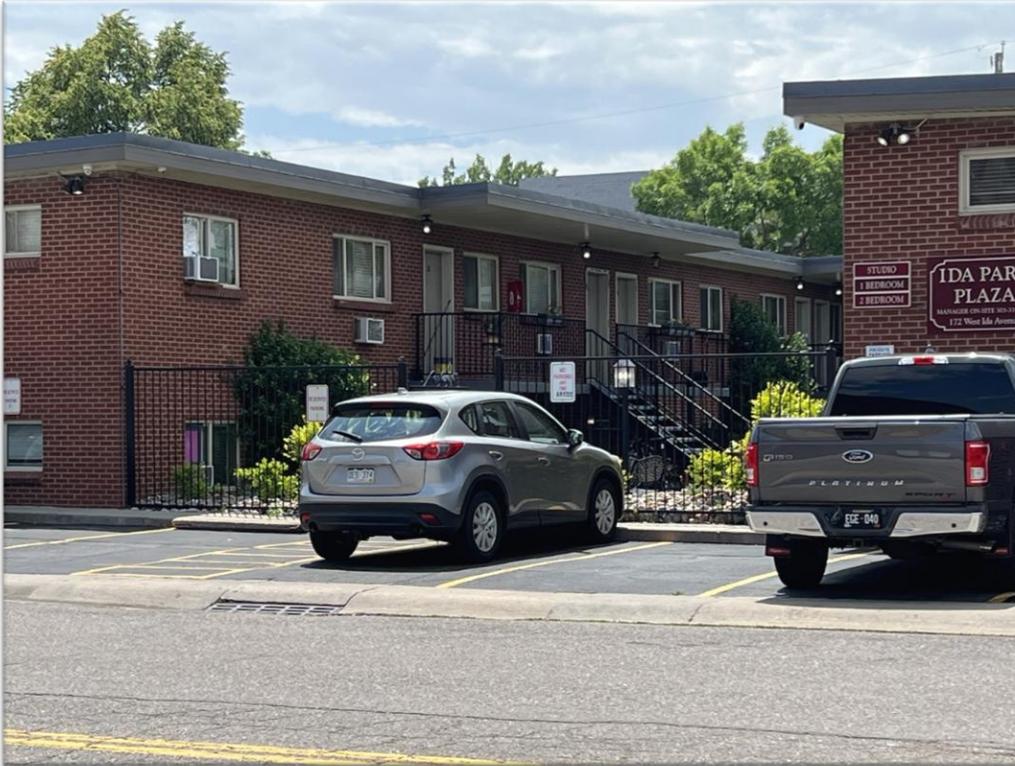
Photo Number: 3

Description: East elevation at the center of the U-shape plan featuring the metal staircase leading to the second story and the roof extending over the entrances.

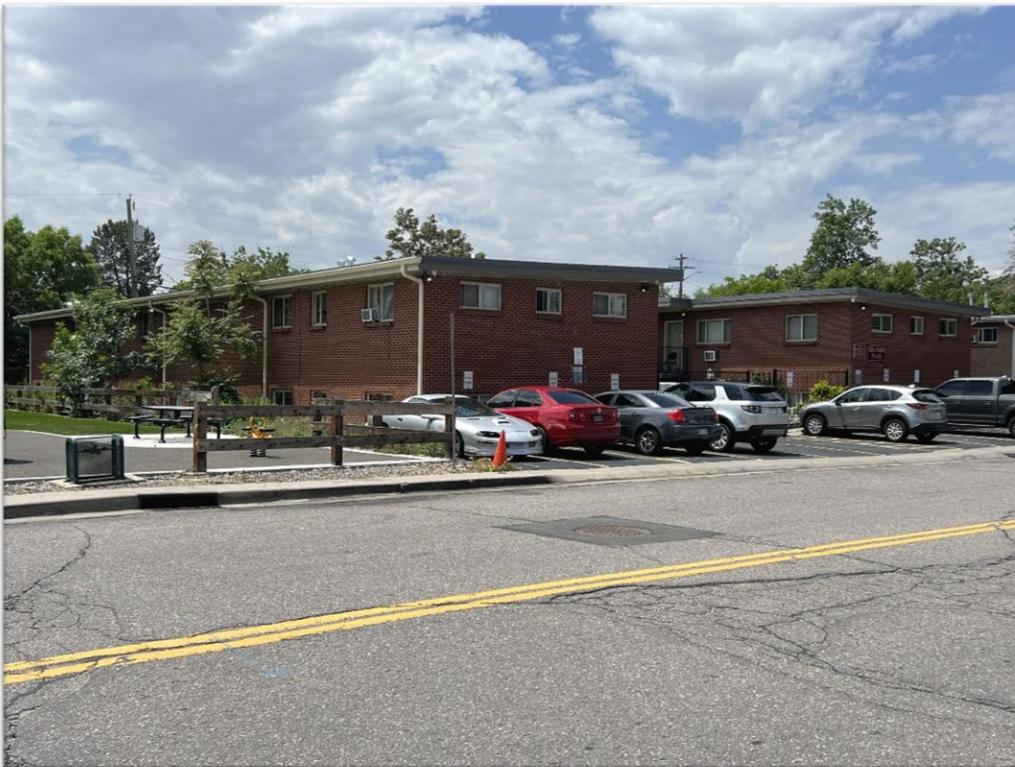
Photo Number: 4

Description: West elevation featuring vinyl one-by-one light sliding windows.

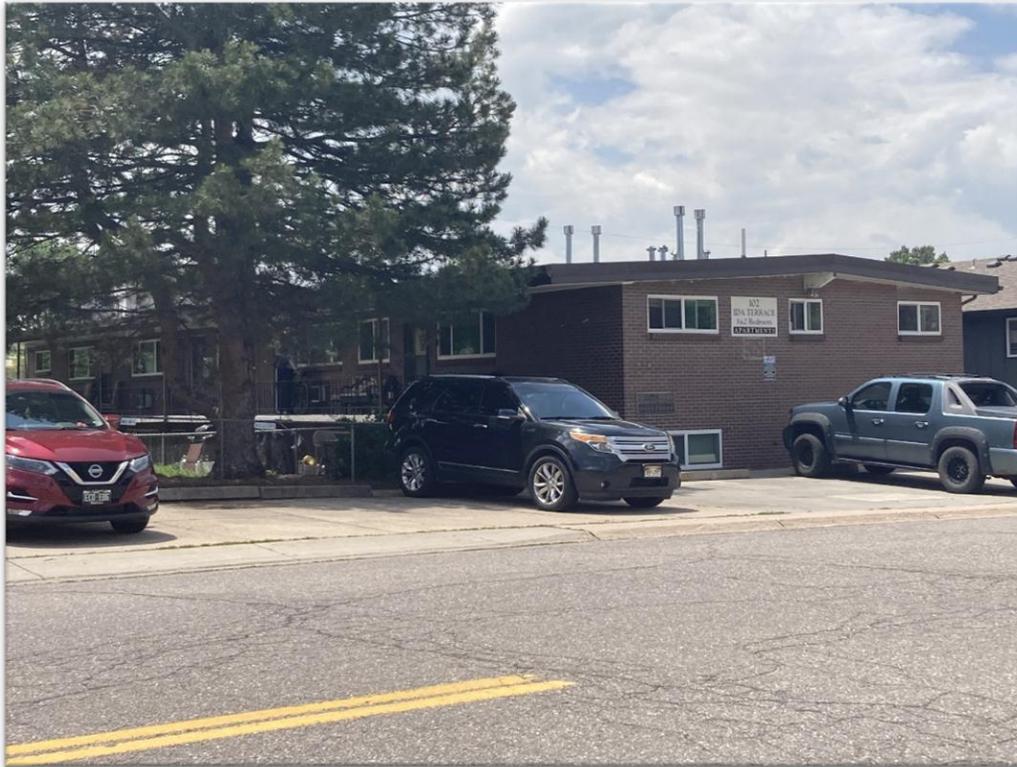
Photo Number: 1

Description: Primary (east) and north elevations of the Ida Terrace Apartments. The vinyl replacement windows are visible.

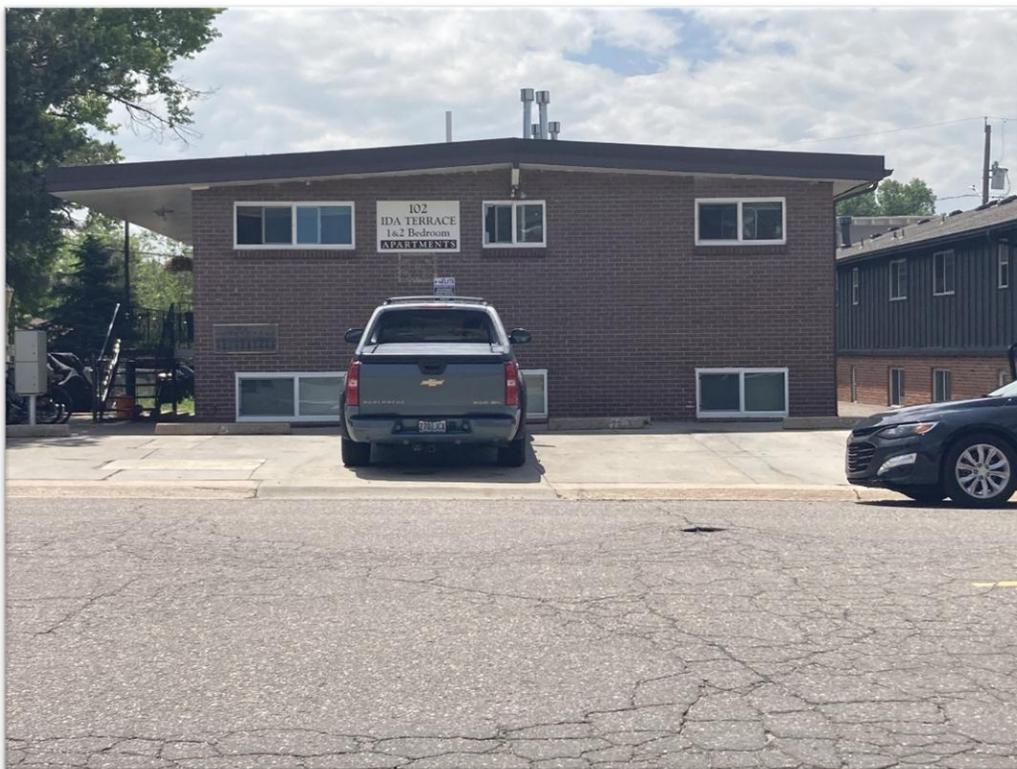
Photo Number: 2

Description: North elevation of the building and the parking lot abutting the north elevation.

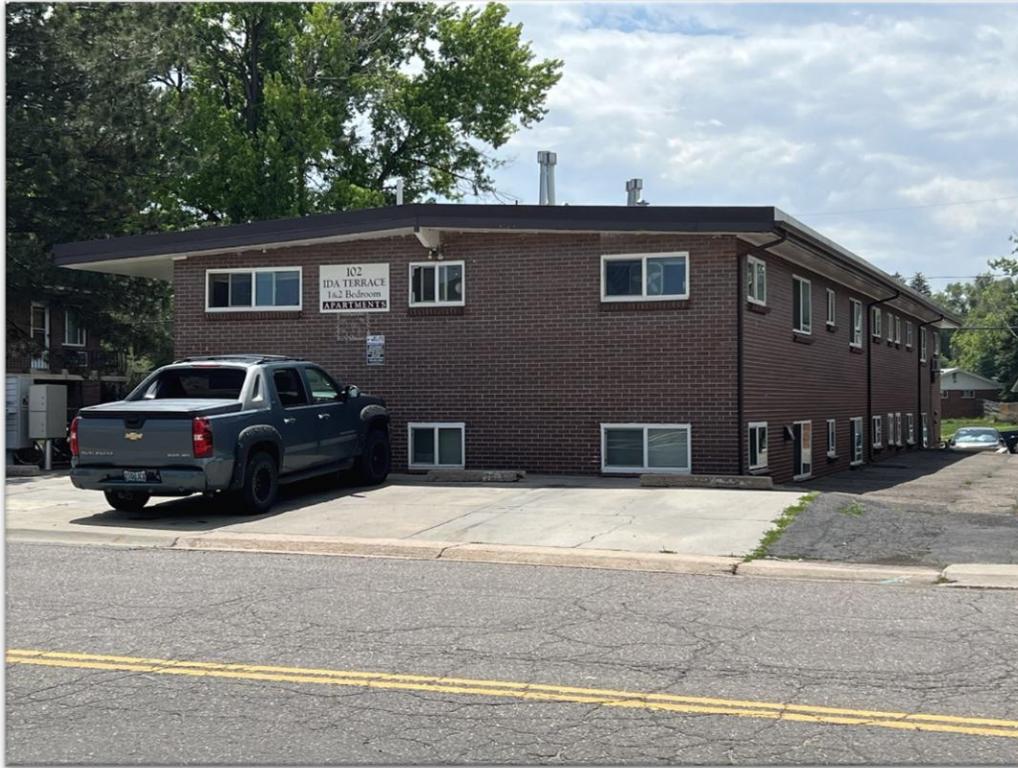
Photo Number: 3

Description: North and west elevations featuring the sliding windows or various sizes.

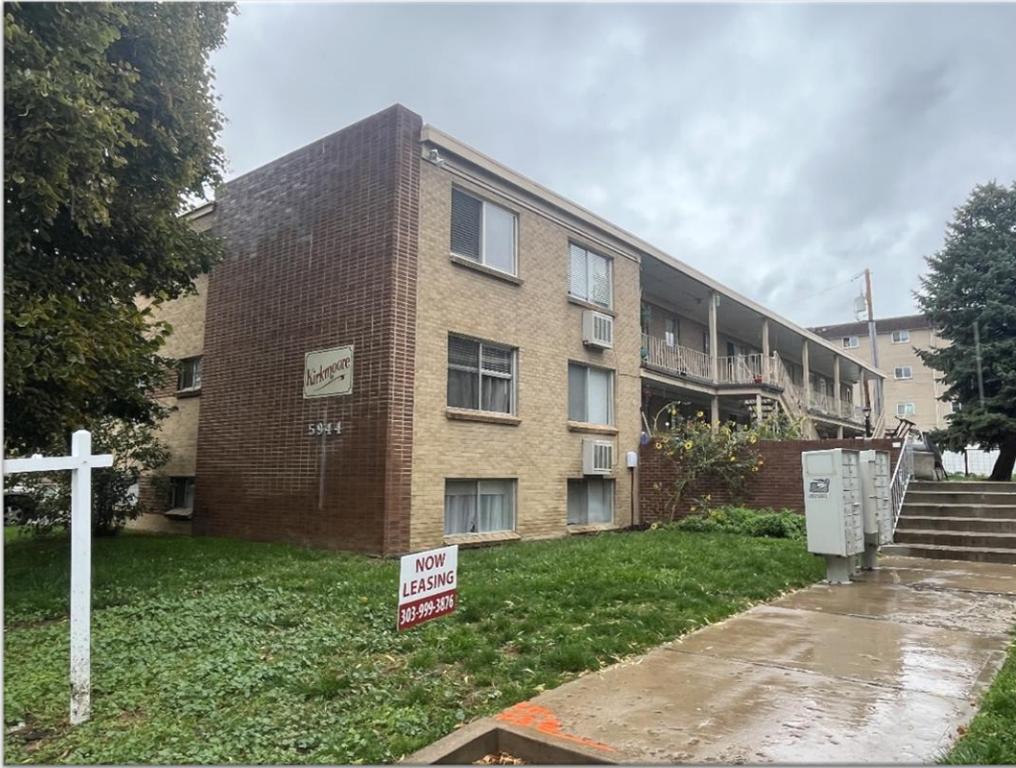
Photo Number: 1

Description: Primary (south) elevation of the building at 5944 South Datura Street featuring the original metal windows. Concrete steps lead up to the terraced yard.
View: Northeast

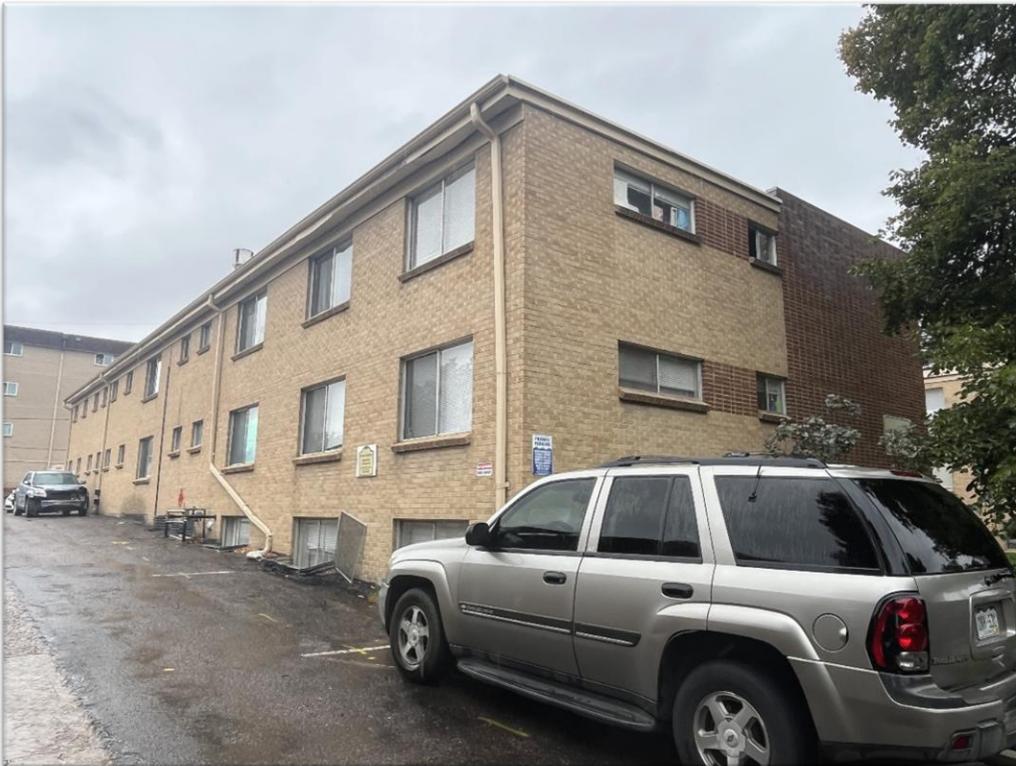
Photo Number: 2

Description: West and north elevations of the building featuring typical windows and the decorative red brick on the west elevation.
View: Southeast

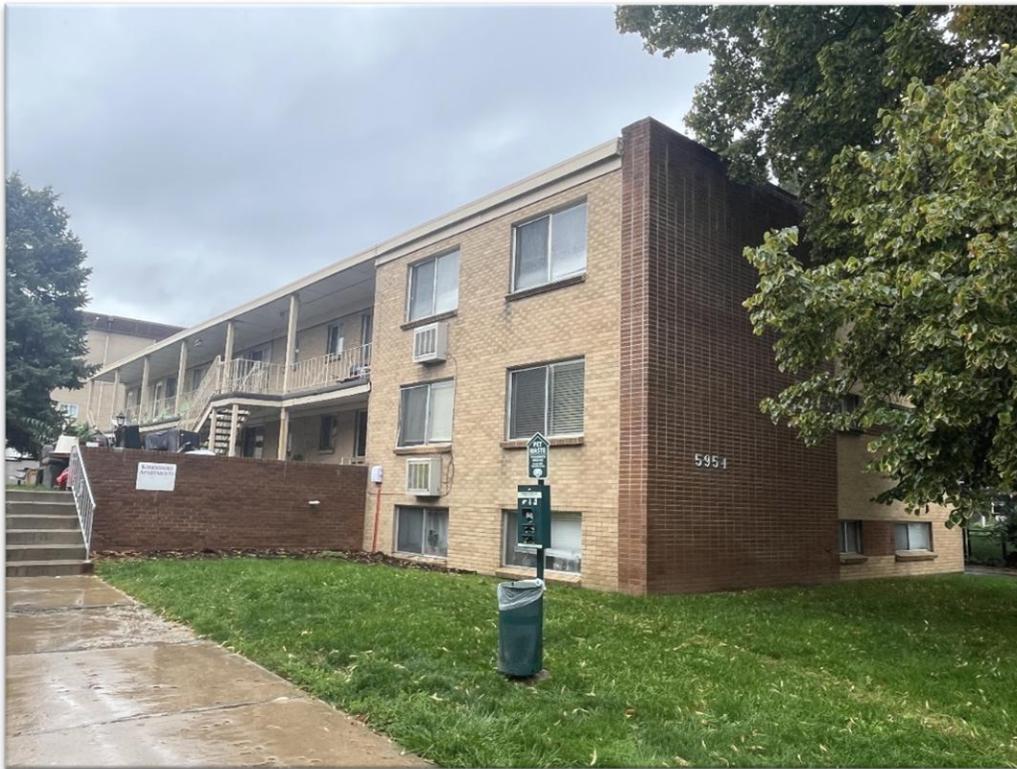
Photo Number: 3

Description: Primary (north) elevation of the building at 5954 South Datura Street featuring metal windows and metal staircase leading to the breezeway on the second story.

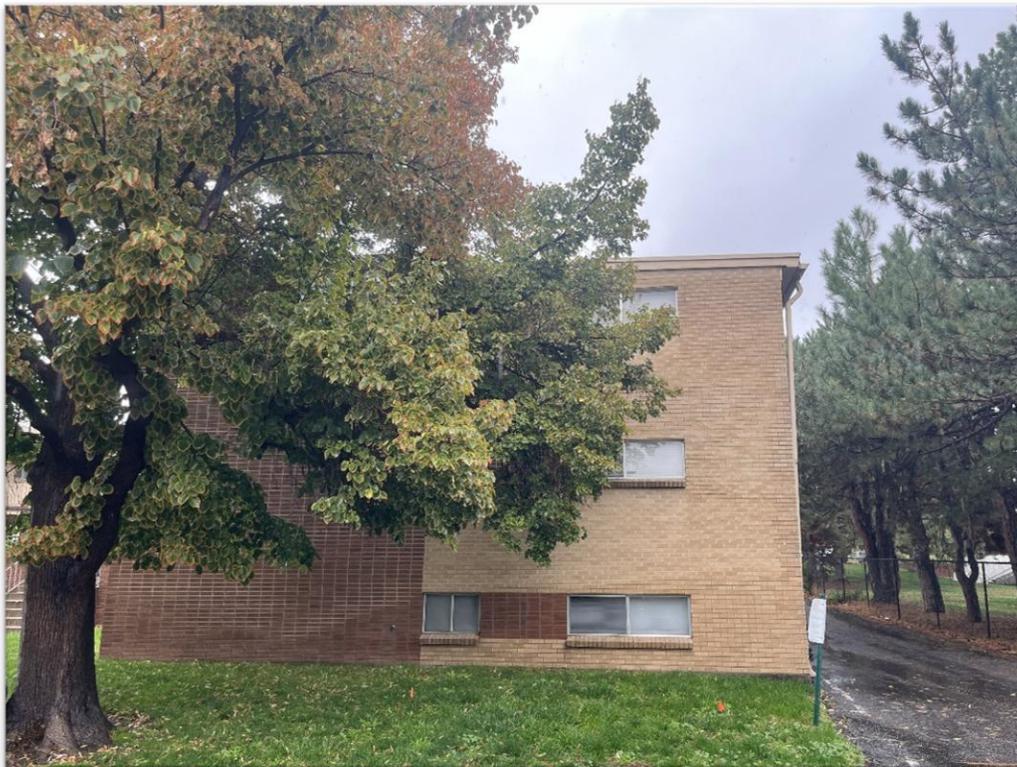
Photo Number: 4

Description: West elevation featuring typical windows and decorative red brick.

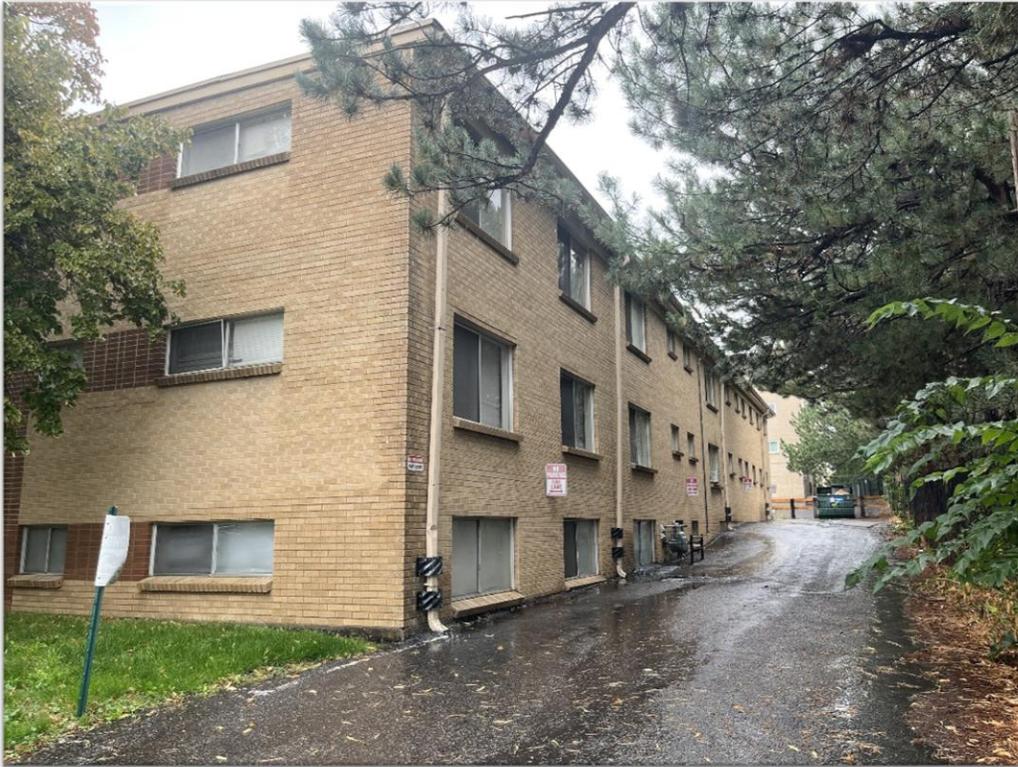
Photo Number: 5

Description: South elevation featuring typical windows.

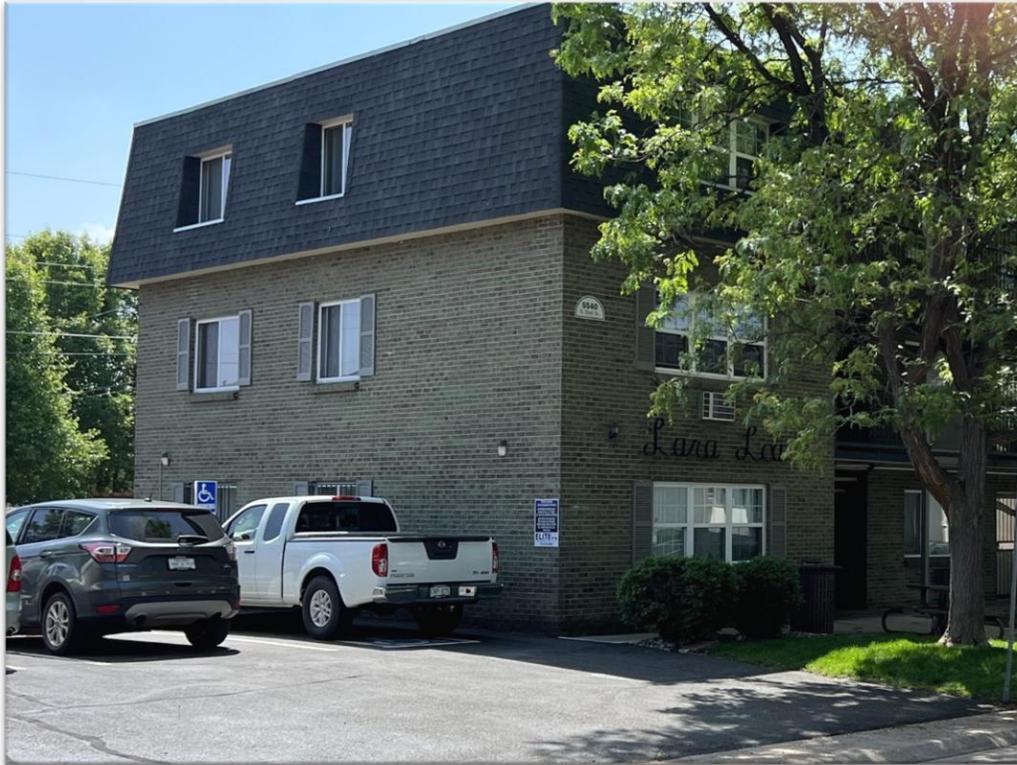
Photo Number: 1

Description: North and primary (west) elevations of the Lara Lea Apartments building. A metal sign reading "Lara Lea" is affixed to the west elevation.

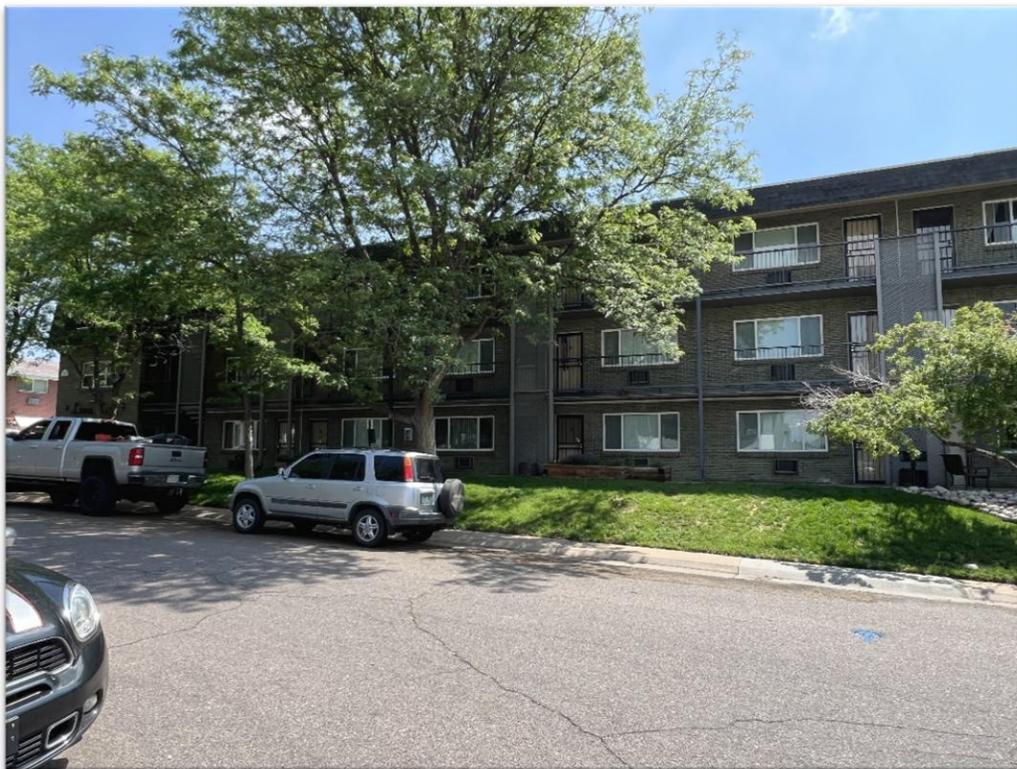
Photo Number: 2

Description: Primary (west) elevation featuring vinyl picture windows.

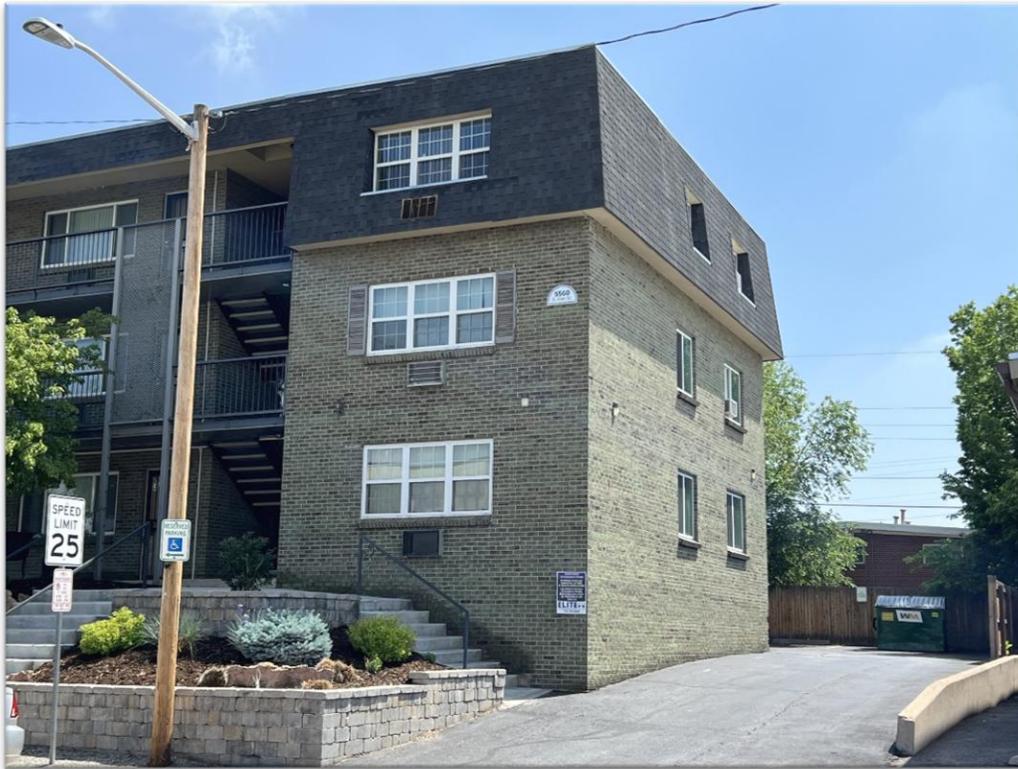
Photo Number: 5

Description: South elevation featuring vinyl one-by-one light sliding windows.

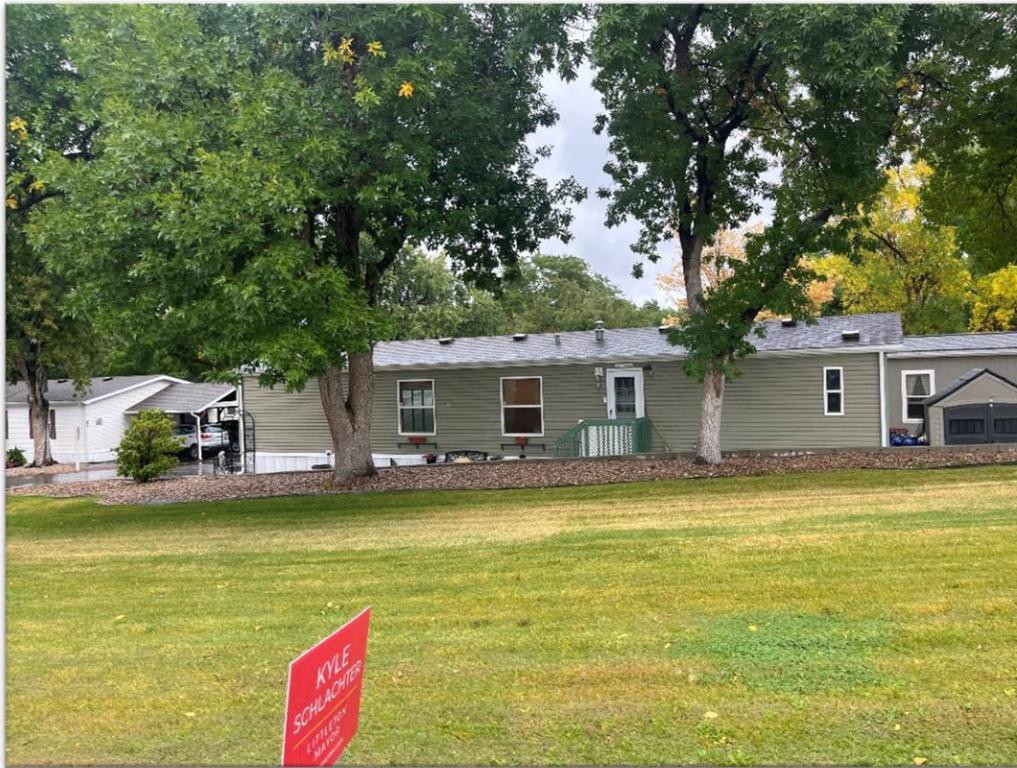
Photo Number: 1

Description: An example of a Typical Style trailer within the Meadowood Cooperative Mobile Home Park.

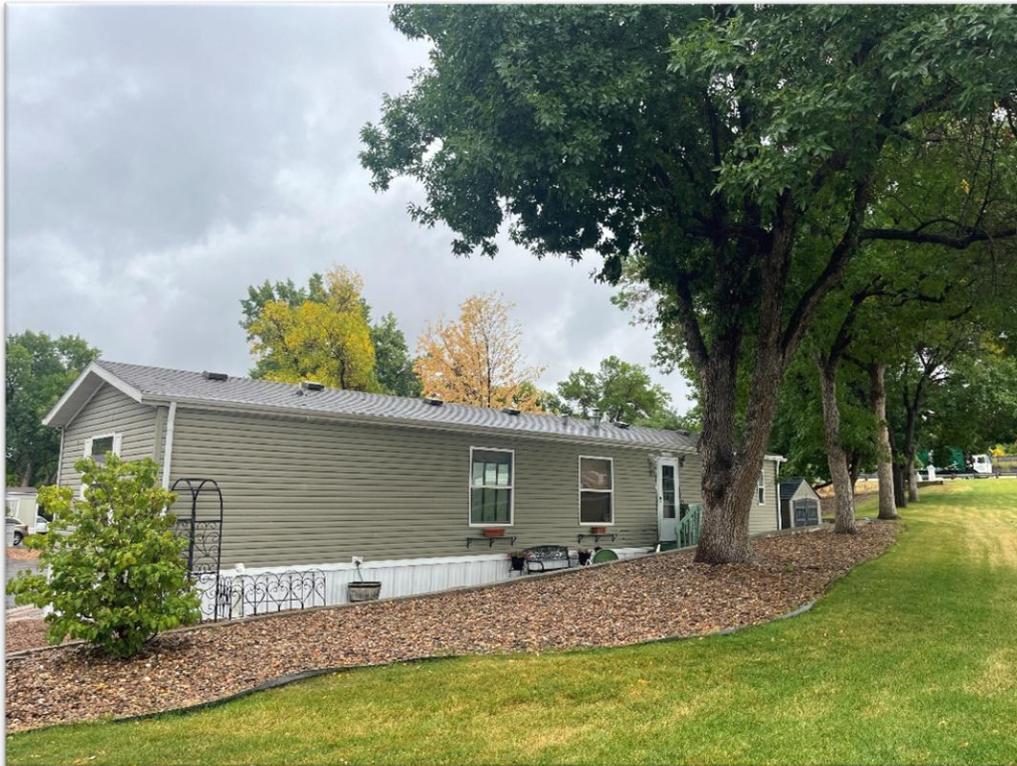
Photo Number: 2

Description: The primary (south) and west elevations of a Typical Style Trailer. Note the replacement windows.

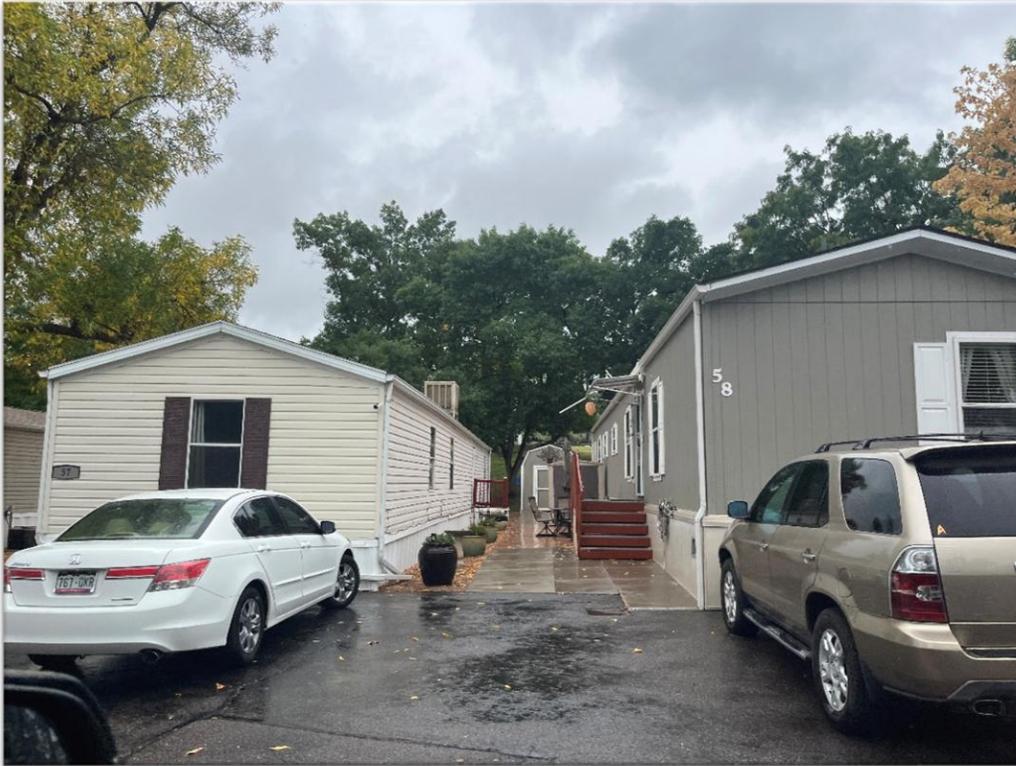
Photo Number: 4

Description: A modified typical style trailer which features a large front porch and a double-wide footprint.

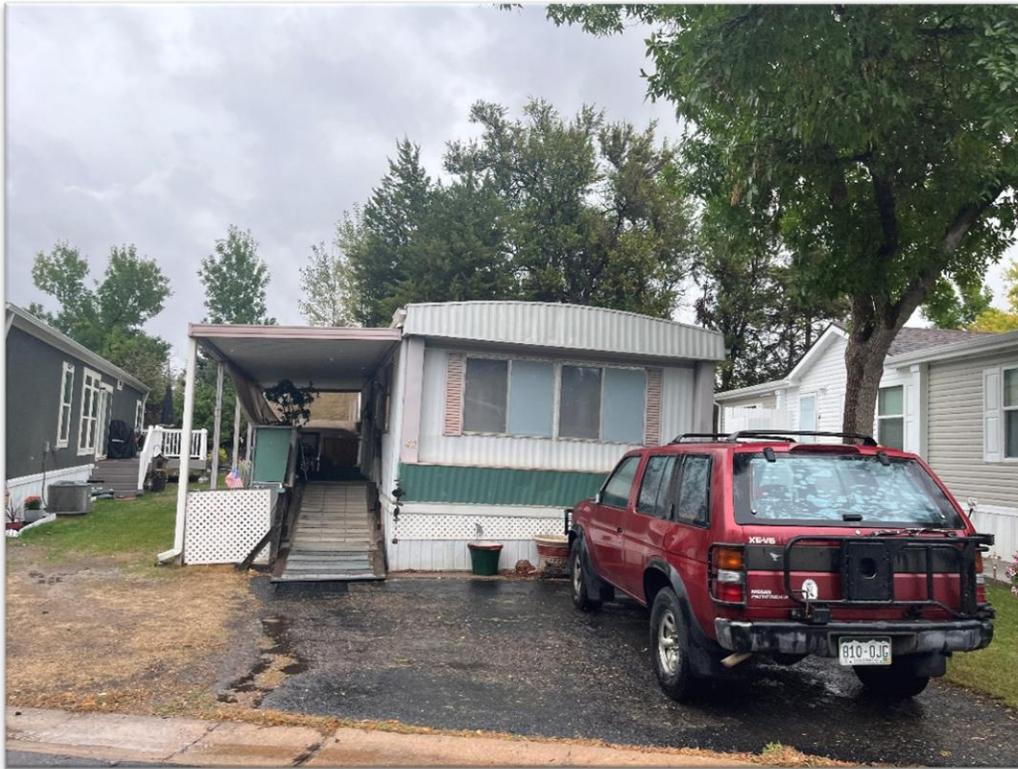
Photo Number: 5

Description: An example of a Type 2 trailer in the Meadowood Cooperative Mobile Home Park. Note the metal siding and the slightly arched roof form as well as the side porch.
