City of Littleton Survey Plan and Reconnaissance Survey Report

Pinyon Project No.:
124169901

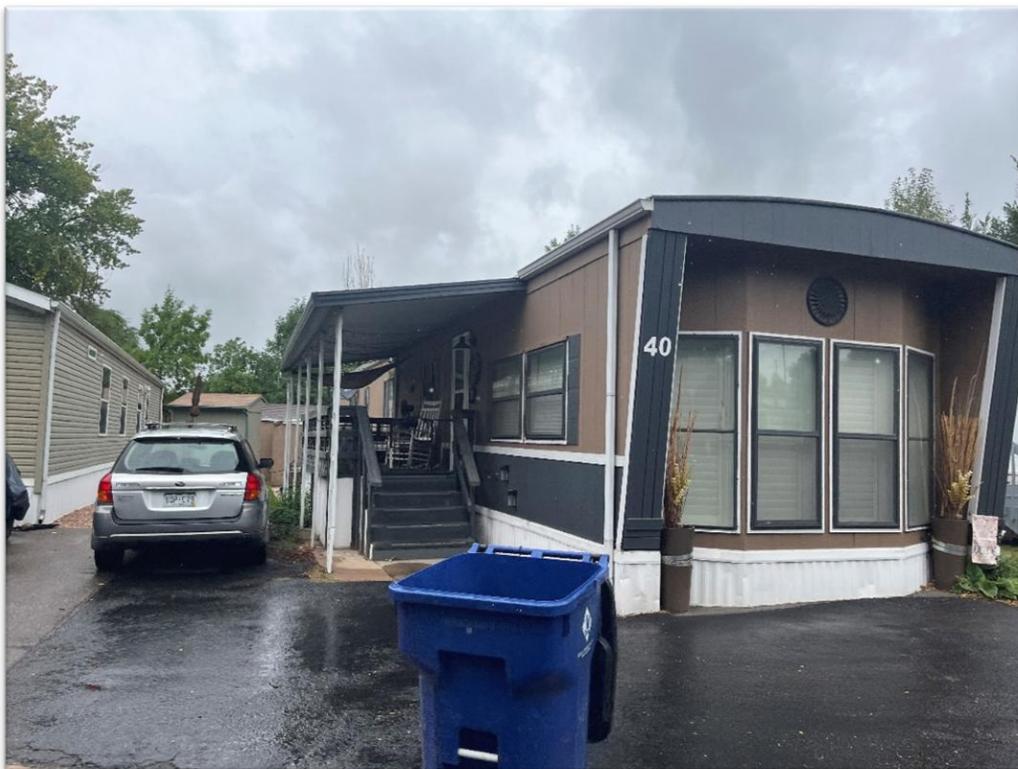
Photo Number: 6

Description: An example of a Type 3 trailer at the Meadowood Cooperative. Note the alterations surrounding the bay window.

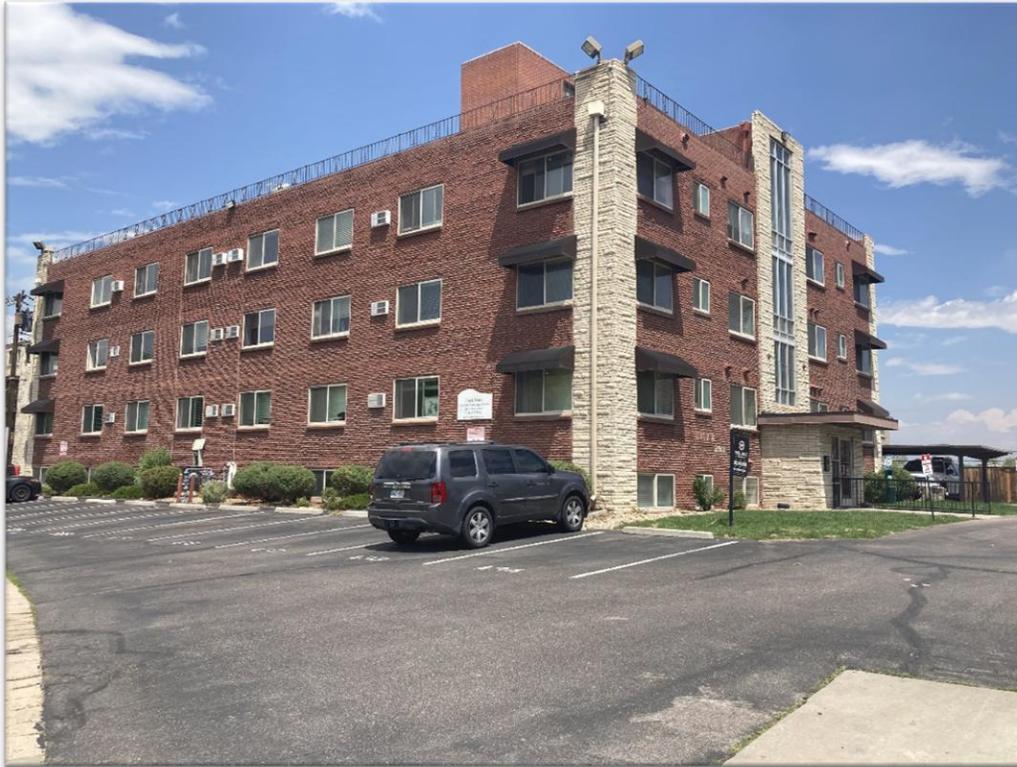
Photo Number: 1

Description: Primary (east) elevation and south elevation of the building at 293 West Powers Place featuring the replacement windows. This is an example of Type 1.

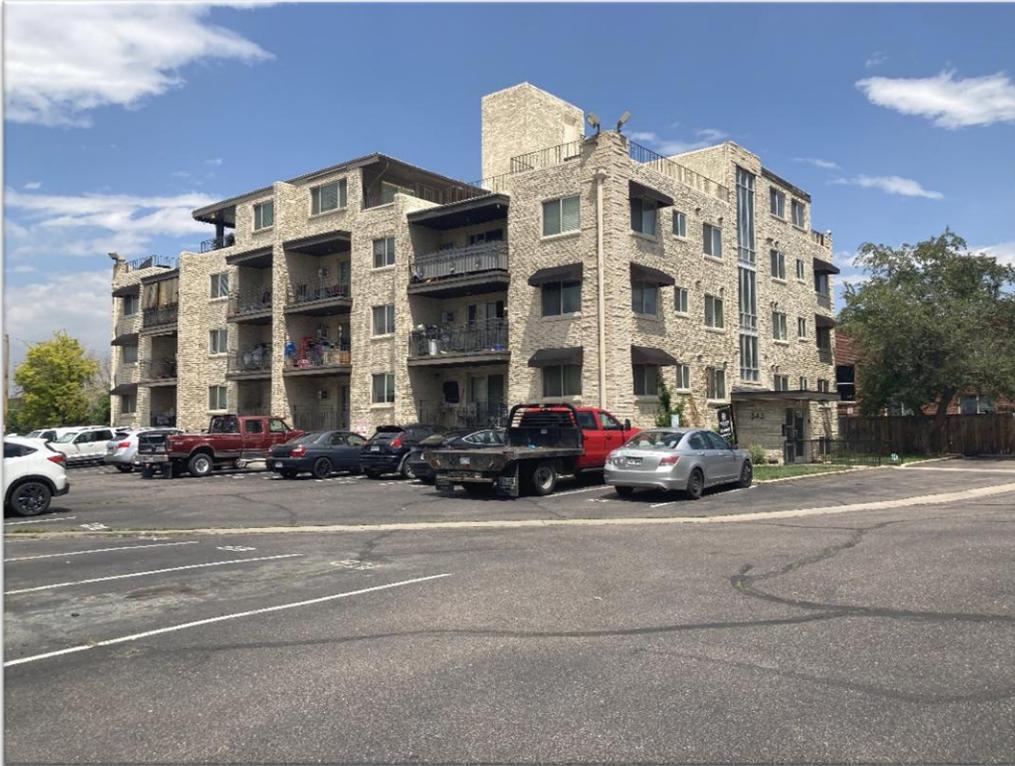
Photo Number: 3

Description: Primary (east) elevation and south elevation of the building at 343 West Powers Place. Four balconies are located on each floor of the south elevation. An example of Type 2.

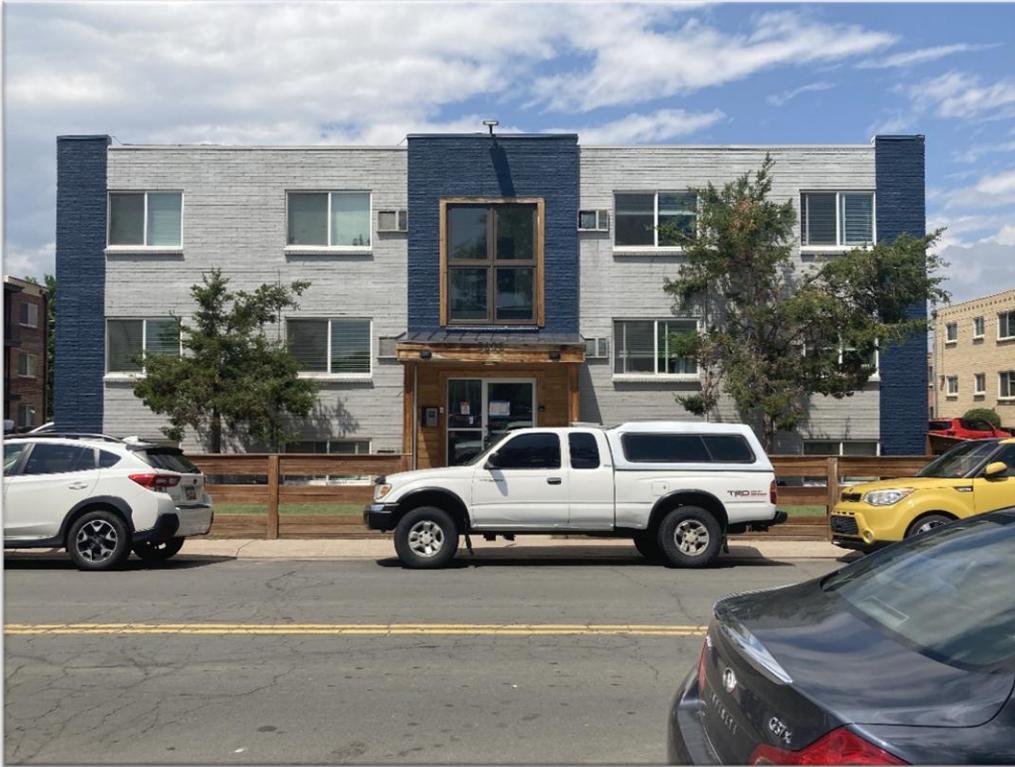
Photo Number: 5

Description: Primary (east) elevation of the Type 3 building at 5635 South Bannock Street featuring the replacement windows.

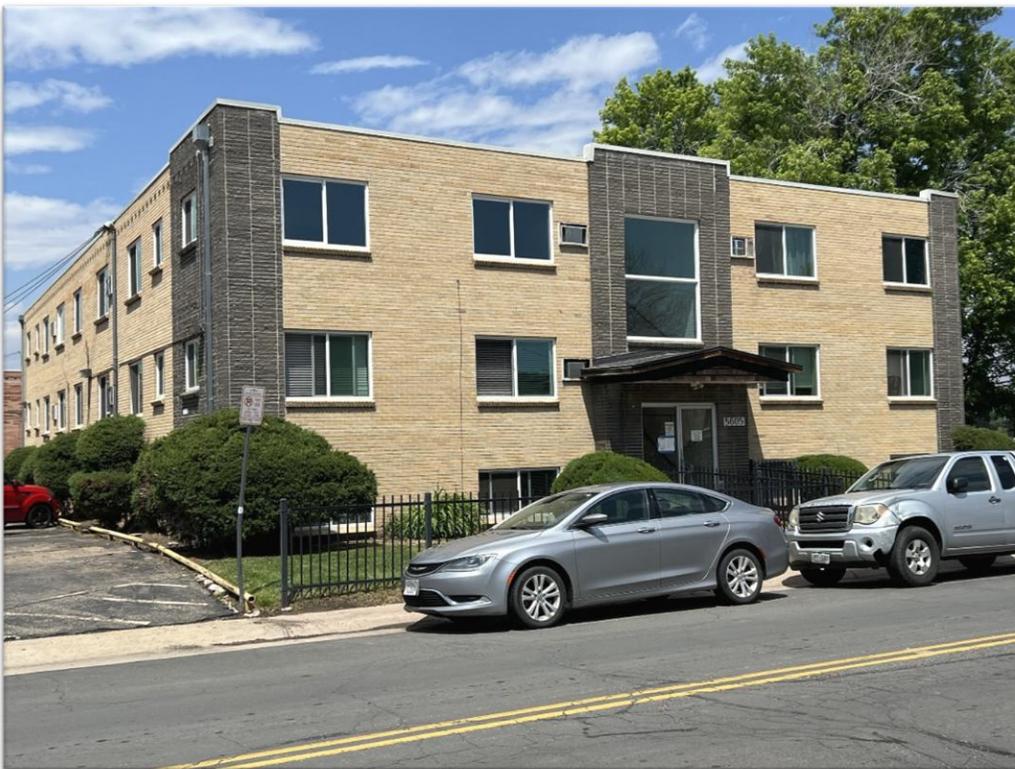
Photo Number: 8

Description: Primary (east) and south elevations of the building at 5605 South Bannock Street featuring replacement windows.

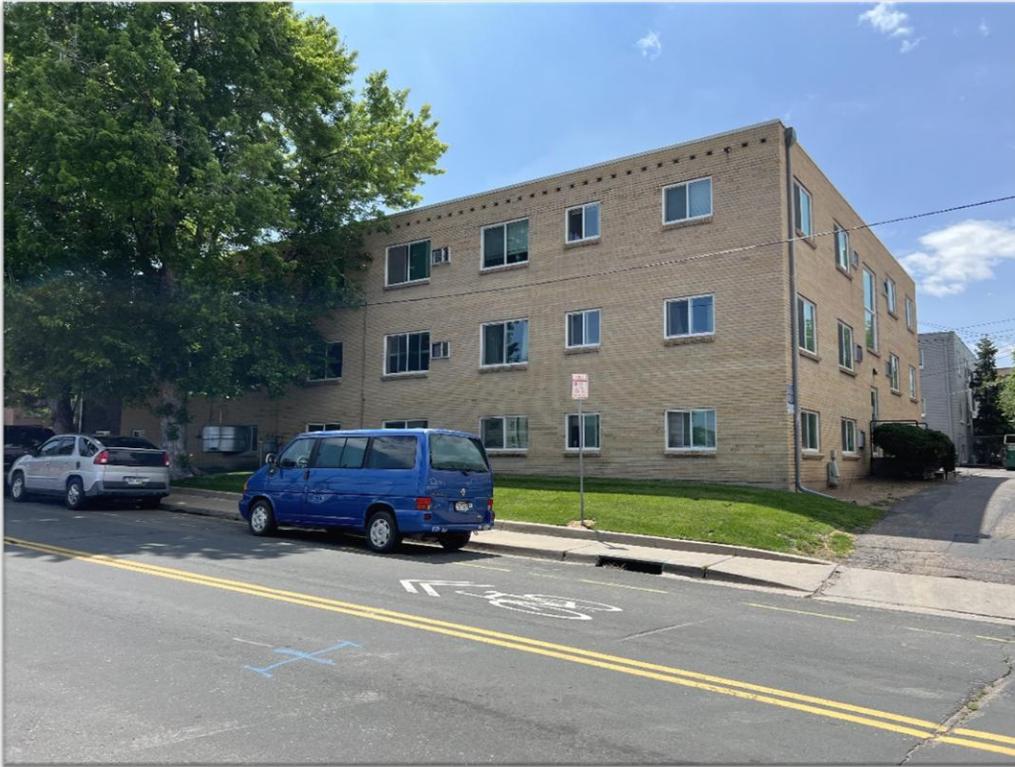
Photo Number: 9
Description: North and west elevations of the building.
View: Southeast

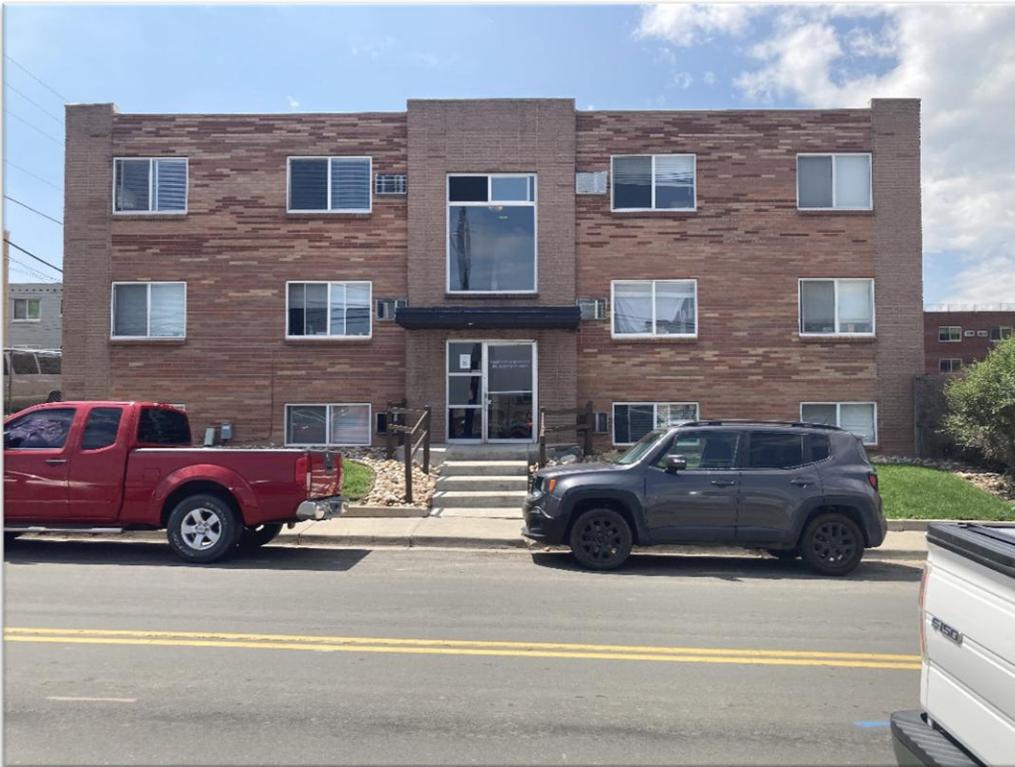
Photo Number: 10
Description: Primary (north) elevation of the building at 258 West Powers Avenue featuring replacement windows.
View: south

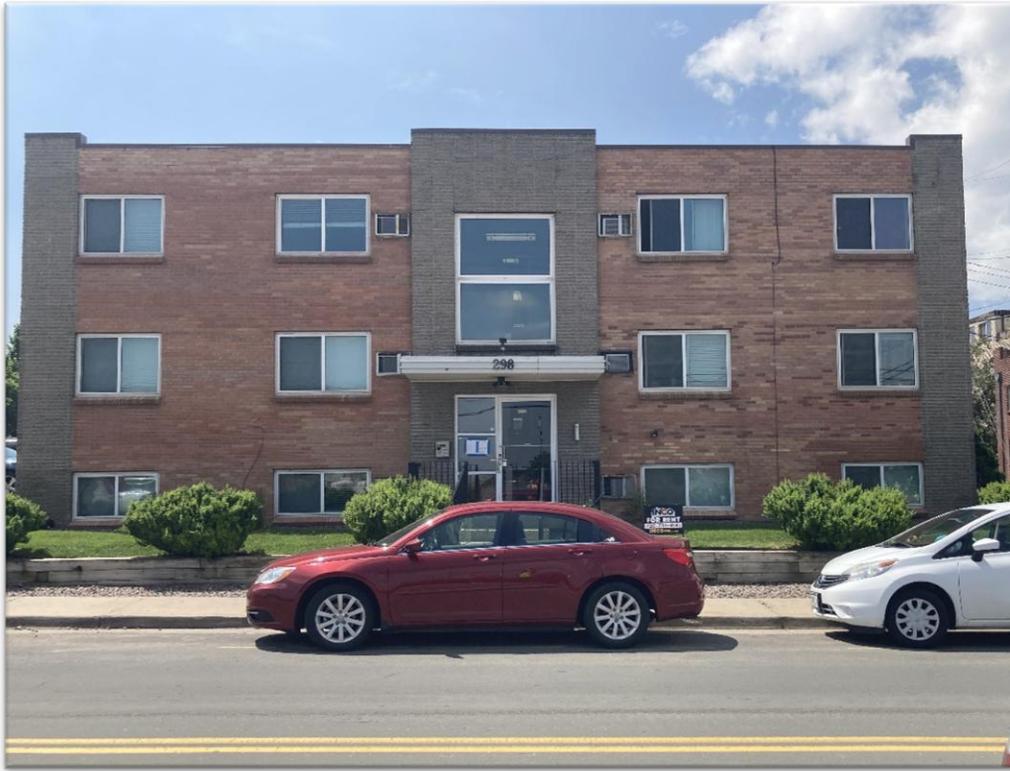
Photo Number: 13

Description: Primary (north) elevation of the building at 298 West Powers Avenue featuring replacement windows.

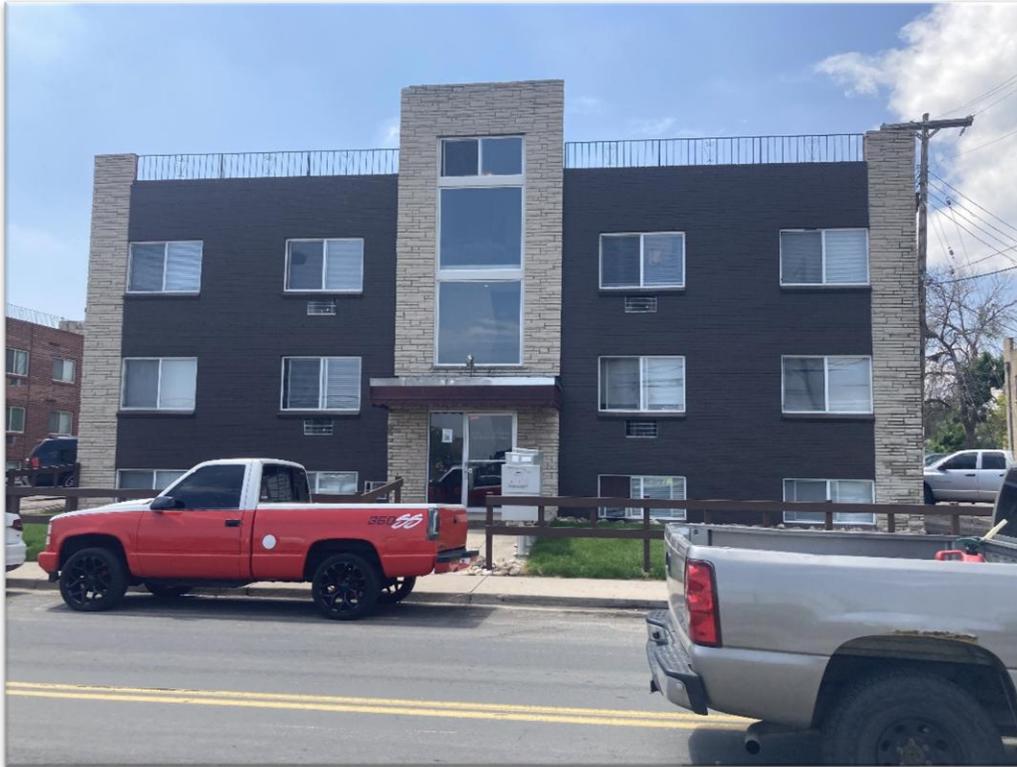
Photo Number: 19

Description: Primary (north) elevation of the building at 336 West Powers Avenue featuring replacement windows.

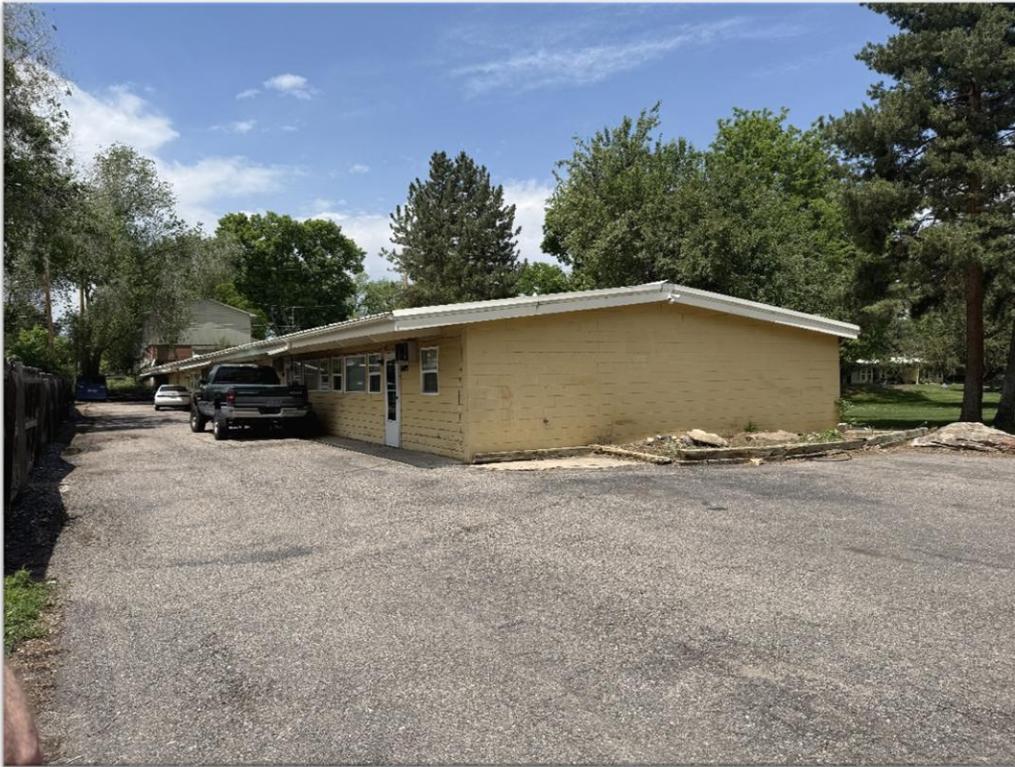
Photo Number: 1

Description: Primary (south) elevation featuring the roof projecting over the entrances.

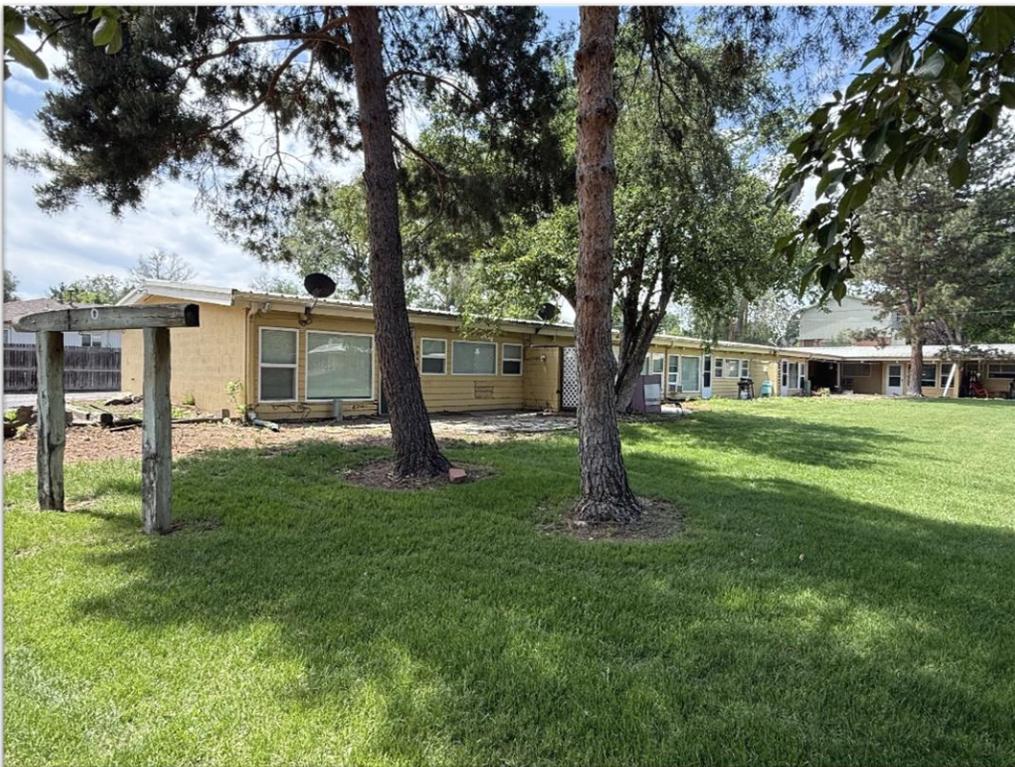
Photo Number: 2

Description: Typical windows and vinyl fixed pane windows located on the north elevation at the interior of the L-shape plan.

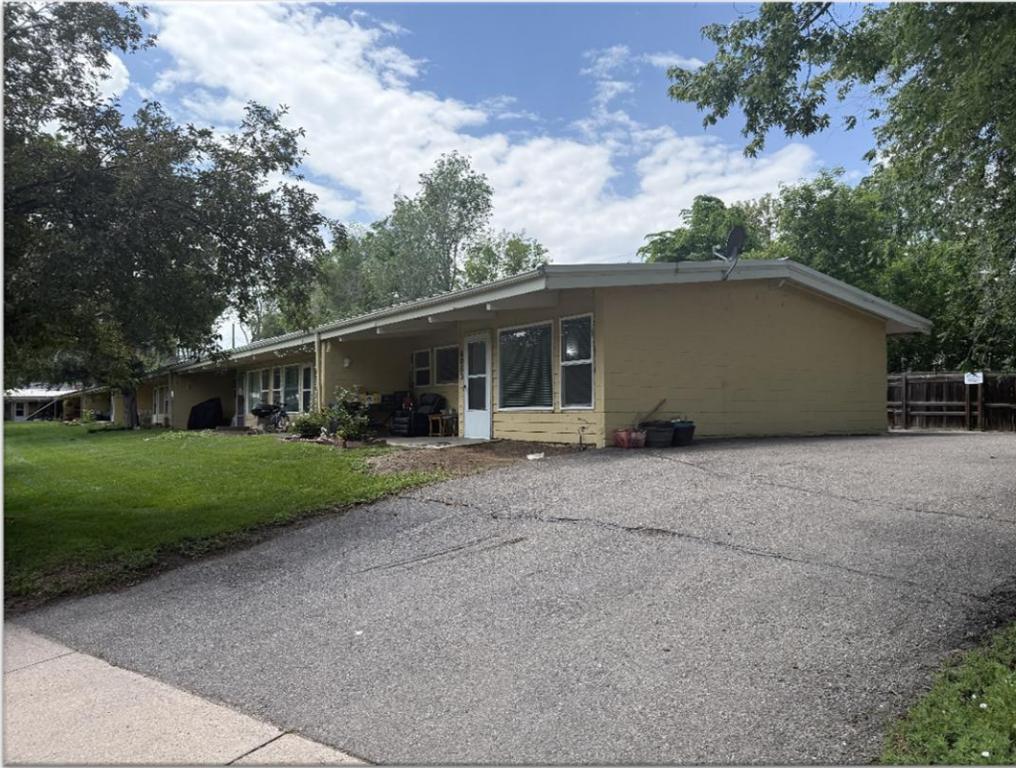
Photo Number: 3

Description: North and east elevations featuring the roof extending over the entrance at the north end of the east elevation.

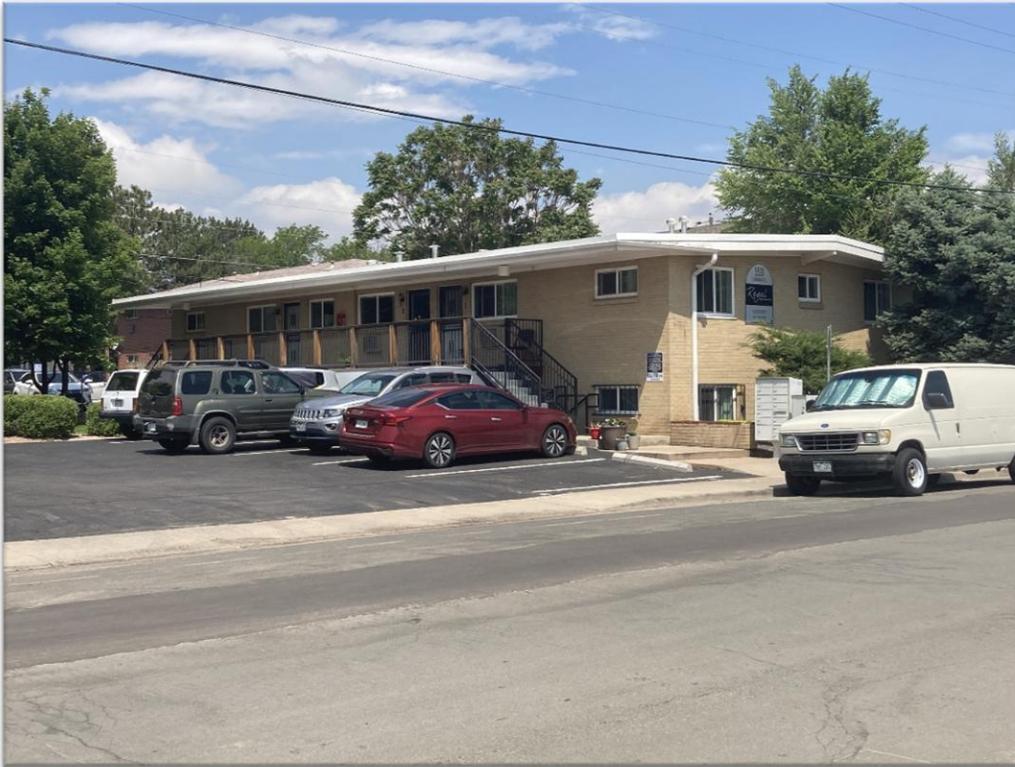
Photo Number: 1

Description: Primary (south) and east elevations of the Regal Apartments building at 5531 South Delaware Street.

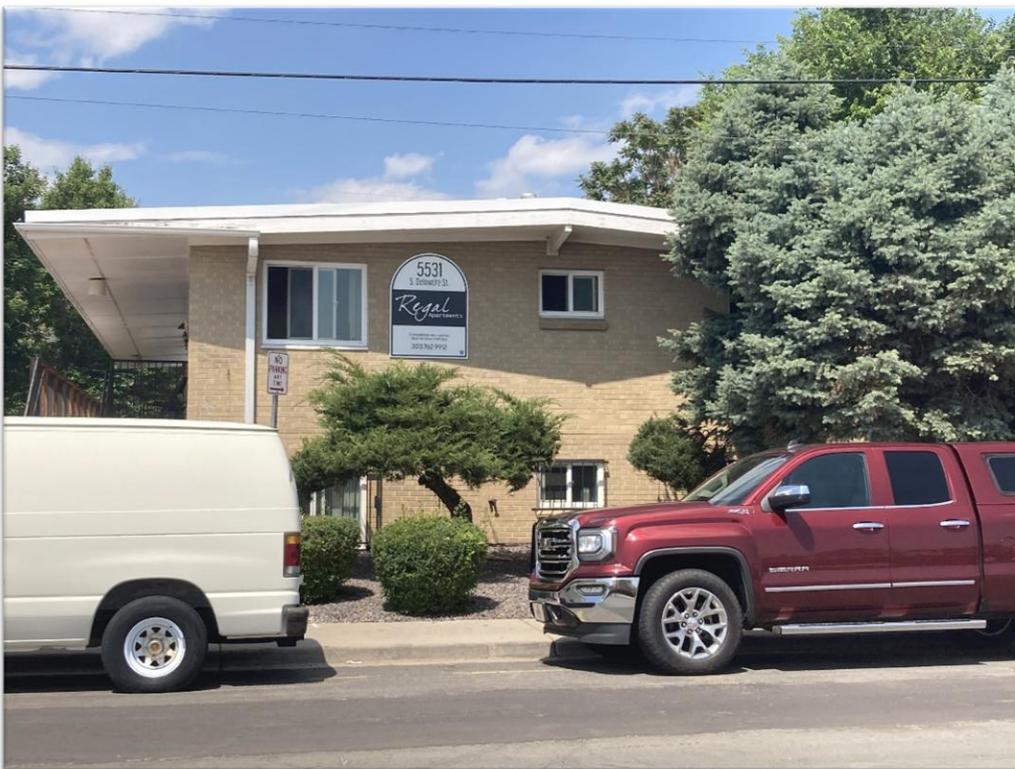
Photo Number: 2

Description: East elevation featuring overhanging eaves and replacement windows.

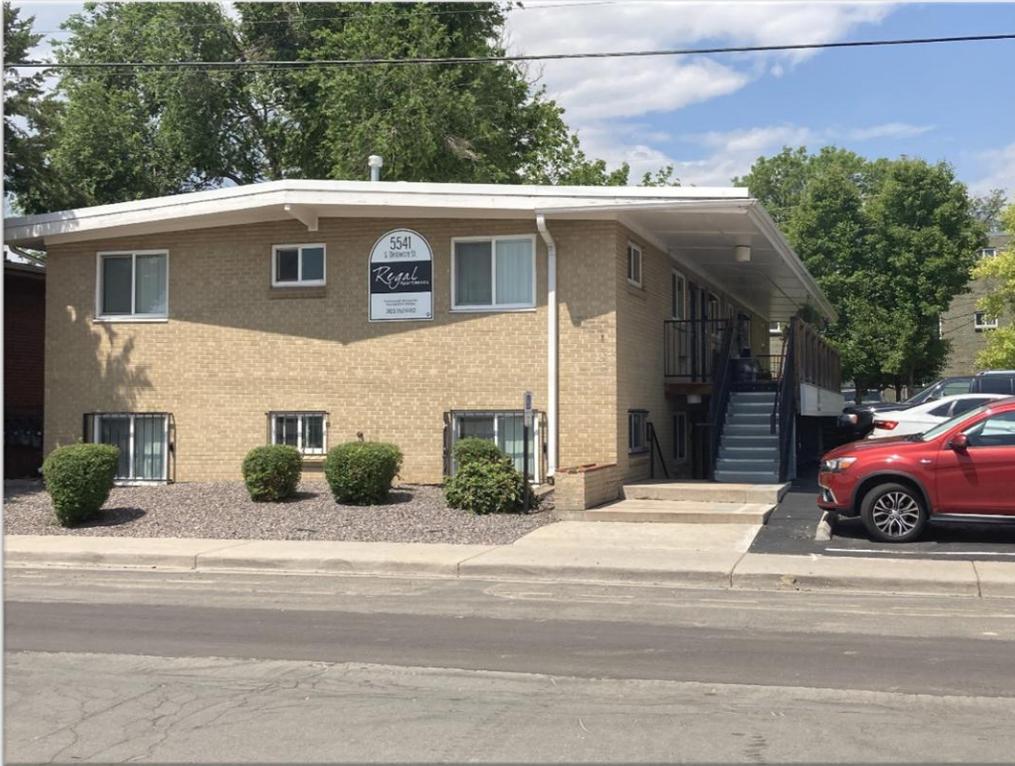
Photo Number: 3

Description: Primary (north) and east elevation of the building at 5541 South Delaware Street.

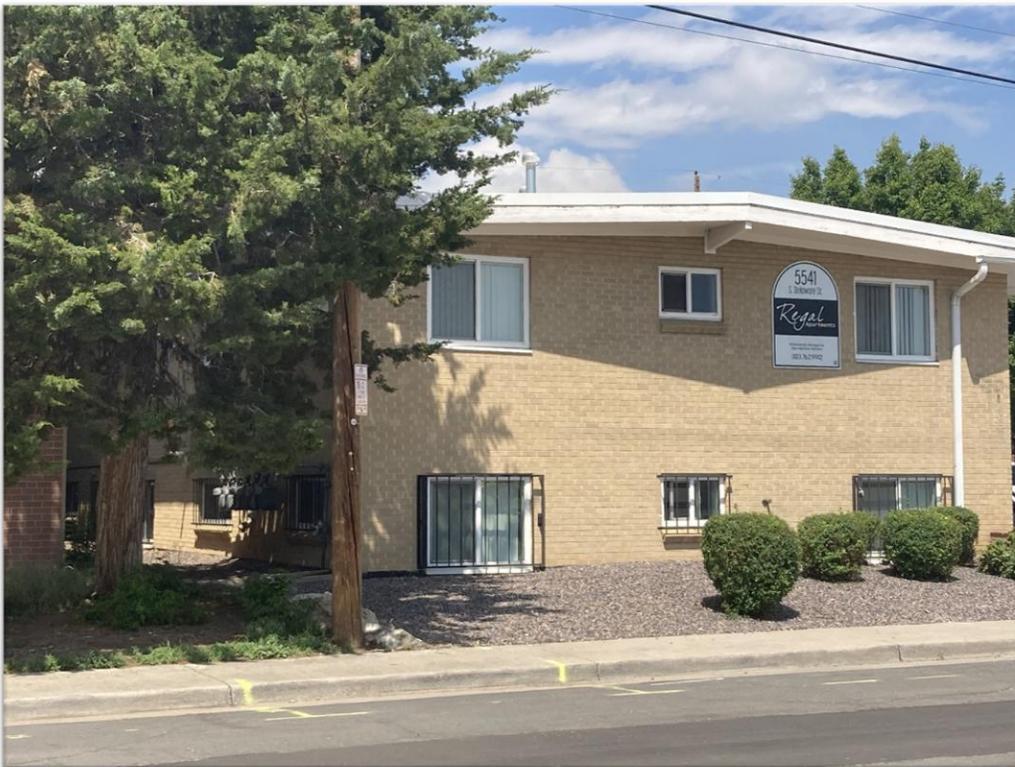
Photo Number: 4

Description: East elevation and a portion of the south elevation obscured from view by mature vegetation.

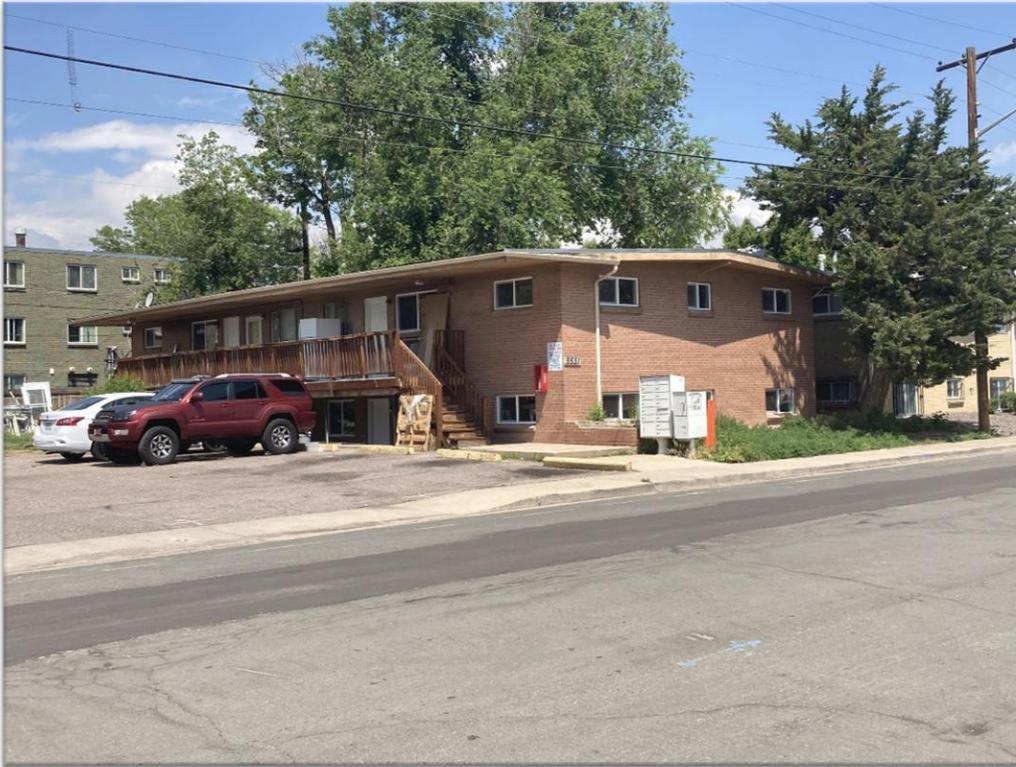
Photo Number: 5

Description: Primary (south) and east elevation of the building at 5551 South Delaware Street.

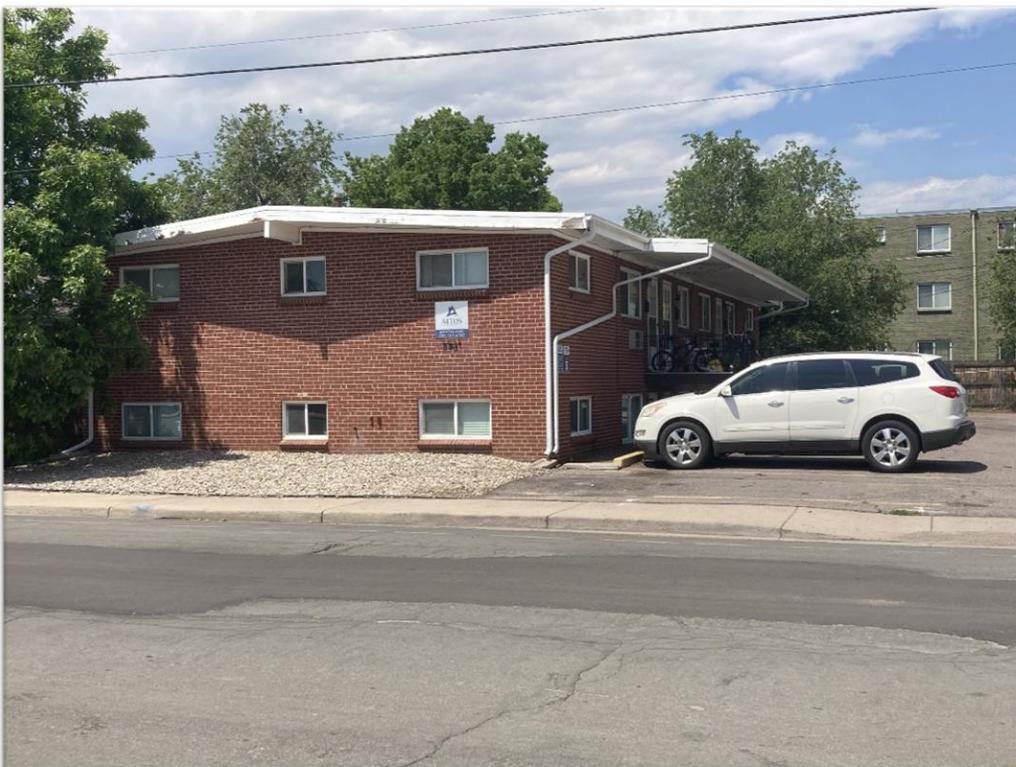
Photo Number: 6

Description: Primary (north) and east elevations of the building at 5561 South Delaware Street.

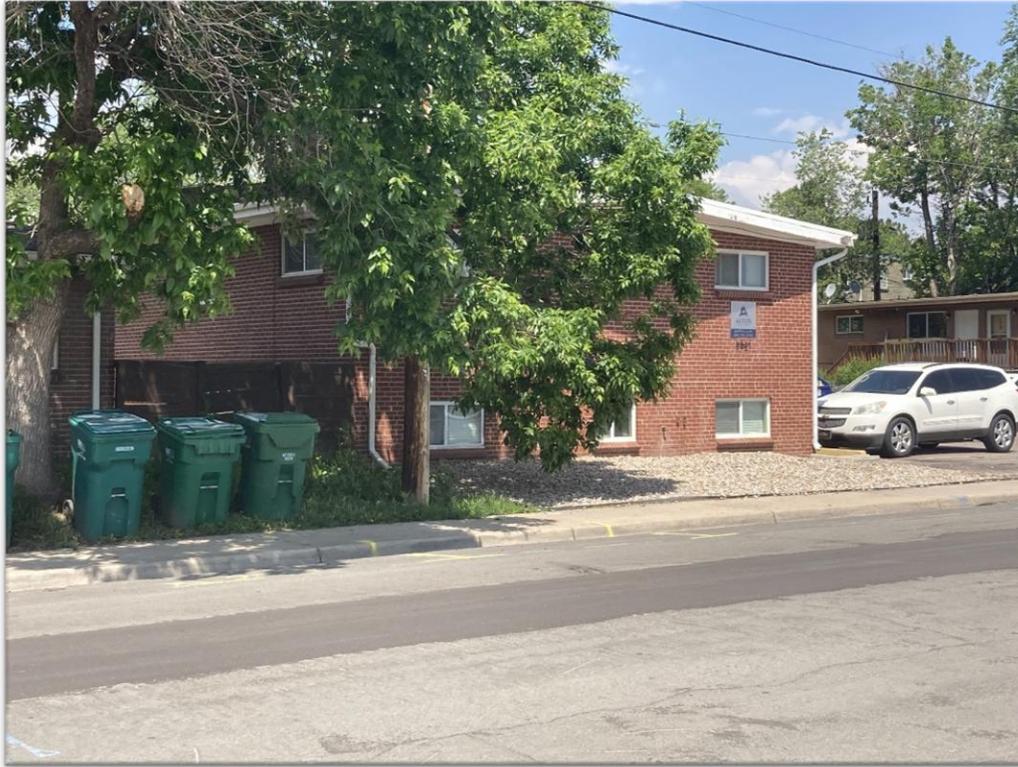
Photo Number: 7

Description: East and a portion of the south elevation of the building.

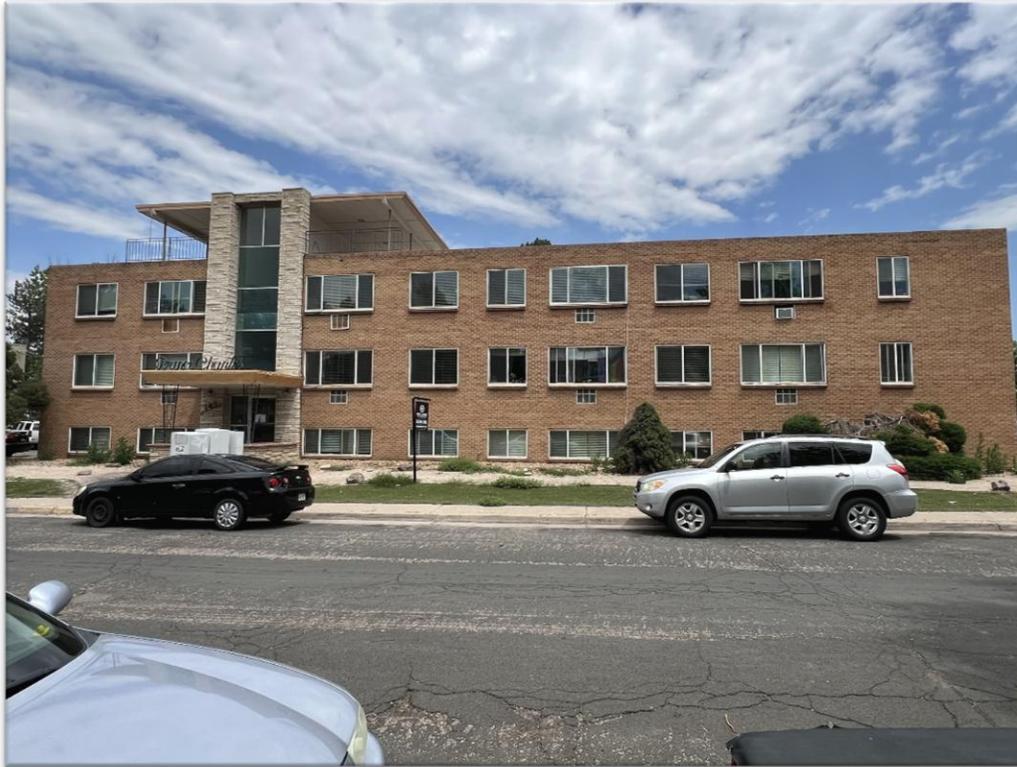
Photo Number: 1

Description: Primary (south) elevation of the Prince Charles building at the Royal Garden Apartments at 143 West Powers Circle.

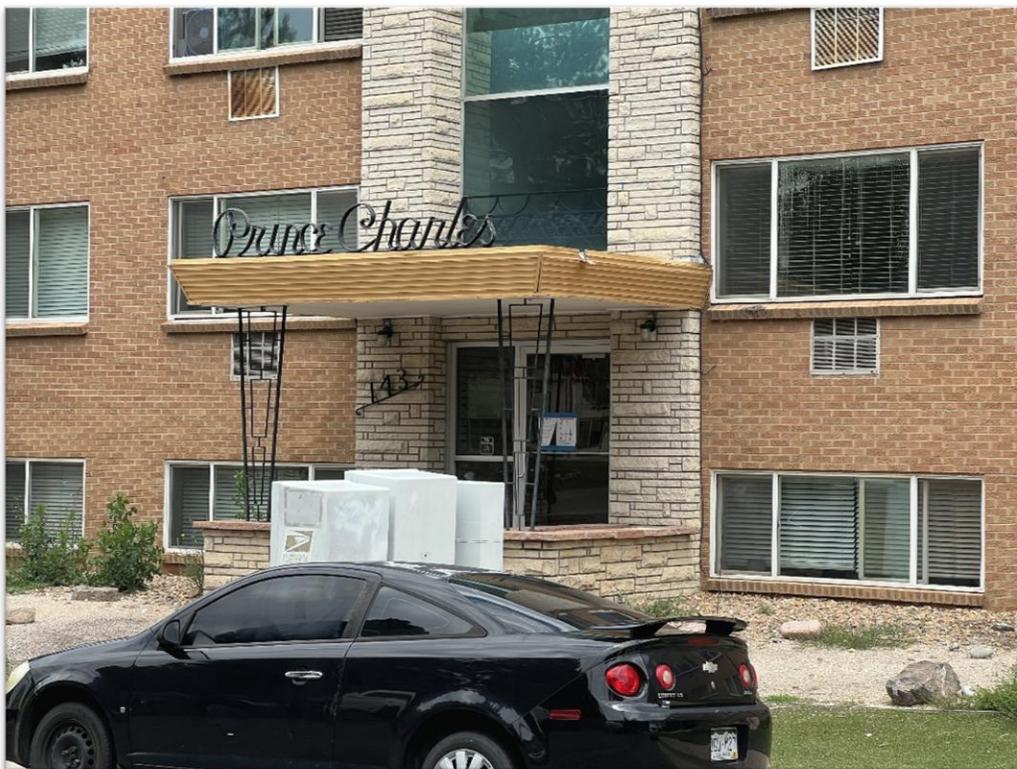
Photo Number: 2

Description: Detail of the primary entrance featuring the wrought iron "Prince Charles" sign

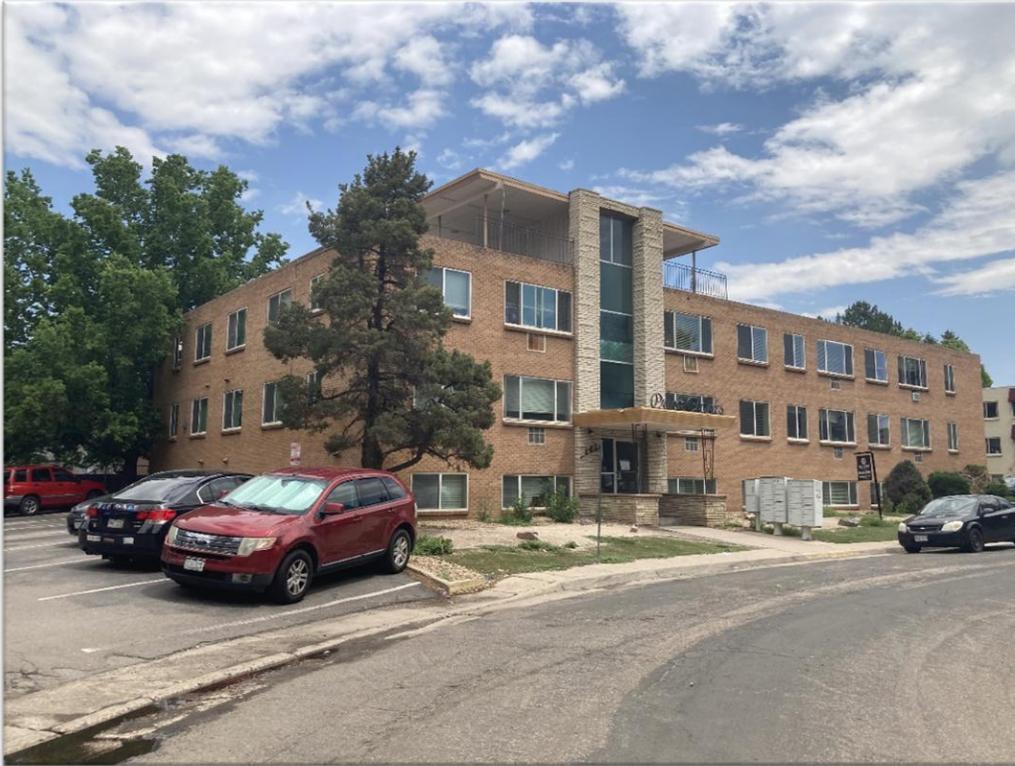
Photo Number: 3

Description: West elevation of the building at 143 West Powers Circle.

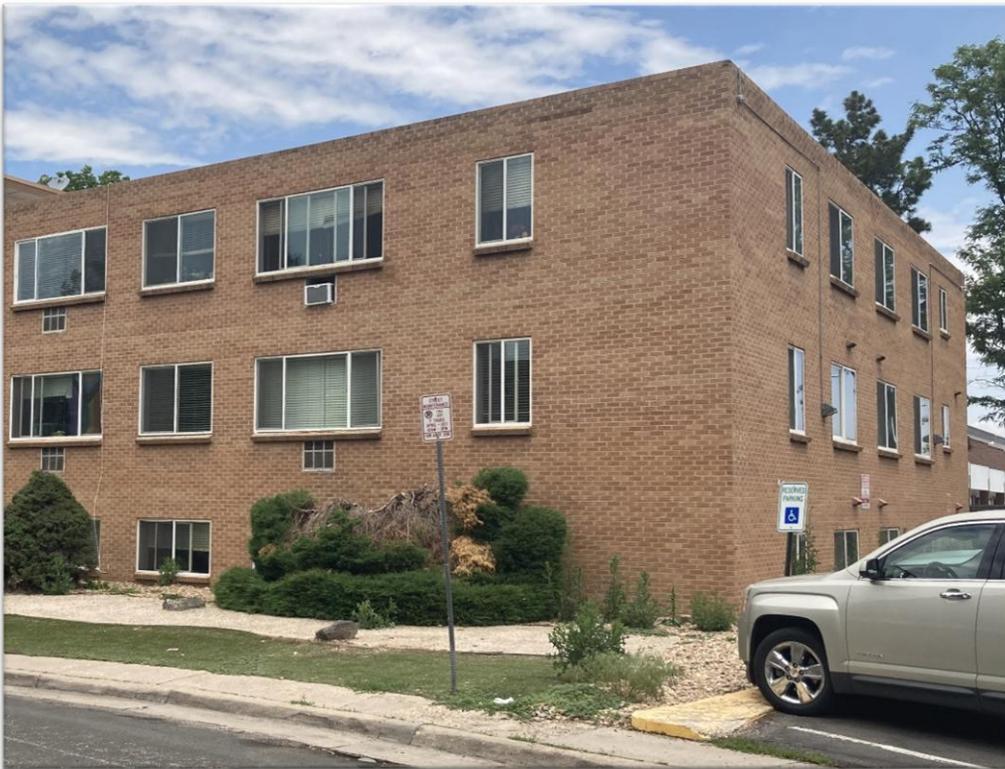
Photo Number: 4

Description: East elevation of the building featuring vinyl replacement windows.

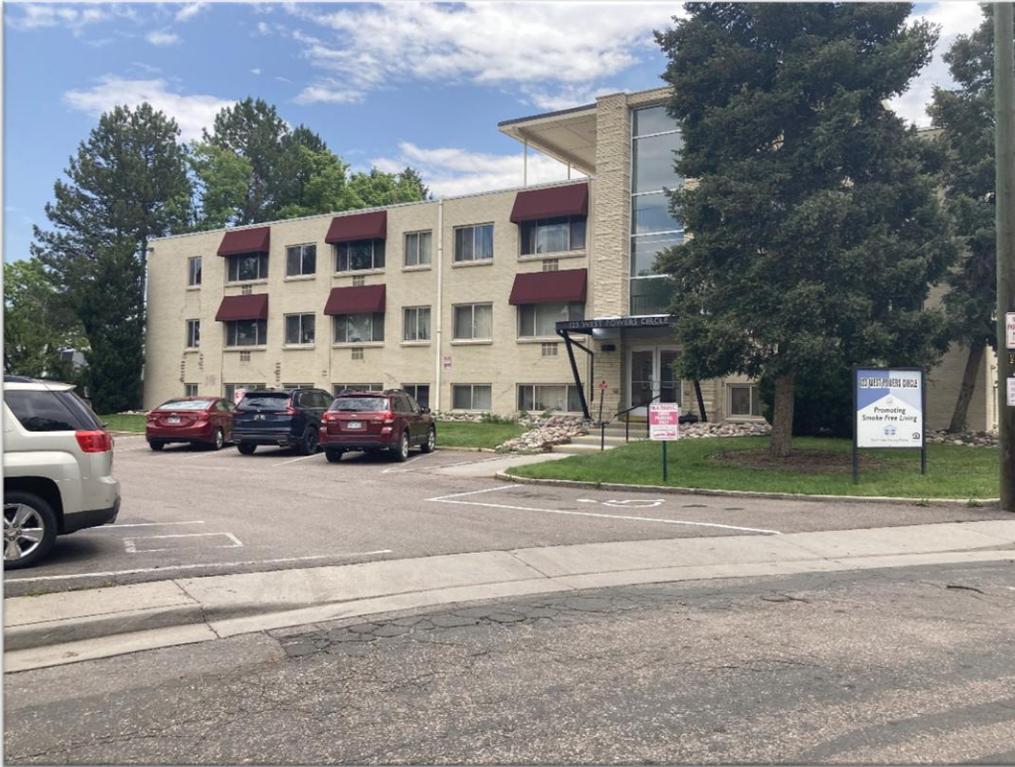
Photo Number: 5

Description: Primary (west) elevation of the building at 123 West Powers Circle.

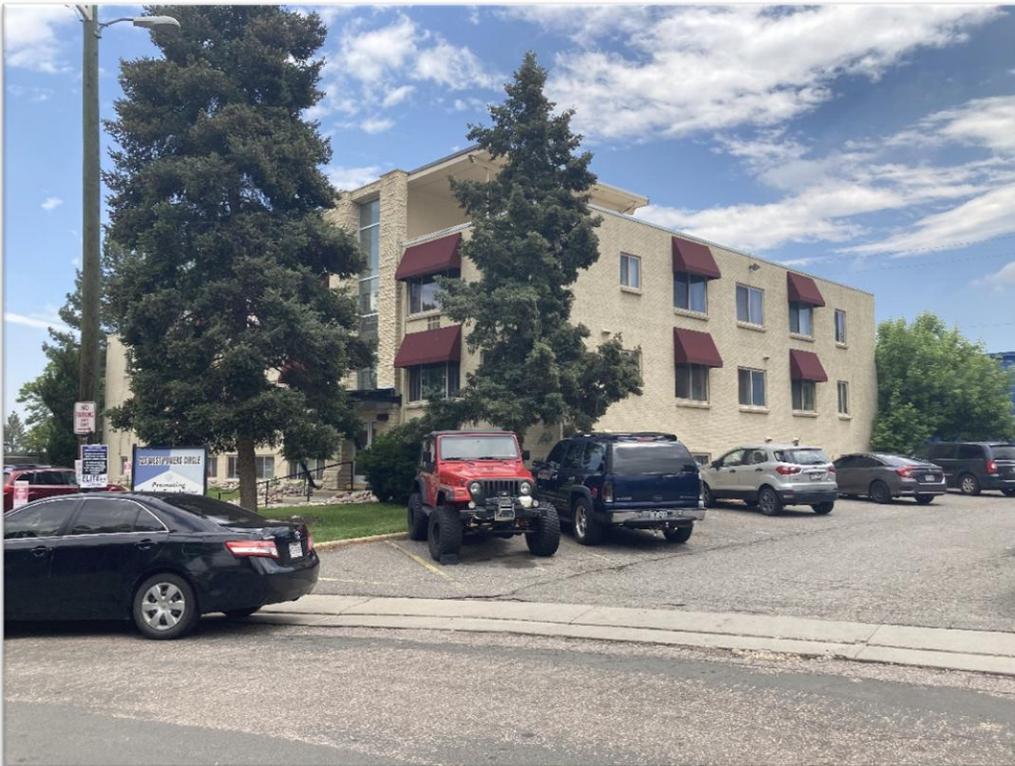
Photo Number: 6

Description: South elevation of the building at 123 West Powers Circle.

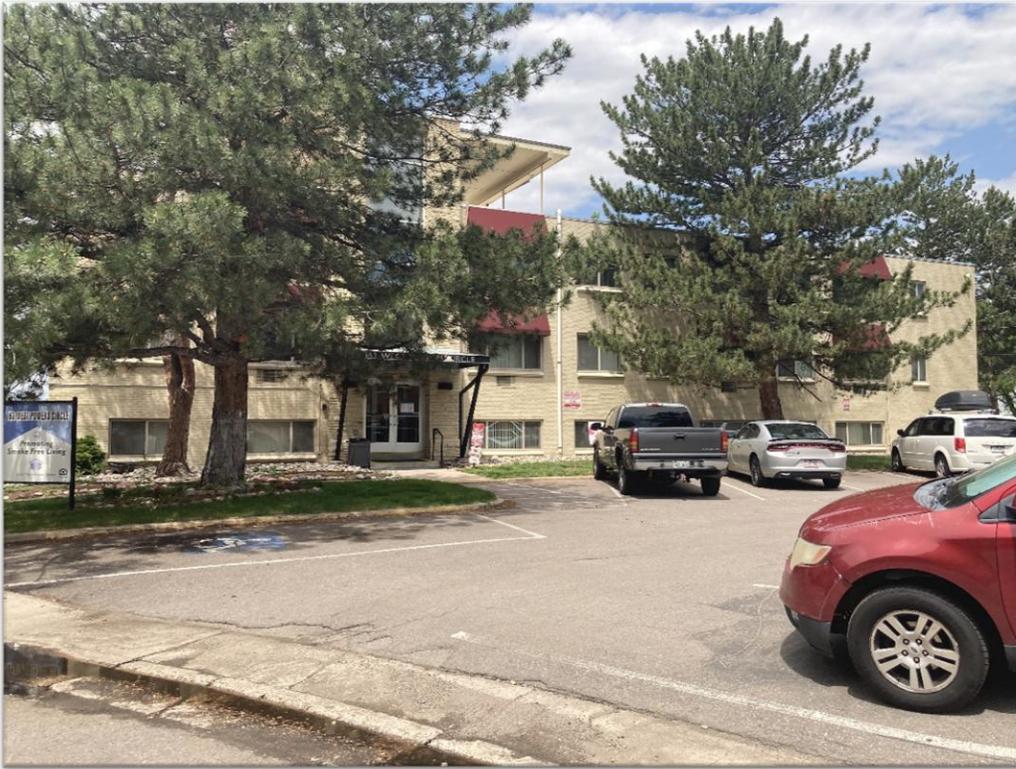
Photo Number: 7

Description: Primary (east) elevation of the building at 163 West Powers Circle.

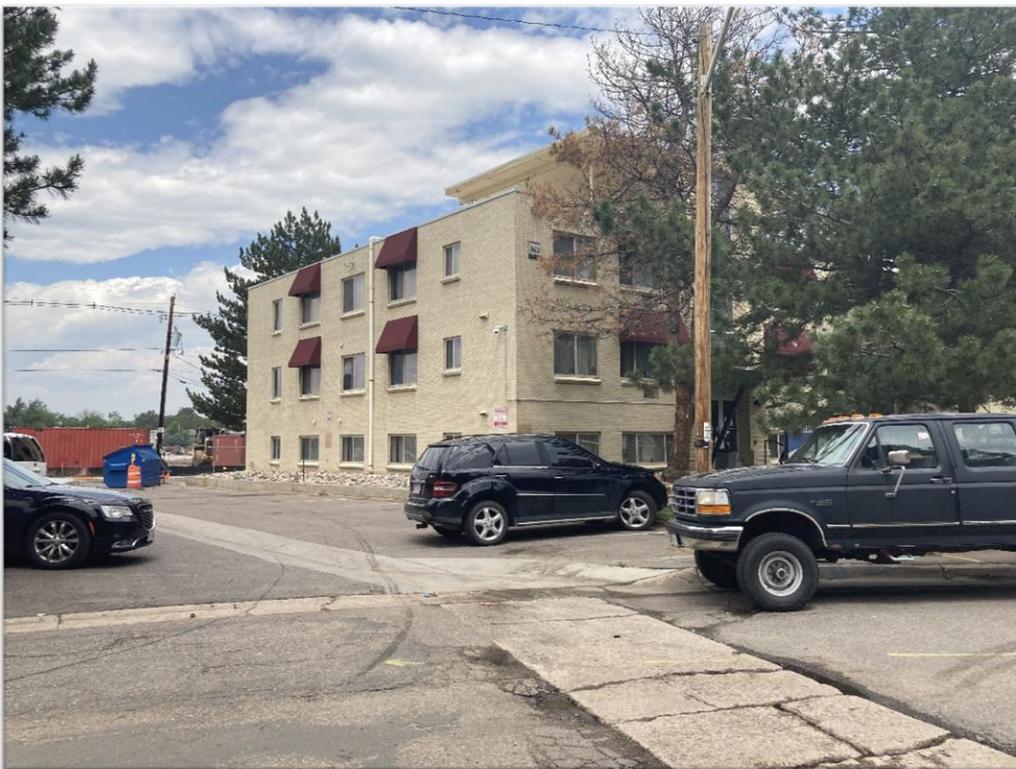
Photo Number: 8

Description: South elevation of the building at 163 West Powers Circle.

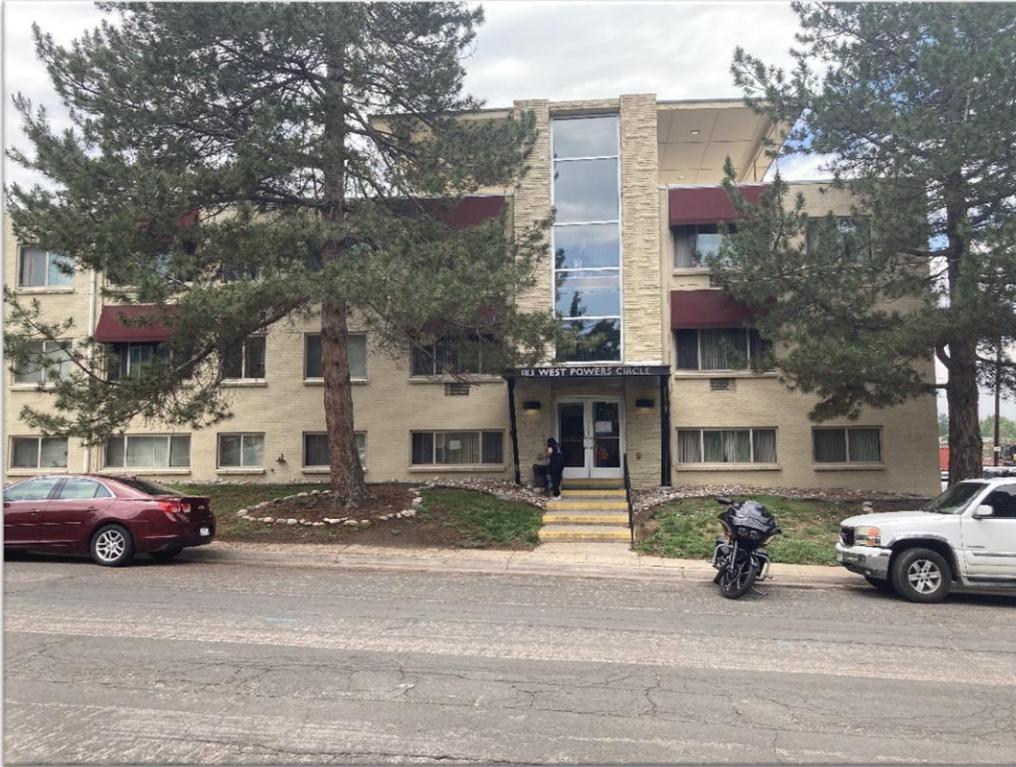
Photo Number: 9

Description: Primary (east) elevation of the building at 183 West Powers Circle.
