City of Littleton Survey Plan and Reconnaissance Survey Report

Pinyon Project No.:
124169901

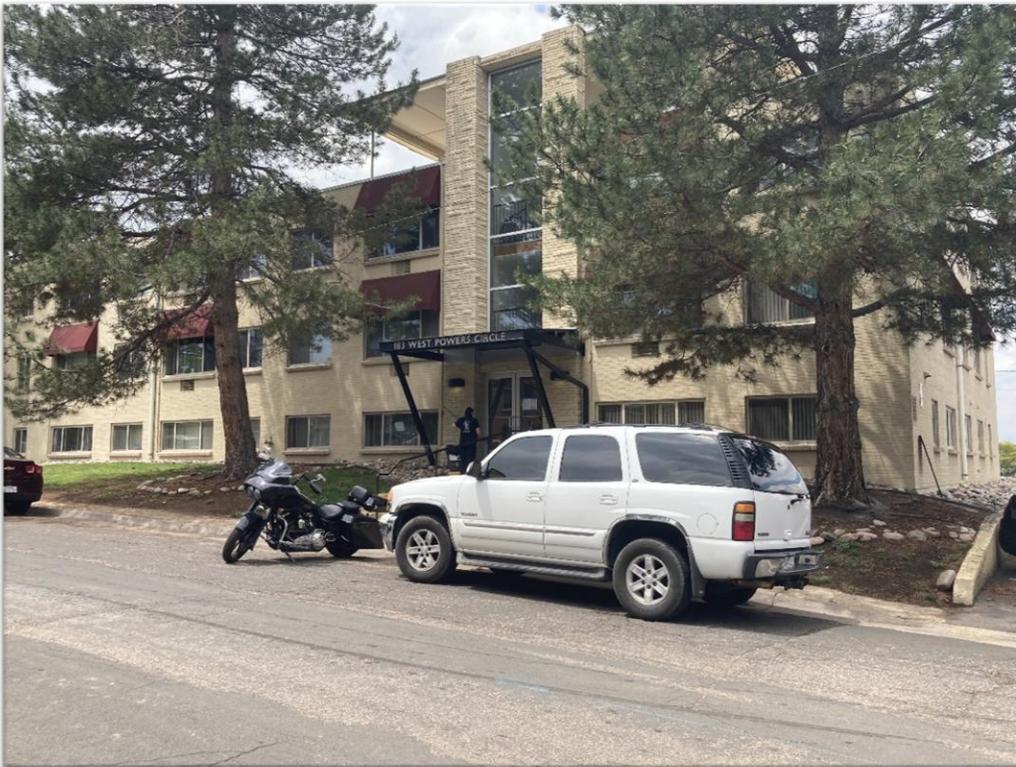
Photo Number: 10

Description: Primary and north elevations.

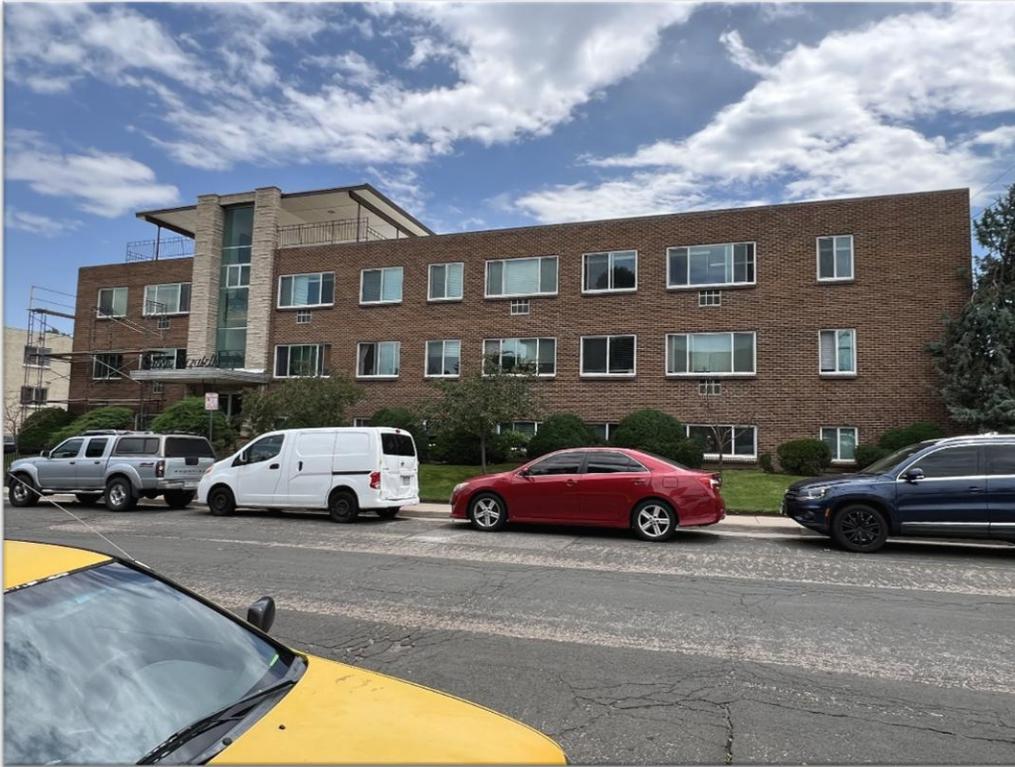
Photo Number: 11

Description: Primary (west) elevation of the building at 103 West Powers Circle.

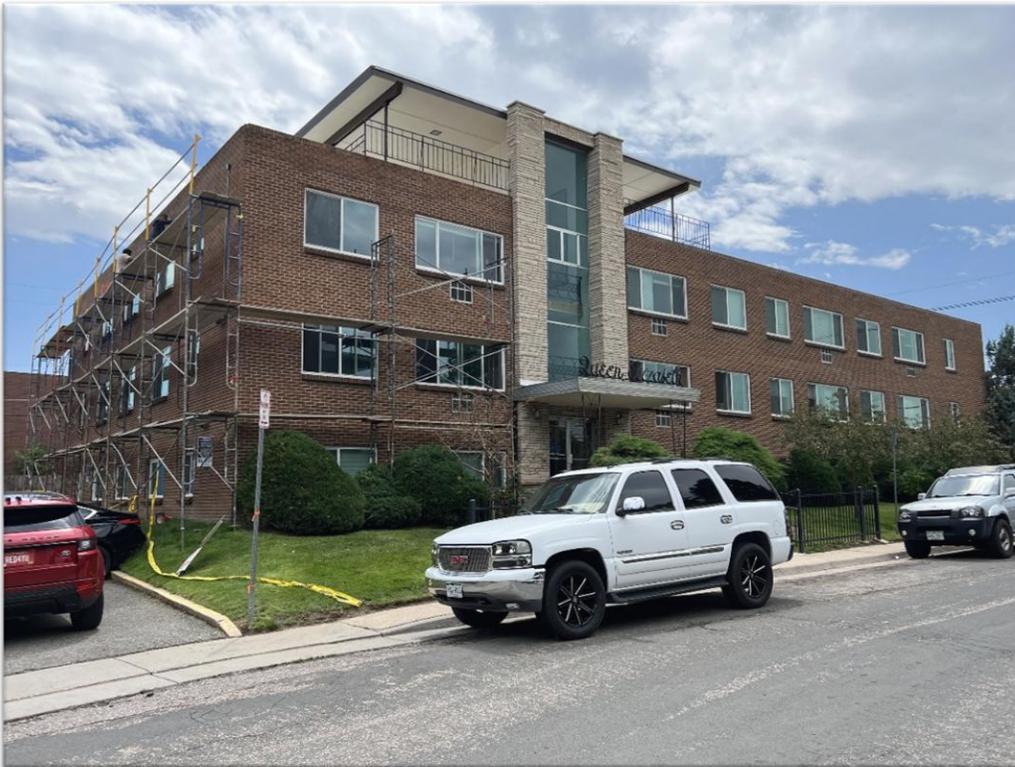
Photo Number: 12

Description: Primary and north elevations of the building.

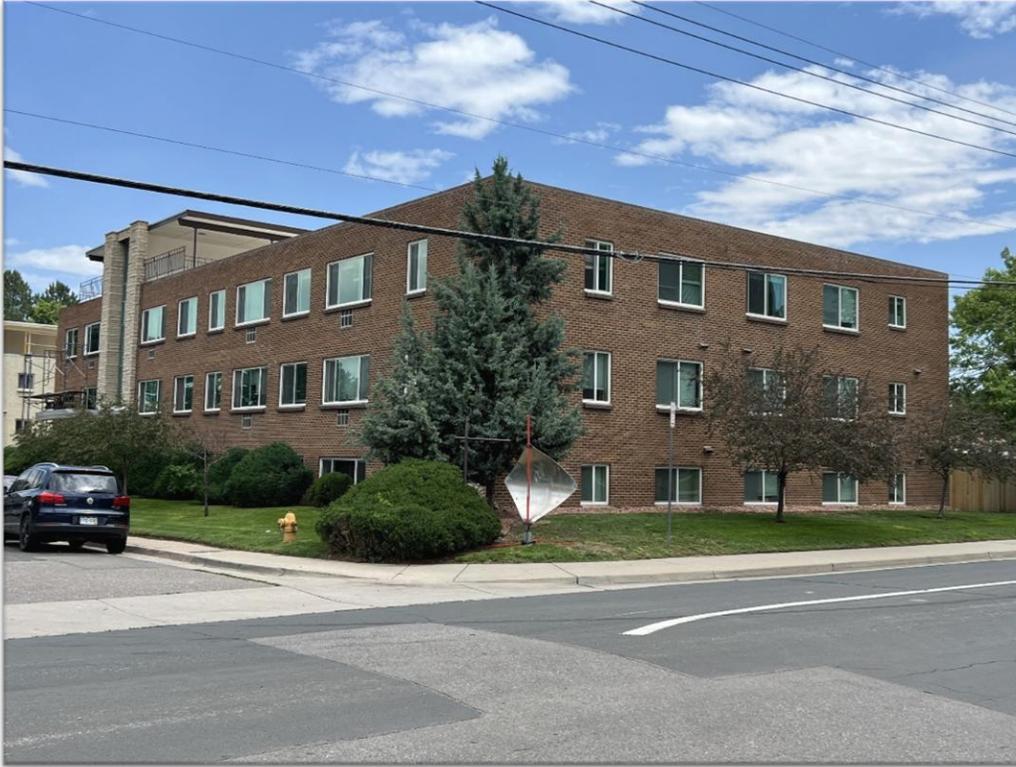
Photo Number: 13

Description: South elevation of the building featuring vinyl replacement windows.

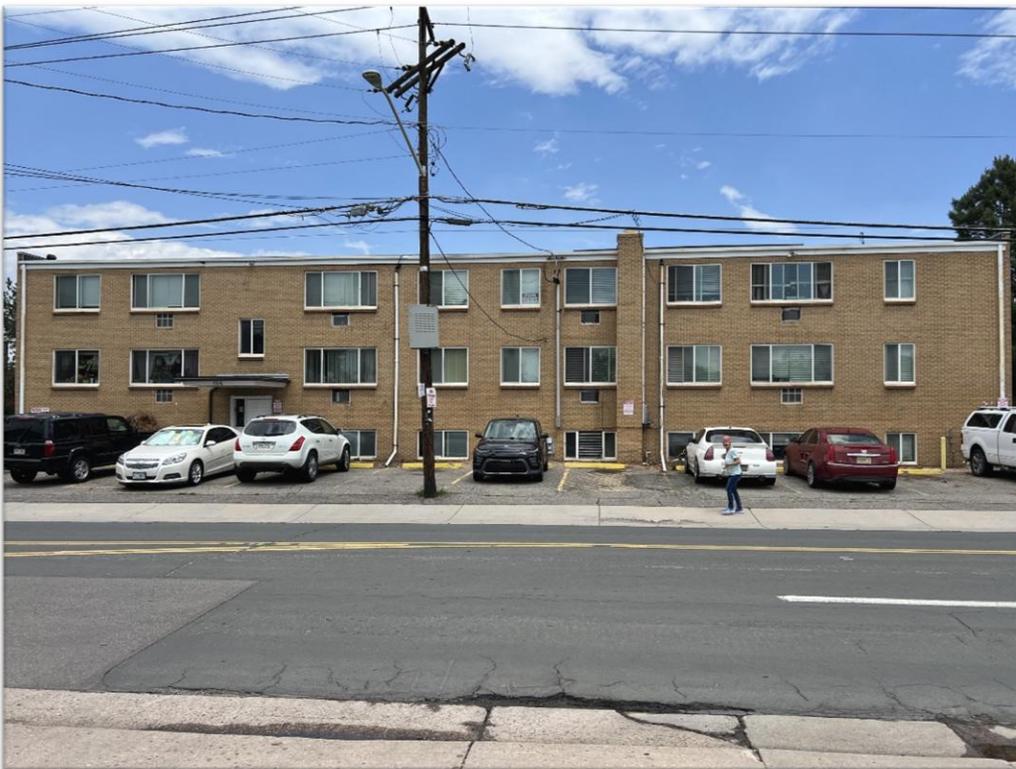
Photo Number: 14

Description: South elevation of the building at 154 West Powers Circle featuring the secondary entrance.

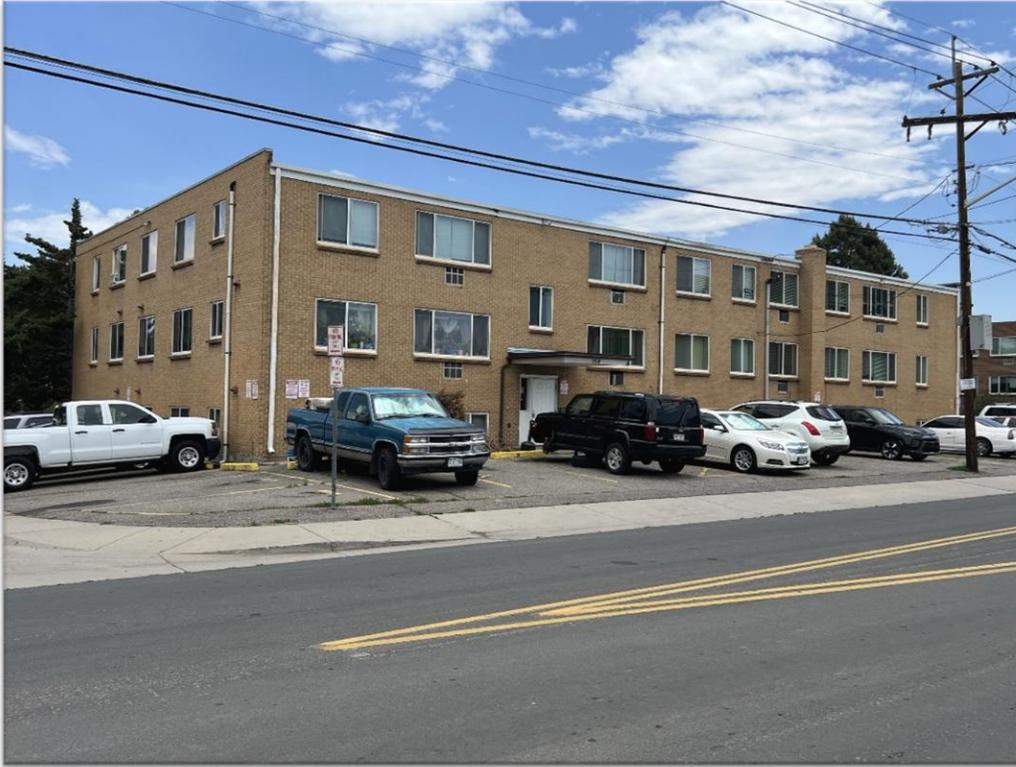
Photo Number: 15

Description: South and west elevations of the building.

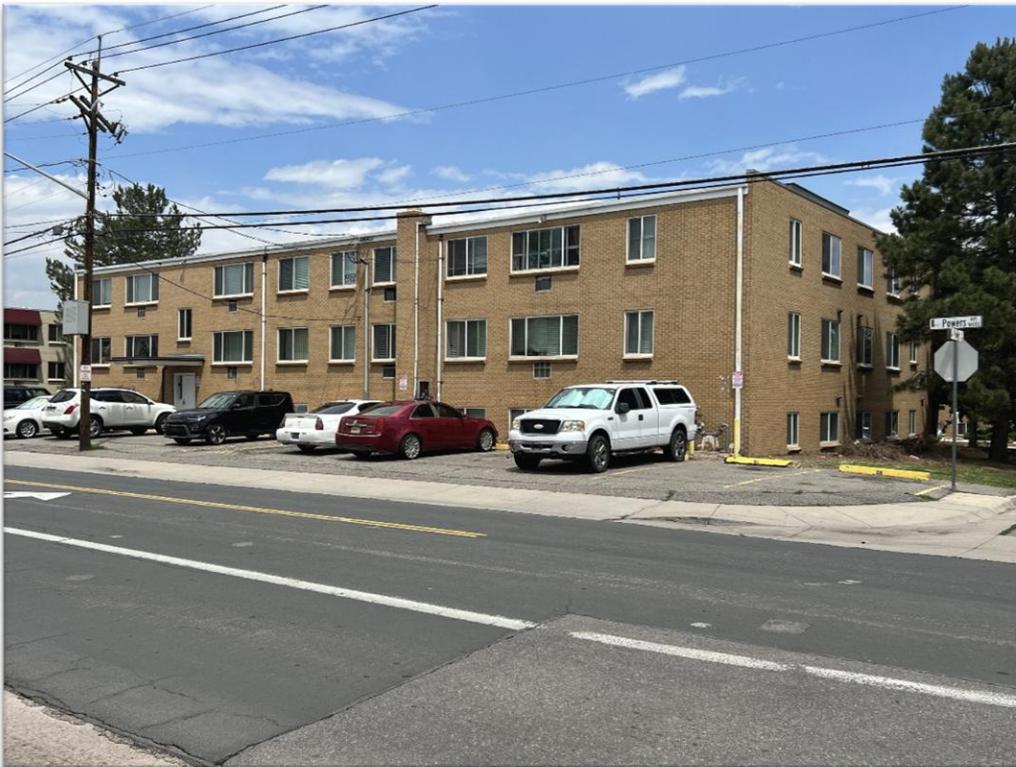
Photo Number: 16

Description: South and east elevations of the building

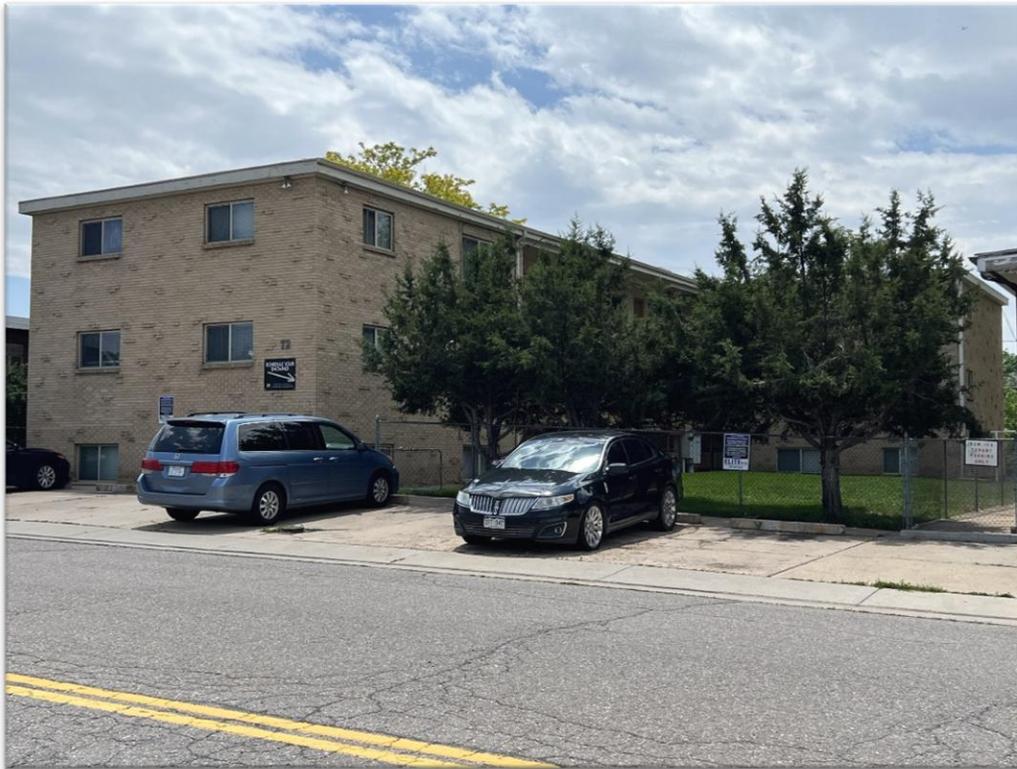
Photo Number: 1

Description: Primary (west) elevation obscured by mature vegetation.

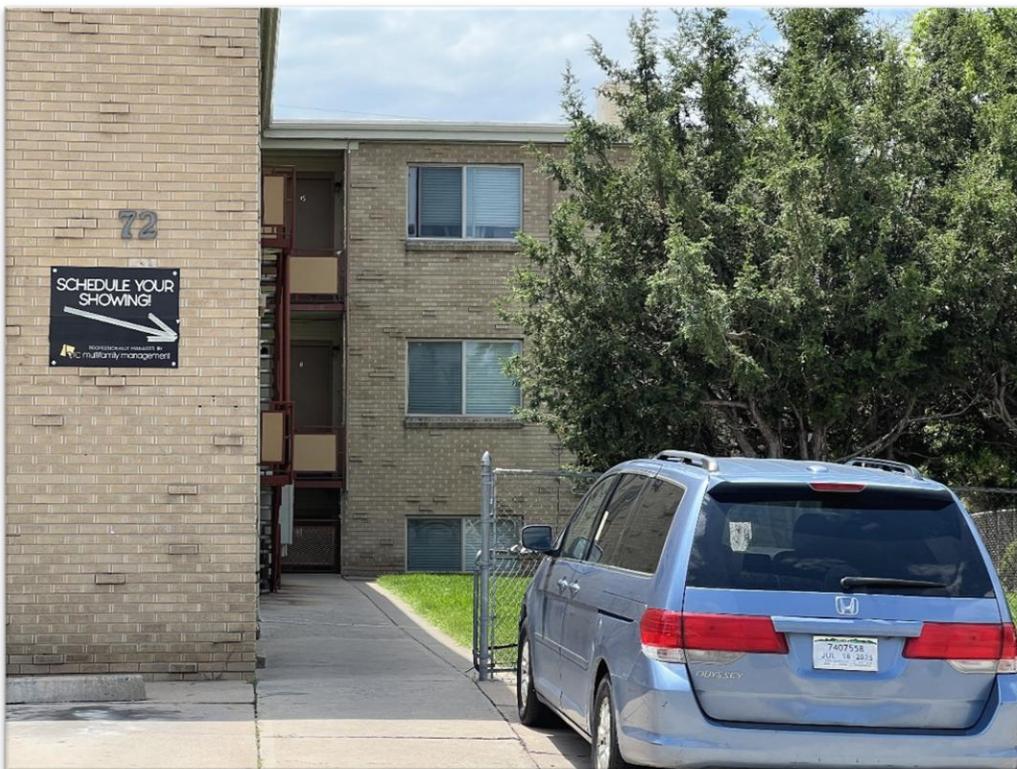
Photo Number: 2

Description: Entrances located through wood doors on each floor of the north elevation.

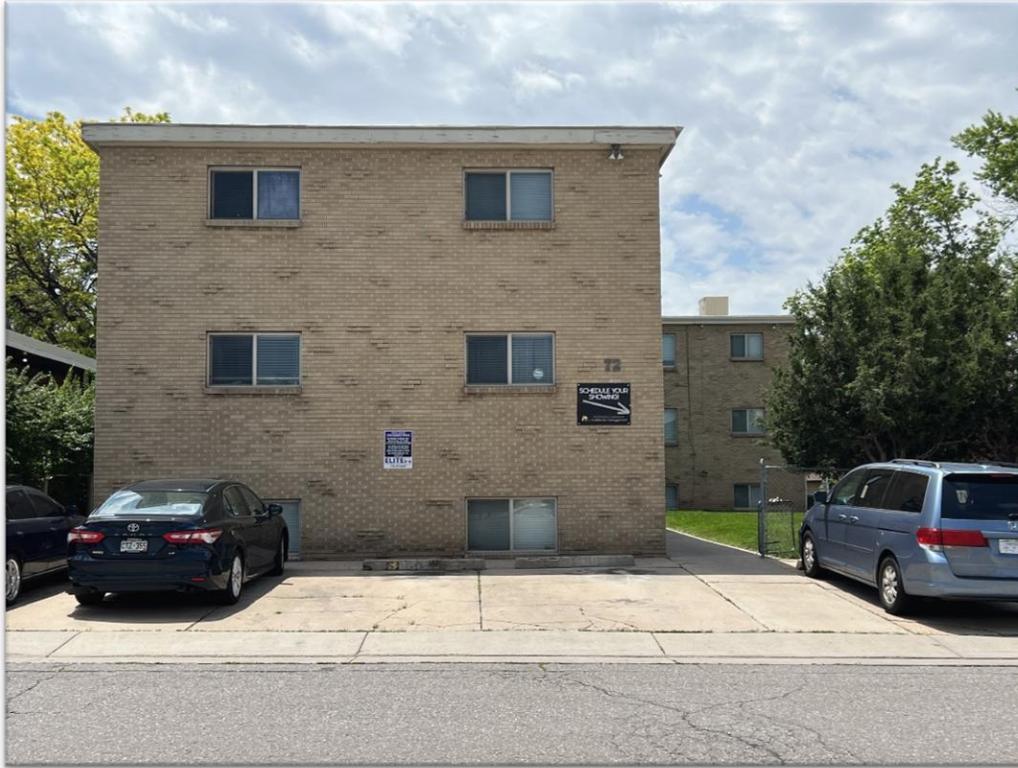
Photo Number: 3

Description: North elevation featuring typical windows.

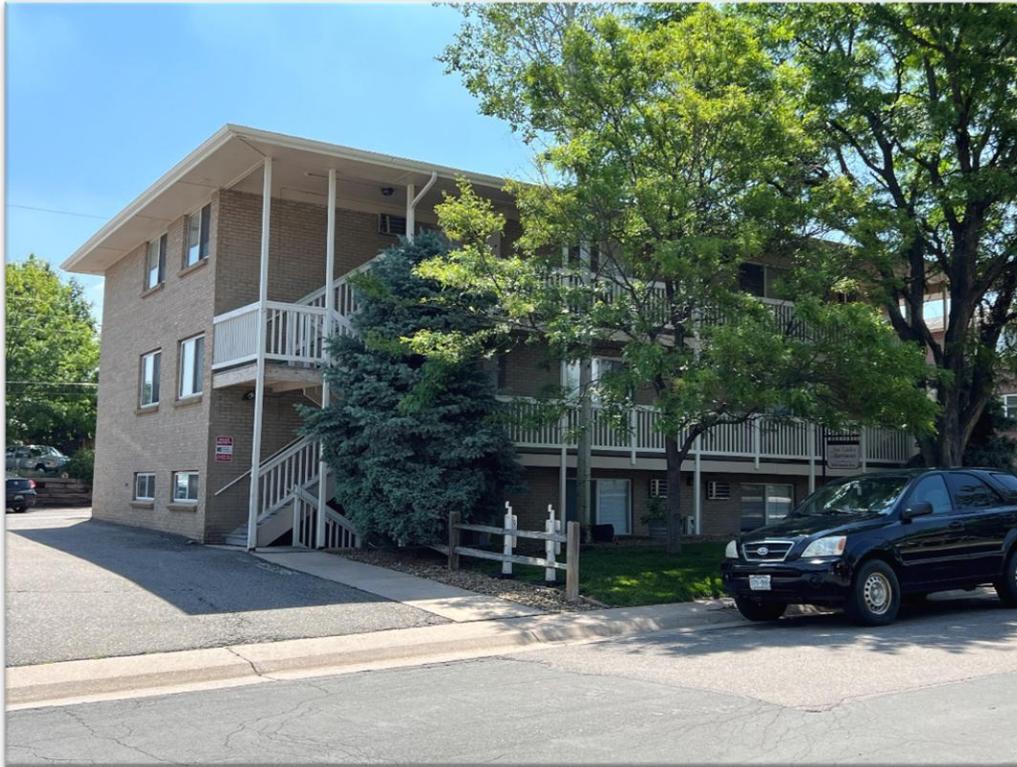
Photo Number: 1

Description: Looking at the primary (west) and north elevations of the building at 5318 South Fox Street.

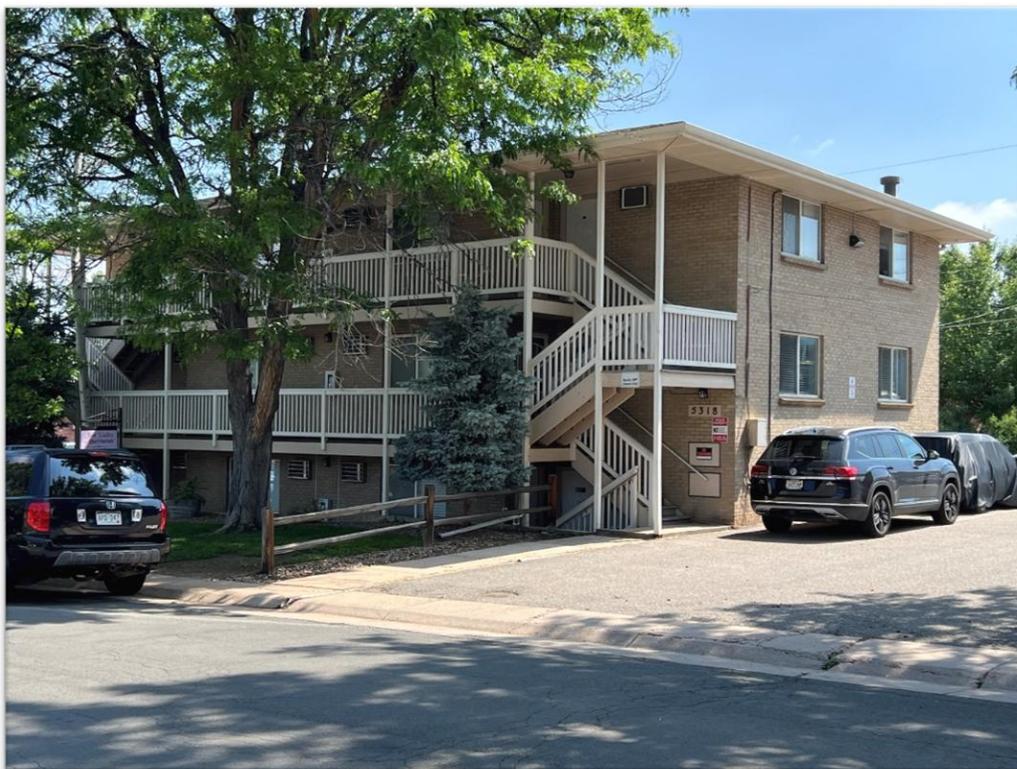
Photo Number: 2

Description: Looking at the primary (west) and south elevations of the building at 5318 South Fox Street.

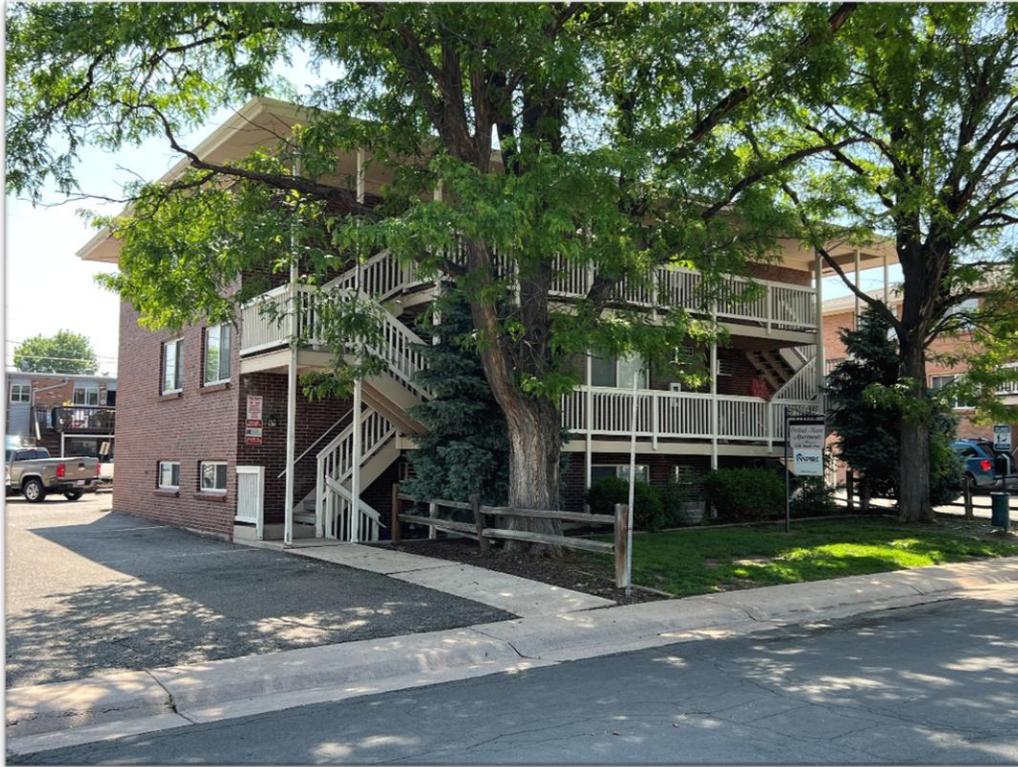
Photo Number: 3

Description: Looking at the primary (west) and north elevations of the building at 5338 South Fox Street.

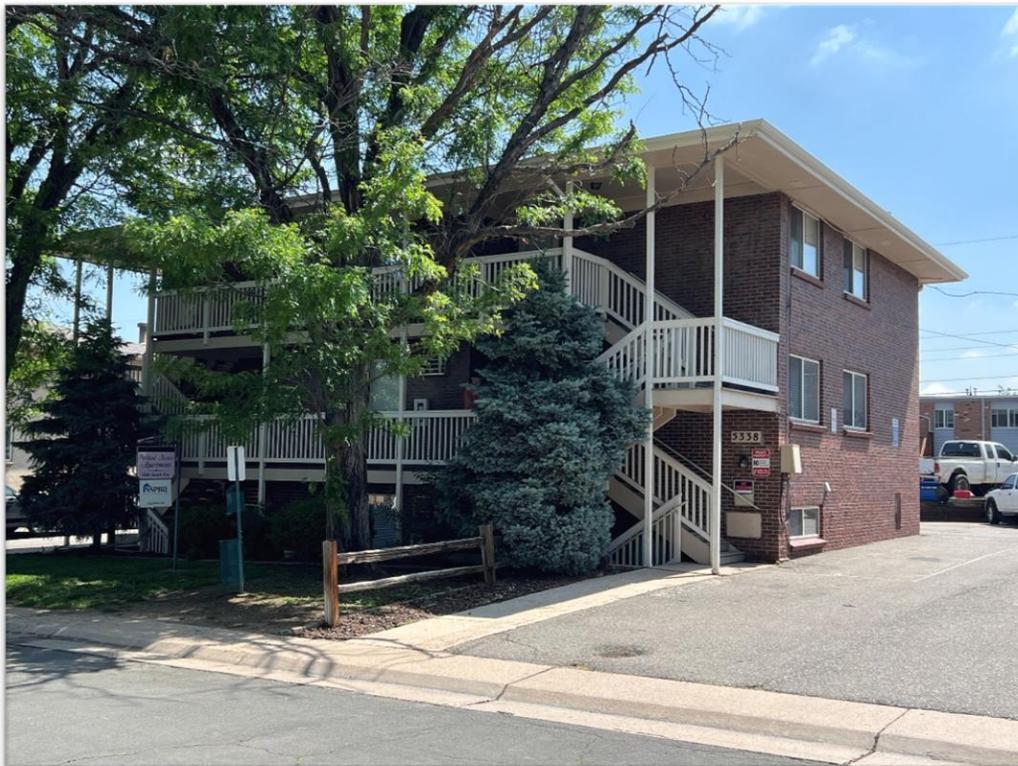
Photo Number: 4

Description: Looking at the primary (west) and south elevations of the building at 5338 South Fox Street.

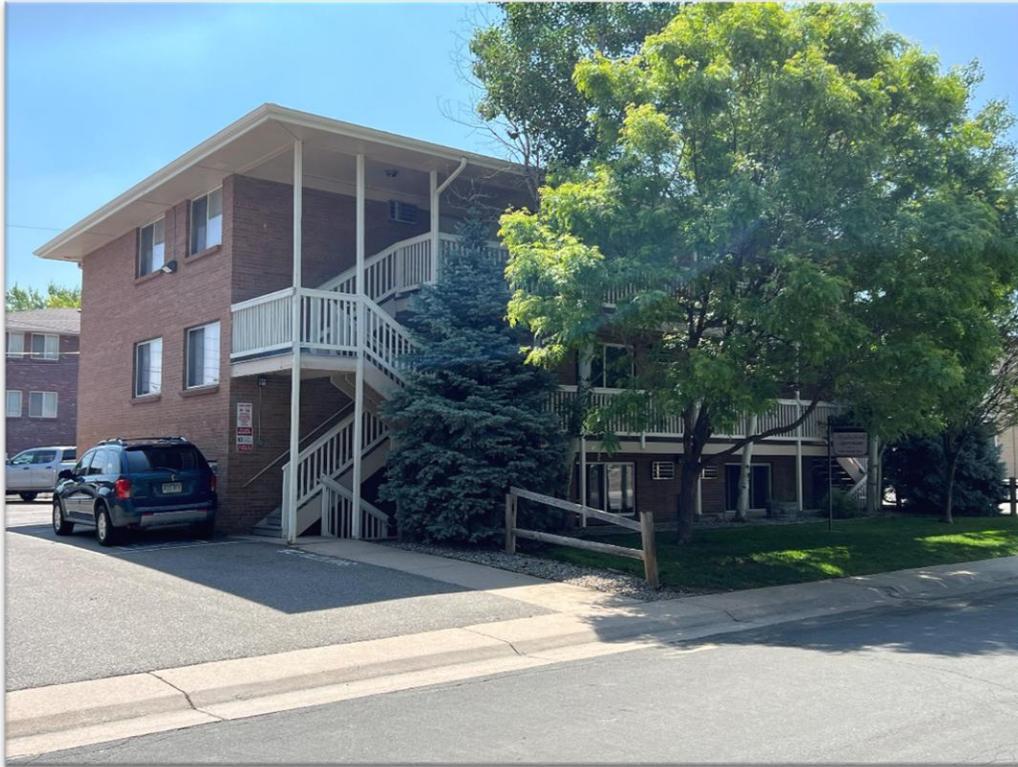
Photo Number: 5

Description: Looking at the primary (west) and north elevations of the building at 5348 South Fox Street.

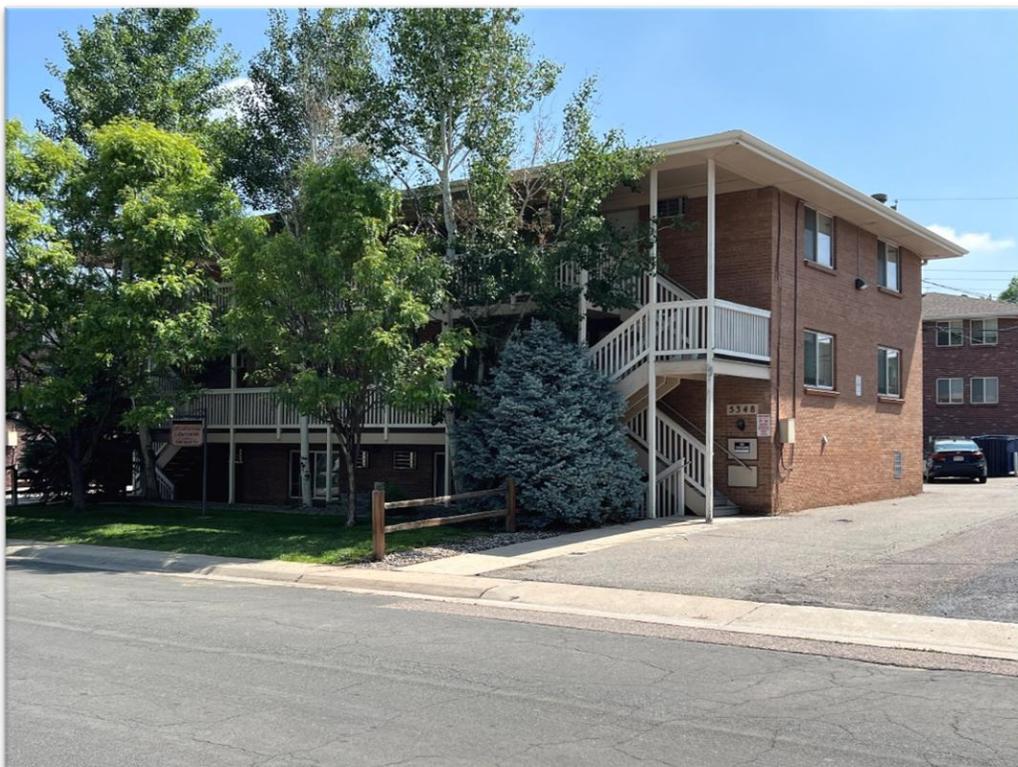
Photo Number: 6

Description: Looking at the primary (west) and south elevations of the building at 5348 South Fox Street.

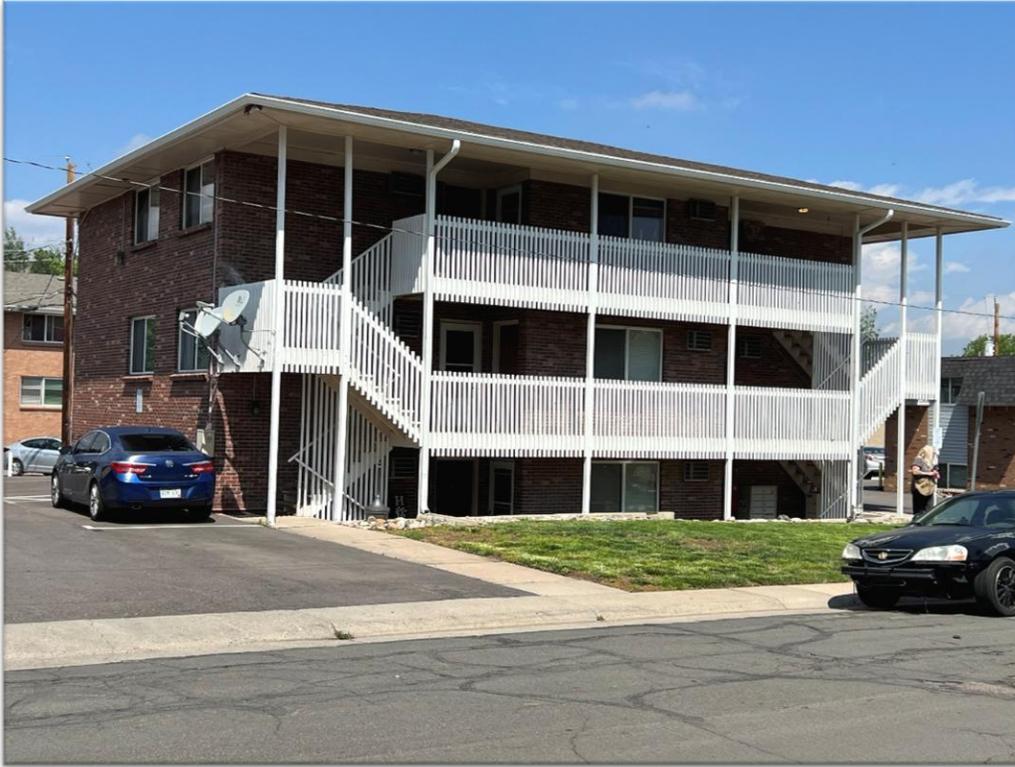
Photo Number: 8

Description: Looking at the north and primary (east) elevations of the building at 5359 South Elati Street.

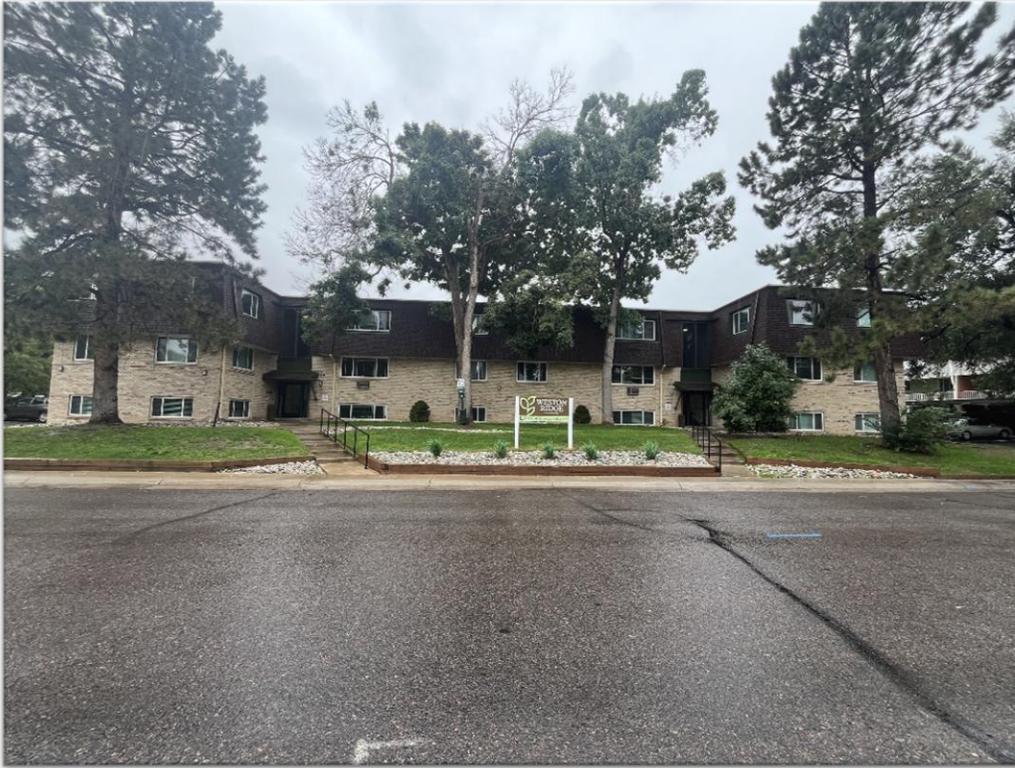
Photo Number: 1

Description: Primary (north) elevation of the Weston Ridge Apartments building at 1314 West Shepperd Avenue.

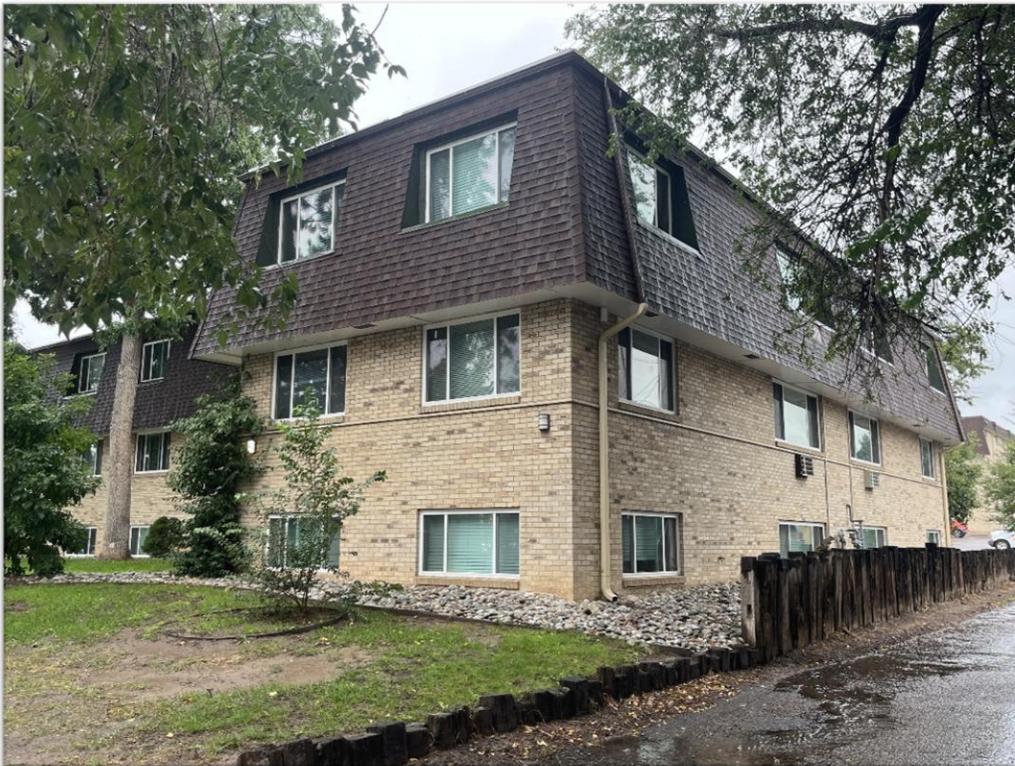
Photo Number: 2

Description: West elevation of the building featuring the typical windows and windows recessed in the mansard roof.

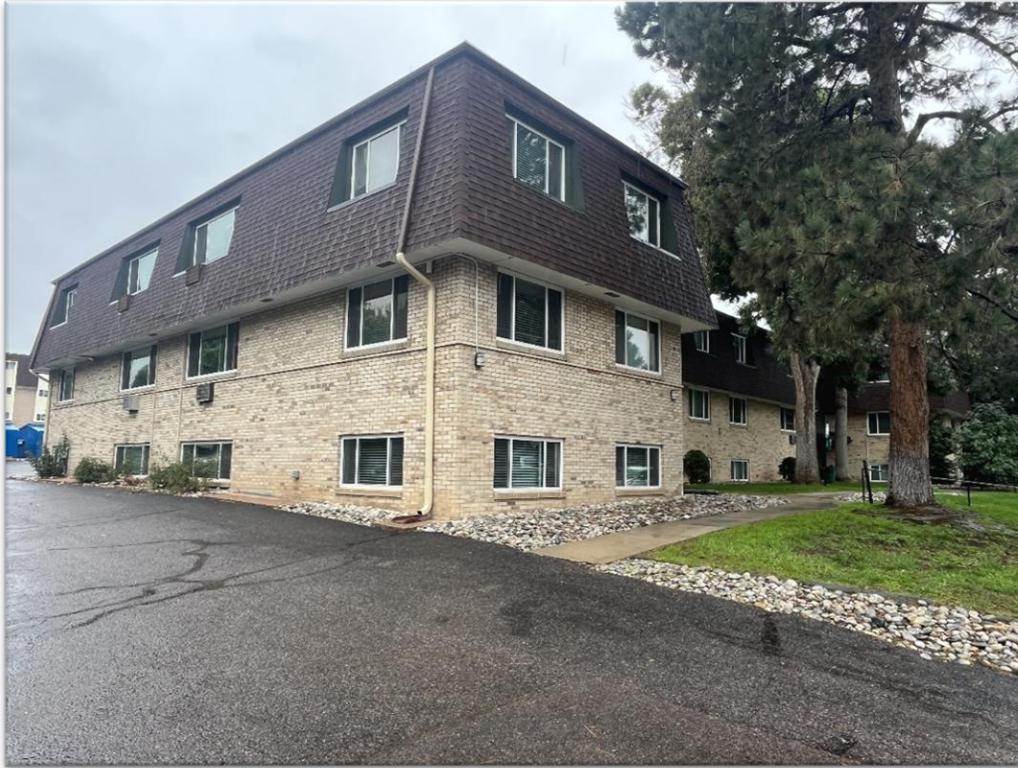
Photo Number: 3

Description: East elevation of the building at 1314 West Shepperd Avenue.

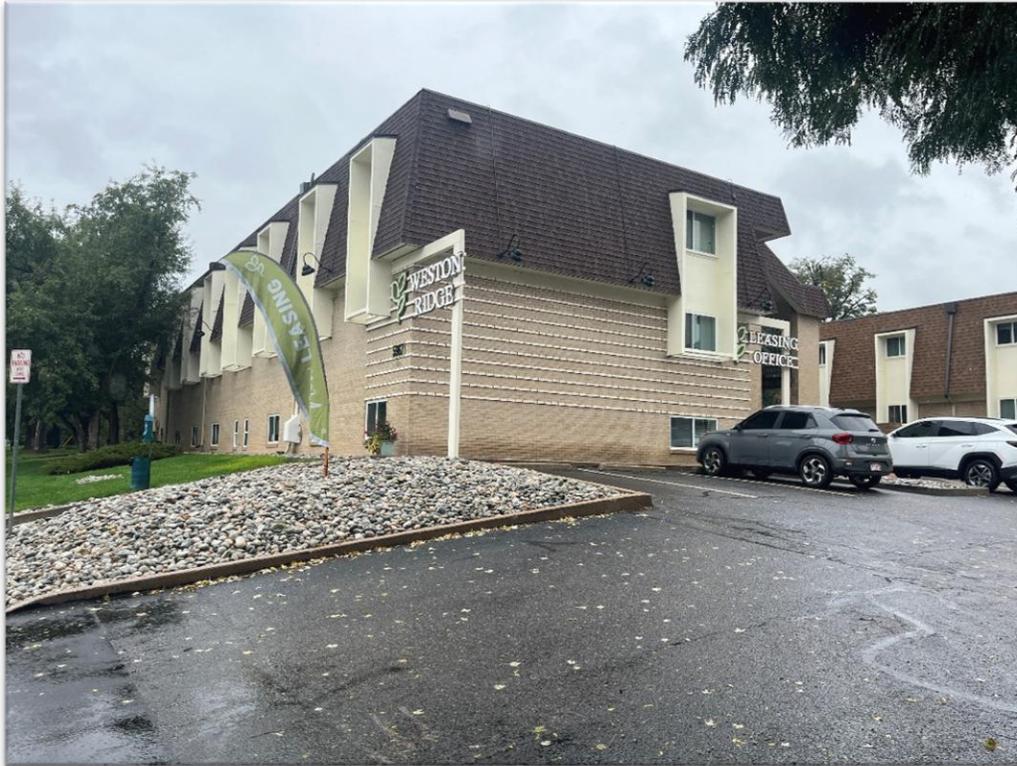
Photo Number: 1

Description: The north and east elevations of the southeasternmost building at the Weston Ridge Apartments.

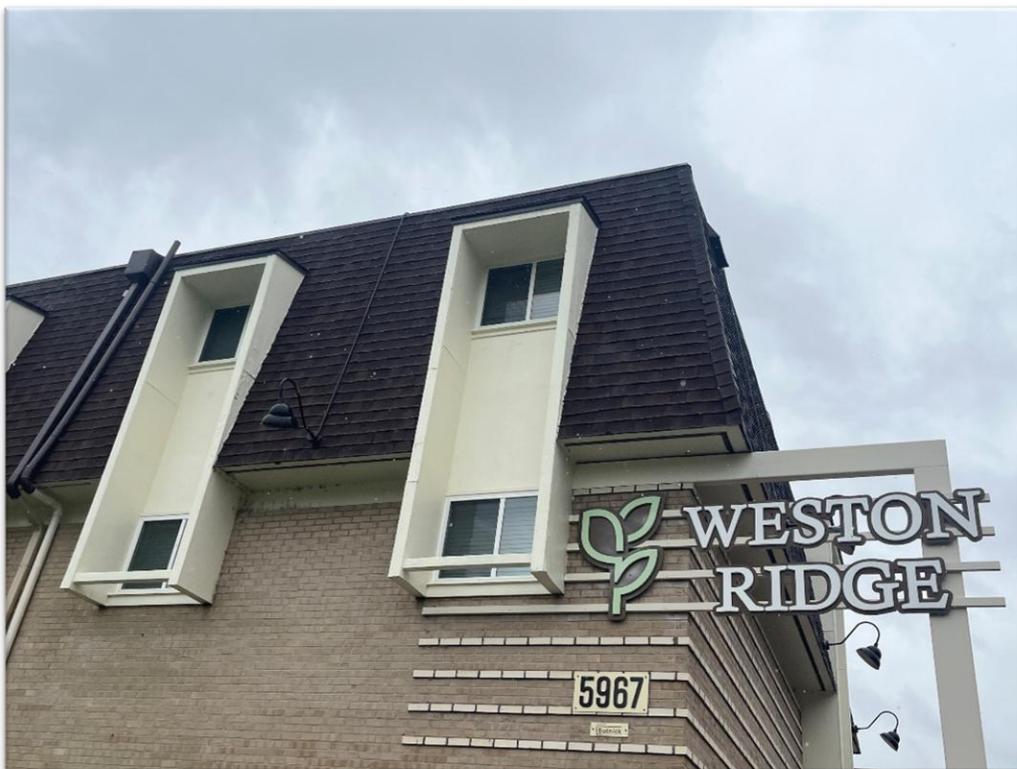
Photo Number: 2

Description: Detail view showing the apartment complex signage as well as the projecting, articulated window bays present on each building. Also note the neo-mansard apron which circumnavigates each building.

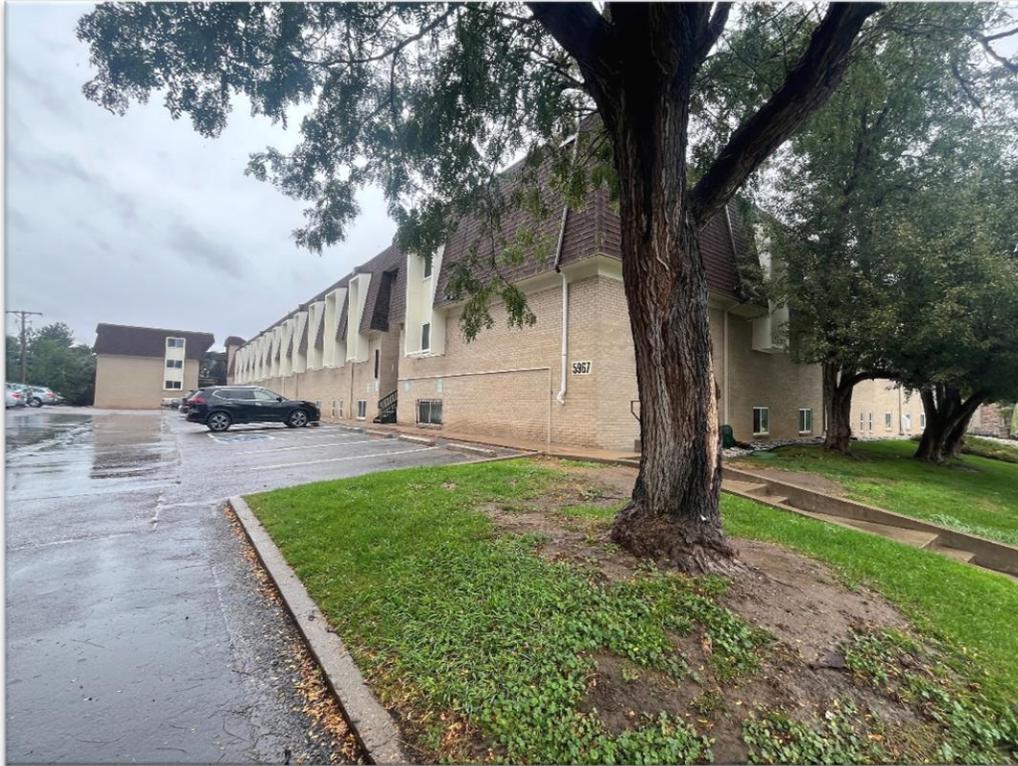
Photo Number: 3

Description: Partial views of the southeast and southwest buildings at the Weston Ridge Apartment Complex.

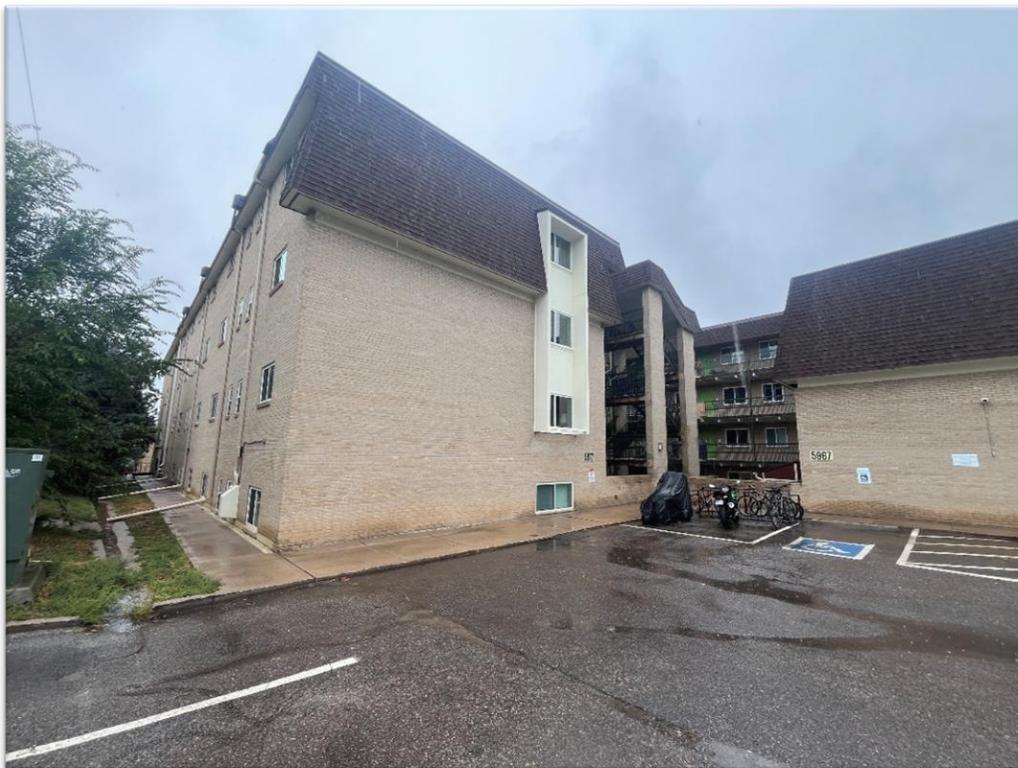
Photo Number: 4

Description: Partial view of the central courtyard on the southwestern building at the Weston Ridge Apartment Complex.

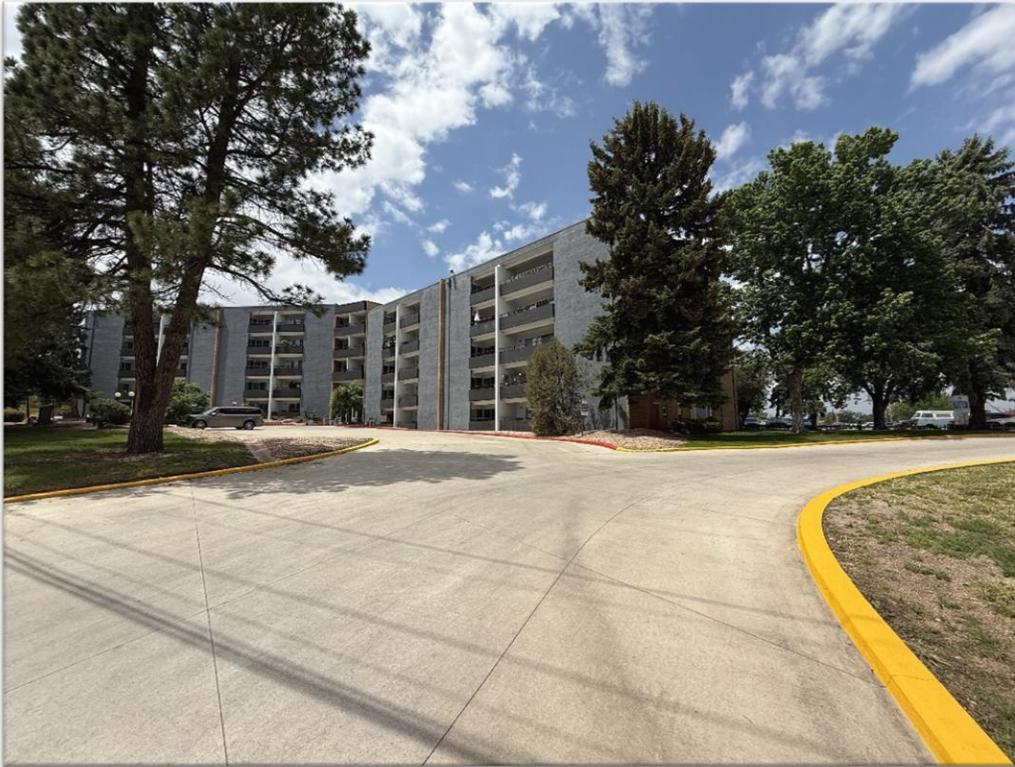
Photo Number: 1

Description: Primary (east) elevation featuring four recessed balconies on each floor of the north prong of the Y-shape plan.

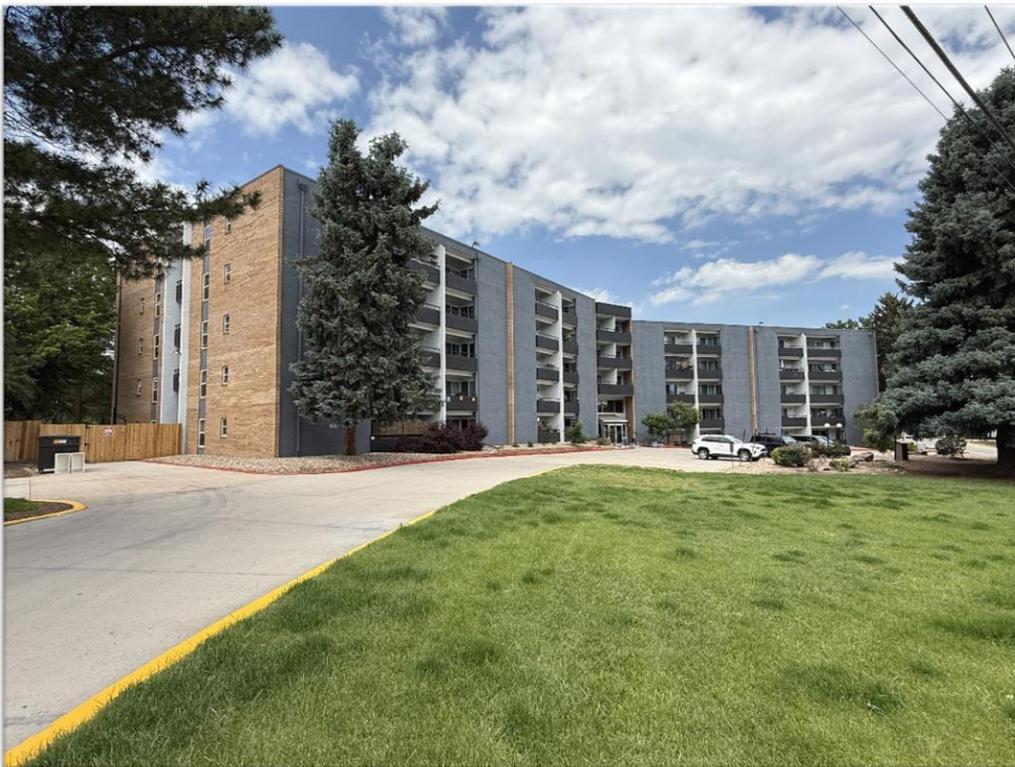
Photo Number: 2

Description: Primary and southeast elevations of the building at 5829 South Datura Street featuring the breezeway.

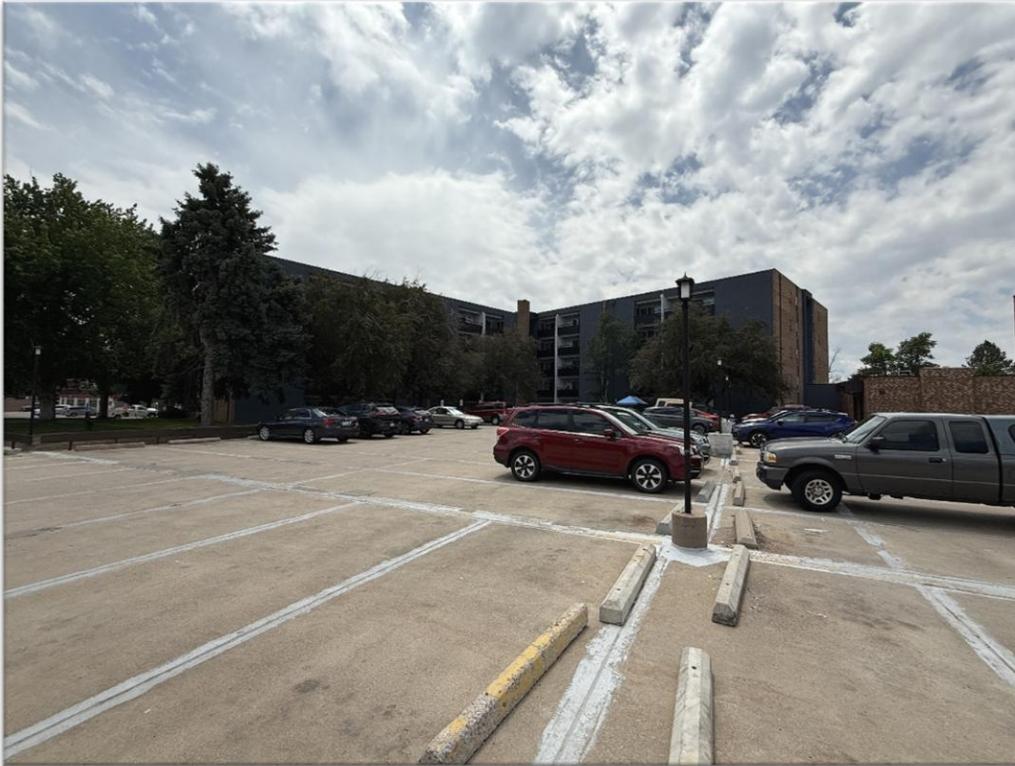
Photo Number: 3

Description: Northeast and northwest elevations of the building at 5829 South Datura Street beyond the parking lot.

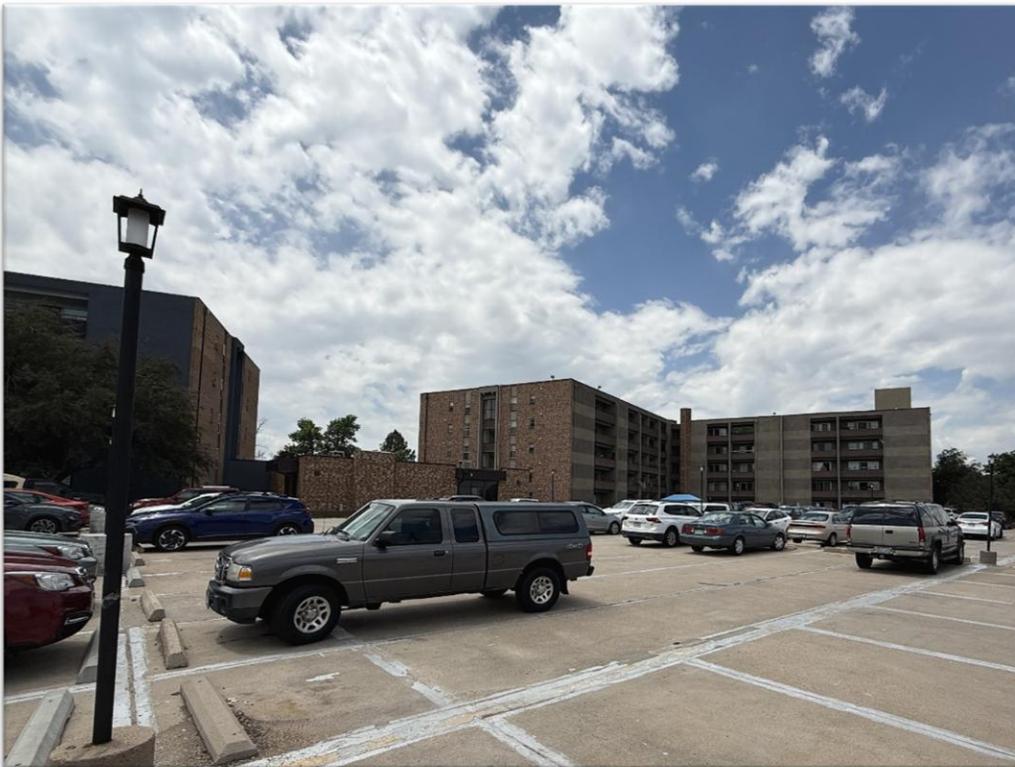
Photo Number: 4

Description: North elevation of the single-story building attaching the two five-story building and the northeast and northwest elevations of the building at 5820 South Windermere Street.
