City of Littleton Survey Plan and Reconnaissance Survey Report

Pinyon Project No.:
124169901

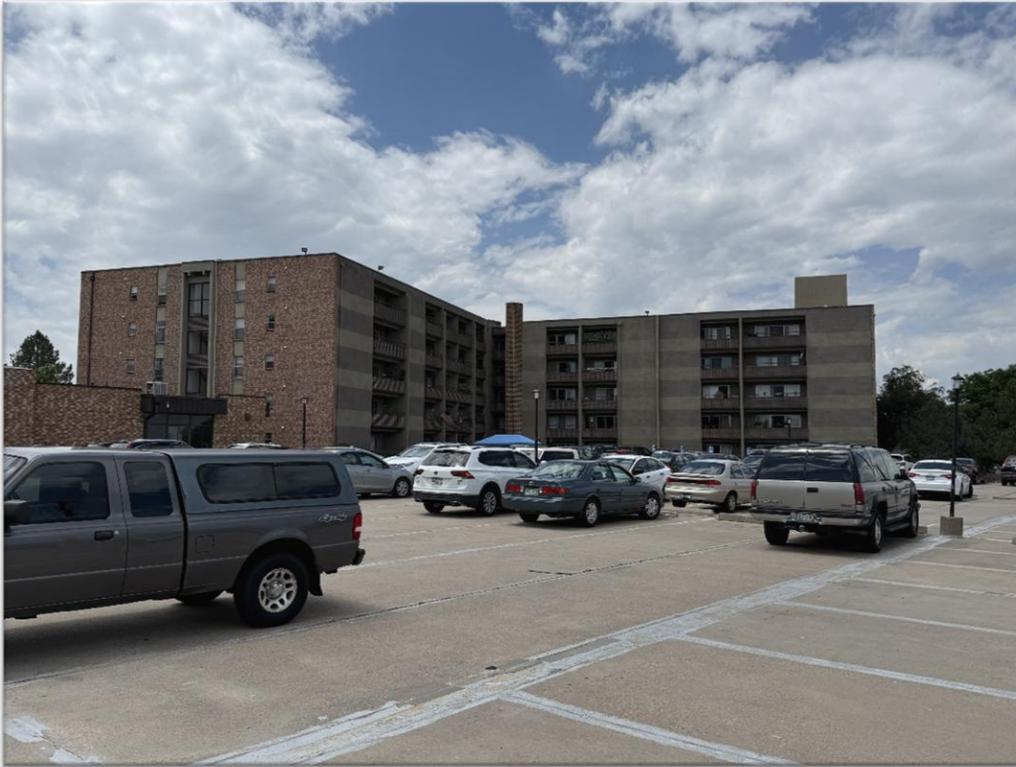
Photo Number: 5

Description: Northeast and northwest elevations of the building at 5820 South Windermere Street.

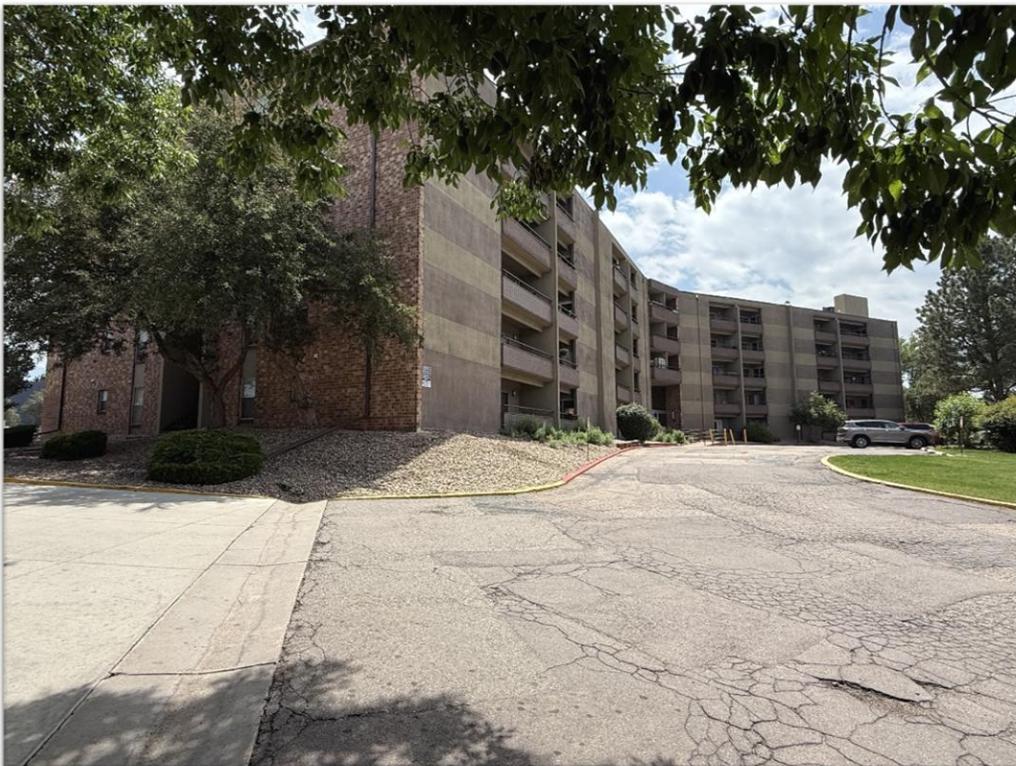
Photo Number: 6

Description: West elevation of the building featuring the balconies on each floor.

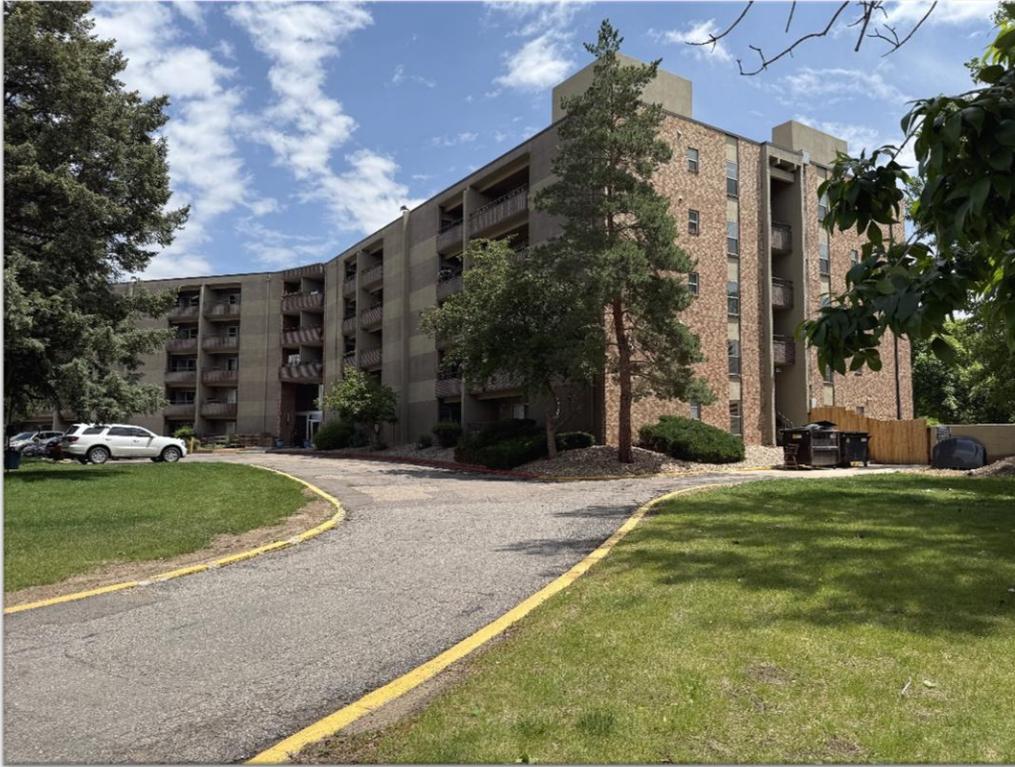
Photo Number: 7

Description: Northwest and west elevations of the Windermere building.
