Bellevue Service Center Building 2 & 3 Basis of Design Report

SITE PLAN ASSESSMENT

SPACE PLANNING ASSESSMENT
BUILDING 3

SPACE PLANNING ASSESSMENT
BUILDING 2

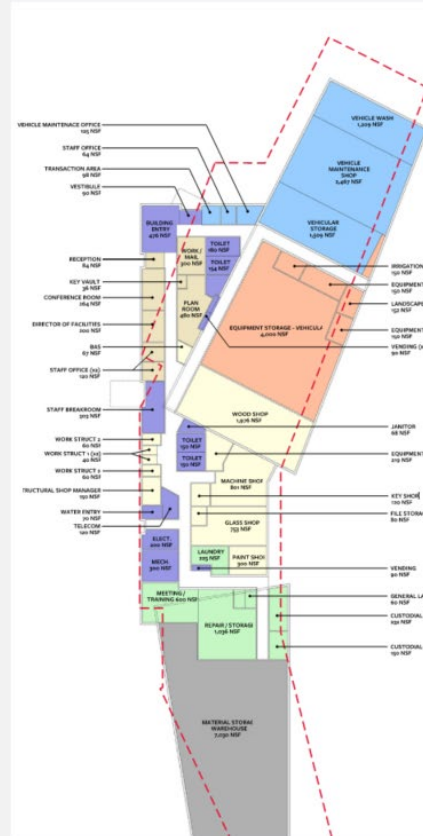
Step 1

“Serve” Block shifted towards community

Step 2

Service & Store Block rotated to engage yard

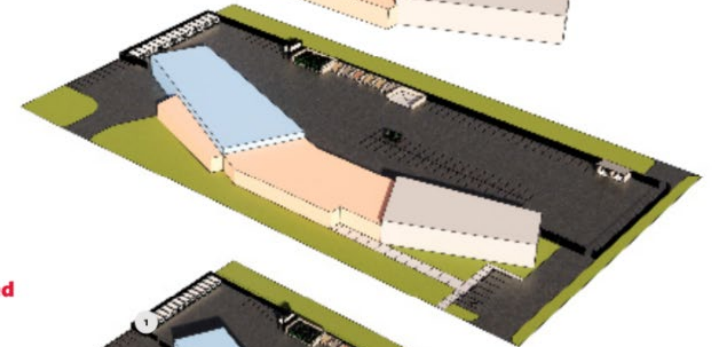
Massing Re-imagined

- 1 Entry parking centralized at single entry
- 2 Serve block simplified to create more efficient admin and shops
- 3 Storage massing rotated to engage community while created a rectilinear yard

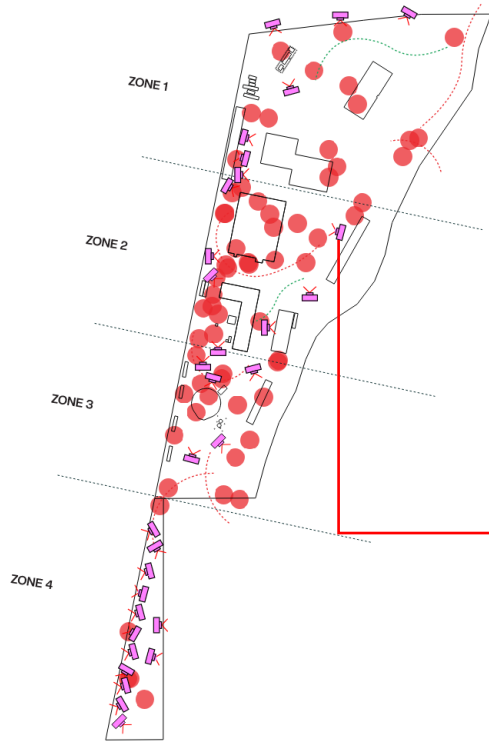
- ZONE 1**
- The entry point from the east ramp on site is a safety hazard
 - Building one has poor proximity for access, disrupts daily use of the building - a safe path should be provided

- The gas tank located in the parking lot is a hazard
 - Some staff have to move between their respective building and building 1. There is not enough space to meet

- Overnight parking is not consistently in one location
 - Building 1 has minimal lockable storage
 - The fueling station is uncovered and lacks all fuel needs on campus

- ZONE 2**
- There is ice build up on the northern sides of the buildings that presents as a hazard to staff
 - There are no protective bollards in front of the buildings

- The wash pit behind building 3 is in a poor location and experiences frequent freezing
 - The was pit is too small and the access is very difficult
 - Operationally the bay entry on the back of building 2 is hazardous

- The areas in front of the buildings can get congested
 - The train track edge is where materials tend to pile up
 - The parking between and around these buildings is not adequate or safe

- The circulation around these buildings are not adequate or safe
 - Chemical wash locations are non-existent
- ZONE 3**
- Storage tends to build up along the borders of these zones

- The entry to the south 40 is a pinch point and hazard
 - Grounds storage area is messy and has narrow access; mixing of dissimilar materials
- ZONE 4**

- The southern 40 has many purposes but is not well defined as a designated space for storage or staging

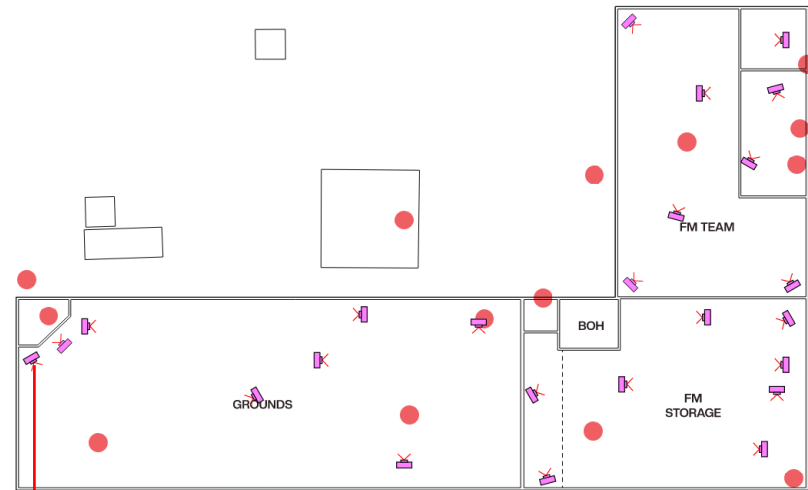
- FM TEAM**
- The office spaces generally are not suitable and need to be improved
 - There is no designated meeting space
 - The workshop space is unsafe and needs to be better outfitted for emergencies

- There is not chemical wash down area for staff protection
 - There is not sufficient access through the side of the building
 - The area of storage above the offices is not usable and has become a hazard

- There is not direct line of site from the offices to the workspace
 - This area has poor electrical layouts and can make working in this space inconvenient

- FM TEAM STORAGE**
- The air compressor is very noisy and has no noise protection
 - The locked storage area is a temporary solution and needs to be more secure

- GROUNDS**
- The compressor located in the closet is loud and needs noise protection
 - There is not chemical wash down area for staff protection
 - This area has poor electrical layouts and can make working in this space inconvenient

- OTHER**
- The restroom space is ill maintained and needs to be larger to better suit the building needs
 - This building is close to the train tracks and needs proper noise protection

- The shed on the exterior of the building is for filters etc. and is not large enough. It would be best for this to be indoors
 - There is ice build up on the north side of the building

- The fire hydrant is what is accessed to use the wash down pit and this connection should be adjusted to avoid this need
 - The building has poor air quality and air quality control

- This building has poor temperature control

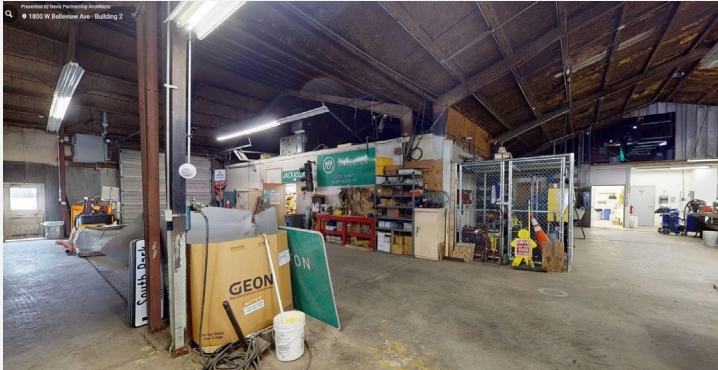
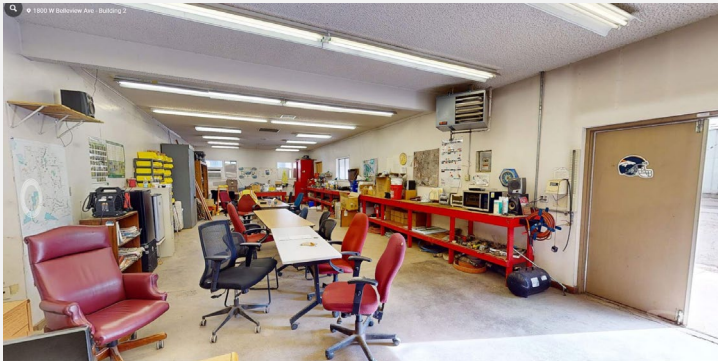
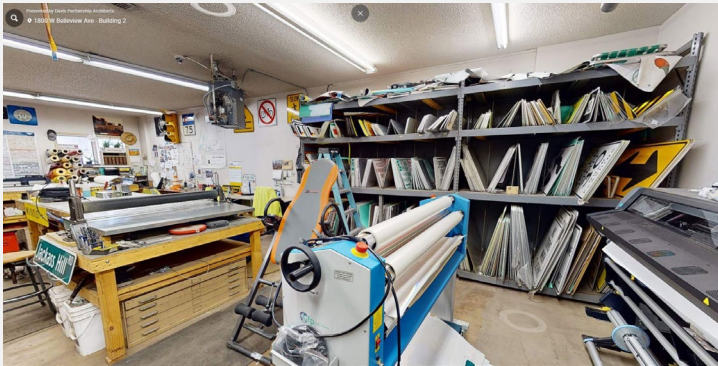
- There is ice building up on the east side of the plan that is a hazard to entry into this space
 - This entire building has poor air quality
 - This entire building has poor thermal control

- This entire building has limit electrical control /capacity/accessibility
 - This entire building has limited safety measures accommodated for
