National Register of Historic Places Registration Form

Historic name: Littleton Post Office

Street & number: 5753 S. Prince St.

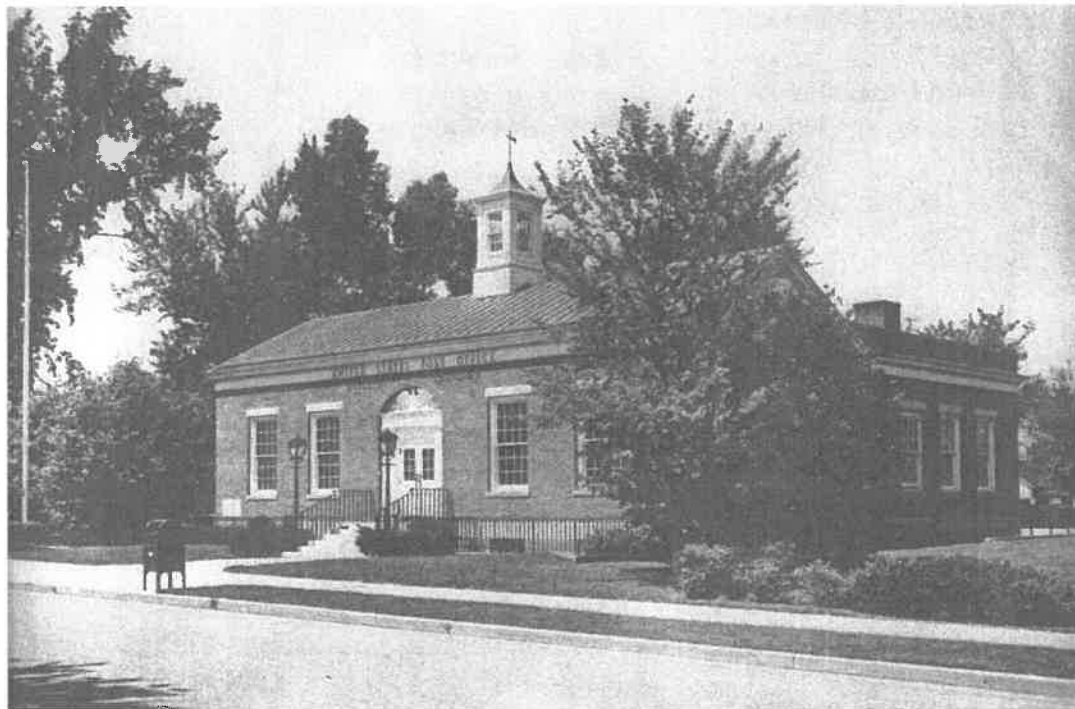
HP1 Littleton Post Office. East and north sides. Historic photo ca. 1948. View to southwest. *Photo Source – Grissinger, Littleton Independent 60th Anniversary Edition 1888-1948; Photo Courtesy of Littleton Museum*

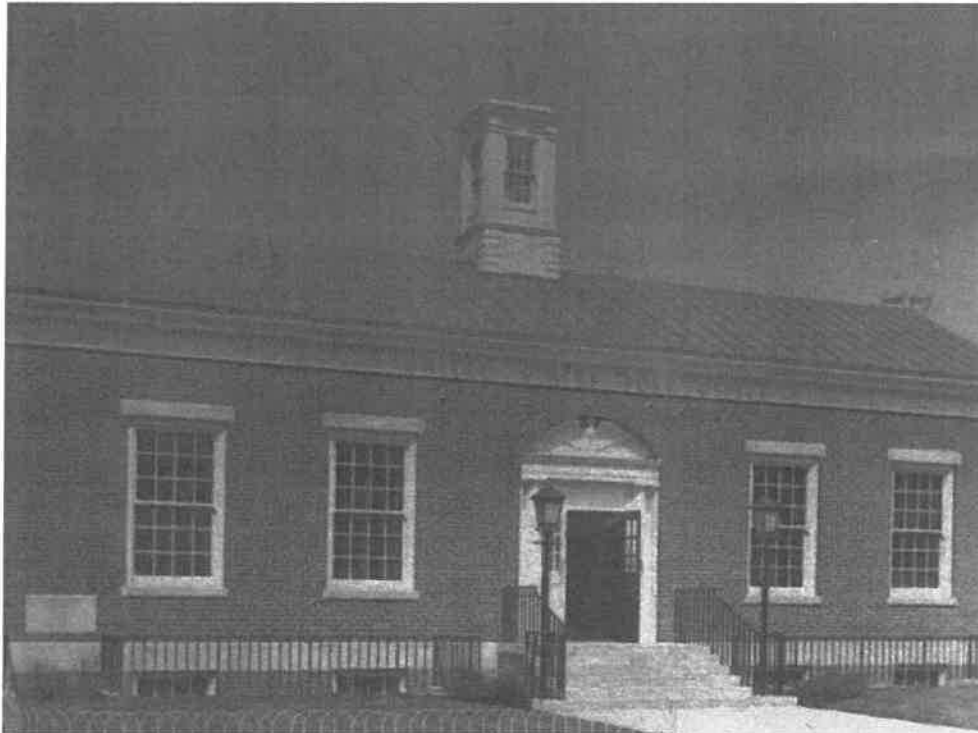
HP2 Littleton Post Office. East side. Historic photo ca 1940-1950. View to west. *Photo Courtesy of Littleton Museum*

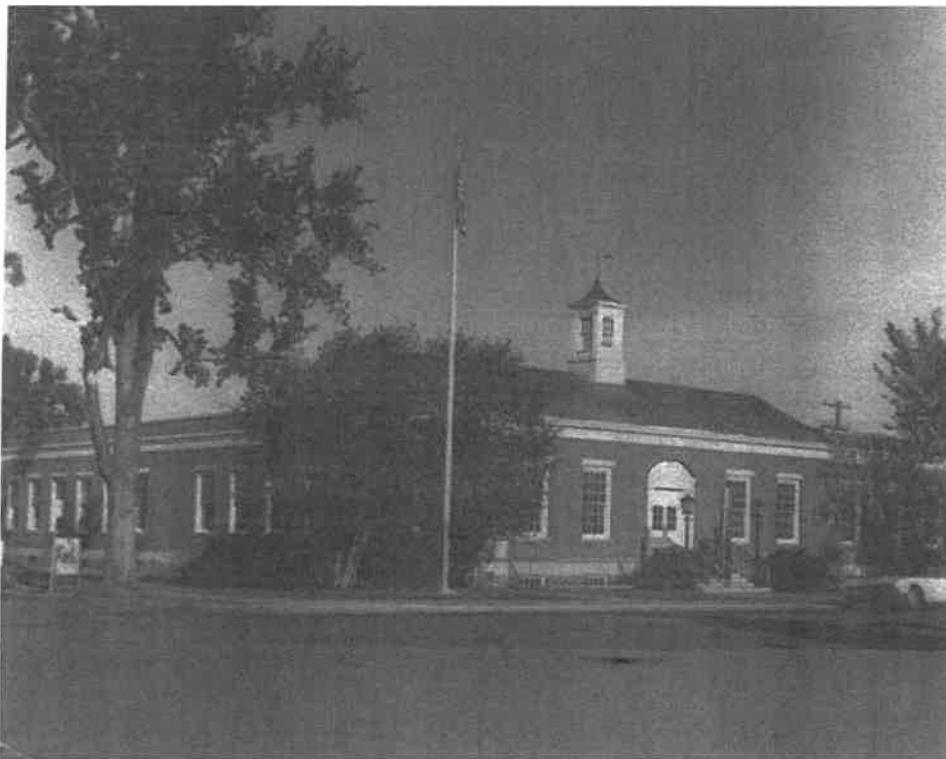
HP3 South and east sides. Historic photo ca 1962. View to northwest. *Photo Courtesy of Littleton Museum*

The 1962 "L" addition to the north and west of the original building is 47' wide x 120' deep and recessed 1'-6" back from the original wall. The addition closely matches the materials of the original building, using a slightly lighter color modular red-brown brick laid in common bond with cast stone water table. It has a flat roof with a brick parapet above the cast stone cornice. The cast stone cornice replicates the 1939 wood cornice in size and shape, but without the dentils. The four northern windows are symmetrically spaced and match the original windows in style and size. There is one scupper draining the roof to the east. The southern-most window was modified to accommodate an accessible entrance with a concrete ramp, which also matches the building in style, materials, and detailing. The ramp, which turns north along the façade, then east out to Prince Street, was installed ca. 2003. The window was sensitively modified into a single width, twelve-light wood door, with an eight-light frosted transom window, and full height six-light sidelight. The entrance is protected by a similar metal-framed canvas awning as found at the main entrance and also installed ca. 2003.

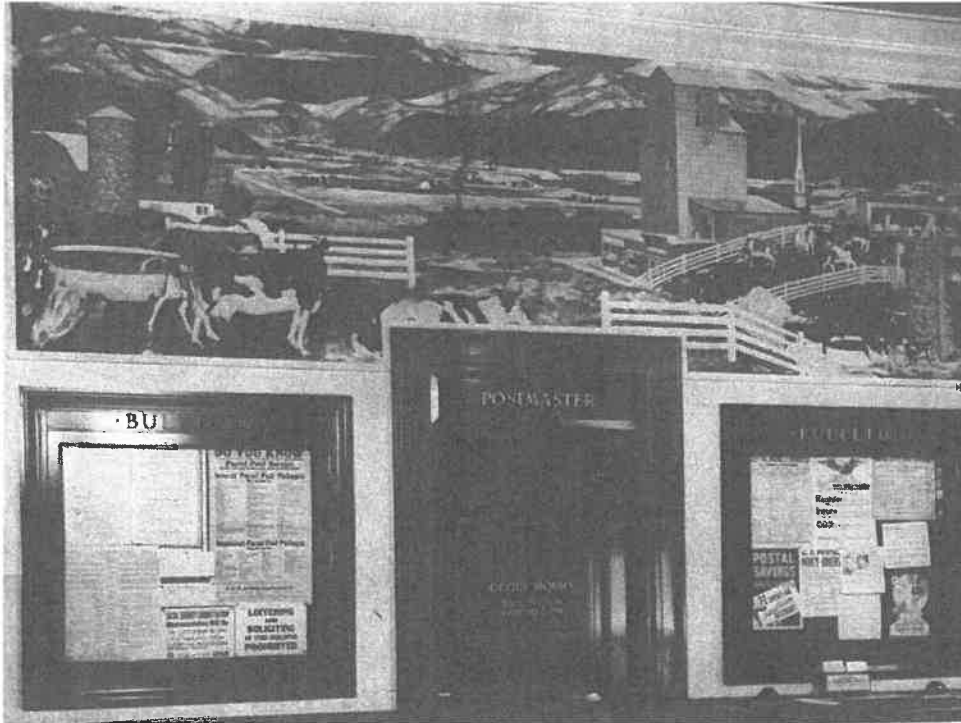
HP4 Littleton Post Office interior showing mural. Historic photo ca 1948. *Photo Source – Grissinger, Littleton Independent 60th Anniversary Edition 1888-1948; Photo Courtesy of Littleton Museum*

In 1939, a 13' x 4'-6" mural titled "Littleton, Colorado," by Pennsylvania-based WPA artist John Fraser, was mounted above Postmaster Willard A. Teller's office door in the lobby area of the new Post Office. Fraser worked from photographs he saw in the local newspaper, the *Littleton Independent*. Conveying the essence of an agricultural town, Fraser's mural is a composite with farms, cows, trains, mountains, and the Columbine Mill. Fraser's mural was selected in a nationwide competition as the mural for Colorado (each state received one mural) and Colorado's selection went to Littleton, since it was the subject of the mural. Mr. Fraser personally transported the completed canvas via train from Pittsburgh to Littleton. It was rated by the *New York Times* as one of the twelve best among murals that were done by a WPA artist for a city in each of the 48 states, and it was featured in *Life* magazine. The mural was removed at an unknown date some years later and discovered in the 1970s by Littleton Museum Director Robert McQuarie, who said it had been "rolled up like wallpaper and dropped in a corner," according to a 1985 *Littleton Independent* story by Dave Zalubowski. It took more than fifteen years to find enough money to pay for conservation services for the painting, which now hangs, restored and handsomely-framed, in the Littleton City Council Chambers.

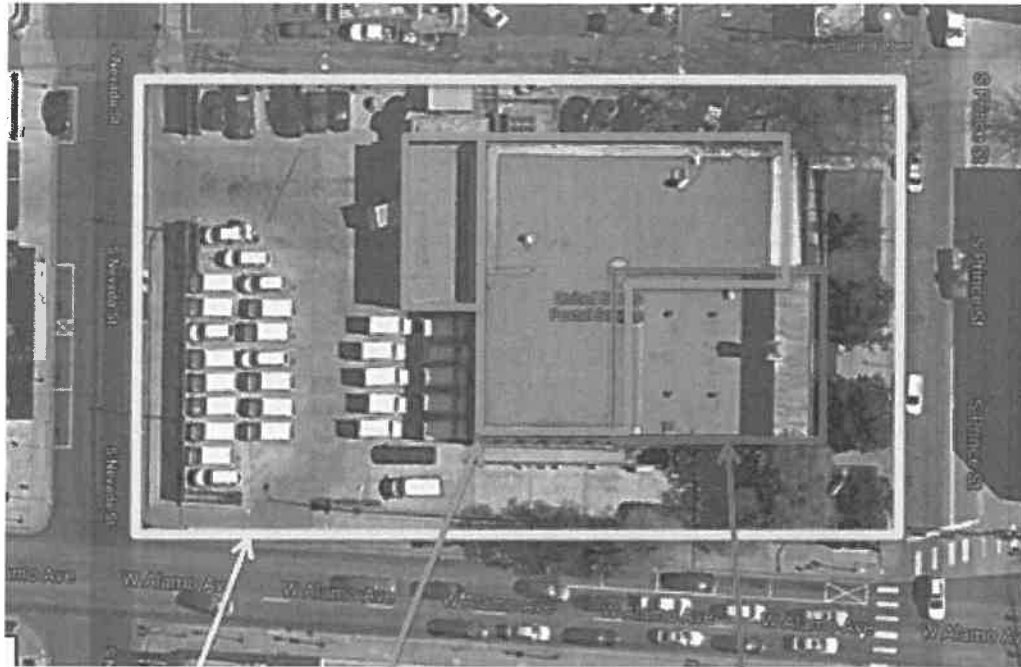
Property
Boundary

1962 Addition to the
Littleton Post Office
