ATTACHMENT A

PHOTOS OF THE BUILDING AND PROJECT

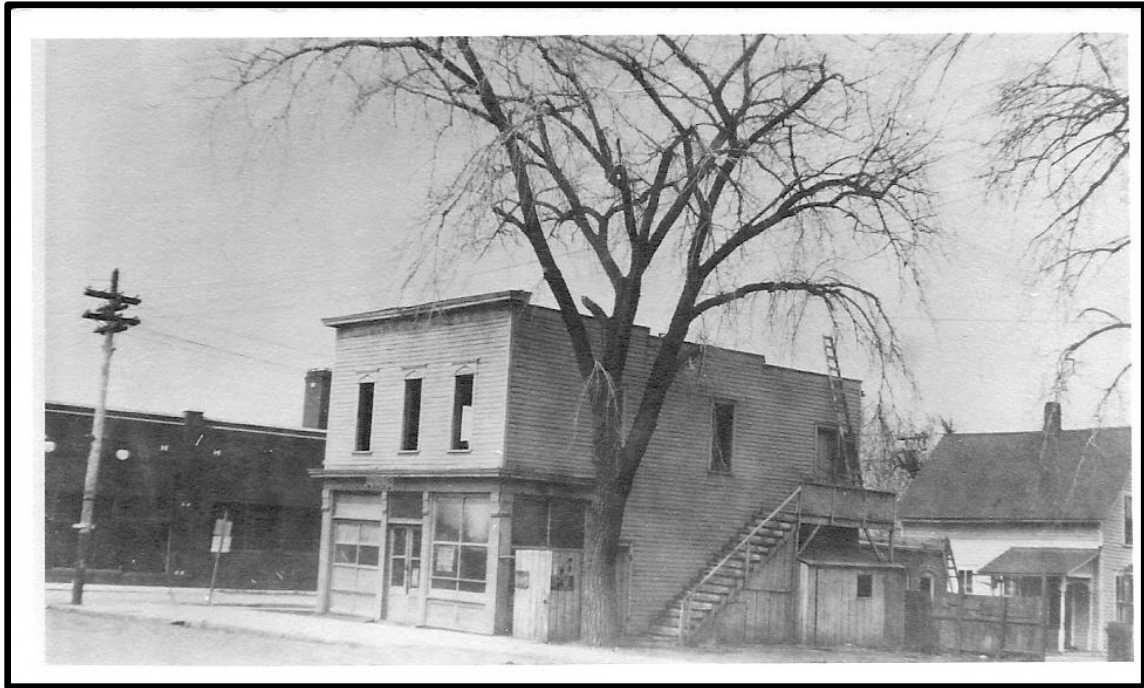
The Last Chance Saloon, at the northeast corner of Main and Sycamore Streets, was demolished and replaced by the Sommers Oil Service Station

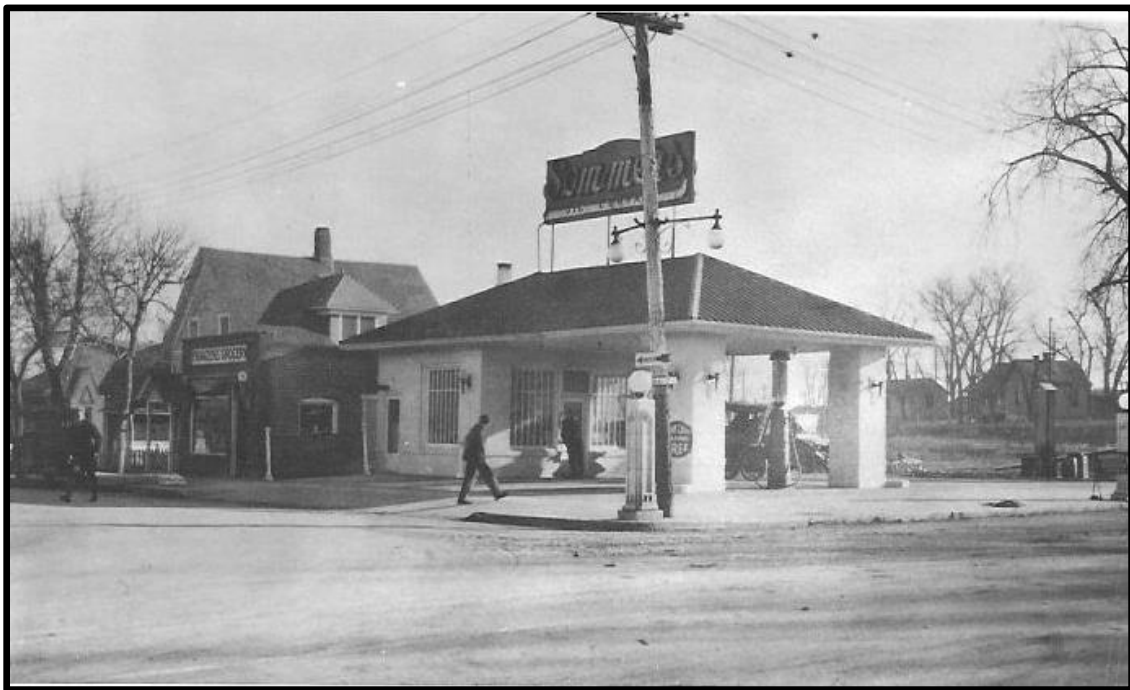
The original Sommers Service Station and the Franzen Grocery store, projecting out from the north side of the service station, prior to the addition of the garages to the east of the original service station and the enclosure of the drive-through canopy. Note the smaller door on the north end of the west wall; that door is now blocked up.

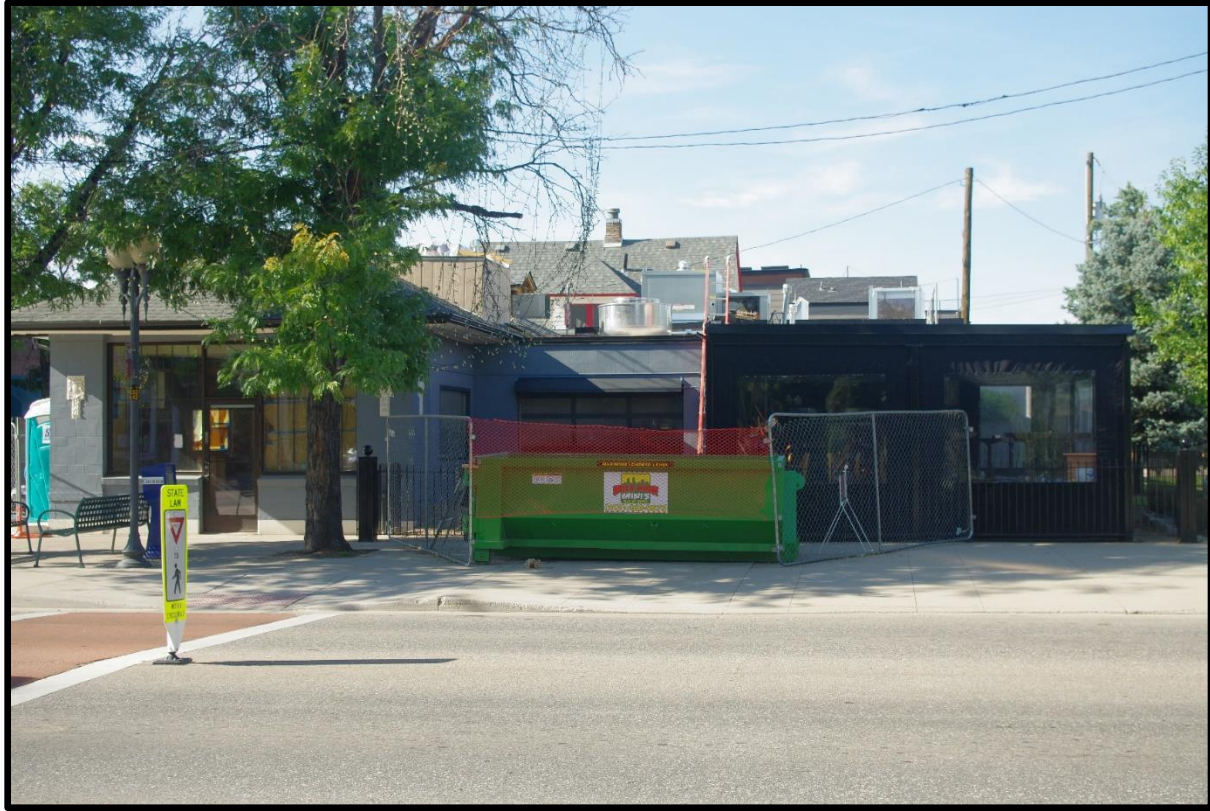
08/14/2016 Rooftop equipment and venting is being installed.

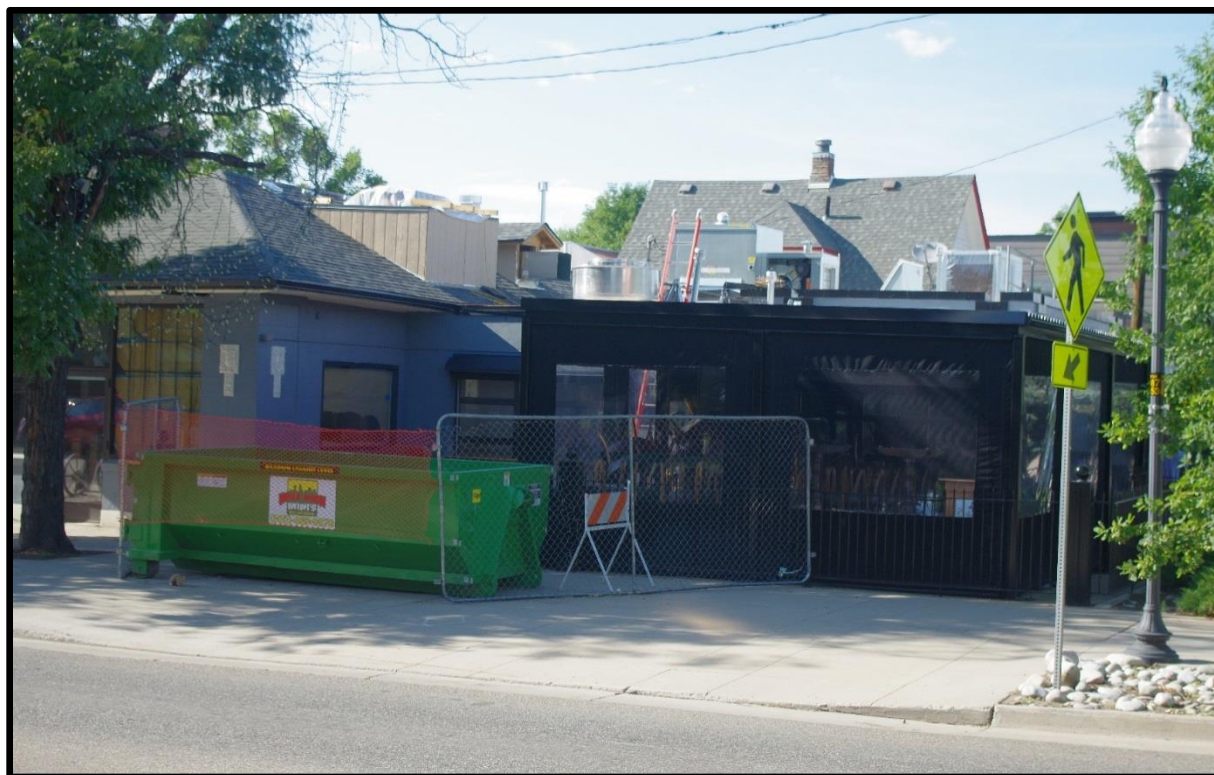
8/16/2016 Roof top HVAC equipment, including a new gable end dormer, with the duct, roof vent enclosure, and the platform for the large kitchen vent in process of being constructed,

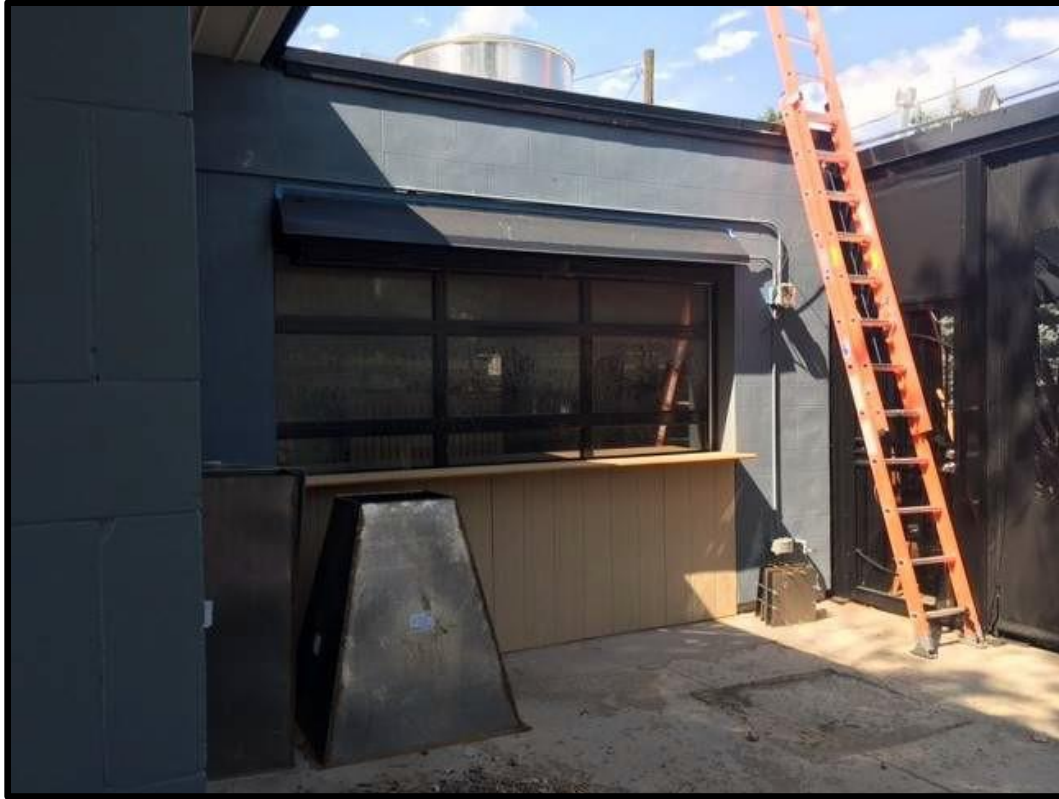
8/16/2016 The new patio bar is on the exterior of the building and will have a white quartz countertop. Staff recommends moving the bar back to the interior of the building to allow the existing garage door to close.

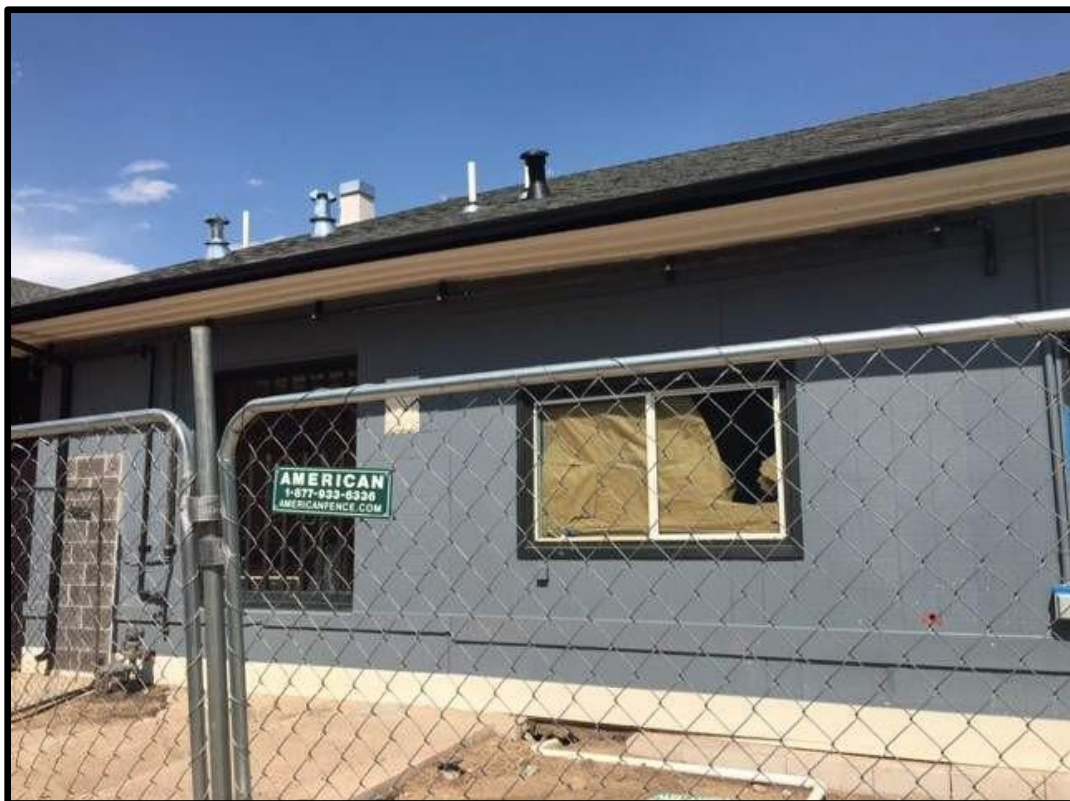
8/16/2016 The doorway was blocked, but is not yet painted. The gas lines were moved and painted black. The existing gas line on the west side of the building was moved up toward the soffit to hide it and make it less visible.

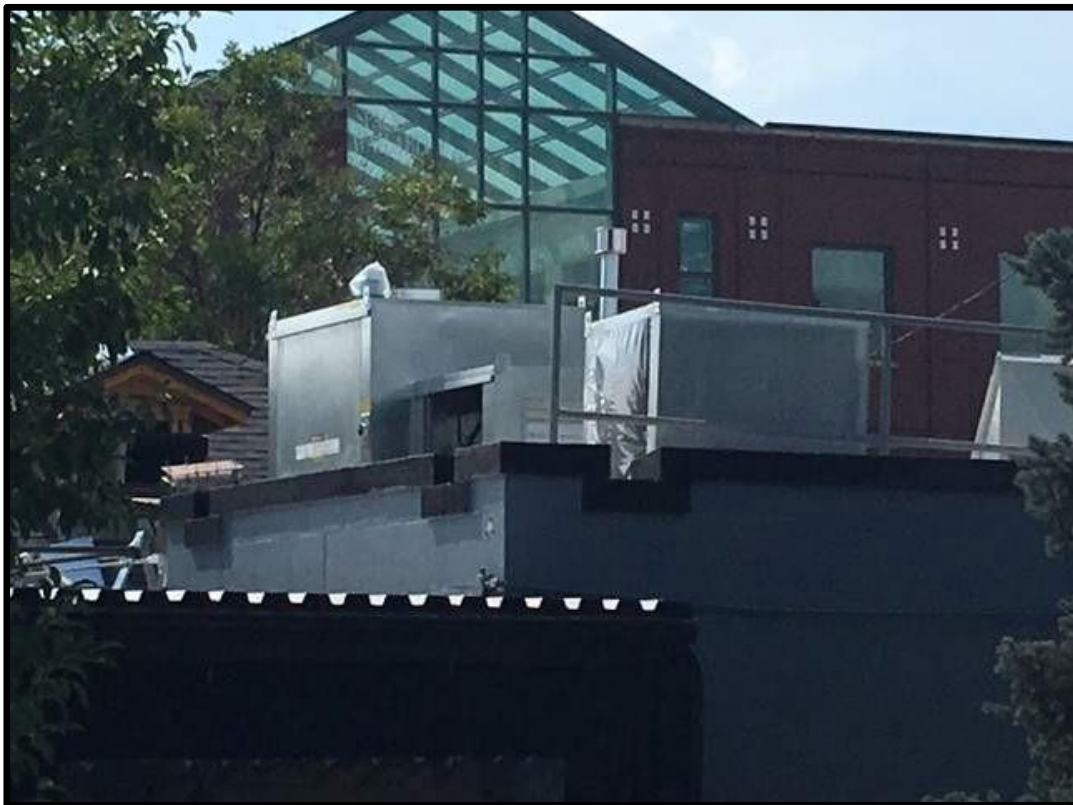
8/16/2016 A new rooftop mechanical unit, exhaust equipment, and ducting, platform, and dormer were installed in order to upgrade the existing kitchen to a commercial kitchen that meets current code and health standards, the HVAC items shown needed to be added to the rooftop.

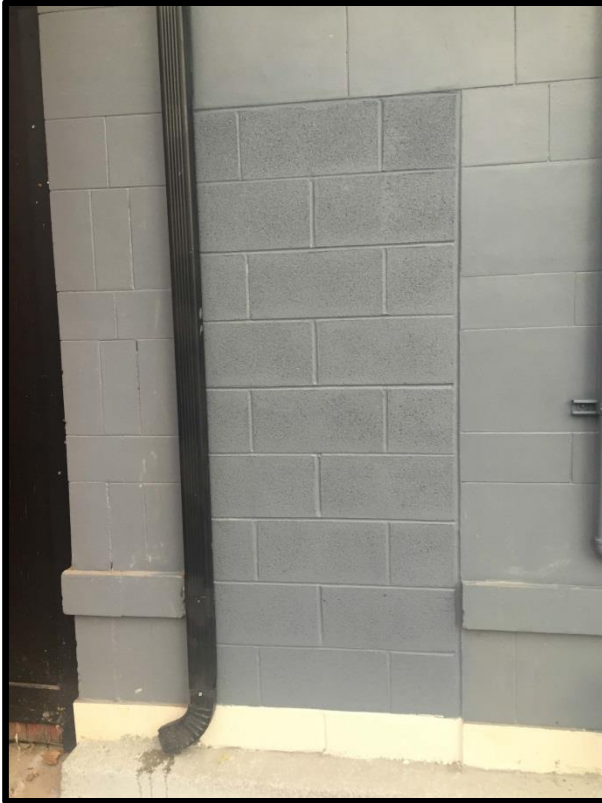
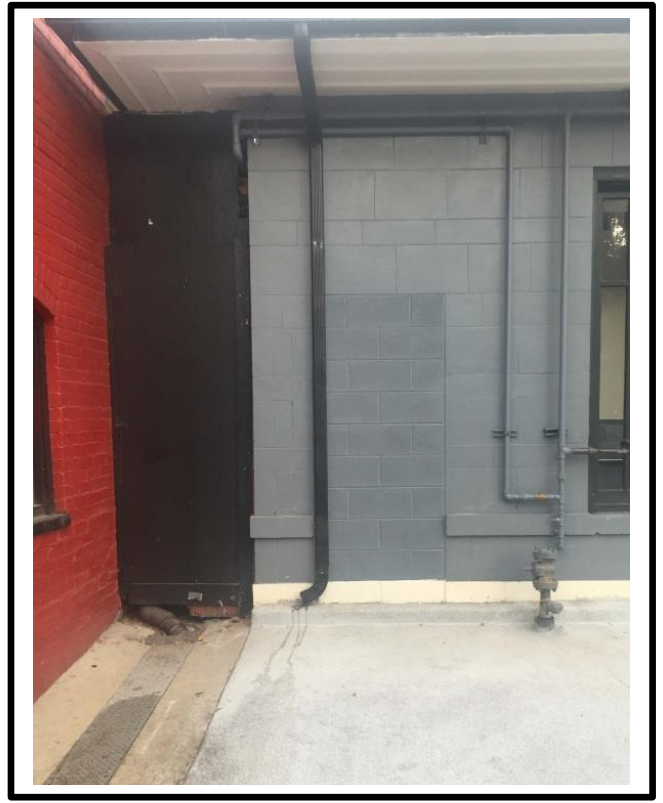
The gas line was repainted from black to blue to match the walls. Staff recommends that they remain blue to help minimize their visual impact.

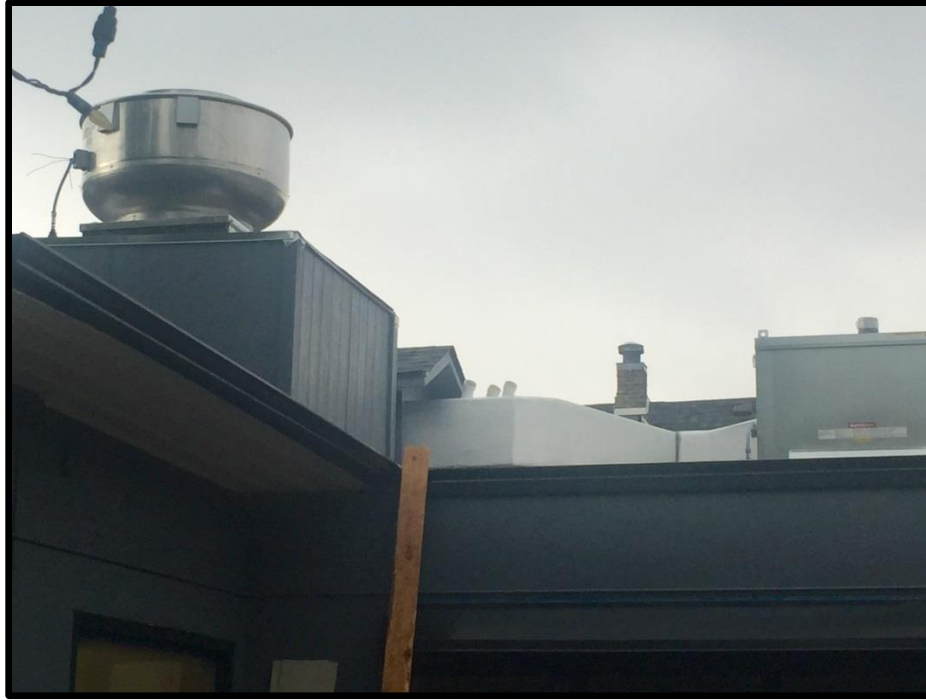
The large kitchen vent has been placed on its platform overlooking the patio. The platform is currently painted blue to match the walls of the building rather than the gray color of the roof. The staff recommends the walls of the platform be repainted to match the gray color of the roof. The recommended opaque screen would extend across the south and east sides of the flat roof, with a setback from the edge of the roof to help it appear more like a secondary parapet. The screen would also be painted gray to match the color of the roof of the pitched roof section of the building and would minimize the view of the new dormer. The dormer appears too much like it could be original to the building, which it is not.

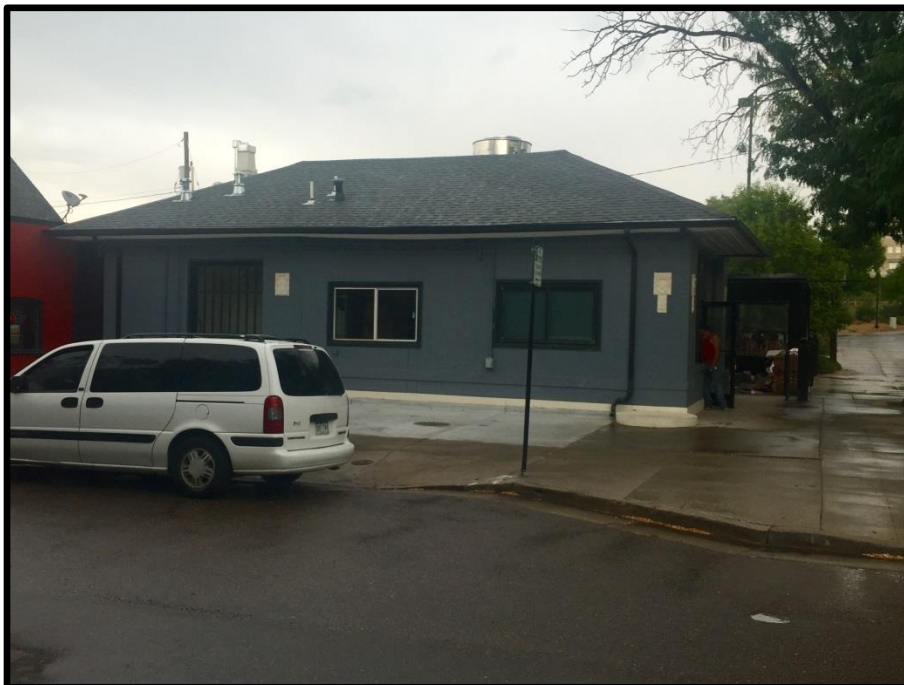
The large vent on the platform is visible over the roof from Sycamore Street, as are the other vents toward the rear of the building. All vents should be painted to match the color of the roof in order to minimize their impact on the character and integrity of the historic structure.

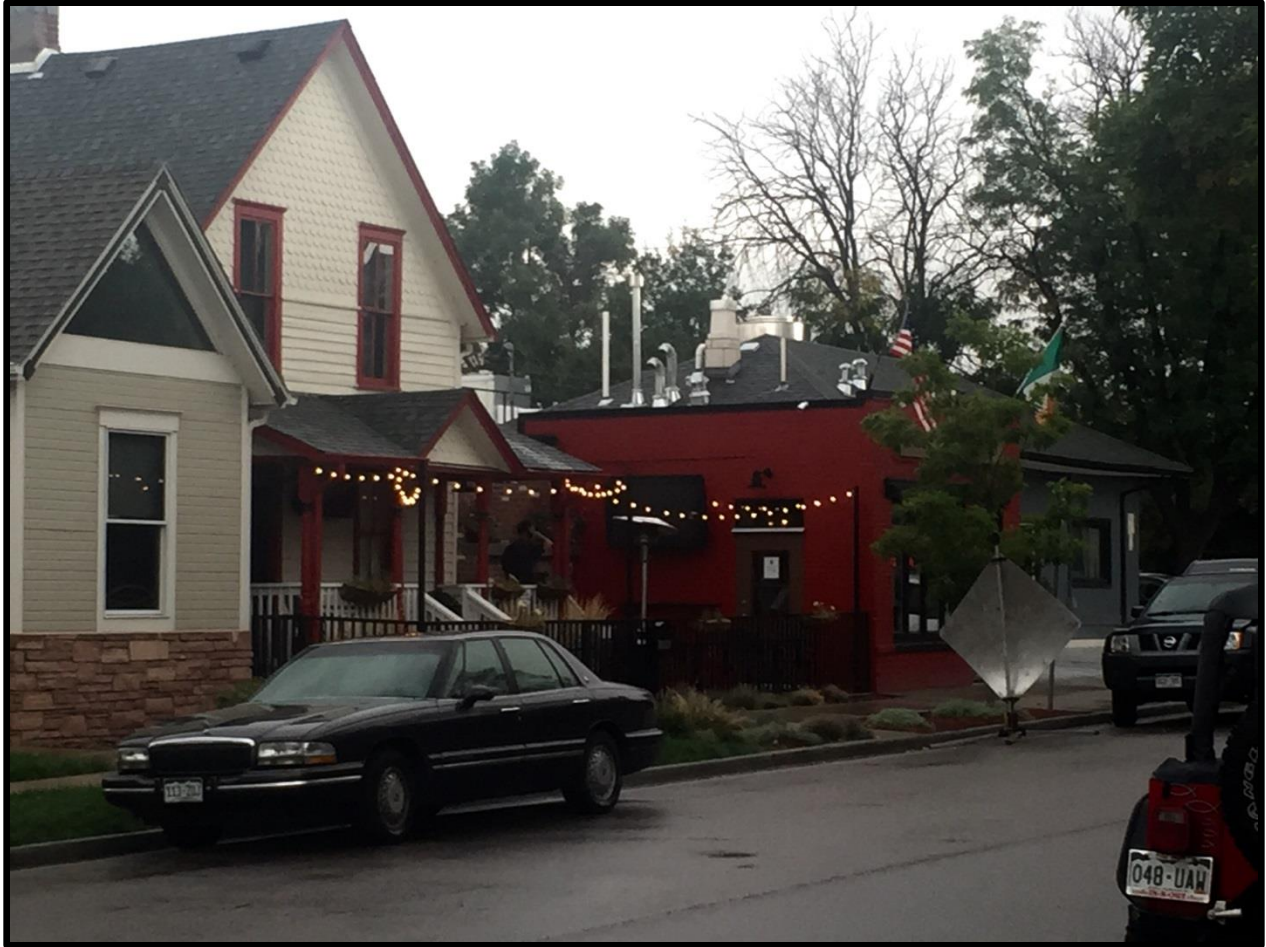
Rooftop vents are visible from north of the building on Sycamore. Staff recommends all rooftop equipment and vents be painted to match the color of the pitched roof in order to minimize their visual impacts.
