PROJECT DESCRIPTION

Property owner Francois Safieddine completed a construction project on the Blue Ribbon Stables Building and the Bussard Building and opened ViewHouse Littleton for business in June, 2017. The properties are located in the Main Street Historic District and an approved COA was in place for the work. However, there are four issues that require resolution in order to comply with the historic preservation code. The proposed COA addresses the four issues and if approved, would supersede the current COA that is in place. The issues are as follows:

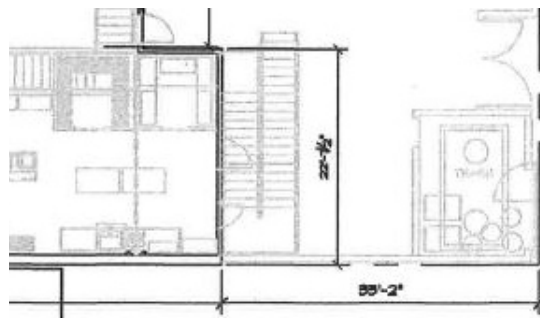
2016_approved COA with no outsider cooler shown

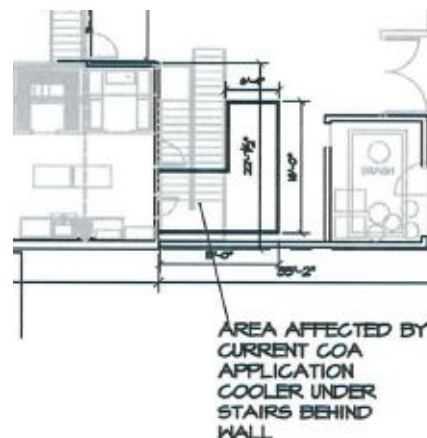
2017 COA application with outside cooler shown

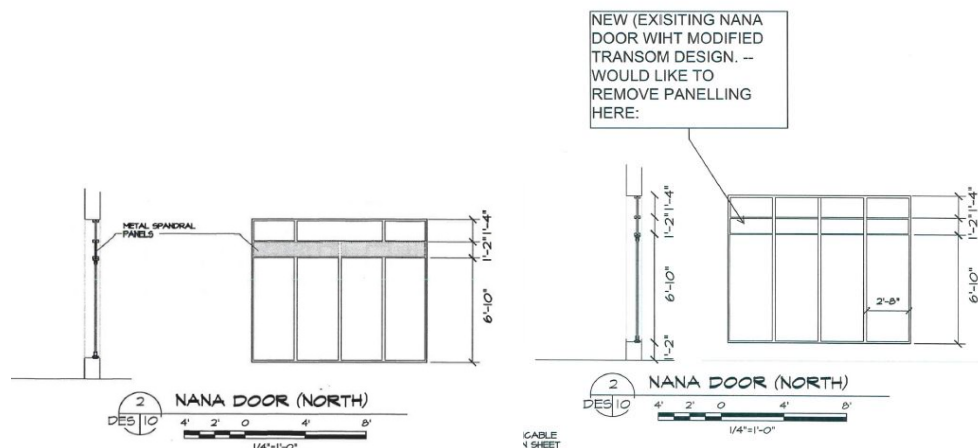
On the left are the Nano doors approved and installed per the 2014 COA. The 2014 windows had three fixed transom windows above, a continuous transom between the upper and lower windows, and four Nano windows below. Because the window fabricator was concerned that the lower windows would not be well supported by the continuous transom, the windows were redesigned to be single windows that extend from the top of the window frame to the bottom of the frame. As a result, there are now four divisions across the top and four across the bottom. The perceptible form of the new windows is intended to be transom windows on top, a continuous transom between, and separate windows below. The middle windows were fabricated with both glass and metal inserts. The 2017 CIA application asks which of the two options is more consistent with the COA criteria.

The design and construction of the Nana windows at the front of the Bussard building were modified during construction in response to issues with the original design, as it was approved by the 2016 COA. The original design was to have the lower windows open and the upper windows be fixed. The two sets of window would be separated by a structural transom. The window fabricator determined that the transom element would not be strong enough to support the Nana windows below. As a result, each vertical division of windows is now a single vertical element that is supported from the top of the window frame. The other result of the shift was to line up the muntions. The applicant is seeking approval of the modification with the current COA application.

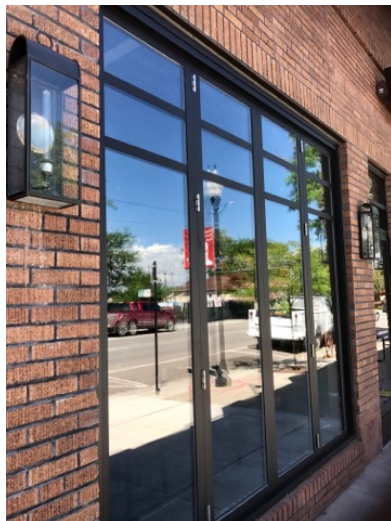
The Nana windows are currently installed without the metal “transom” inserts.

The applicant prefers to leave the panels off the transom windows to provide more light to the interior.

Staff believes that the metal transom panels are necessary for the windows to best meet the design guidelines, which call for the new design to “Preserve the character-defining elements of a traditional storefront.” With the metal transom panel inserts, the form of the upper windows bears a much stronger resemblance to the traditional transom windows.

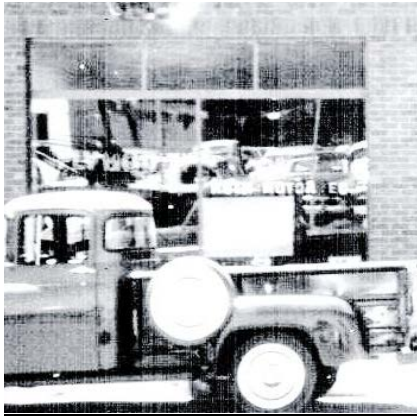
The original windows had three fixed transom windows above two larger fixed panels

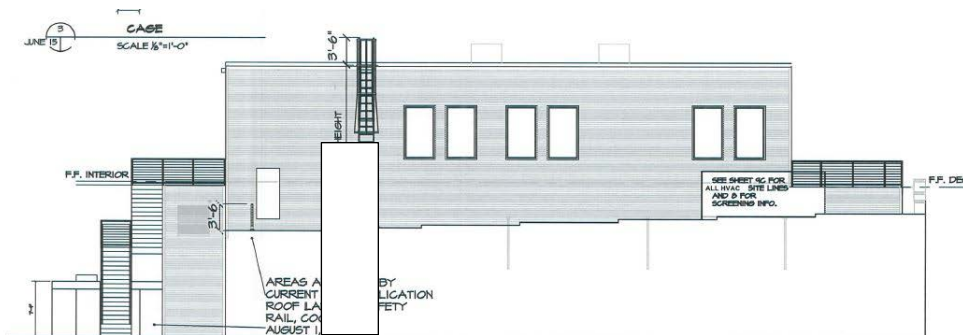
The city fire code has mandated that the contractor install an access ladder to the roof of the second floor. The ladder was not anticipated in the 2016 COA and was not included in the building permit plans. The ladder is proposed to be located on the east wall and will provide access to the roof of the second floor addition from the roof of the first floor.

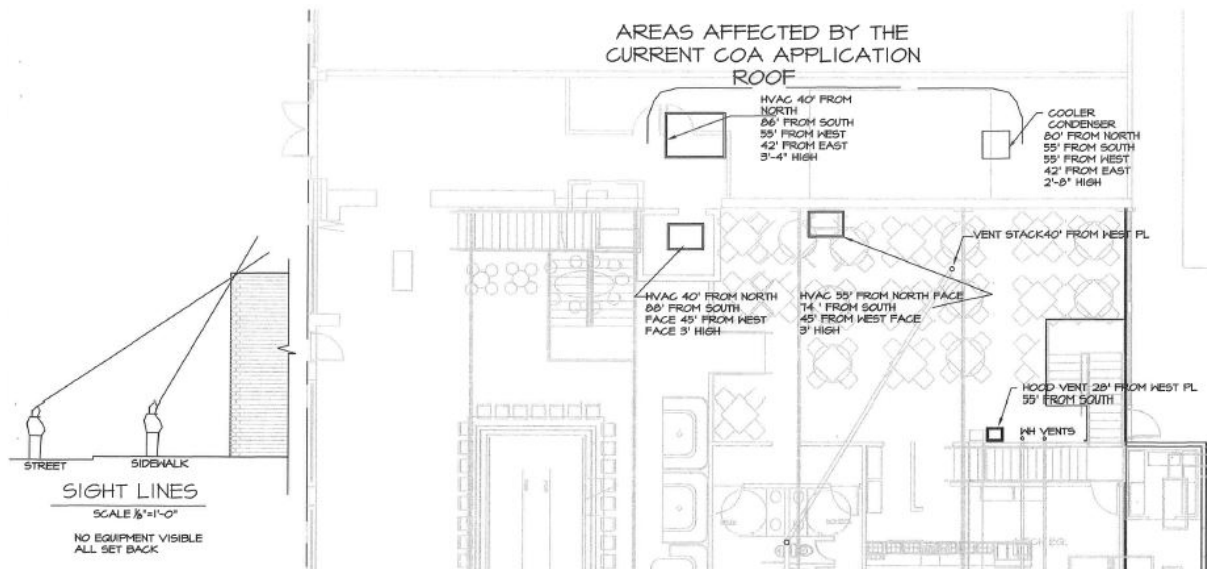
The approved 2016 COA showed the northernmost HVAC unit as 40' from the north wall and 3-4' high.

The approved COA plan set showed the HVAC unit to be 40 feet from the north face of the building. At this setback, it was demonstrated to be out of site from the sidewalk across Main Street, meeting the standard in the Downtown Design Guidelines and Standards. However, the plan set submitted with the building permit application was approved with a 13-foot setback from the north face. As such, the location of the HVAC has been approved. In order to be in compliance with the historic preservation code, however, it must be screened or an acceptable alternative must be approved, per applicable design guidelines.

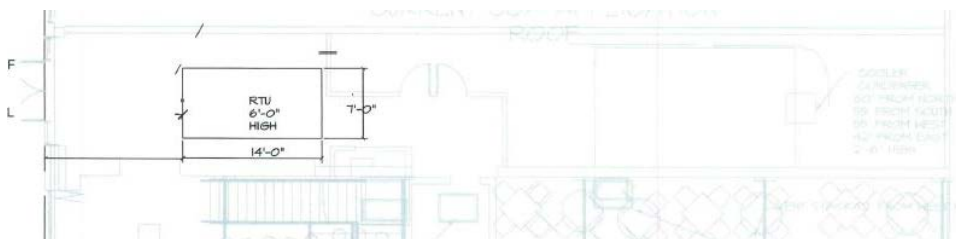
The current location of the HVAC unit, as shown on the 2017 COA application

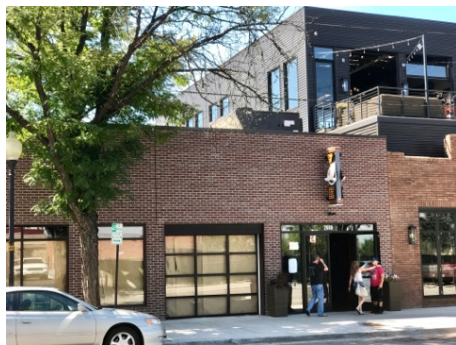
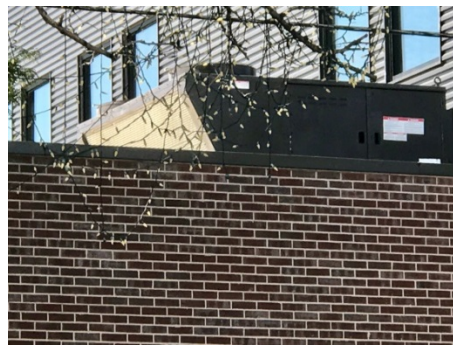
Engineering discoveries during construction resulted in the largest HVAC unit being placed 13' from the north wall, rather than 40' as approved in the 2016 COA. The HVAC unit is also 6' tall, rather than 3-4' tall, as indicated on the approved 2016
