2018 MAIN STREET HISTORIC DISTRICT GRANT PROGRAM

Restore 12 historic windows on the Spotswood

Spotswood Residence 5650 So. Curtice St.

WOOD WINDOW RESTORATION METHOD OF PROCEDURE

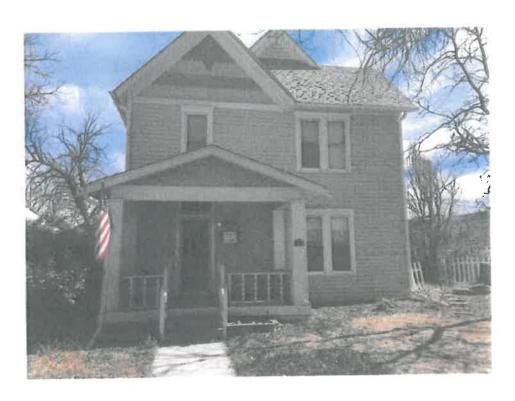
The 11 double sash Windows to be restored

There are 12 original windows in the building that we will be restoring. 11 are double sash and one is 15 pane with colored glass corners.

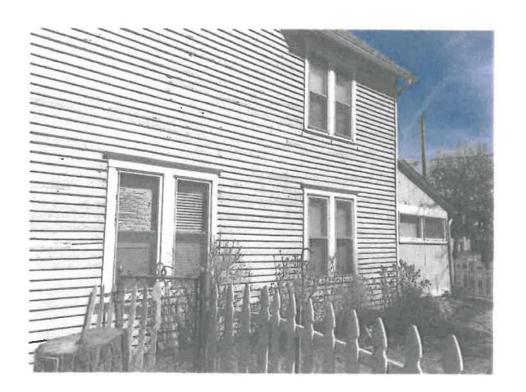
The 15 pane with colored glass corners.
To be restored on the north side of building.

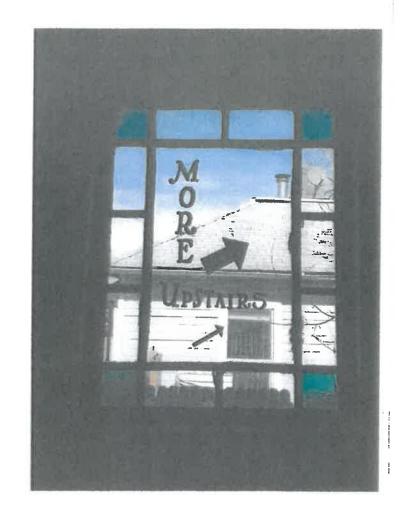
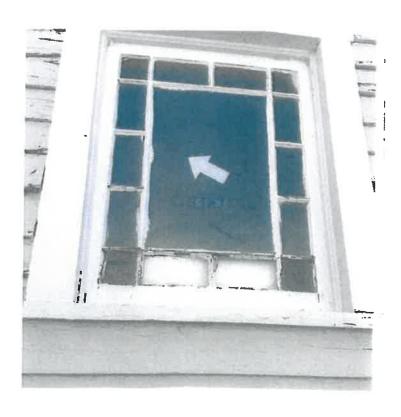
When I purchased the home in 1978 I did not know this window exsisted. It was painted on the outside The same Color of the body of the house. The inside had been paineled over. Wonderful surprise!

window frames are rotten.

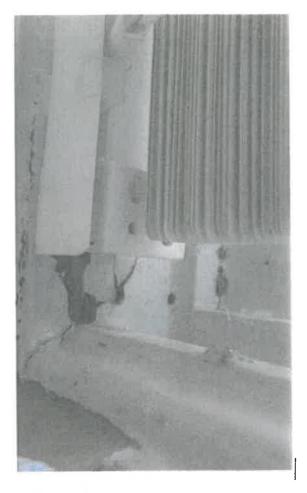
Window Frames are warped and of lass is loose

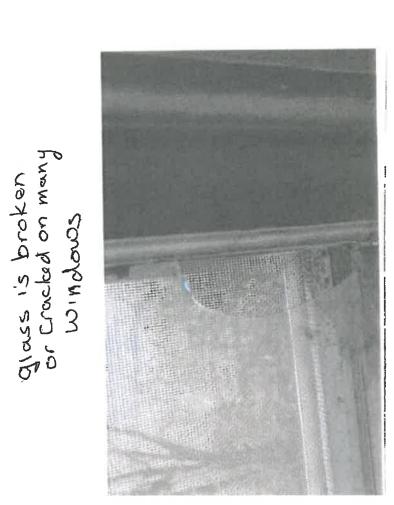
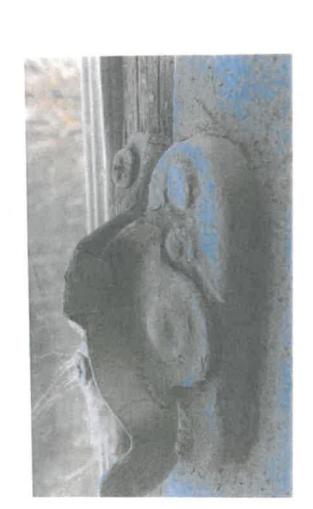
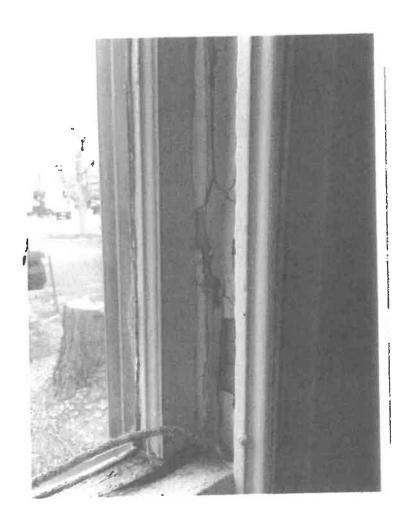
These photos represent the condition of the windows in the building. The glass no longer can be secured firmly in the frames due to rotting and warping. Creating an unsafe situation. The windows no longer stay open on there own.
