The Secretary of the Interior's Standards
for the Treatment of Historic Properties

with Guidelines for
Preserving, Rehabilitating
Restoring & Reconstructing
Historic Buildings

Kay D. Weeks and Anne E. Grimmer

U.S. Department of the Interior
National Park Service
Cultural Resource Stewardship and Partnerships
Heritage Preservation Services
Washington, D.C.
1995

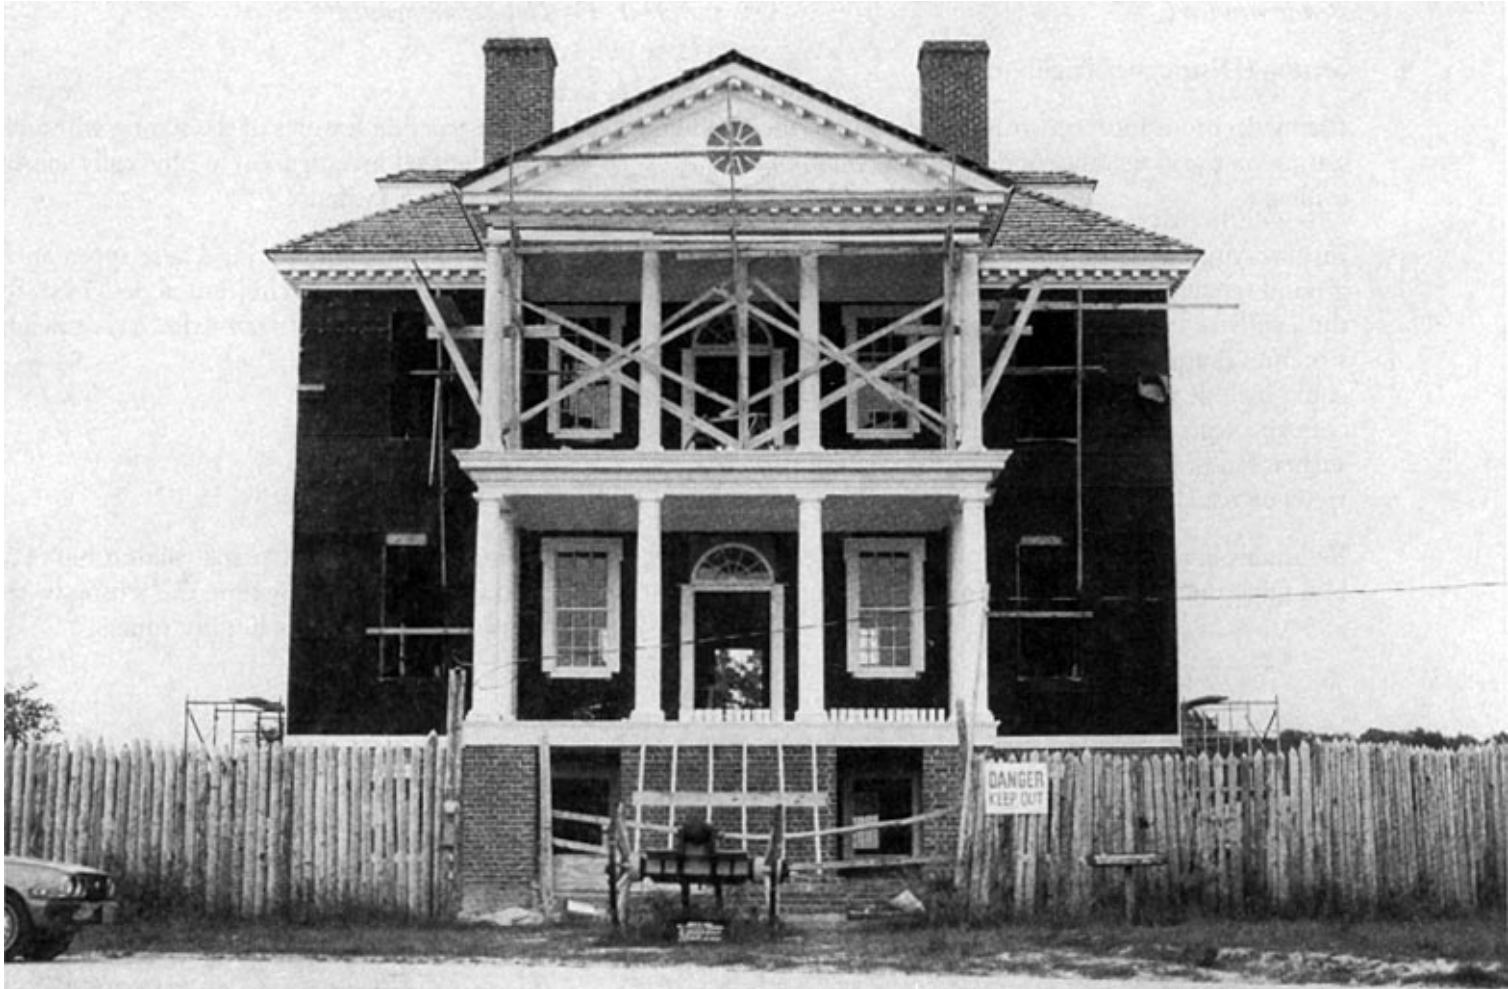
The 1778 Kershaw House, which served as British Headquarters during the Revolutionary War, was burned by Union troops in 1865. In the early 1970s, the house was reconstructed as part of Camden Battlefield, Camden, South Carolina. Built expressly for interpretive purposes, it serves as an illustrative reminder of a past event of national significance. The Standards for Reconstruction call for any re-created building to be clearly identified as a contemporary depiction. This is most often done by means of an exterior sign or plaque, or through an explanatory brochure or exhibit. A guide may inform visitors as well. Photo: Richard Frear.
