**APPLICATION FOR COLORADO STATE INCOME TAX CREDIT  
FOR THE PRESERVATION OF HISTORIC STRUCTURES  
(RESIDENTIAL PROPERTY – 2014 CREDIT)**

Name of Property: The Nyman House

Address: 5475 S Mohawk Road

DESCRIPTION OF REHABILITATION

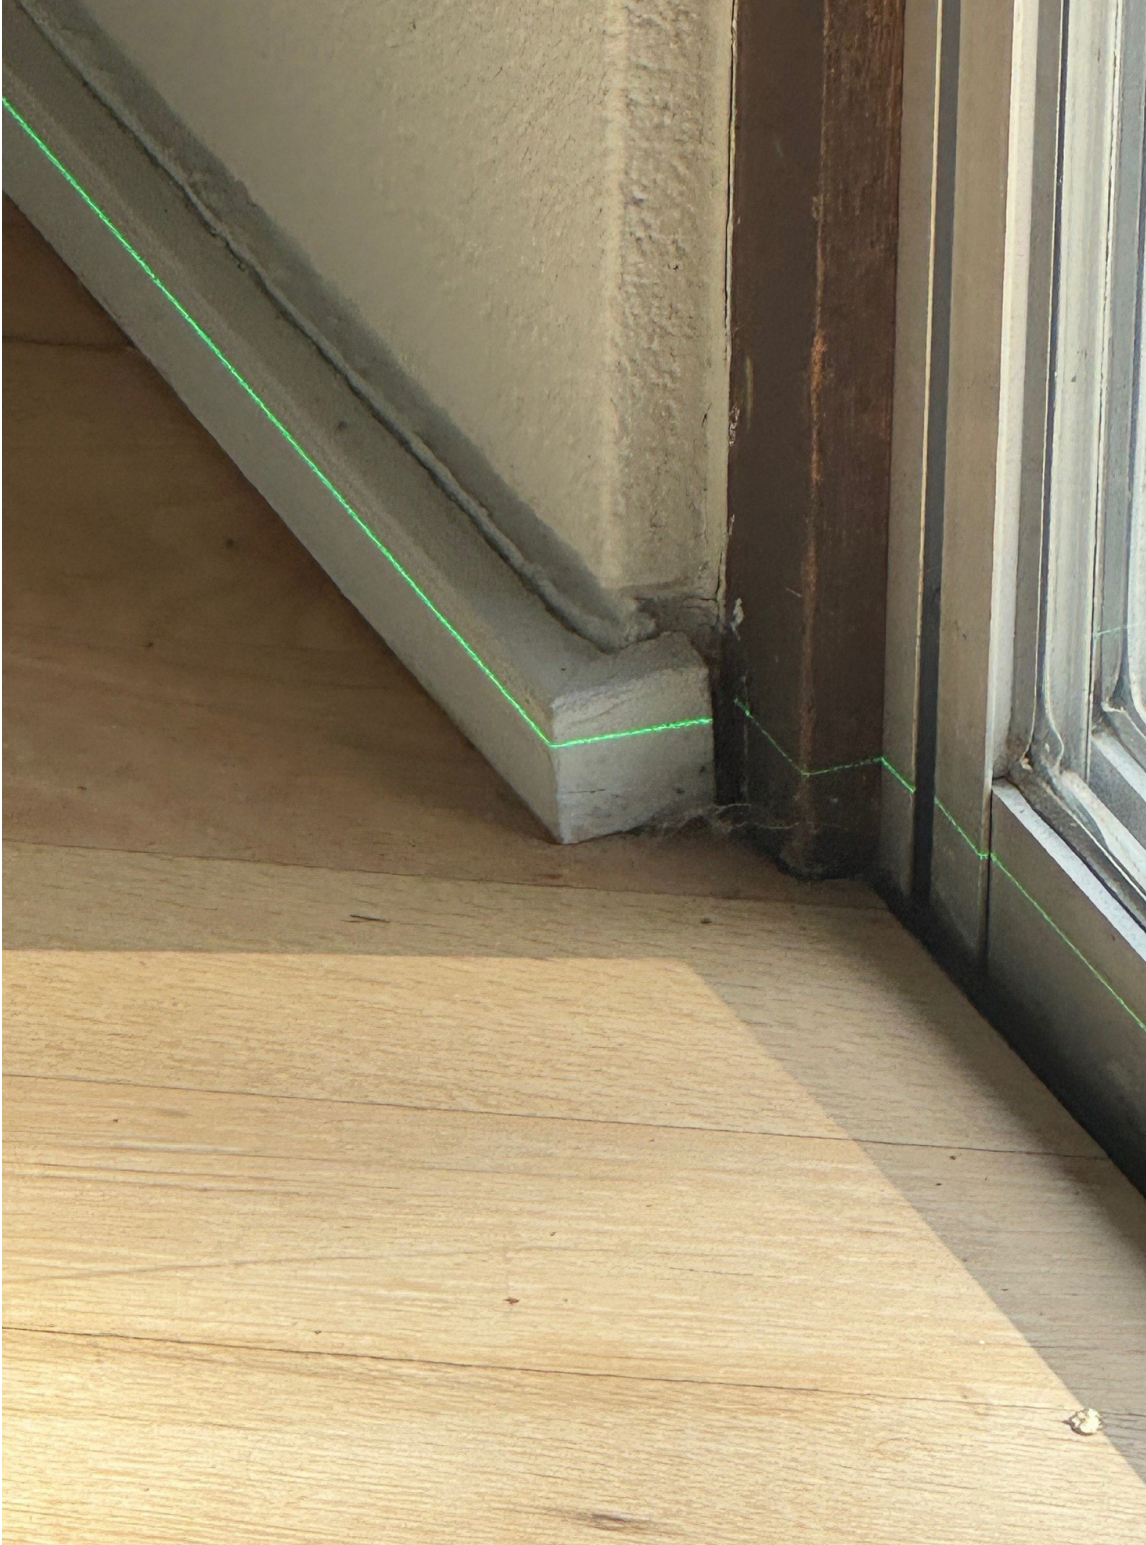
## #2 SLAB SETTLEMENT

| 1. | Architectural Feature: <small>Sewer Line Backup</small><br><br>Describe feature and its condition: | Describe work/impact on feature: |
|---|---|---|
| | <p>The house is slab on grade. When the small area of wood flooring was removed from the kitchen for mold remediation, it revealed major cracks in the concrete slab. When a hardwood floor installer came to look at patching the wood floor in the kitchen he put a laser on the floor and revealed that the slab had settled up to 2 inches in many areas, with a high point at the center of the home, and the low points along the exterior walls. The settlement was so extreme that it was not possible to install new wood flooring over top of it to patch the kitchen floor because the floor variation exceeded the allowable limits for wood flooring installation.</p> | <p>The wood floor and plywood subfloor had to be removed from the living room, kitchen, dining room, and guest bedroom, which were continuous areas of flooring. This fully revealed extent of damage to the slab from settlement. The settlement extended under the kitchen cabinets, and in order to level the slab to the point that new flooring could be installed, the remaining kitchen cabinets had to be removed. Because they were site built and structurally connected, it was not possible to remove them without damaging them. The slab had to be ground down at the high point, and up to an 1-1/2" of leveling concrete with fiber mesh reinforcement had to be poured. New 4" wide white oak flooring to match the previous floors will be installed over the leveled slab.</p> |

LASER LINE SHOWS HIGH POINT OF FLOOR  
IN CENTER OF THE ROOM, AND HOW MUCH  
THE SLAB HAS SETTLED AT THE  
PERIMETER WALLS

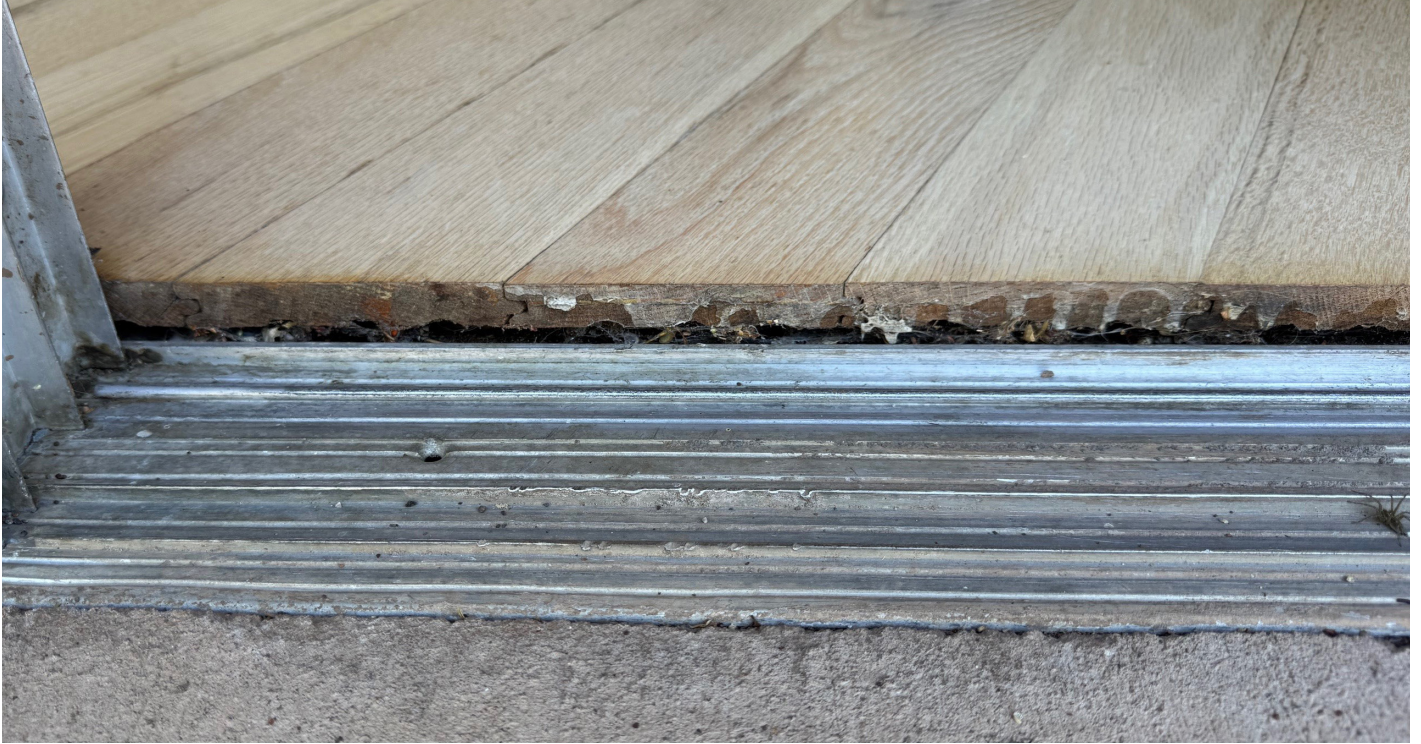
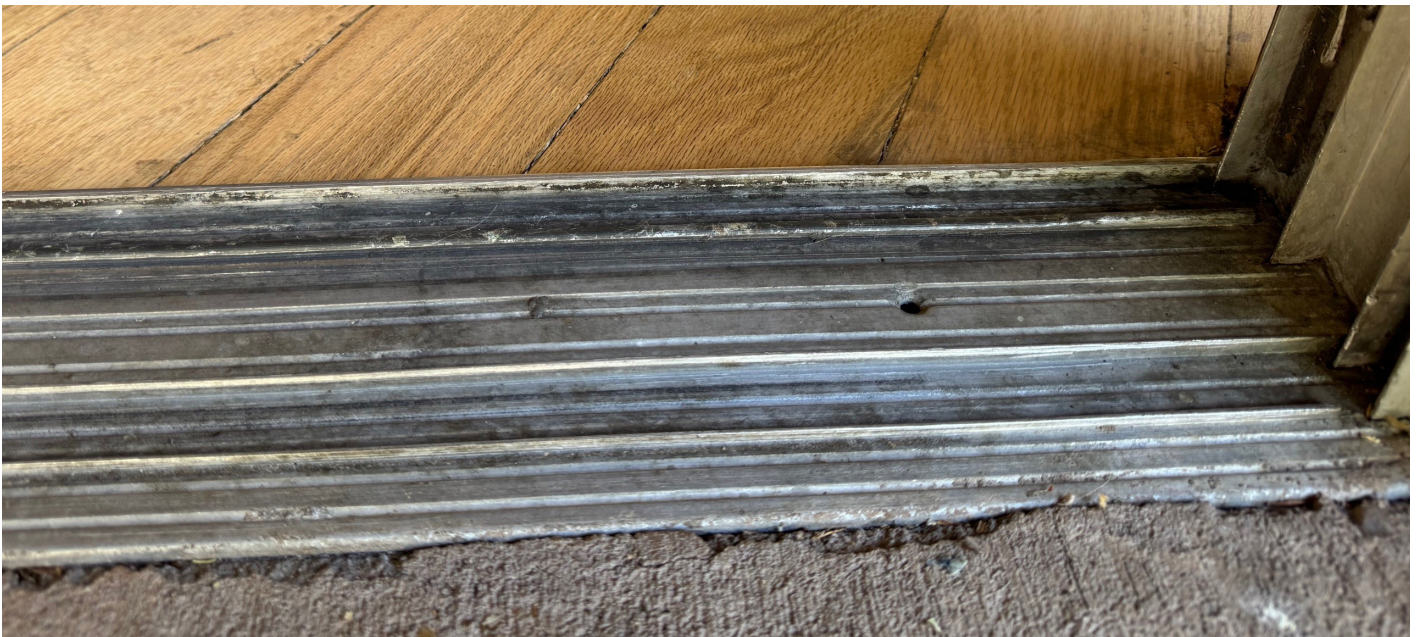
#6 DINING ROOM WINDOW WALL

| 6 | <p>Architectural Feature: Dining Room Window Wall</p> <p>Describe feature and its condition:</p> <p>The dining room features a wall of floor to ceiling windows along its western edge. Two original aluminum sliding glass doors bracket 4 fixed windows. All of the sliding doors and fixed window feature single pane glass. The wood frames of the windows are deteriorated and rotten. The weather stripping and seals of the sliding glass doors are missing or damaged, leading to considerable air and insect infiltration. The non-thermally broken aluminum frames of the sliding door ice up on the interior side during the winter. The interior floor slab has experienced differential settling along the length of this window wall, varying by as much as 2" from end to end. The settlement of the slab and the structural posts that bear on it have lead the beam at the head of the windows to sag 1-1/2" at its center point.</p> | <p>Describe work/impact on feature:</p> <p>In order to fix the floor slab settlement issues, the two existing sliding doors, and the fixed windows had to be removed. The Nyman house was designed for direct connection of the interior and exterior spaces. Every room features a connection to outside. If the original architect had today's window and door technology, he would undoubtedly have used this to increase this connection even more. The decision was made to take advantage of today's door technology and replace the sliders and fixed windows with two bifolding Nanawall doors. This will allow the entire wall of the dining room to be opened to the exterior. The panels of the new doors match size, spacing, and rhythm of the previous sliding door and fixed window panels. A new steel beam, matching the size of the existing wood beam was installed to carry the roof load over the opening and fix the sagging issue of the previous beam.</p> |

PHOTOS SHOW DIFFERENCE IN INTERIOR  
FLOOR HEIGHT RELATIVE TO DINING ROOM  
SLIDING DOOR SILLS FROM ONE END TO  
ANOTHER

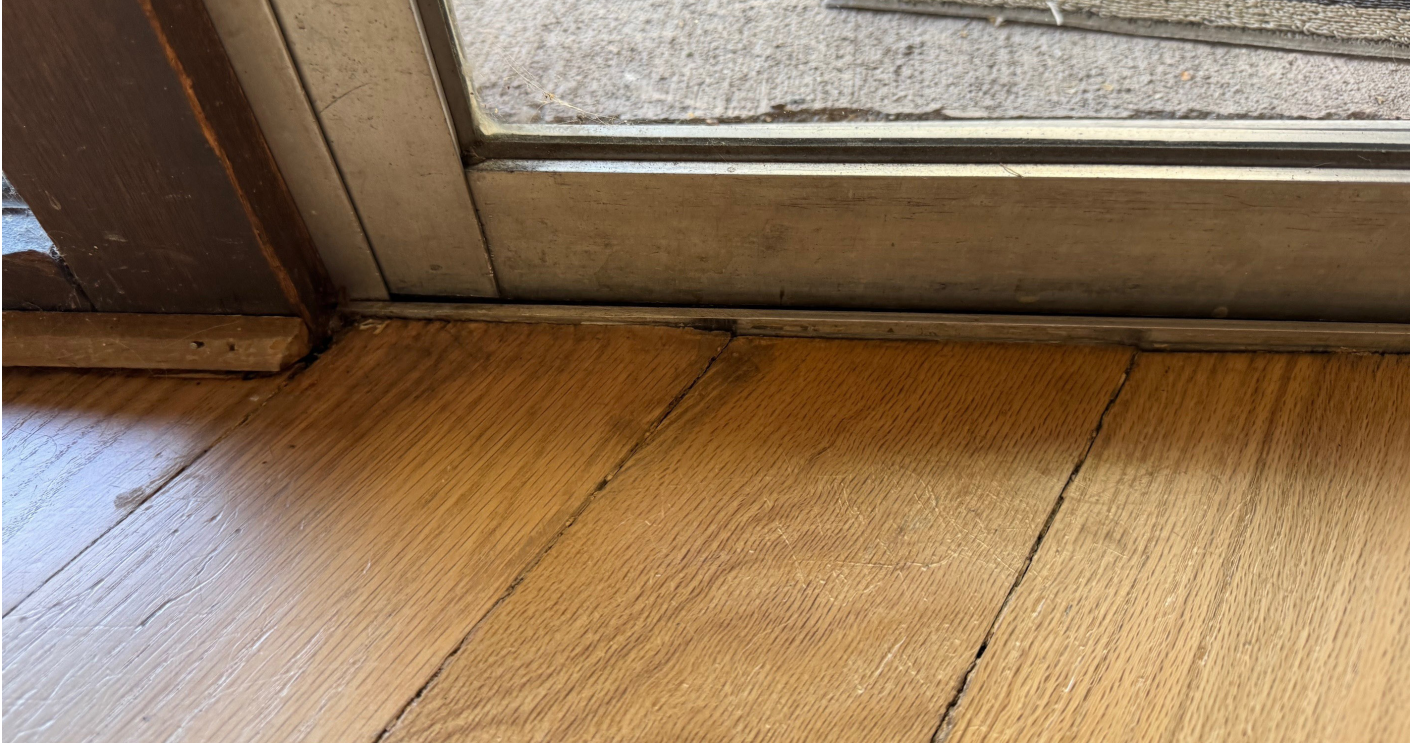
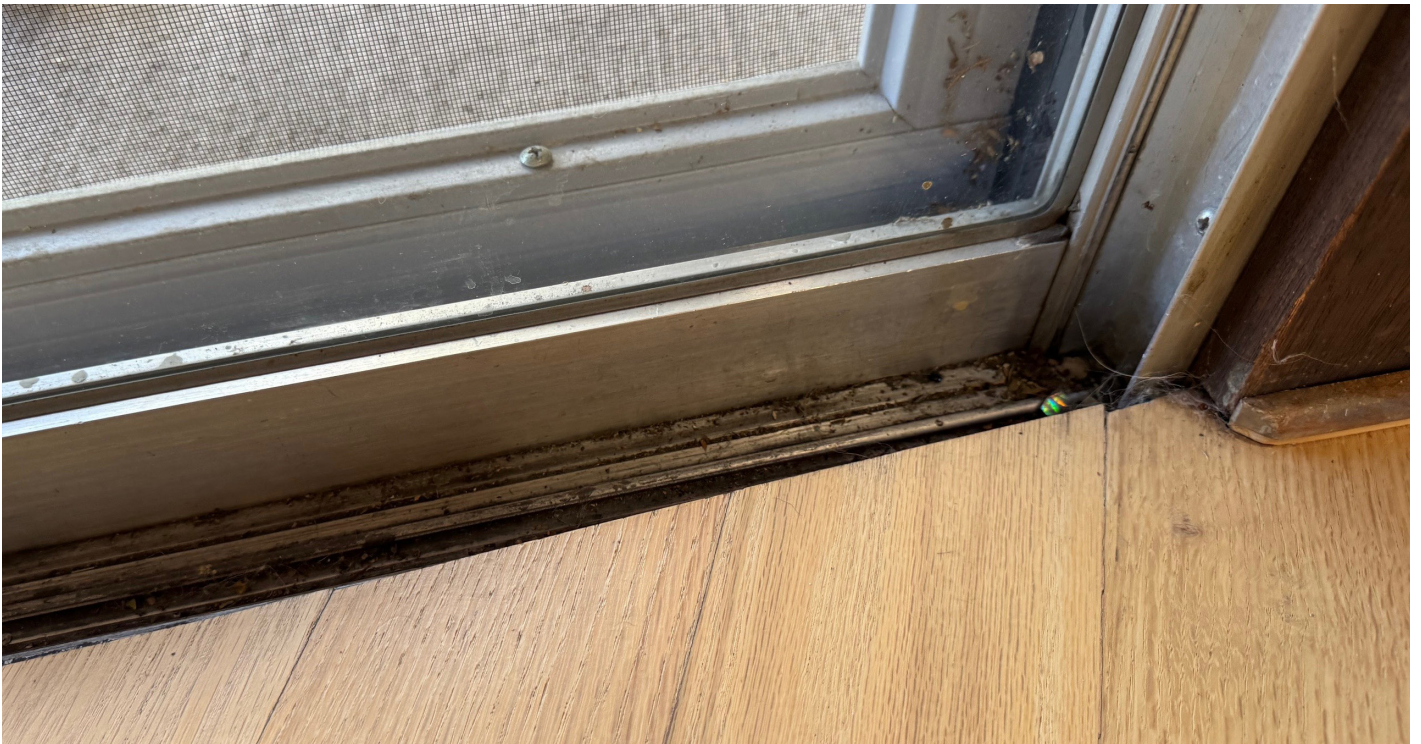
#6 DINING ROOM WINDOW WALL

PHOTOS SHOW DIFFERENCE IN INTERIOR  
FLOOR HEIGHT RELATIVE TO DINING ROOM  
SLIDING DOOR SILLS FROM ONE END TO  
ANOTHER

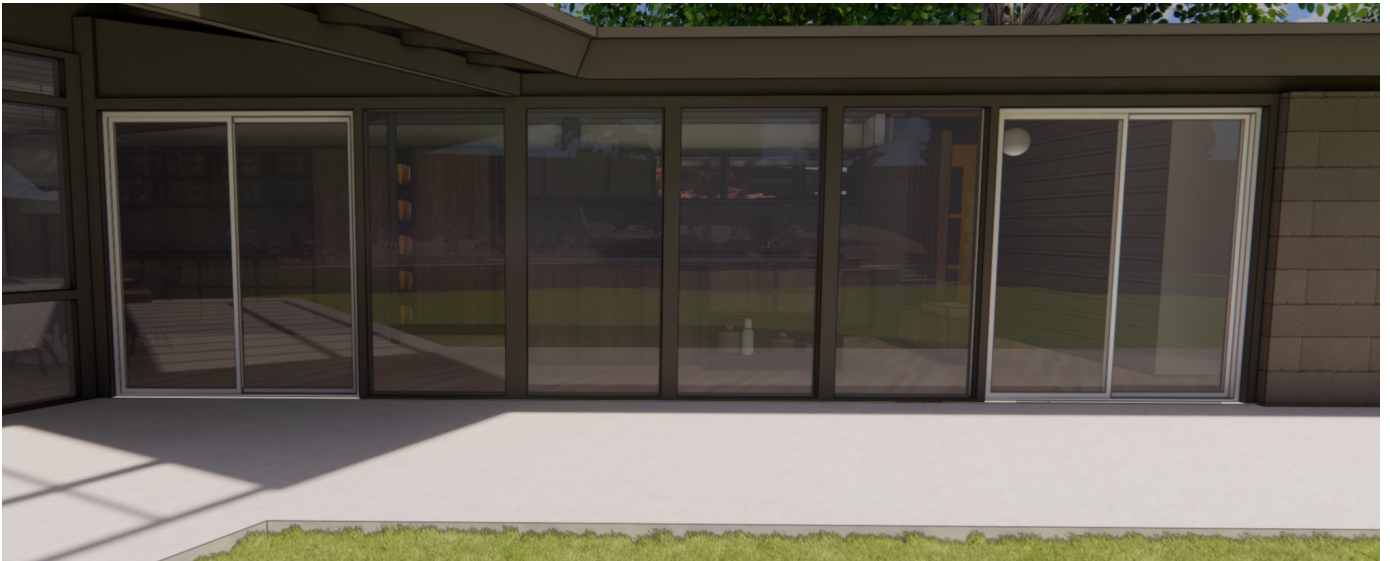
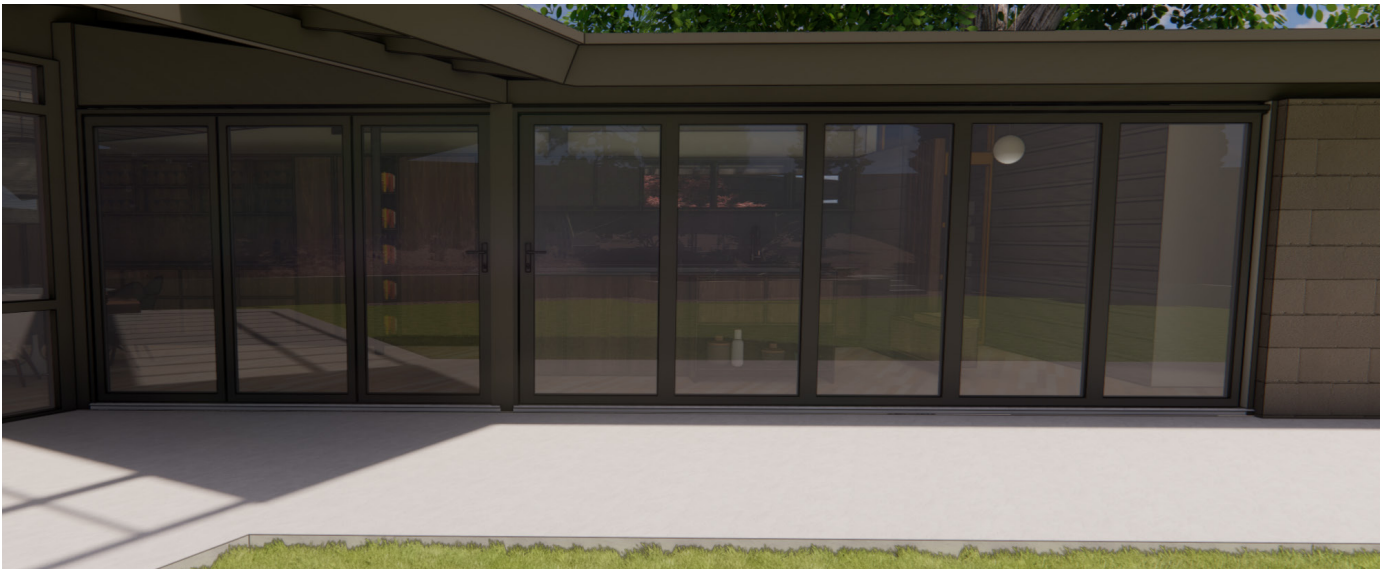
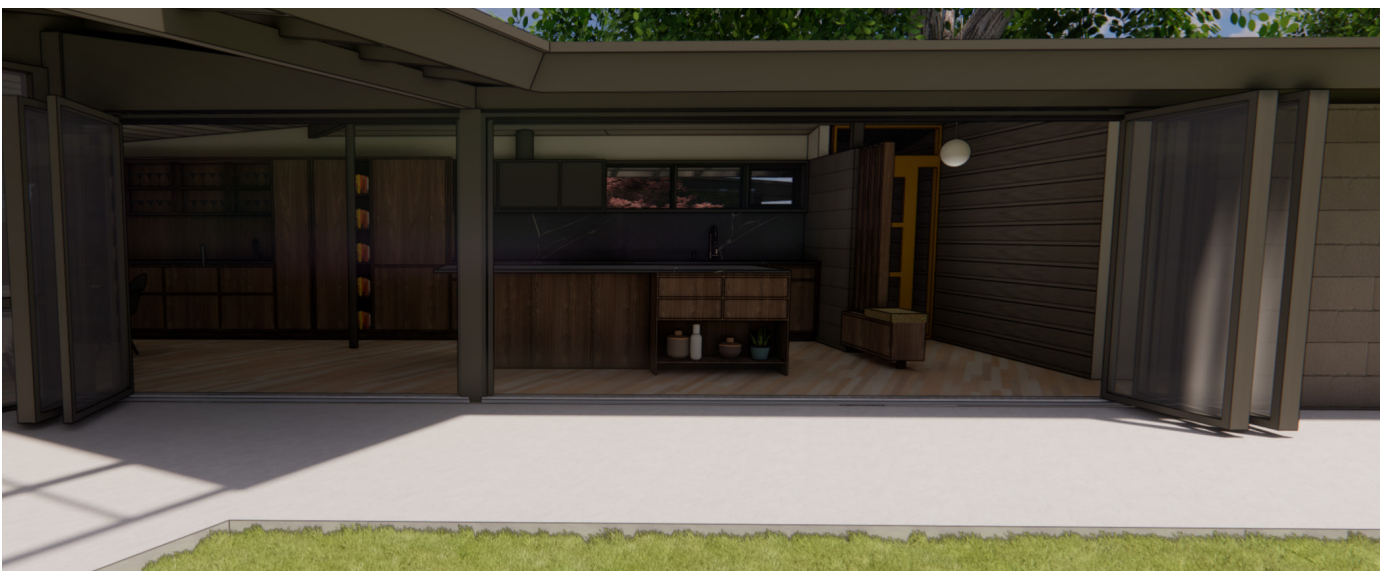
## #6 DINING ROOM WINDOW WALL

TOP IMAGE - EXISTING  
MIDDLE IMAGE - PROPOSED (DOORS CLOSED)  
BOTTOM IMAGE - PROPOSED (DOORS OPEN)
