#### **POND 1 NOTES**

POND 1 IS A DETENTION AND WATER QUALITY FACILITY THAT SERVES THE SOUTH PORTION OF THE WILD PLUM PROJECT. THE POND WAS DESIGNED PER UDFCD FULL SPECTRUM PROCEDURES AND UTILIZES THE SAND FILTER CONCEPT FOR WATER QUALITY TREATMENT. STORMWATER IS RELEASED AT A CONTROLLED AND ALLOWED RATE VIA TWO OVERFLOW WEIRS TO COOLEY LAKE.

# WILD PLUM POND 1 MAINTENANCE SITE PLAN

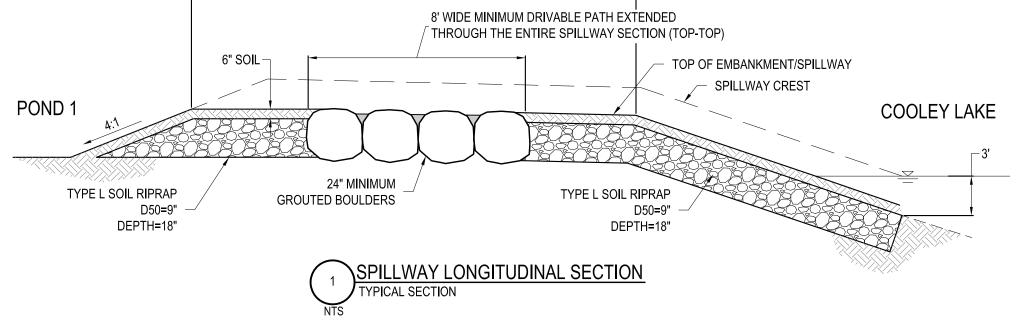
⊢6" SOIL

\*34.8 CFS IS THE TOTAL ALLOWED DISCHARGE **KEY MAP** FROM POND 1. EACH SPILLWAY CONVEYS HALF OF THIS FLOW, 17.4 CFS, AT THE 100-YR WSE. NOTE THAT THE EXISTING DISCHARGE TO COOLEY LAKE

-50-60' WIDE BENCH-

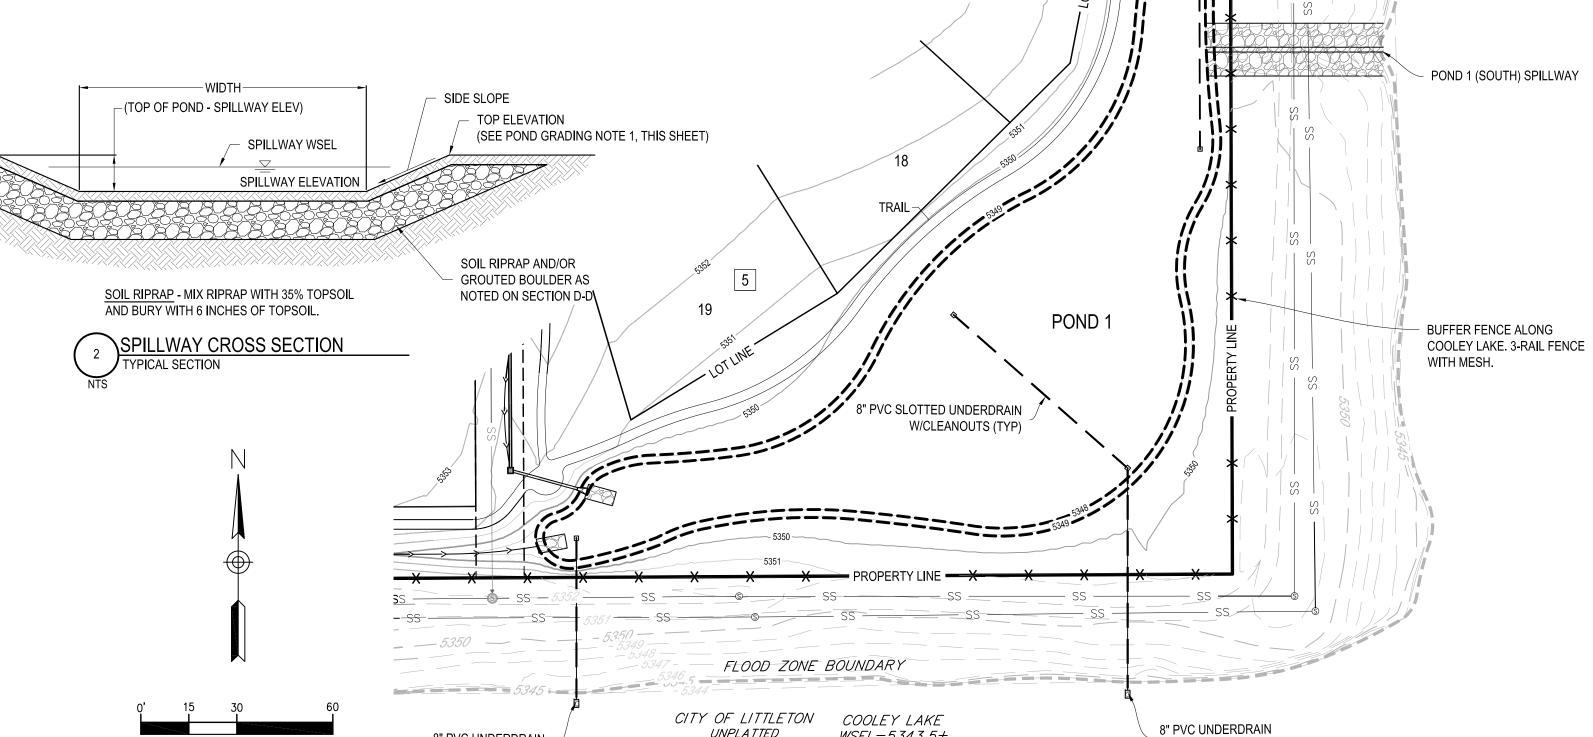
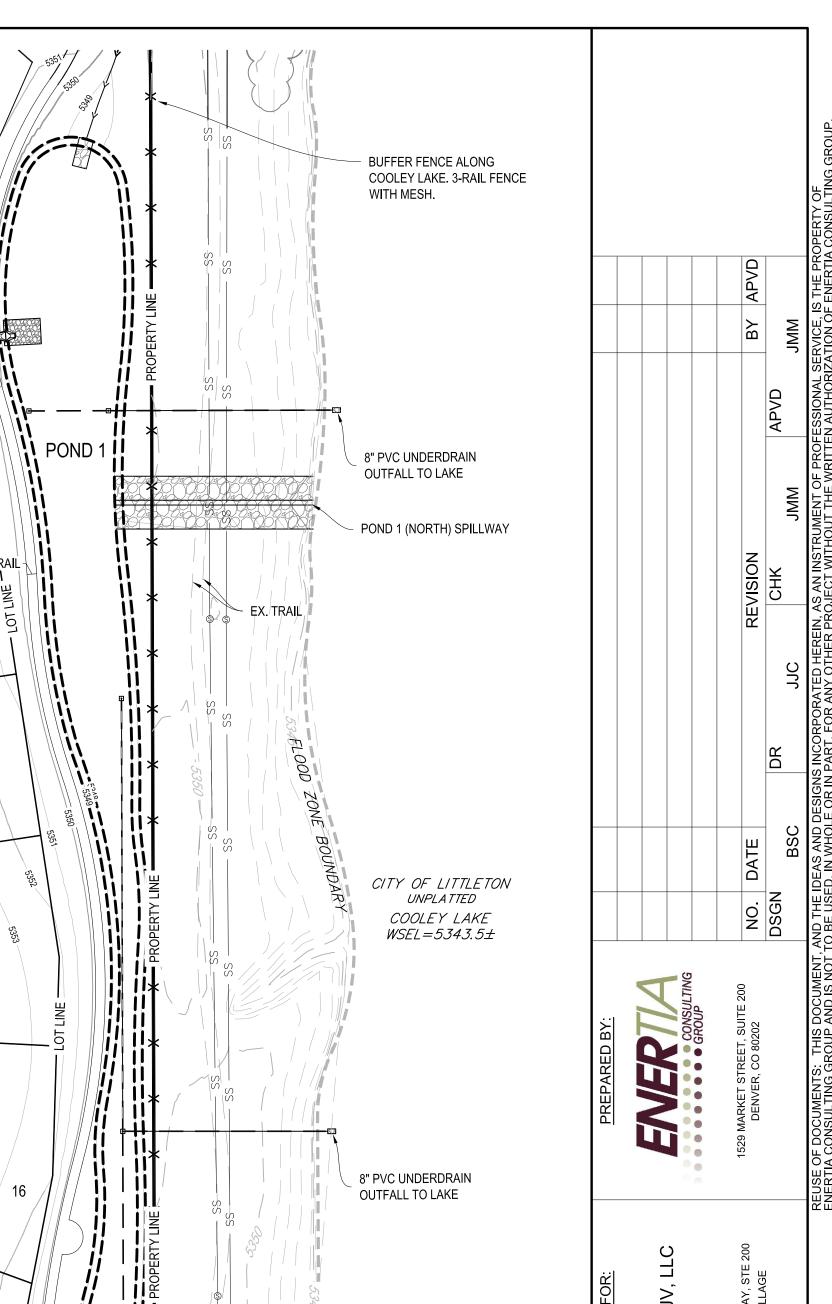
8" PVC UNDERDRAIN

OUTFALL TO LAKE

WSEL=5343.5±

#### TWO SOIL RIPRAP SPILLWAYS. THE SPILLWAYS ARE SIZED TO DISCHARGE THE TOTAL ALLOWED OUTFLOW FROM POND 1 (34.8 CFS TOTAL)
